CHAPTER ONE

McWay Landslide Restoration - Task One

History of McWay and Restoration Activities

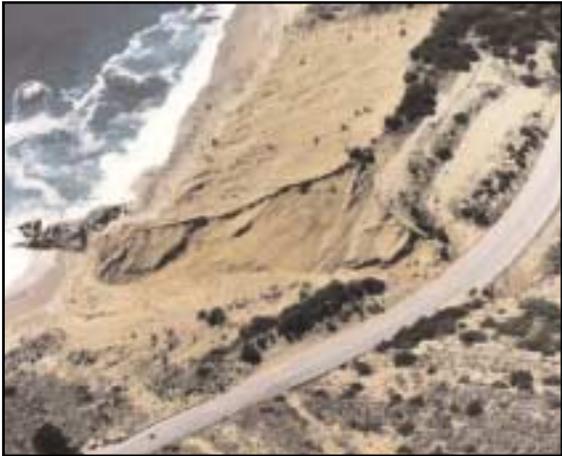
Figure 1.5. Mcway 1993. Note the evolution of gully on right side of slide in this photograph and the following figure.

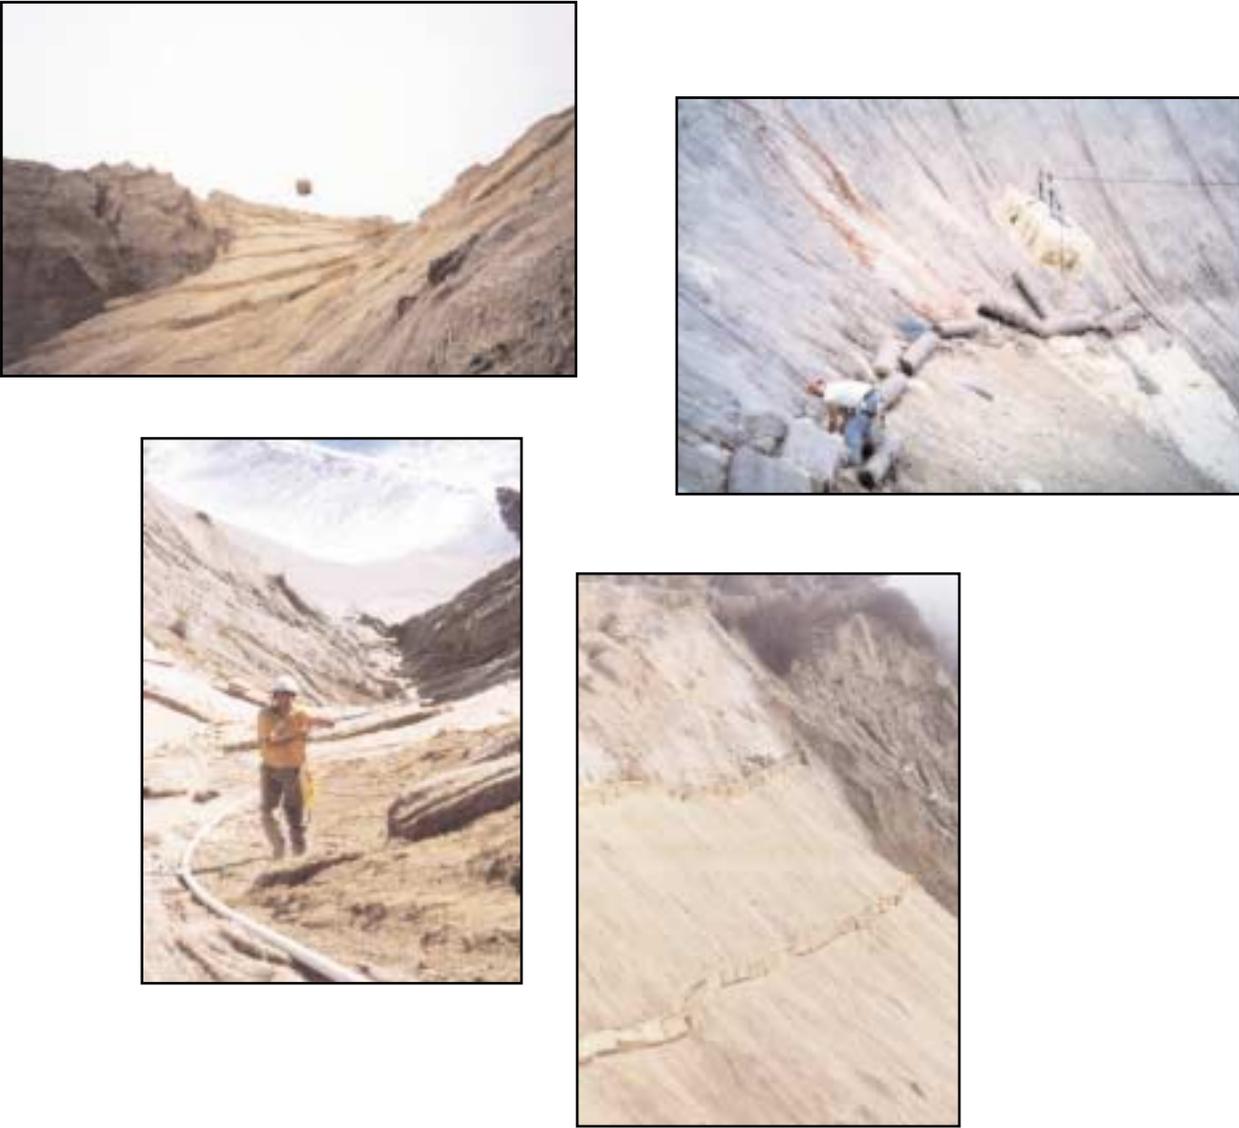
Figure 1.9. 1998 McWay site preparation.

Initial site preparation in 1998 included placement of straw bale slope breakers, jute netting, and irrigation lines. This formidable task was accomplished by training crews to work in climbing harnesses and ropes. (Fig. 1.9.)

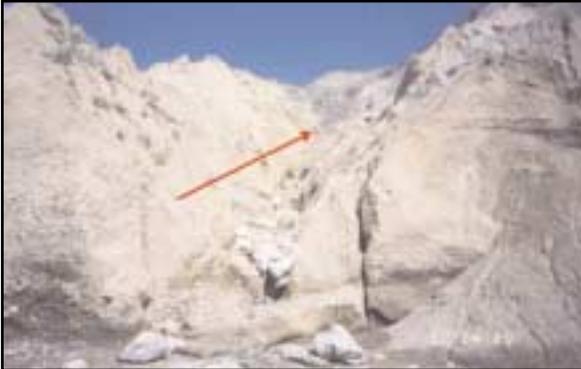
Figure 1.14. The main gully pictured from the beach. Arrow marks the top of the point at which the smaller, more unstable gully begins on the slope.

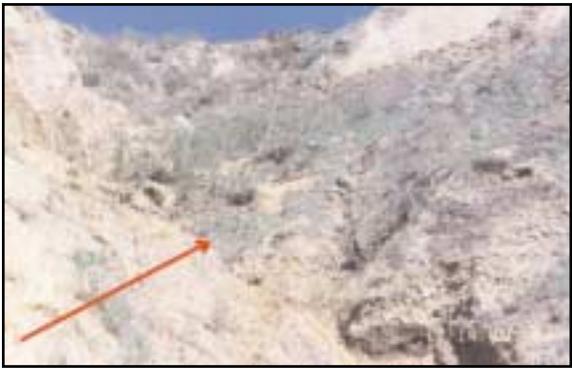
Figure 1.15. A close up of the top of the smaller gully showing the willows in the more stable area, and bare soils below.

The head of the main gully is bowl shaped and stable. Within the main gully a smaller gully formed during the winter of 1998. This smaller gully continues to erode and move upslope towards the more stable bowl at the

head of the main gully. Little vegetation has established at and below this unstable part of the main gully. Continued work will be required in this area in order to protect the stable areas up slope. This work would be best conducted in the fall of 2001 just prior to winter rains.

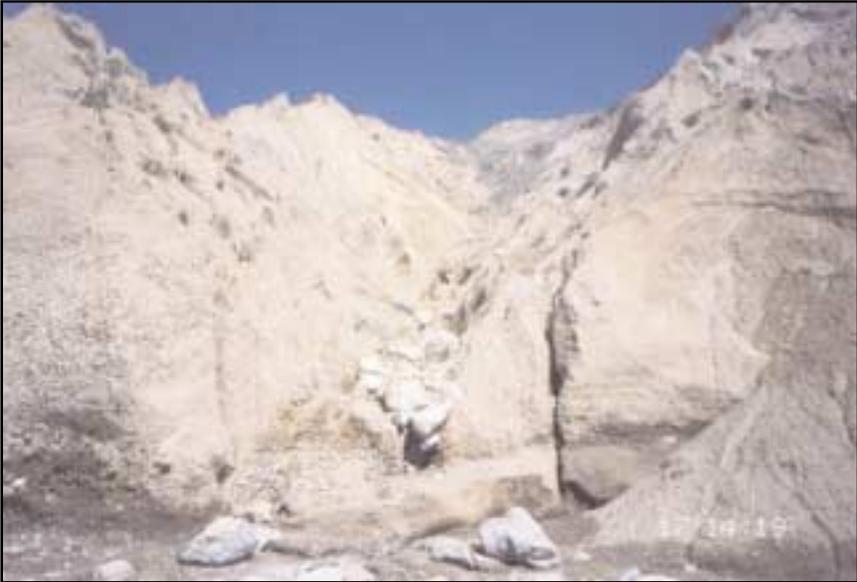
Figure 1.16. Main gully from the beach.

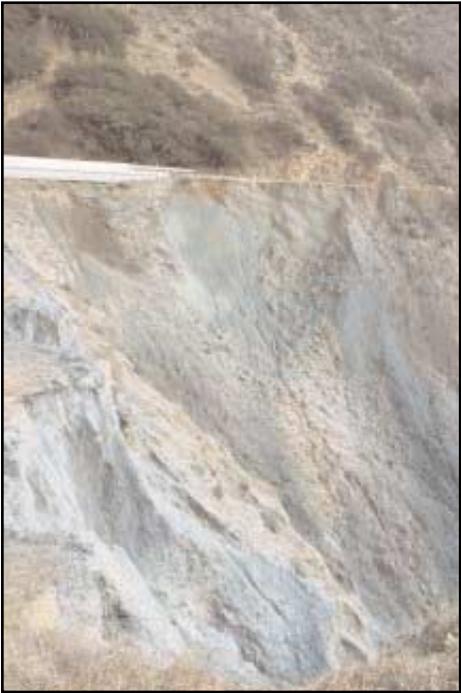
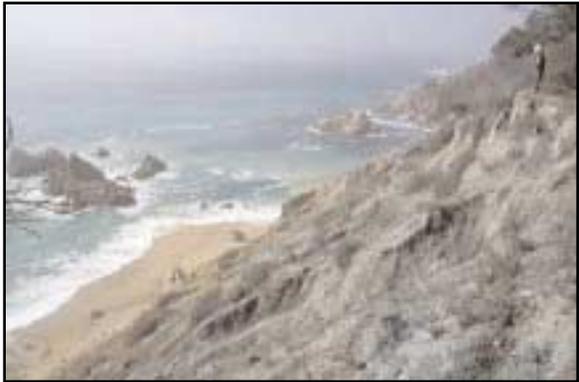
Figure 1.17. Two views of hydroseeded slope.

The unconsolidated mass of soil overcast west of Highway One is unstable and subject to significant soil migration. Since these areas have often experienced additional land movements we recommend the use of inexpensive annual cover crops on unconsolidated fill and the unstable sites. Permanent revegetation seed

mixes of coastal sage scrub may be applied in stabilized locations. Selected annual cover crops will mitigate surface erosion and may help stabilize sites, but can not solve geologic problems on unconsolidated/non-engineered fill in areas west of Highway One.

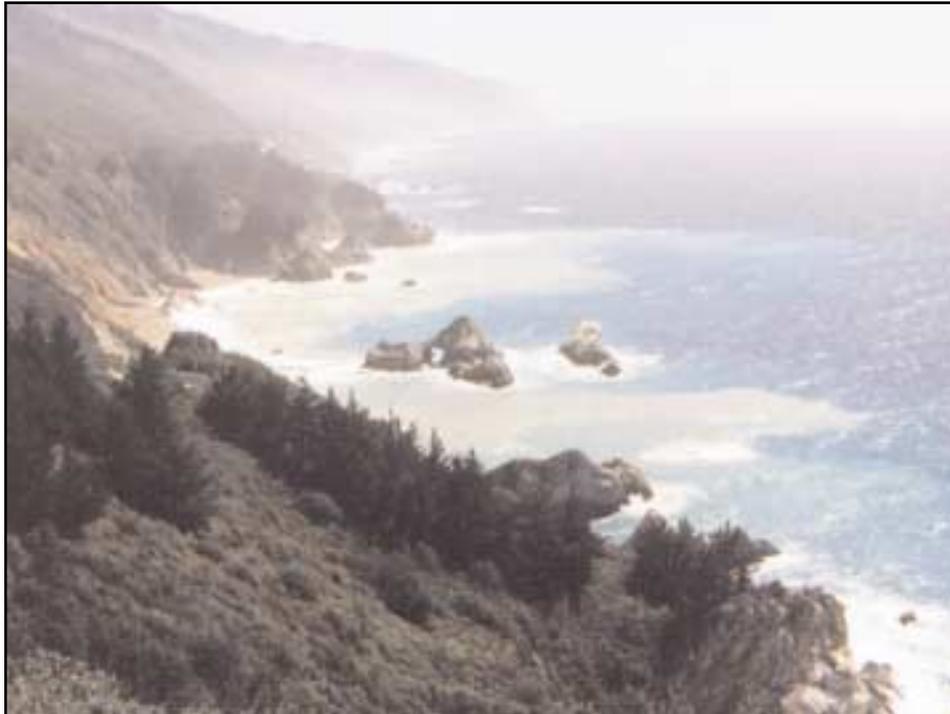
Figure 1.19. Sediment plume from rain-washed slope.

slope occurred. One day after seeding was completed, a majority of the surface dislodged and fell onto the boulder strewn toe of the slope and washed out into the Sanctuary. Subsequently 2,500 bales of rice straw were applied to cover the exposed areas, effectively halting a significant amount of the erosion (Fig. 1.19 and 1.20.).

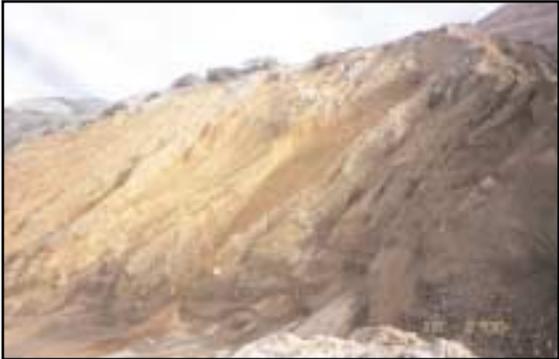
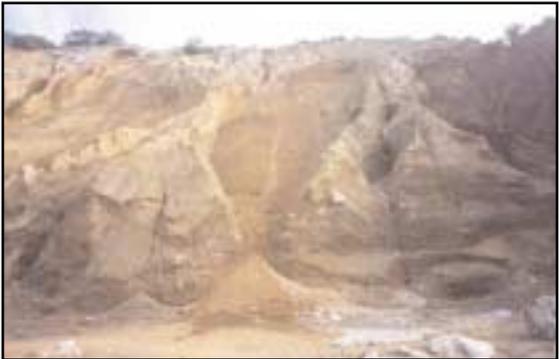
Front face prior to rain.

Figure 1.20. Front face of McWay, before and after rain. Time series photographs showing erosional events before and after rain in February 2000.

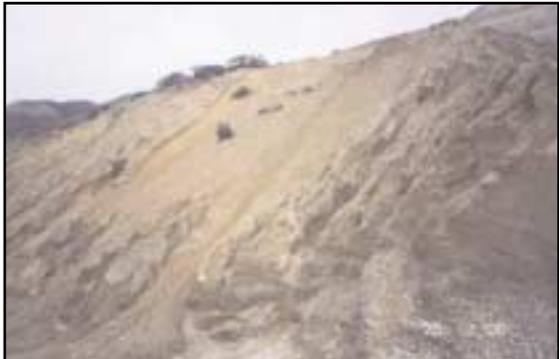
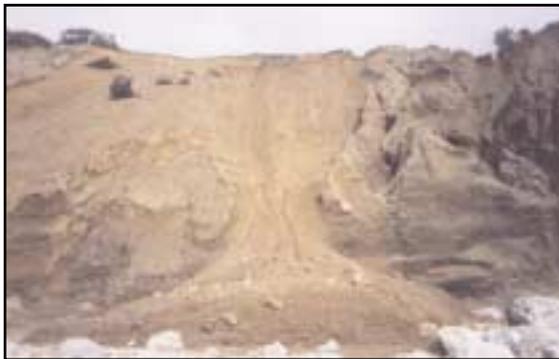
Front face after rain and debris flow.

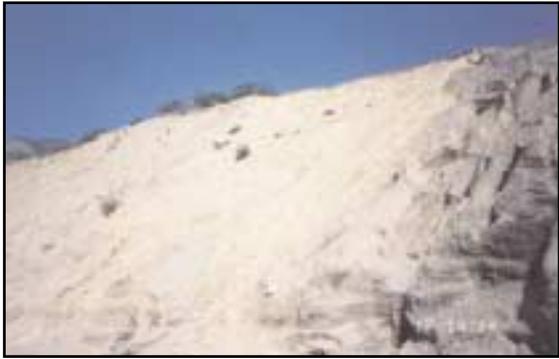
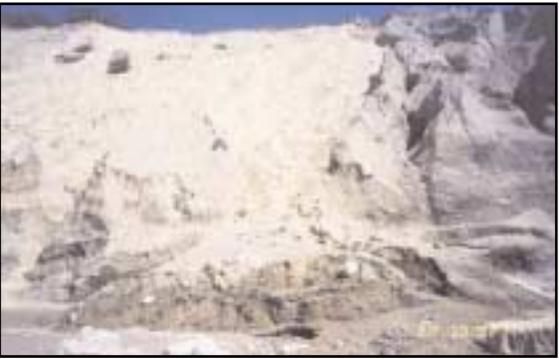
Front face after bales of rice straw where thrown.

Regreen sterile wheat was also hand-broadcast. Most of the straw was retained, and the Regreen sprouted. The front slope still remains somewhat barren, and is highly susceptible to continued failure. It is recommended future erosion control seeding should be applied during winter 2000-2001.

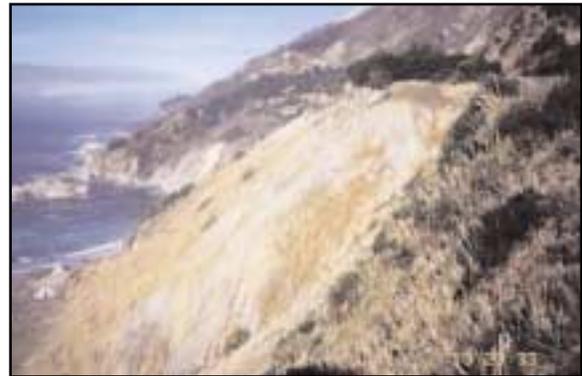
Figure 1.21. Pampas grass on site.

pampas grass plants on the slope face. Continued pest plant control is recommended. The site has been maintained in this manner for the past three years. If weed control operations are suspended, the level of control gained to date would be effectively lost.
