ASBESTOS AND LEAD-CONTAINING PAINT SURVEY

**South Coast 101 HOV Lanes
Between 0.44 Mile South of
Carpinteria Creek, Carpinteria, and
Sycamore Creek in Santa Barbara
Santa Barbara County, California**

**GEOCON PROJECT NO. S9200-06-81
TASK ORDER NO. 81, EA 05-0N7000**

FEBRUARY 2010

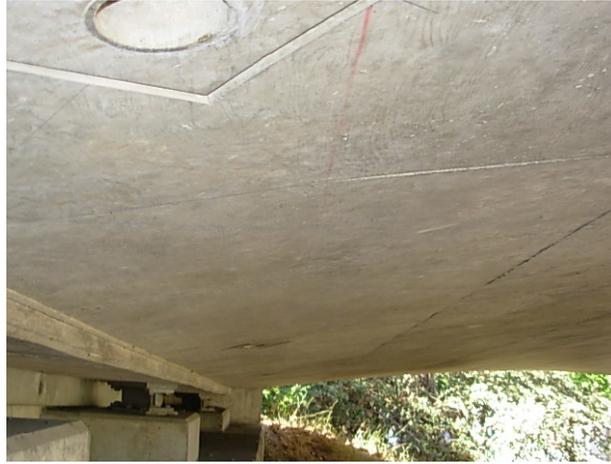
Chrysotile asbestos at concentrations ranging from 30% to 40% was detected in samples representing approximately 25 square feet of nonfriable asbestos cement drainpipe inserts on the Cabrillo Boulevard Undercrossing (51-0086R).

Photo 4 – Bridge 51-0086R box girder drains (inserts are asbestos cement)

NESHAP regulations require that asbestos cement drainpipe inserts (a Category II nonfriable/nonhazardous material) on the Cabrillo Boulevard Undercrossing (51-0086R) be removed and disposed of prior to demolition or other activities that would disturb the material. We recommend that a licensed contractor registered with Cal/OSHA for asbestos-related work (or trained in accordance with Cal/OSHA requirements for asbestos cement pipe disturbance activities) perform the asbestos cement pipe removal and disposal.

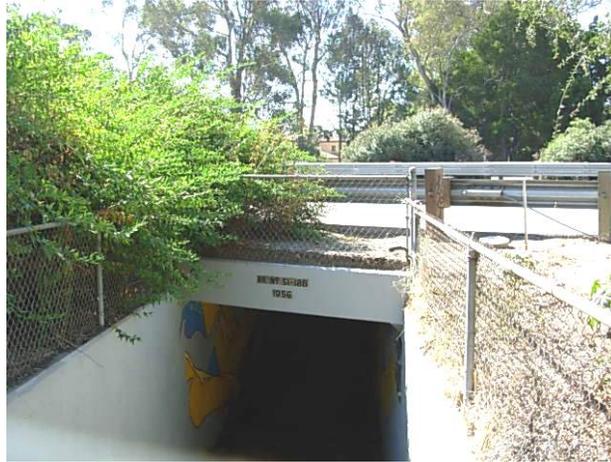
A sample representing intact gray paint on the Butterfly Lane Pedestrian Undercrossing (51-0188) exhibited a total lead concentration of 28 mg/kg.

Paint identified on the Butterfly Lane Pedestrian Undercrossing (51-0188) during our survey would not be classified as California or Federal hazardous based on lead content.

Photo 13 – Butterfly Lane PUC (51-0188)

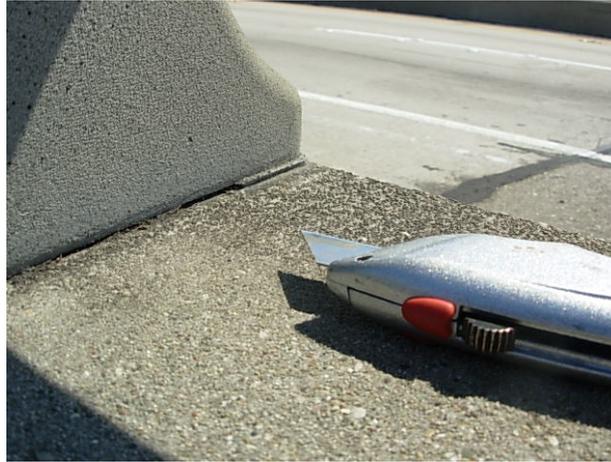
Chrysotile asbestos at a concentration of 70% was detected in samples representing a total of approximately 45 square feet of nonfriable asbestos sheet packing used as barrier rail shims on the Evans Avenue Undercrossing (51-0226L/R), South Padaro Lane Undercrossing (51-0228L/R), and the Santa Monica Creek Bridge (51-0050R). Asbestos is assumed to be present in approximately one square foot of barrier rail shim material observed on the Arroyo Parida Creek Bridge (51-0049R); however, we were unable to safely access the shims due to safety concerns (i.e., traffic).

Photo 37 – Bridge 51-0226L/R barrier rail shims

NESHAP regulations do not require that asbestos-containing sheet piling (a Category I nonfriable/nonhazardous material) used in barrier rail systems on the Evans Avenue Undercrossing (51-0226L/R), South Padaro Lane Undercrossing (51-0228L/R), Arroyo Parida Creek Bridge (51-0049R), and the Santa Monica Creek Bridge (51-0050R) or materials containing 1% or less asbestos (i.e., asphalt pipe coating on the Santa Monica Creek Bridge [51-0050Y]) identified during our survey be removed prior to demolition or treated as hazardous waste. However, the disturbance of these materials is still covered by the Cal/OSHA asbestos standard (Title 8, CCR Section 1529). We recommend that a licensed contractor registered with Cal/OSHA for asbestos-related work perform activities that would disturb these asbestos-containing materials. Contractors are responsible for informing the landfill of the contractor's intent to dispose of asbestos-containing waste. Some landfills may require additional waste characterization. Contractors are responsible for segregating and characterizing waste streams prior to disposal.

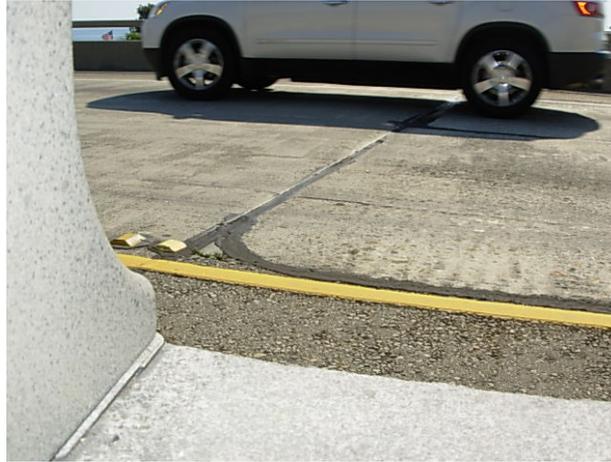
Photo 52 – Bridge 51-0228L/R barrier rail shims

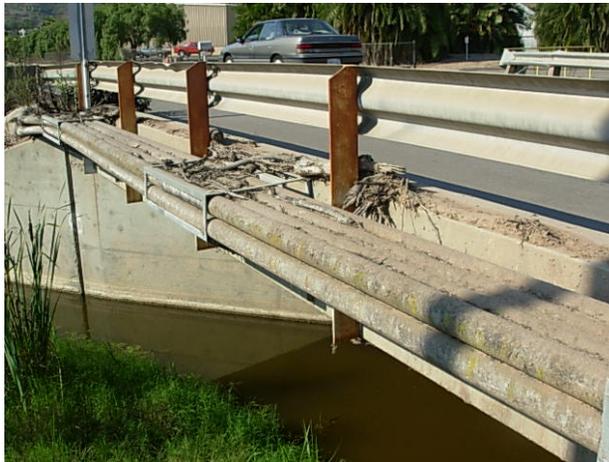
A sample representing intact white paint on the Arroyo Parida Creek Bridge (51-0049Y) barrier rail posts exhibited a total lead concentration of 400,000 mg/kg and a TCLP lead concentration of 480 mg/l.

Paint identified on the Arroyo Parida Creek Bridge (51-0049Y) during our survey would be classified as California and Federal hazardous based on lead content if stripped, blasted, or otherwise separated from the substrate.

Photo 57 – Bridge 51-0049Y barrier rails and asphalt pipe wrap

Geocon recommends that all paints at the project location (graffiti, graffiti abatement, signage, traffic striping, etc.) be treated as lead-containing for purposes of determining the applicability of the Cal/OSHA lead standard during any future maintenance, renovation, and demolition activities. This recommendation is based on LCP sample results and the fact that lead was a common ingredient of paints manufactured before 1978 and is still an ingredient of some paints. In accordance with Title 8, CCR, Section 1532.1(p), written notification to the nearest Cal/OSHA district office is required at least 24 hours prior to certain lead-related work.

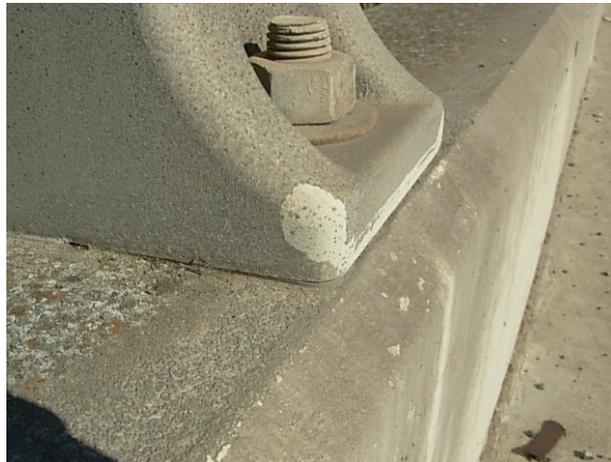
Photo 60 – Bridge 51-0049R barrier rail shims (assumed to contain asbestos)

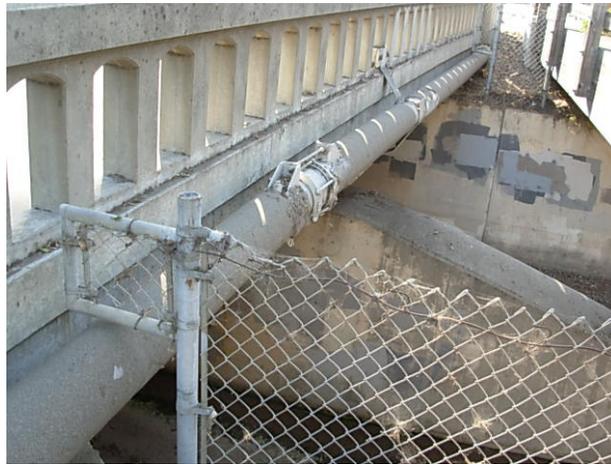
Amosite asbestos at concentrations ranging from 0.75% to 1.00% was detected (using PLM point counting) in samples representing approximately 65 square feet of nonfriable asphalt pipe coating (8-inch-diameter) on the Santa Monica Creek Bridge (51-0050Y).

Photo 62 – Bridge 51-0050Y asphalt pipe wrap (8-inch)

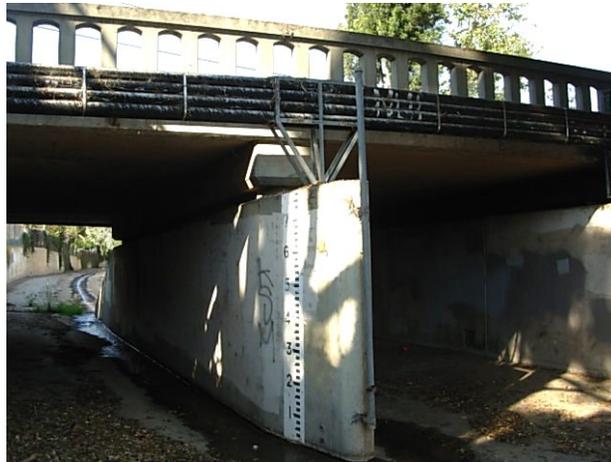
Photo 63 – Bridge 51-0050Y asphalt pipe wrap (4-inch)

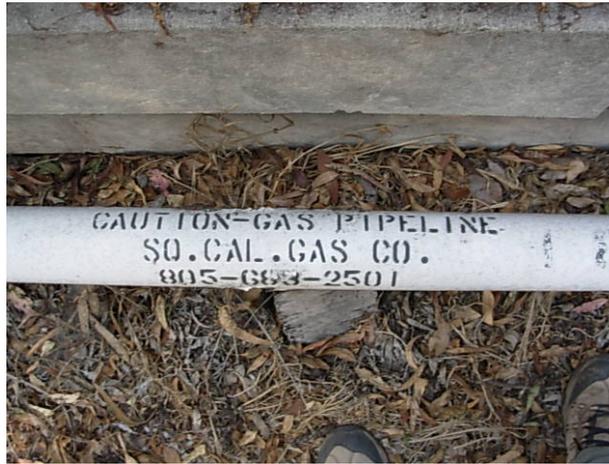
Photo 64 – Bridge 51-0050Y asphalt pipe wrap (3-inch)
