ASBESTOS AND LEAD-CONTAINING PAINT SURVEY

DOYLE DRIVE ACM AND LCM PROJECT SAN FRANCISCO, CALIFORNIA

GEOCON PROJECT NO. E8435-06-24
CALTRANS EA 04-163731

GEOCON
MAY 2009

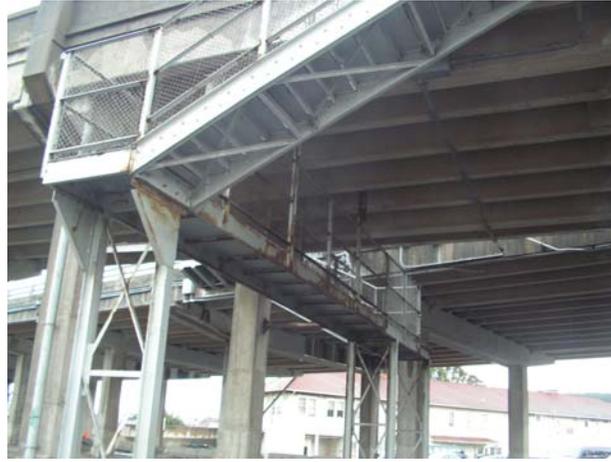
Photo 16 – Asbestos-containing silver paint on the pedestrian stairway at the merge of Richardson Ave. and Marina Blvd. (representative of Sample Group 8 material and paint sample 2A)

NESHAP regulations do not require that asbestos-containing joint material (a Category I nonfriable/nonhazardous material) or asbestos-containing paint identified during this survey be removed prior to demolition or be treated as hazardous waste. However, the disturbance of the materials is still covered by the Cal/OSHA asbestos standard (Title 8, CCR Section 1529). We recommend that demolition activities be performed by a licensed contractor registered with Cal/OSHA for asbestos-related work (or by a certified asbestos abatement contractor) following Cal/OSHA asbestos work requirements if the asbestos-containing materials are left in place during demolition. Contractors are responsible for informing the landfill of the contractor's intent to dispose of asbestos waste. Some landfills may require additional waste characterization. Contractors are responsible for segregating and characterizing waste streams prior to disposal.

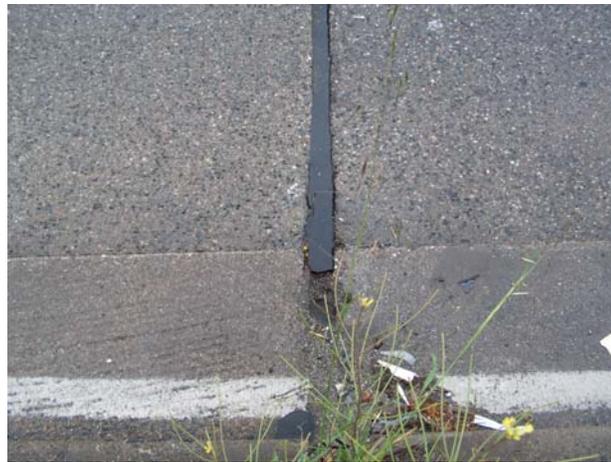
Photo 17 – Elastomeric deck joint material on Marina Boulevard approach to Doyle Drive at the eastern portion of the project area (representative of Sample Group 9 material)

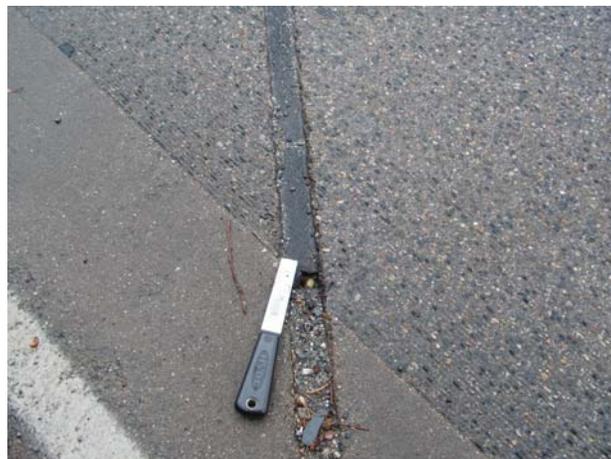
Photo 18 – Elastomeric deck joint material on Marina Boulevard (Bridge No. 34-0165L) at the eastern portion of the project area (representative of Sample Group 10 material)

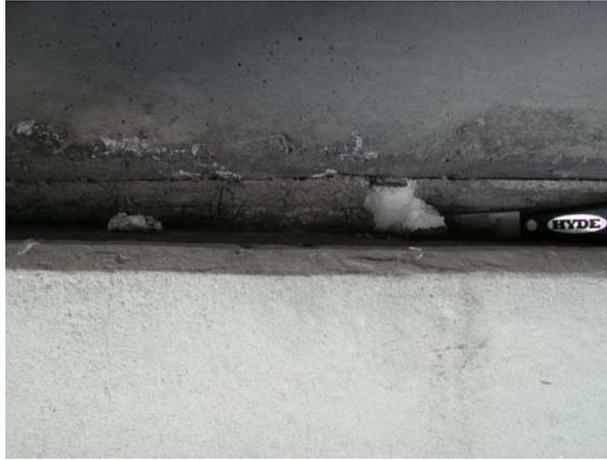
Photo 25 – Bridge bent joint fill material (styrene) on underside of Marina Boulevard road deck at the eastern portion of the project area (representative of Sample Group 17 material)

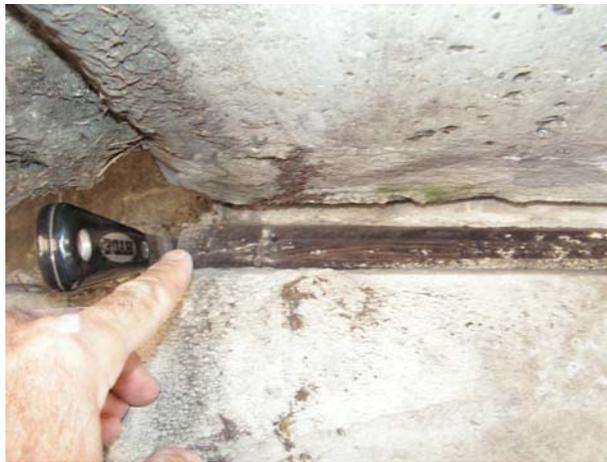
Photo 26 – Elastomeric bent joint material on underside of eastbound Doyle Drive at the eastern portion of the project area (representative of Sample Group 18 material)

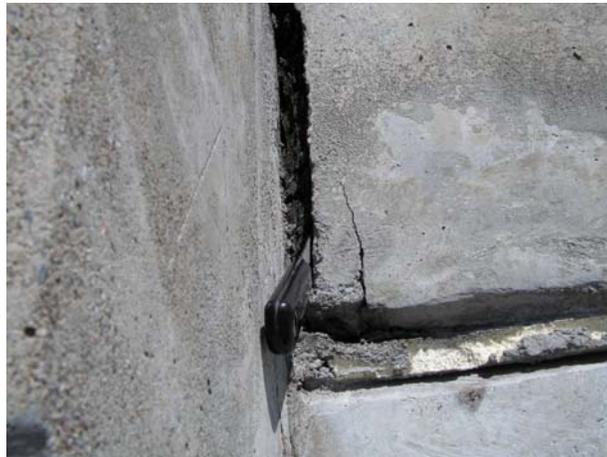
Photo 27 – Bridge bent joint fill material (styrene and brown fiberboard) on Richardson Avenue (representative of Sample Group 19 and 20 materials)

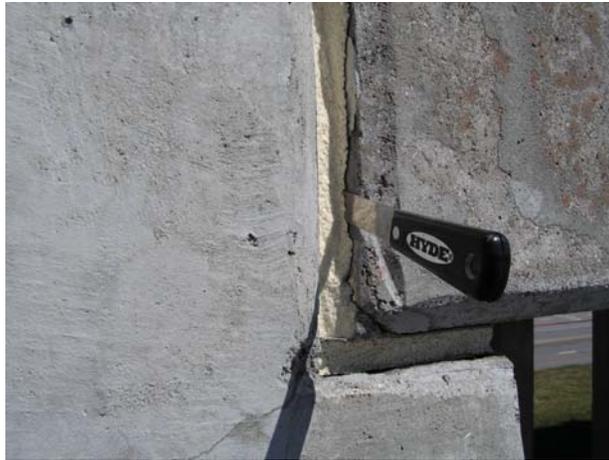
Photo 29 – Bridge bent joint fill material (styrene) on eastbound Doyle Drive (representative of Sample Group 22 material)

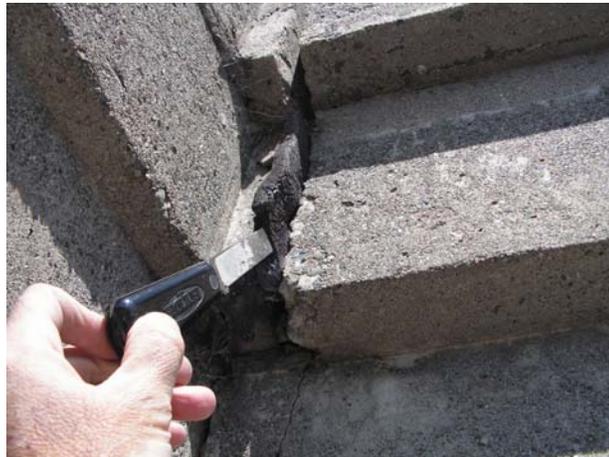
Photo 30 – Asbestos-containing black deck joint material on eastbound Doyle Drive (representative of Sample Group 23 material)

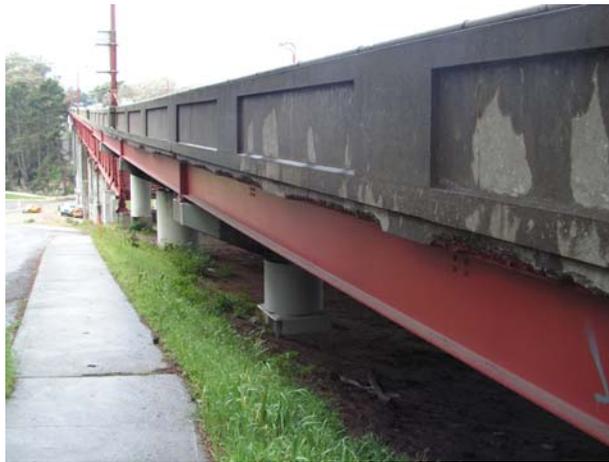
Photo 35 – Intact red paint on Bridge 34-0157R and L (Doyle Drive) girders

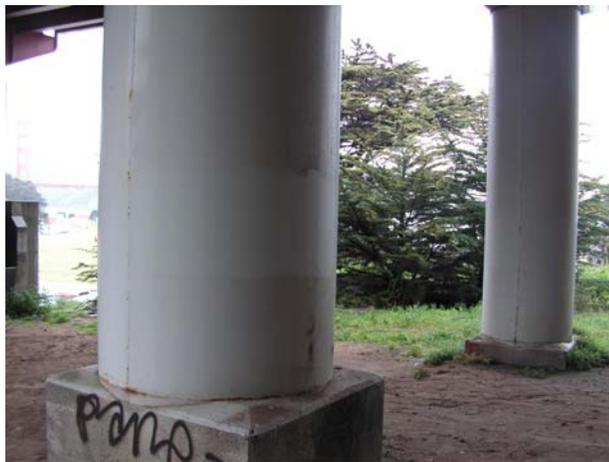
Photo 36 – Intact white paint on seismic retrofit collar on Doyle Drive bridge bents

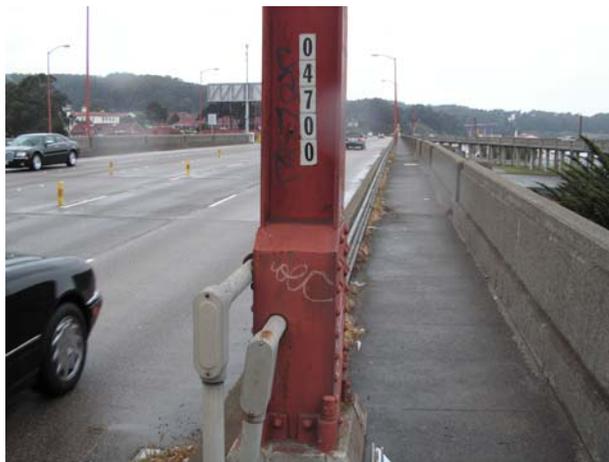
- A bulk sample representing deteriorated red paint used on light posts on Doyle Drive exhibited a total lead concentration of 52,000 mg/kg and a soluble (TCLP) lead concentration of 54 mg/l. We were unable to quantify the deteriorated paint due to safety constraints (i.e., traffic).

Photo 38 – Deteriorated red paint on Doyle Drive light posts

Based on the analytical test results, we recommend that deteriorated LCP applied to the light posts, pedestrian railing, and fencing along Doyle Drive (California and Federal [RCRA] hazardous waste) be removed and disposed of prior to renovation, demolition, or other activities that would disturb the paint. We recommend that the contractor be required to use personnel who have lead-related construction certification as supervisors or workers, as appropriate, from the California DPH for LCP removal work. Loose and peeling/flaking LCP require removal prior to demolition for waste segregation purposes: to separate potentially hazardous waste (Category III concentrated lead such as loose paint, paint sludge, vacuum debris, and vacuum filters) from non-hazardous demolition debris (Category II intact lead-painted architectural components such as doors, windows, framework, cladding, and trim). Category I waste is low lead waste (typically non-hazardous) such as construction materials, filtered wash water, and plastic sheeting. Contractors are responsible for informing the landfill of the contractor's intent to dispose of RCRA waste, California hazardous waste, and/or architectural components containing intact LCP. Some landfills may require additional waste

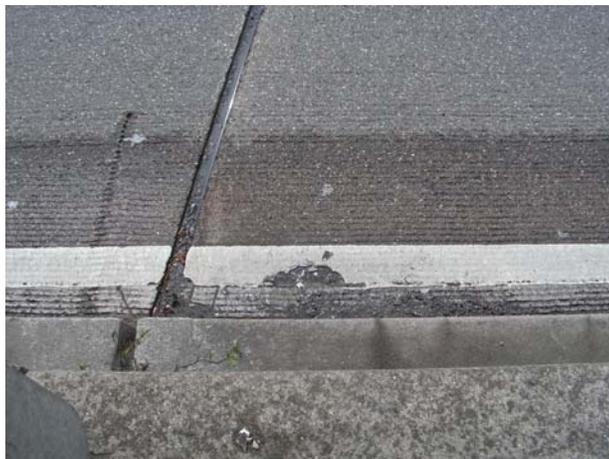
- A bulk sample representing intact white roadway striping used on Doyle Drive exhibited a total lead concentration of 28 mg/kg.
- A bulk sample representing approximately 500 square feet of deteriorated green paint used on the pedestrian railing adjacent to the westbound Doyle Drive exit to southbound Highway 1 exhibited a total lead concentration of 130,000 mg/kg and a soluble (TCLP) lead concentration of 9.5 mg/l.

Photo 39 – Intact white roadway striping paint on Doyle Drive

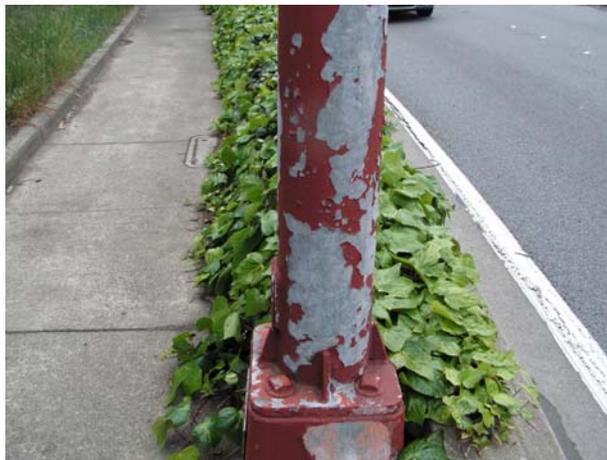
Photo 42 – Deteriorated red paint on Doyle Drive light posts (approach to Golden Gate Bridge toll plaza)

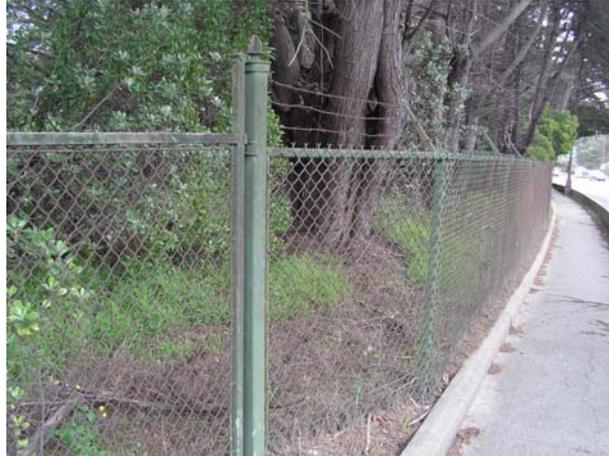
- A bulk sample of deteriorated green paint used on the pedestrian sidewalk fence adjacent to westbound Doyle Drive approaching the Golden Gate Bridge toll plaza exhibited a total lead concentration of 220,000 mg/kg and a soluble (TCLP) lead concentration of 3.7 mg/l.

Photo 43 – Deteriorated green paint on pedestrian walkway fence adjacent to westbound Doyle Drive (approaching the Golden Gate Bridge toll plaza)

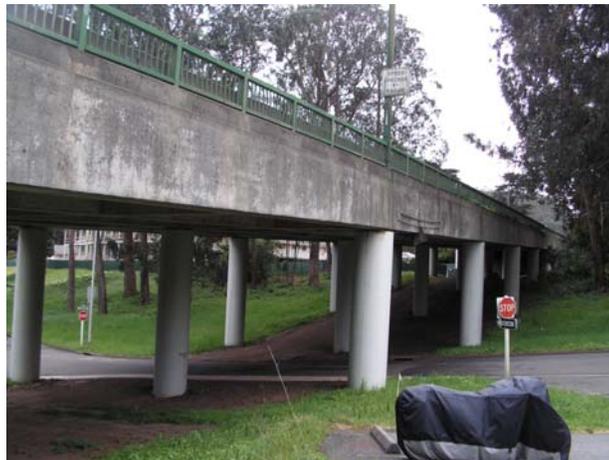
Photo 44 – Intact white paint on Bridge 34-0156 pilings, Highway 1
