ASBESTOS AND LEAD-CONTAINING PAINT SURVEY

DOYLE DRIVE ACM AND LCM PROJECT SAN FRANCISCO, CALIFORNIA

GEOCON PROJECT NO. E8435-06-24
CALTRANS EA 04-163741
EA 04-163751
EA 04-163761
EA 04-163771

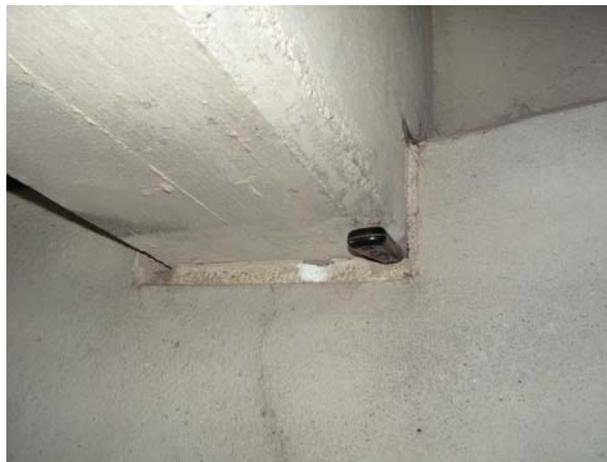
Photo 11 – Bridge bent fill material (styrene) on the underside of the Marina Viaduct (Bridge No. 34-0014) deck at the central and eastern portions of the project area (representative of Sample Group 1 material)

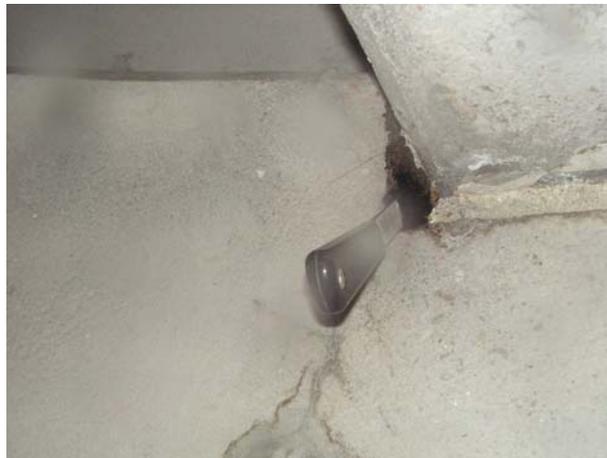
Photo 12 – Bridge bent fill material (brown fiberboard) on the underside of the Marina Viaduct deck at the central and eastern portions of the project area (representative of Sample Group 2 material)

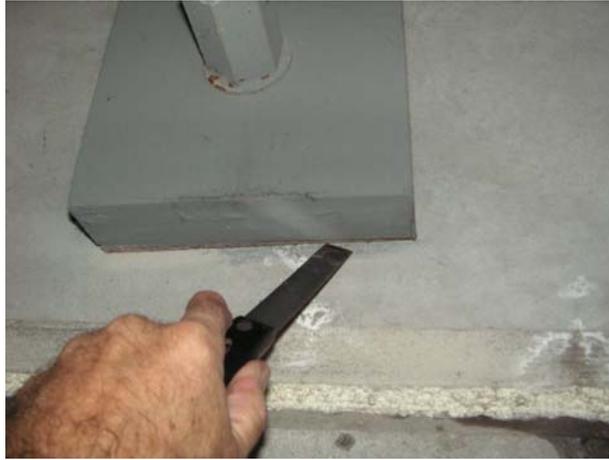
Photo 13 – Brown fiberboard behind seismic retrofit cable covers on the underside of Marina Viaduct deck at the central and eastern portions of the project area (representative of Sample Group 3 and 7 materials)

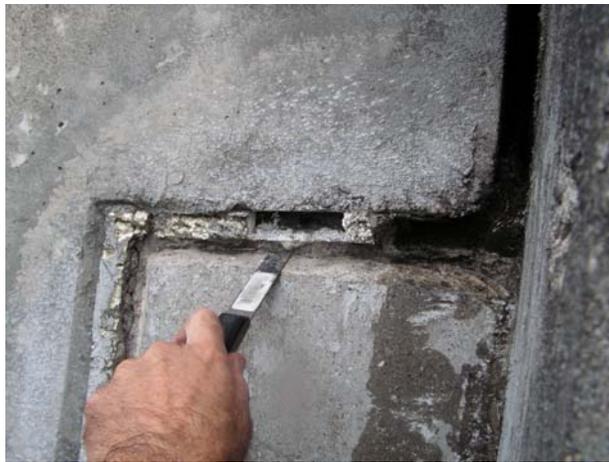
Photo 14 – Bent joint material (styrene) and underlying black elastomeric material at the sides of Marina Viaduct at the central and eastern portions of the project area (representative of Sample Group 4 and 5 materials)

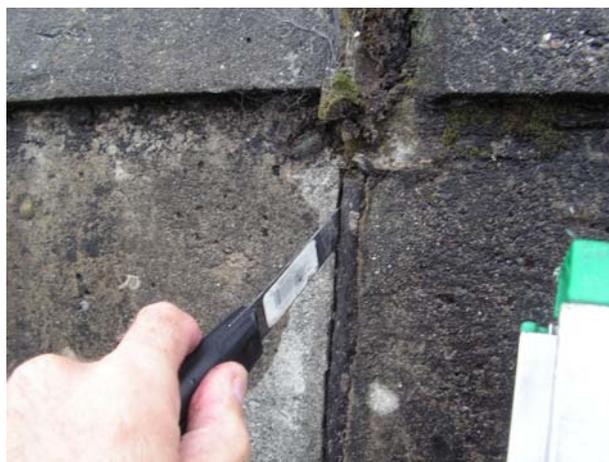
Photo 15 – Asbestos-containing black joint fill material on the Marina Viaduct abutment Drive near the eastern end of the project limits (representative of Sample Group 6 material)

NESHAP regulations do not require that asbestos-containing joint material (a Category I nonfriable/nonhazardous material) or asbestos-containing paint identified during this survey be removed prior to demolition or be treated as hazardous waste. However, the disturbance of the materials is still covered by the Cal/OSHA asbestos standard (Title 8, CCR Section 1529). We recommend that demolition activities be performed by a licensed contractor registered with Cal/OSHA for asbestos-related work (or by a certified asbestos abatement contractor) following Cal/OSHA asbestos work requirements if the asbestos-containing materials are left in place during demolition. Contractors are responsible for informing the landfill of the contractor's intent to dispose of asbestos waste. Some landfills may require additional waste characterization. Contractors are responsible for segregating and characterizing waste streams prior to disposal.

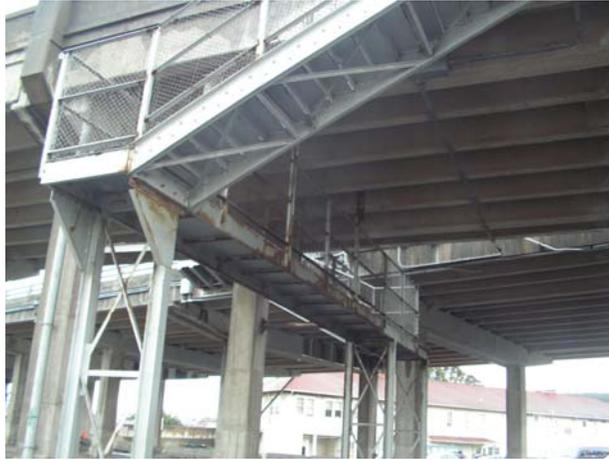
Photo 16 – Asbestos-containing silver paint on the pedestrian stairway at the merge of Richardson Ave. and the Marina Viaduct (representative of Sample Group 8 material and paint sample 2A)

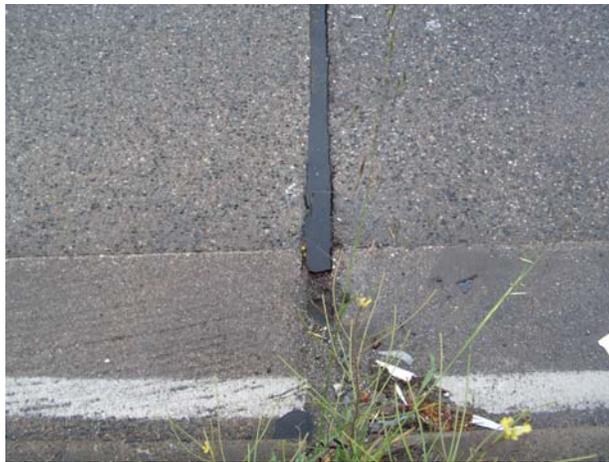
Photo 17 – Elastomeric deck joint material on the Marina Viaduct at the eastern portion of the project area (representative of Sample Group 9 material)

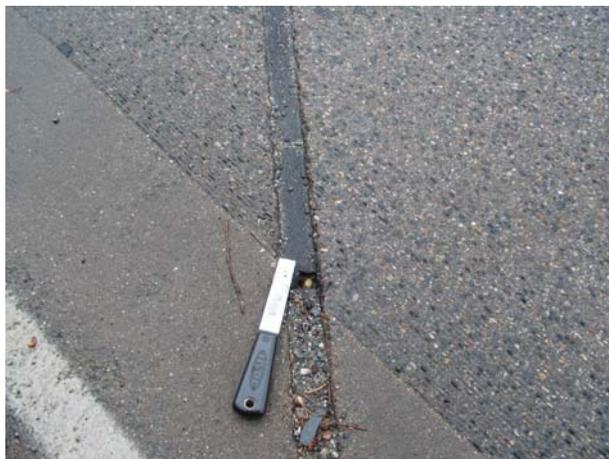
Photo 18 – Elastomeric deck joint material on Marina Viaduct at the eastern portion of the project area (representative of Sample Group 10 material)

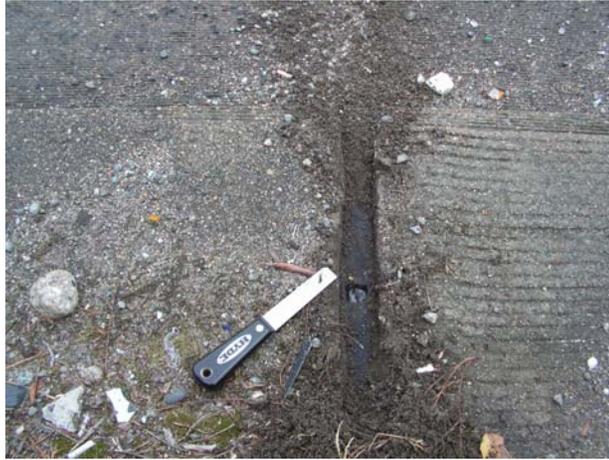
Photo 19 – Elastomeric deck joint material on Richardson Avenue at the merge with the Marina Viaduct (representative of Sample Group 11 material)

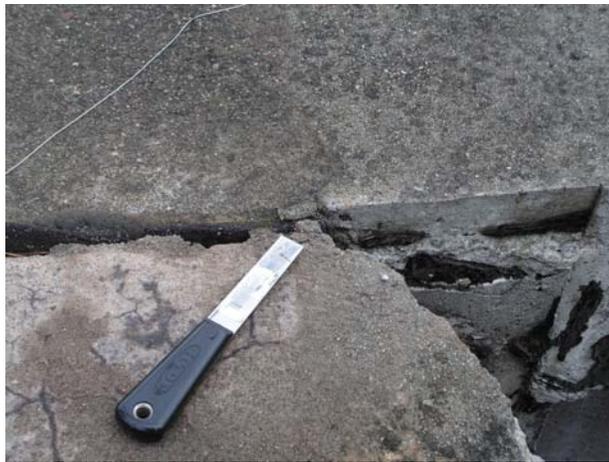
Photo 20 – Asbestos-containing black (brittle) deck joint fill material at the Richardson Avenue merge with the Marina Viaduct (representative of Sample Group 12 material)

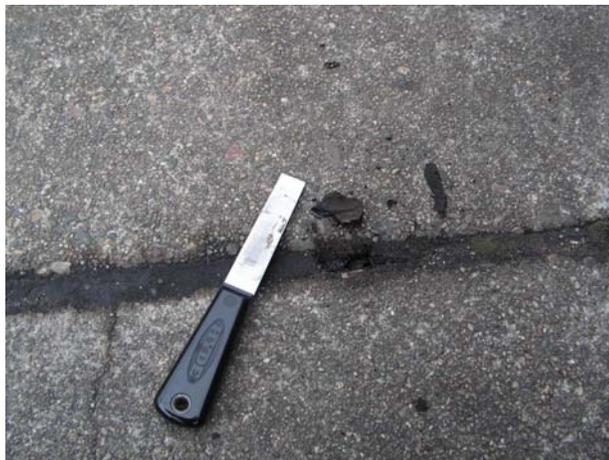
Photo 21 – Black sidewalk joint material on northbound Presidio Viaduct (Bridge No. 34-0019) (representative of Sample Group 13 material)

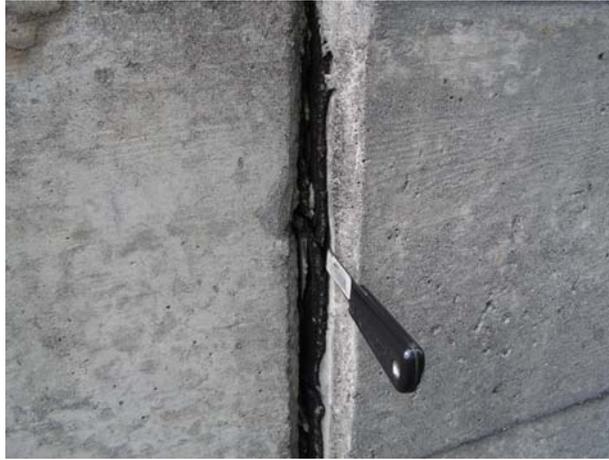
Photo 22 – Retaining wall joint fill material on the N101-S1 Connector PUC (Bridge No. 34-0025G) [pedestrian tunnel] (representative of Sample Group 14 material)

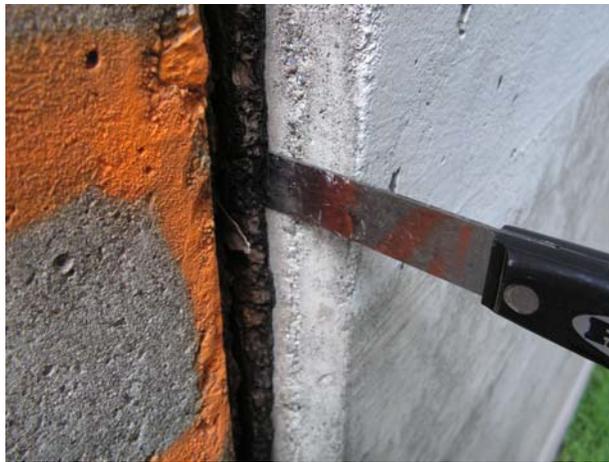
Photo 23 – Retaining wall joint fill material on the N1-N101 Connector PUC (Bridge No. 34-0023) [pedestrian tunnel] (representative of Sample Group 15 material)

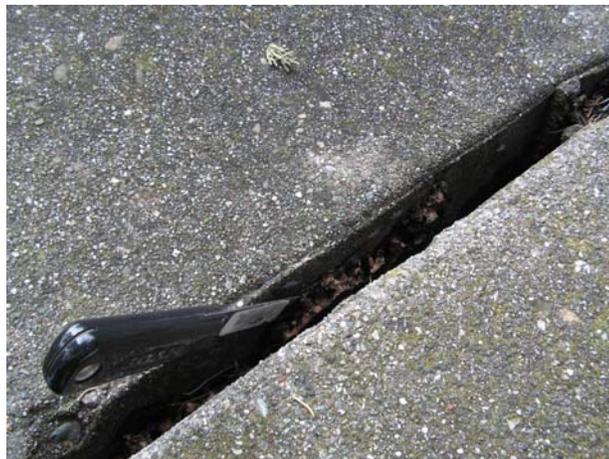
Photo 24 – Black abutment joint fill material on the N101-S1 Connector (Bridge No. 34-0020) (representative of Sample Group 16 material)

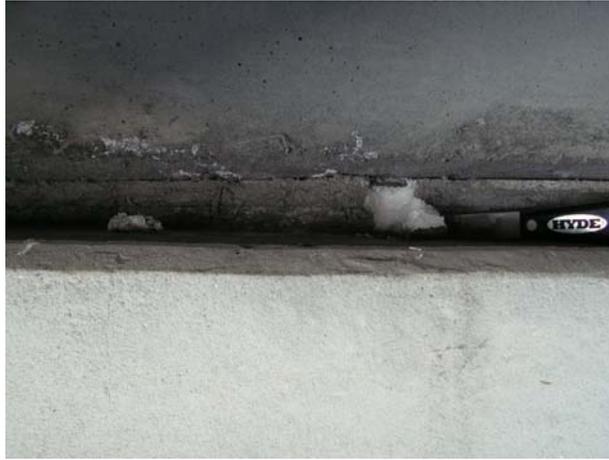
Photo 25 – Bridge bent joint fill material (styrene) on underside of the Marina Viaduct deck at the eastern portion of the project area (representative of Sample Group 17 material)

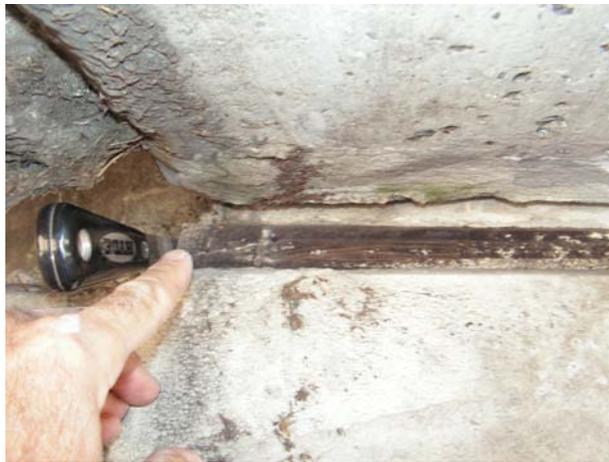
Photo 26 – Elastomeric bent joint material on underside of southbound Marina Viaduct connector to Richardson Avenue at the eastern portion of the project area (representative of Sample Group 18 material)

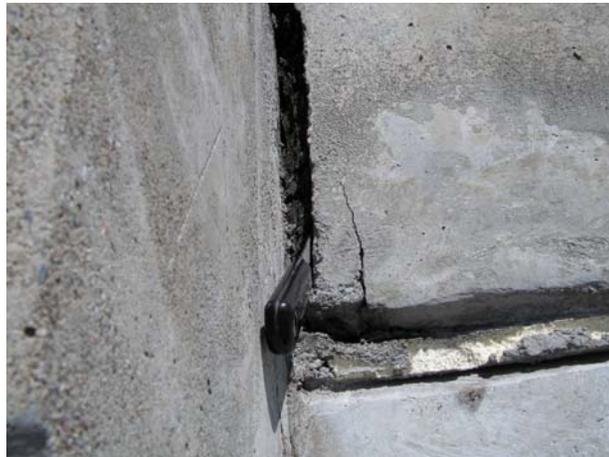
Photo 27 – Bridge bent joint fill material (styrene and brown fiberboard) on Richardson Avenue connector to northbound Marina Viaduct (representative of Sample Group 19 and 20 materials)

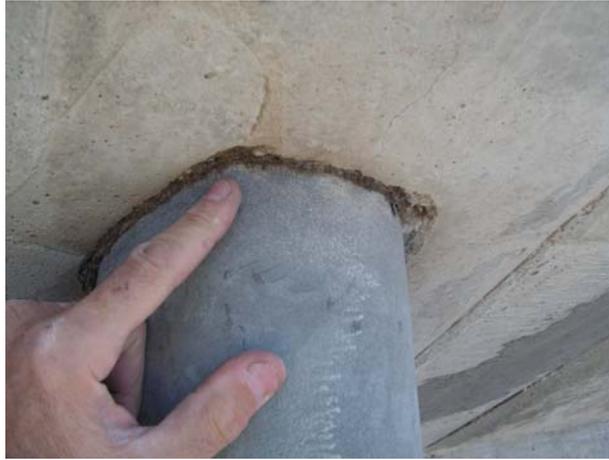
Photo 28 – Drain pipe packing (foam sheeting) on Richardson Avenue connector to northbound Marina Viaduct (representative of Sample Group 21 material)

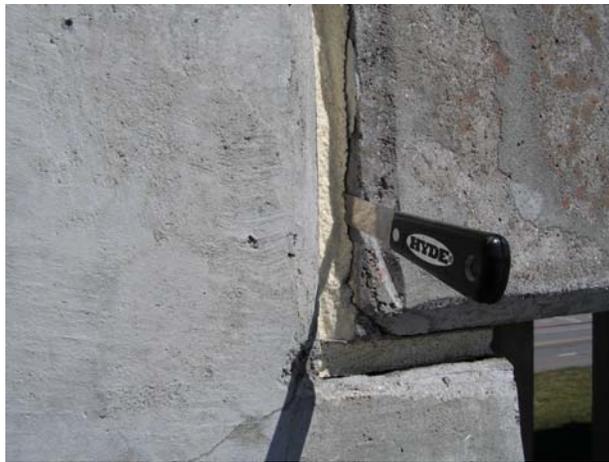
Photo 29 – Bridge bent joint fill material (styrene) on southbound Marina Viaduct connector to Richardson Avenue (representative of Sample Group 22 material)

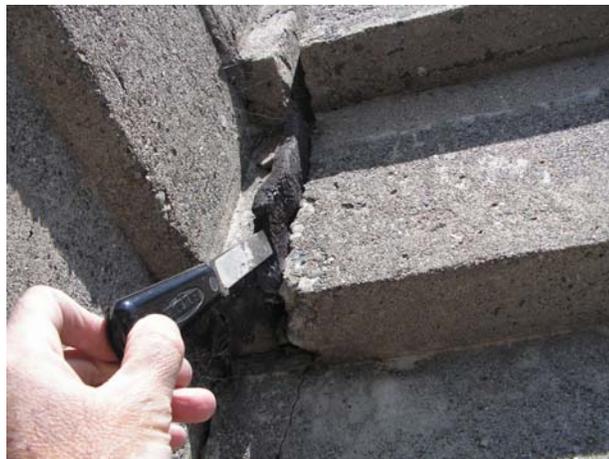
Photo 30 – Asbestos-containing black deck joint material on southbound Marina Viaduct connector to Richardson Avenue (representative of Sample Group 23 material)

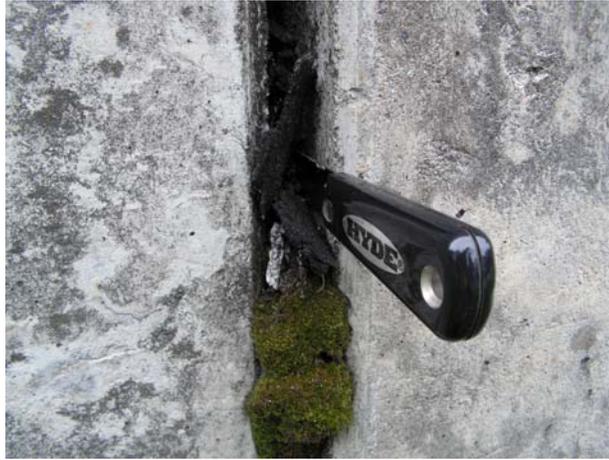
**Photo 31 – Black joint fill material on Ruckman Avenue UC (Bridge No. 34-0018)
(representative of Sample Group 24 material)**

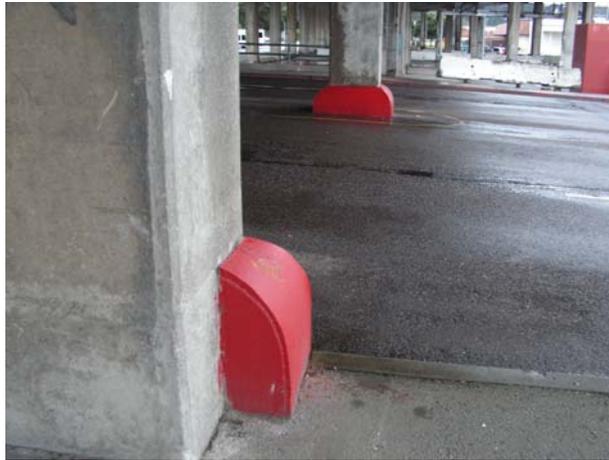
Photo 32 – Intact red paint on bent footings at Halleck Street beneath the Marina Viaduct

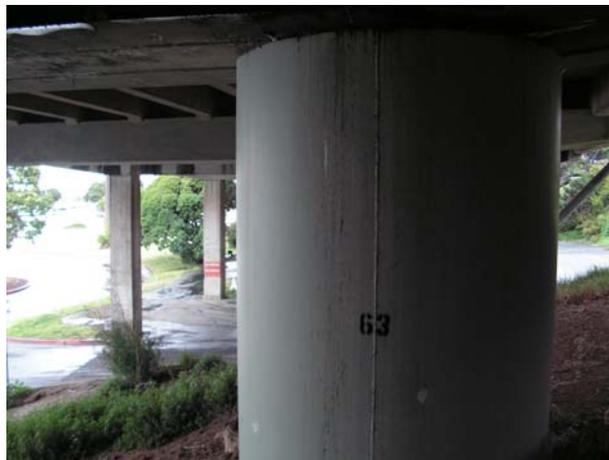
Photo 33 – Intact beige paint on seismic retrofit collar on the Marina Viaduct bridge bents

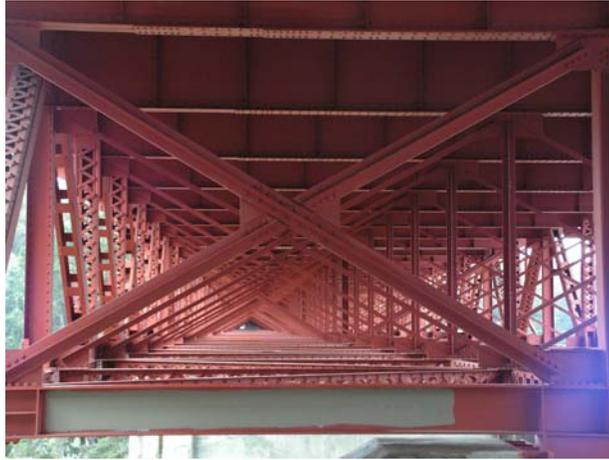
Photo 34 – Intact red paint on the Presidio Viaduct (Bridge No. 34-0019) girders and trusses

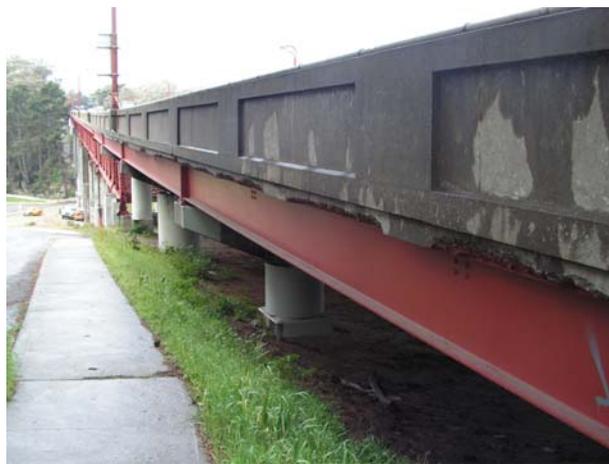
Photo 35 – Intact red paint on the Presidio Viaduct (Bridge No. 34-0019) girders

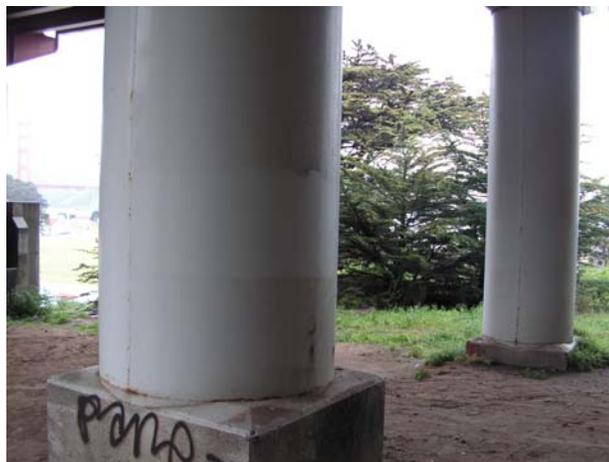
Photo 36 – Intact white paint on seismic retrofit collar on the Lincoln Boulevard UC (Bridge No. 34-0062) bents

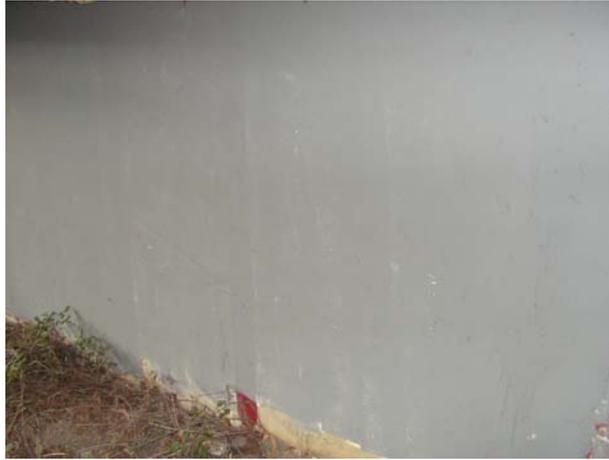
Photo 37 – Intact off-white graffiti abatement paint on the Lincoln Boulevard UC (Bridge No. 34-0062) bent wall

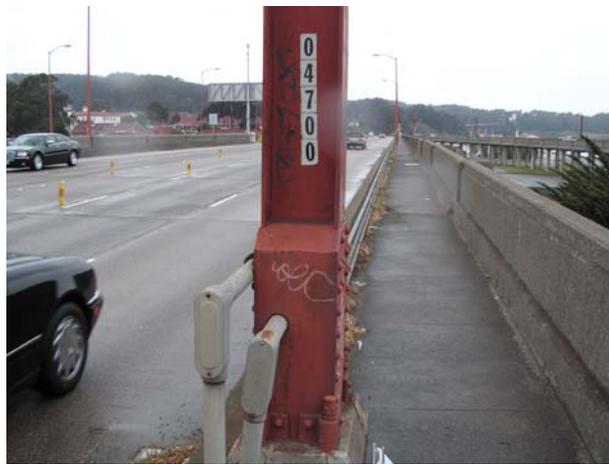
- A bulk sample representing deteriorated red paint used on the Marina Viaduct (Bridge No. 34-0014) light posts exhibited a total lead concentration of 32,000 mg/kg and a soluble (TCLP) lead concentration of 67 mg/l. We were unable to quantify the deteriorated paint due to safety constraints (i.e., traffic).

Photo 38 – Deteriorated red paint on the Marina Viaduct (Bridge No. 34-0014) light posts

Based on the analytical test results, we recommend that deteriorated LCP applied to the light posts, pedestrian railing, and fencing along Doyle Drive (California and Federal [RCRA] hazardous waste) be removed and disposed of prior to renovation, demolition, or other activities that would disturb the paint. We recommend that the contractor be required to use personnel who have lead-related construction certification as supervisors or workers, as appropriate, from the California DPH for LCP removal work. Loose and peeling/flaking LCP require removal prior to demolition for waste segregation purposes: to separate potentially hazardous waste (Category III concentrated lead such as loose paint, paint sludge, vacuum debris, and vacuum filters) from non-hazardous demolition debris (Category II intact lead-painted architectural components such as doors, windows, framework, cladding, and trim). Category I waste is low lead waste (typically non-hazardous) such as construction materials, filtered wash water, and plastic sheeting. Contractors are responsible for informing the landfill of the contractor's intent to dispose of RCRA waste, California hazardous waste, and/or architectural components containing intact LCP. Some landfills may require additional waste

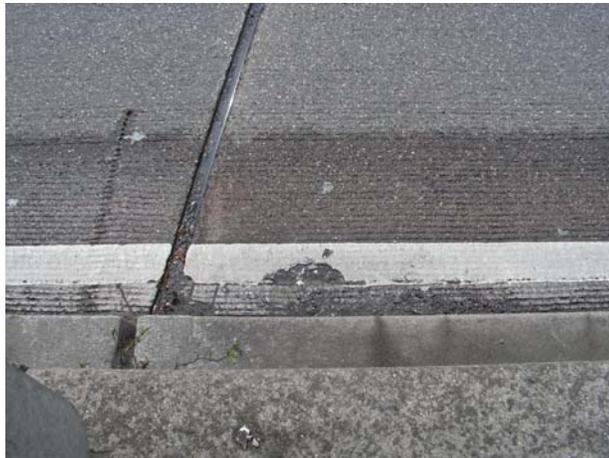
Photo 39 – Intact white roadway striping paint on the Marina Viaduct (Bridge No. 34-0014)

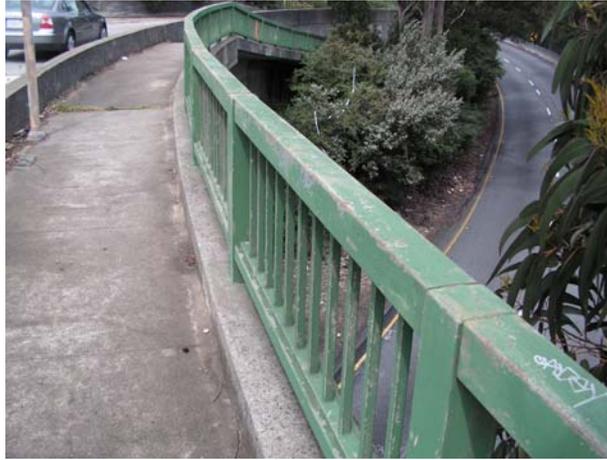
- A bulk sample representing approximately 500 square feet of deteriorated green paint used on the pedestrian railing of the Lincoln Boulevard UC (Bridge No. 34-0062) exhibited a total lead concentration of 130,000 mg/kg and a soluble (TCLP) lead concentration of 9.5 mg/l.

Photo 40 – Deteriorated green paint on pedestrian walkway railing at the Lincoln Boulevard UC (Bridge No. 34-0062)

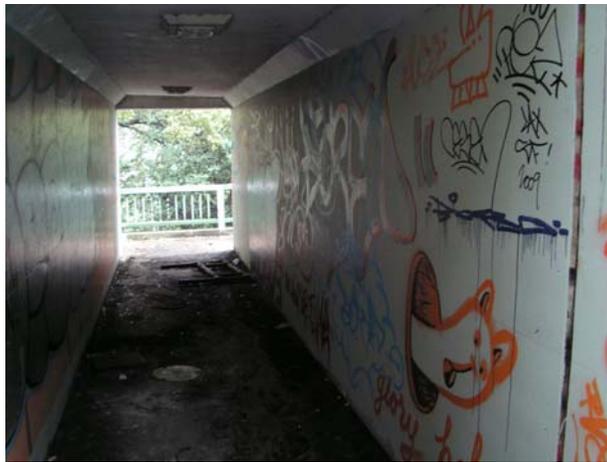
Photo 41 – Intact multi-layered graffiti abatement paint on N101-S1 Connector PUC (Bridge No. 34-0025)

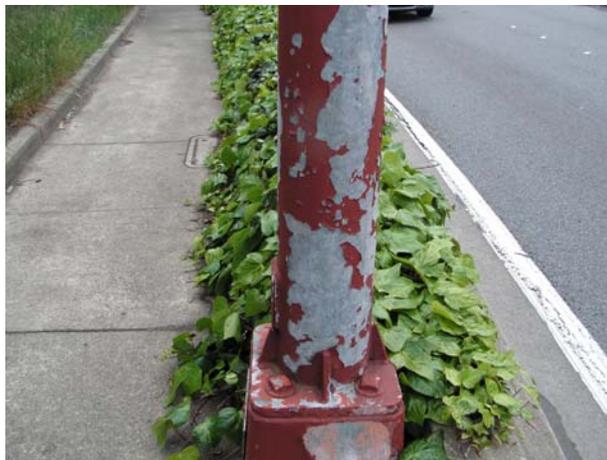
- A bulk sample representing deteriorated red paint used on light posts on Doyle Drive exhibited a total lead concentration of 52,000 mg/kg and a soluble (TCLP) lead concentration of 54 mg/l. We were unable to quantify the deteriorated paint due to safety constraints (i.e., traffic).

Photo 42 – Deteriorated red paint on Doyle Drive light posts (approach to Golden Gate Bridge toll plaza)

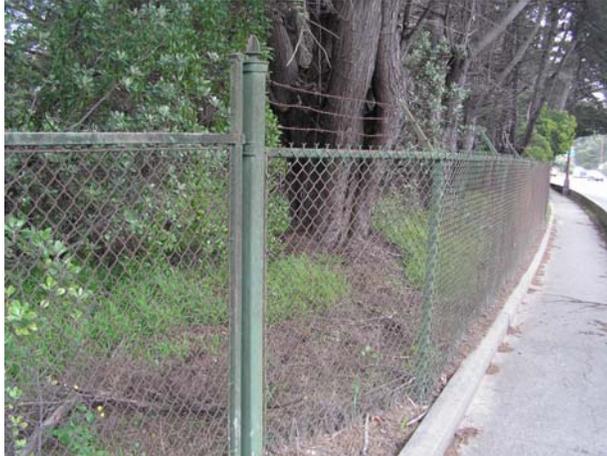
- A bulk sample of deteriorated green paint used on the pedestrian sidewalk fence adjacent to westbound Doyle Drive approaching the Golden Gate Bridge toll plaza exhibited a total lead concentration of 220,000 mg/kg and a soluble (TCLP) lead concentration of 3.7 mg/l.

Photo 43 – Deteriorated green paint on pedestrian walkway fence adjacent to westbound Doyle Drive (approaching the Golden Gate Bridge toll plaza)

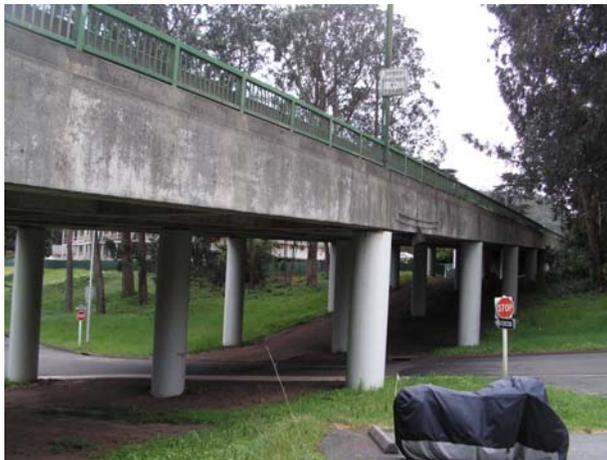
Photo 44 – Intact white paint on Ruckman Avenue UC (Bridge No. 34-0018) bents
