ASBESTOS AND DETERIORATED LEAD-CONTAINING PAINT SURVEY

TAM TRAIL SOUNDWALLS SAN RAFAEL, CALIFORNIA

GEOCON PROJECT NO. E8348-06-01

AUGUST 2006

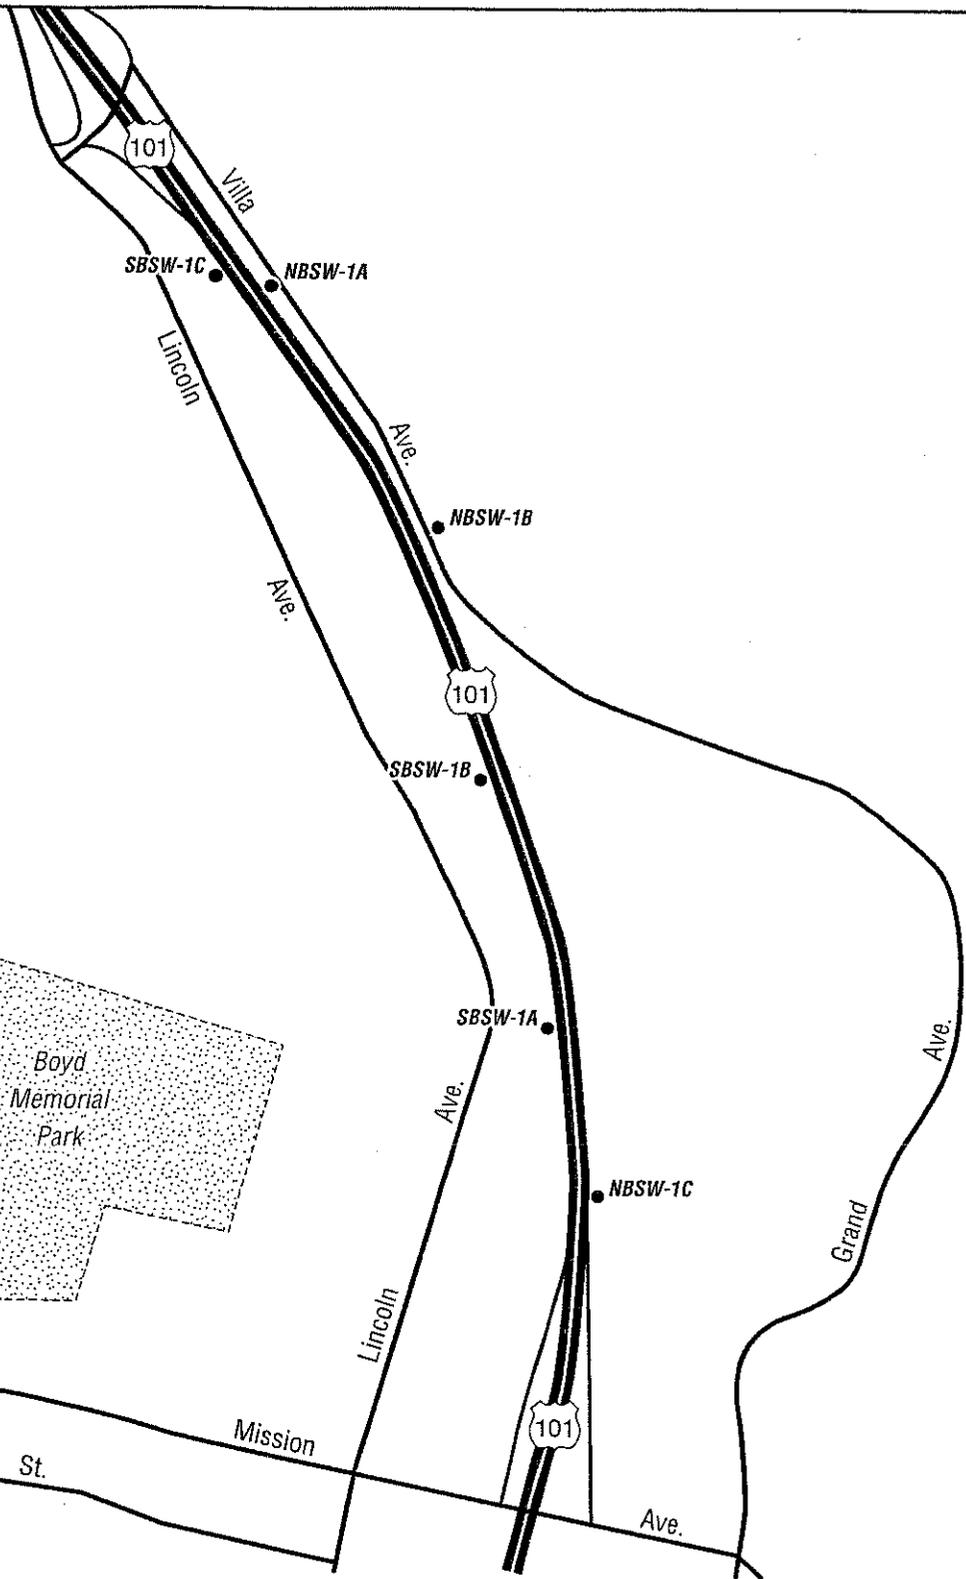
Figure 2

Geocon sample identification numbers, material descriptions, approximate quantities, friability assessments, conditions, and photographic references are summarized as portions of Table 1. Sample locations are presented in Figure 2. Photographs of suspect asbestos-containing materials are presented with the Site Photographs.

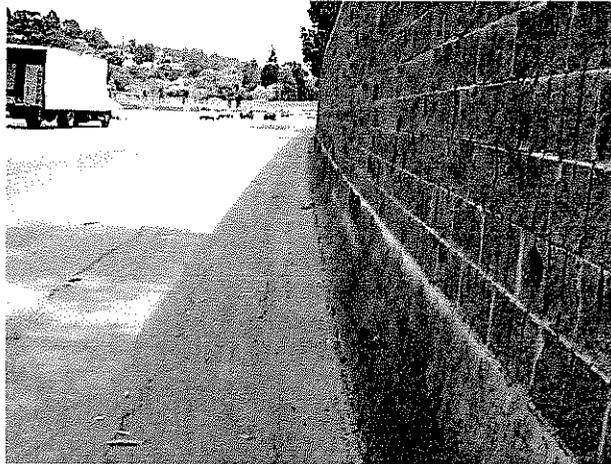
Sample No.	Description of Material	Approximate Quantity	Friable	Condition	Site Photo	Asbestos Content
SBSW-1A	Southbound soundwall joint fill material	NA	NA	NA	1 & 3	ND
SBSW-1B						ND
SBSW-1C						ND
NBSW-1A	Northbound soundwall joint fill material	NA	NA	NA	2 & 3	ND
NBSW-1B						ND
NBSW-1C						ND

Photo 1 – Southbound SR 101 soundwall

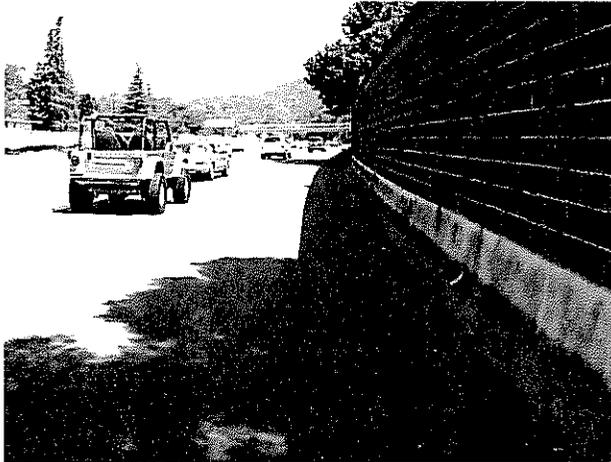
Photo 2 – Northbound SR 101 soundwall

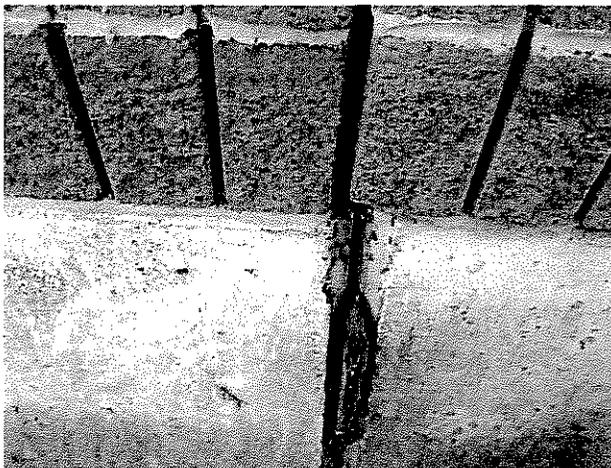
Photo 3 – Typical soundwall joint
