ASBESTOS SURVEY

ROUTE 80/101 CENTRAL FREEWAY GIRDER REPLACEMENT PROJECT SAN FRANCISCO, CALIFORNIA

GEOCON PROJECT NO. E8435-06-28
CALTRANS EA 04-2A1401

Subject: SUPPLEMENTAL ASBESTOS SURVEY REPORT
ROUTE 80/101 CENTRAL FREEWAY GIRDER REPLACEMENT PROJECT
SAN FRANCISCO, CALIFORNIA
CONTRACT NO. 04A2912
TASK ORDER NO. 28, EA 04-2A1401

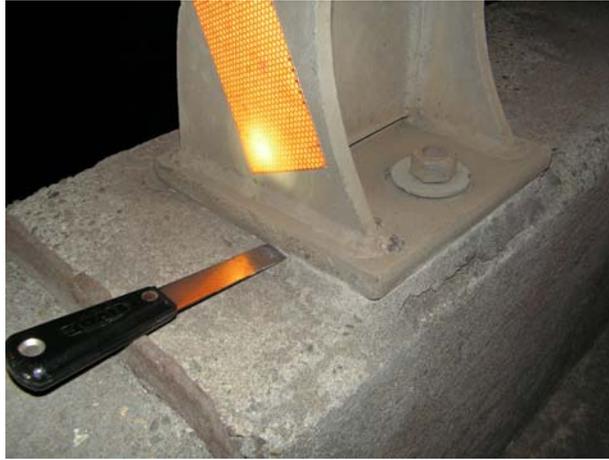
Photo 1 – Central Viaduct (Highway 80 westbound, Number 1 lane), typical guard rail post at proposed replacement segment (no suspect materials)

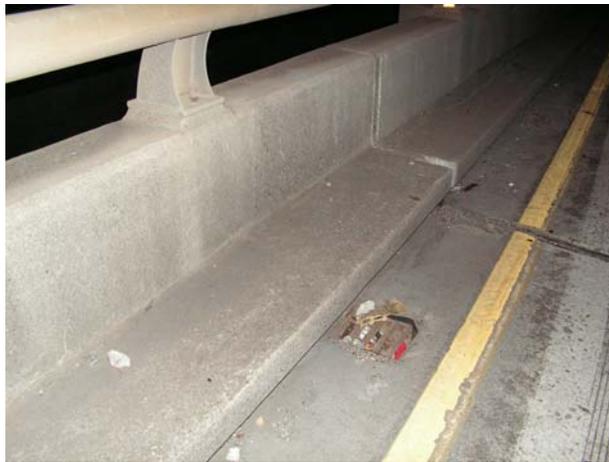
Photo 2 – Central Viaduct (Highway 80 westbound, Number 1 lane), typical guard rail post at proposed replacement segment (no suspect materials)

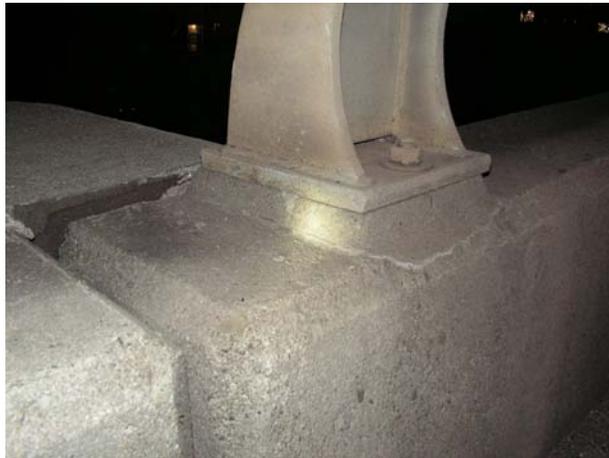
Photo 3 – Central Viaduct (Highway 80 westbound, 4th Street on-ramp), typical guard rail post at proposed replacement segment (no suspect materials)

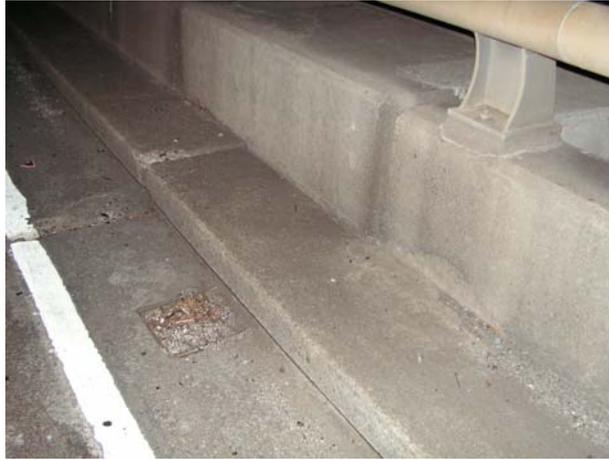
Photo 4 – Central Viaduct (Highway 80 westbound, 4th Street on-ramp), typical guard rail post at proposed replacement segment (no suspect materials)

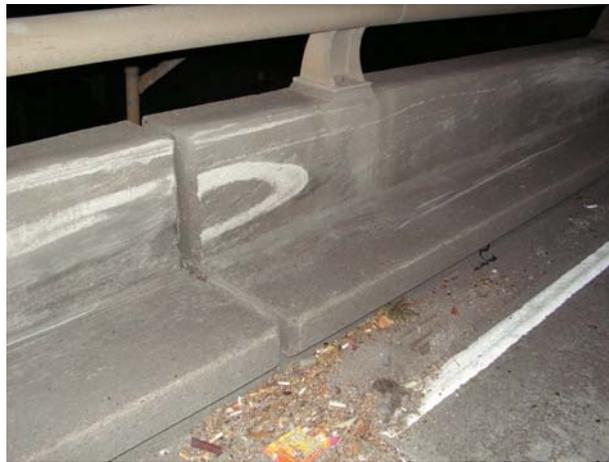
Photo 5 – Central Viaduct (Highway 80 westbound, 4th Street on-ramp), typical guard rail post at proposed replacement segment (no suspect materials)

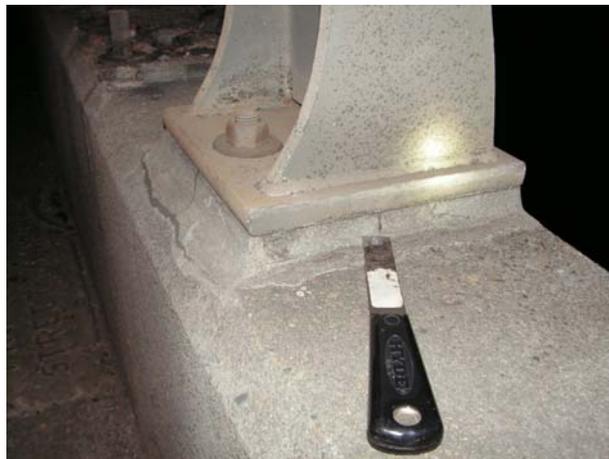
Photo 6 – Central Viaduct (Highway 80 westbound, connector ramp to Bayshore Viaduct), typical guard rail post at proposed replacement segment (no suspect materials)

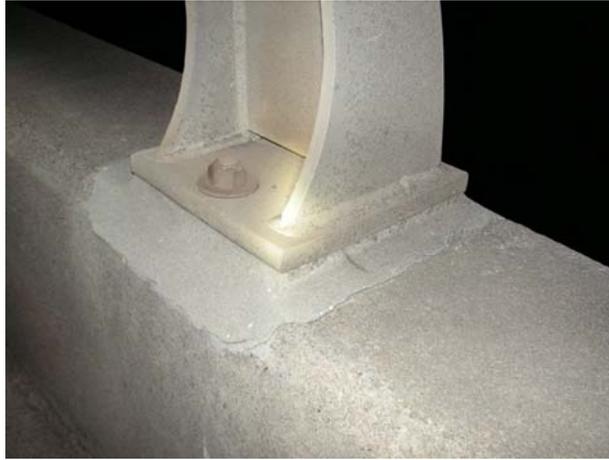
Photo 7 – Central Viaduct (Highway 80 westbound, connector ramp to Bayshore Viaduct), typical guard rail post at proposed replacement segment (no suspect materials)

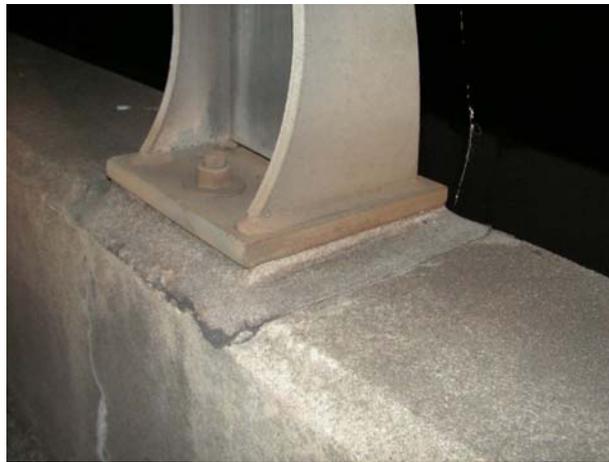
Photo 8 – Bayshore Viaduct (Highway 101 northbound), typical guard rail post at proposed replacement segment (no suspect materials)

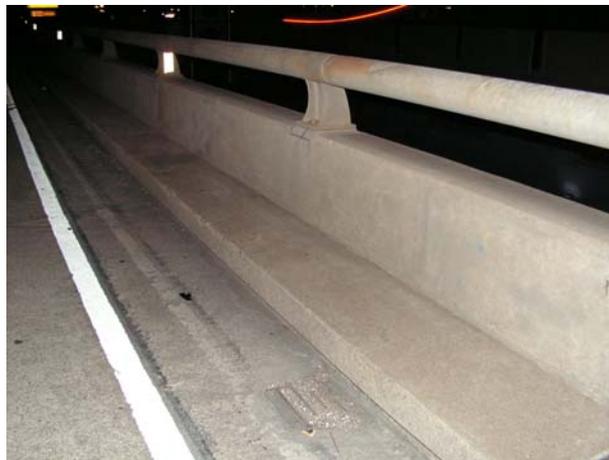
Photo 9 – Bayshore Viaduct (Highway 101 northbound), typical guard rail post at proposed replacement segment (no suspect materials)

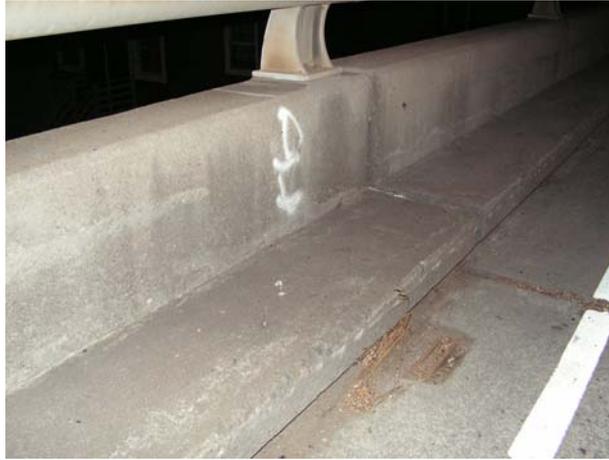
Photo 10 – Bayshore Viaduct (Highway 101 southbound), typical guard rail post at proposed replacement segment (no suspect materials)

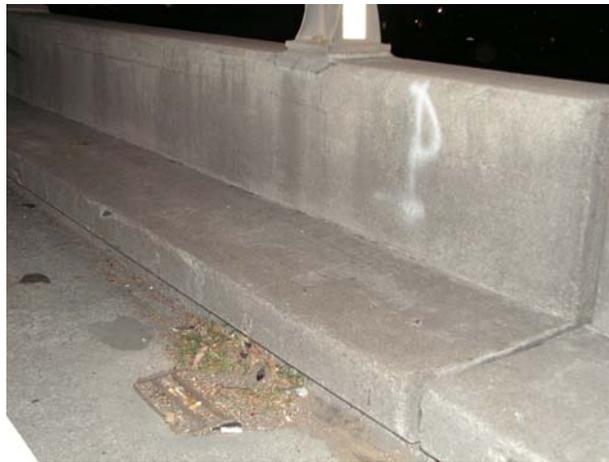
Photo 11 – Bayshore Viaduct (Highway 101 southbound), typical guard rail post at proposed replacement segment (no suspect materials)

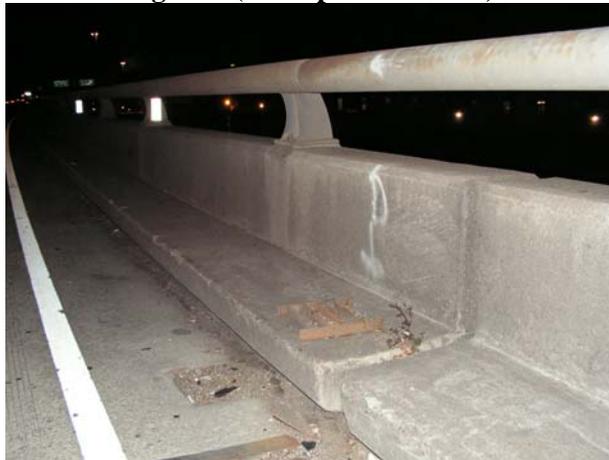
Photo 12 – Bayshore Viaduct (Highway 101 southbound), typical guard rail post at proposed replacement segment (no suspect materials)

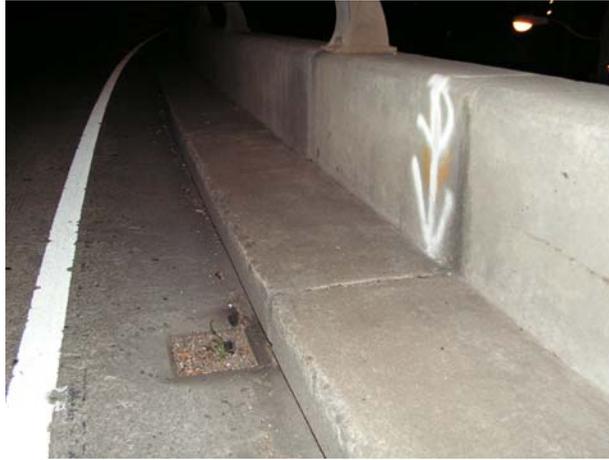
Photo 13 – Bayshore Viaduct (connector ramp to Highway 101 southbound), typical guard rail post at proposed replacement segment (no suspect materials)

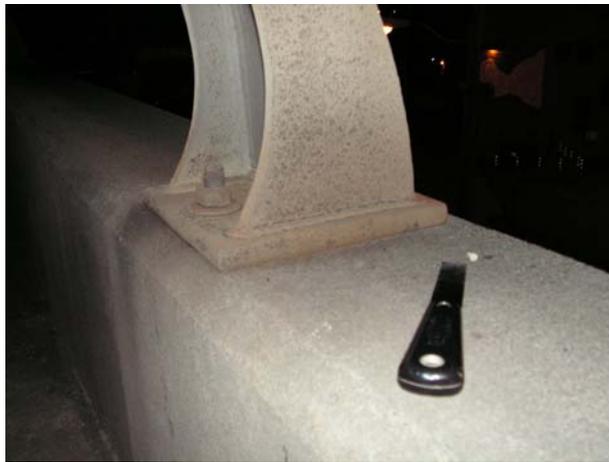
Photo 14 – Bayshore Viaduct (connector ramp to Highway 101 southbound), typical guard rail post at proposed replacement segment (no suspect materials)

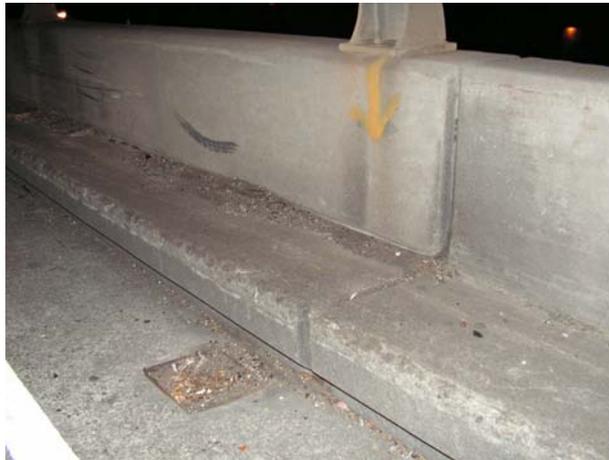
Photo 15 – Bayshore Viaduct (connector ramp to Highway 101 southbound), typical guard rail post at proposed replacement segment (no suspect materials)

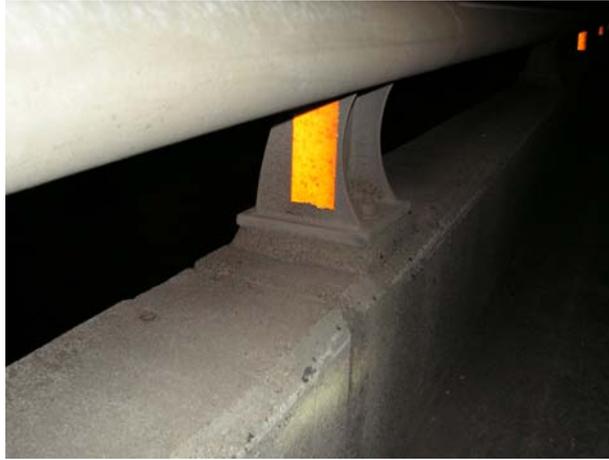
Photo 16 – Central Viaduct (Highway 80 eastbound, Number 1 lane), typical guard rail post at proposed replacement segment (no suspect materials)

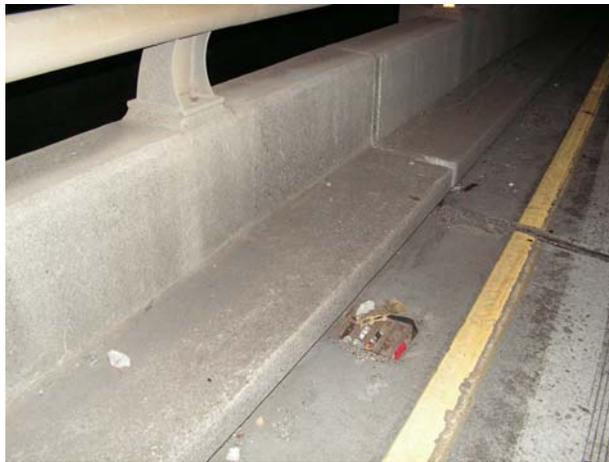
Photo 17 – Central Viaduct (Highway 80 eastbound, Number 1 lane), typical guard rail post at proposed replacement segment (no suspect materials)

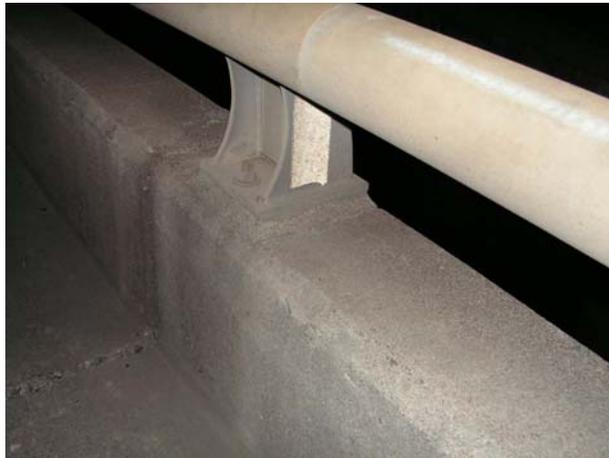
Photo 18 – Central Viaduct (Highway 80 eastbound, Number 3 lane), typical guard rail post at proposed replacement segment (no suspect materials)

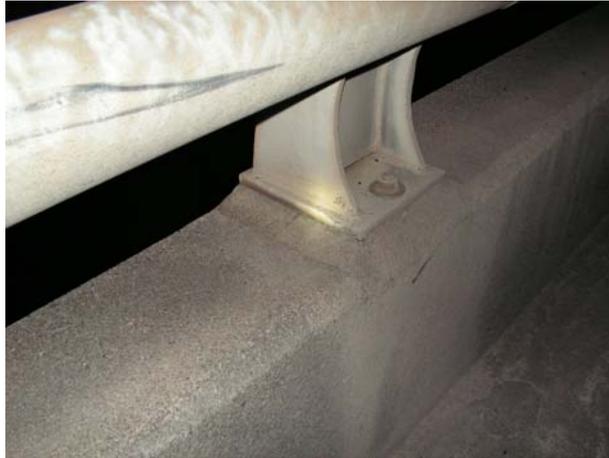
Photo 19 – Central Viaduct (Highway 80 eastbound, Number 3 lane), typical guard rail post at proposed replacement segment (no suspect materials)

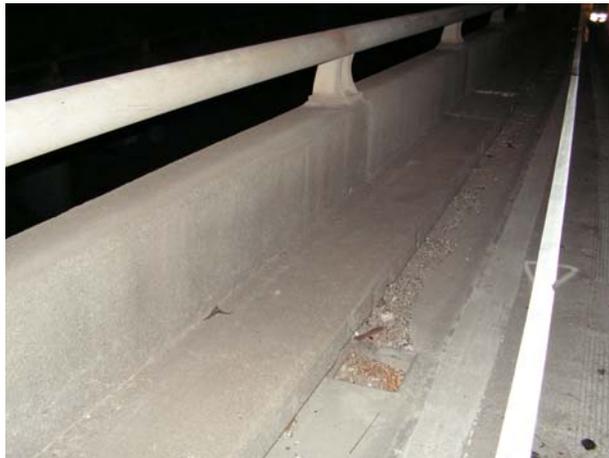
Photo 20 – Central Viaduct (Highway 80 eastbound, Number 3 lane), typical guard rail post at proposed replacement segment (no suspect materials)
