## Road Safety Assessment (RSA)

SR 84 – Niles Canyon Corridor  
Alameda Co., California  
May 2012

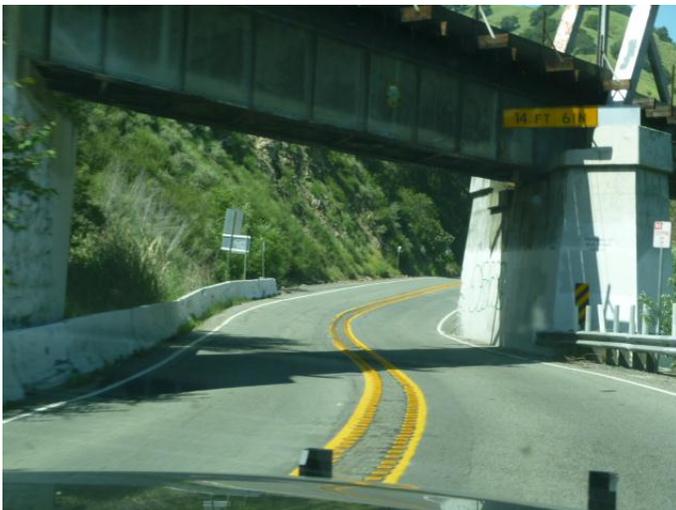
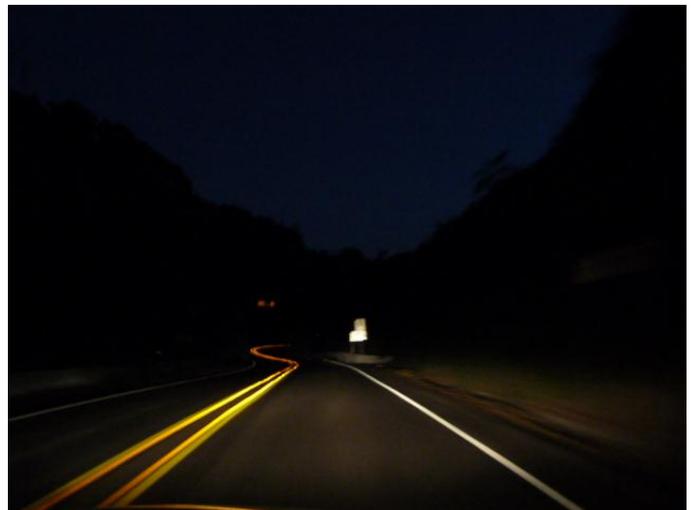
The centerline rumble strips installed in the immediate vicinity of several of the sharper curves along the corridor provide very effective delineation of the upcoming change in alignment. The distinct contrast with the less bright upstream markings clearly communicates to the approaching driver that he is approaching a much different condition.

Figure 14: Centerline Rumble Strips effective, day and night

*Avoid the temptation to “upgrade” other stretches of the corridor to this particular design detail, as making the entire corridor the same will negate the effect of the contrasting brightness. (If pavement markings are maintained by Caltrans maintenance forces, this advice should be communicated to them so that other stretches of the centerline are not inadvertently “upgraded” resulting in unintended consequences.)*
