Devil's Slide/Hwy 1 Storm Repair

Daily Updates from Bijan Sartipi

Daily Update
July 5

Devil's Slide (post mile 39.14)

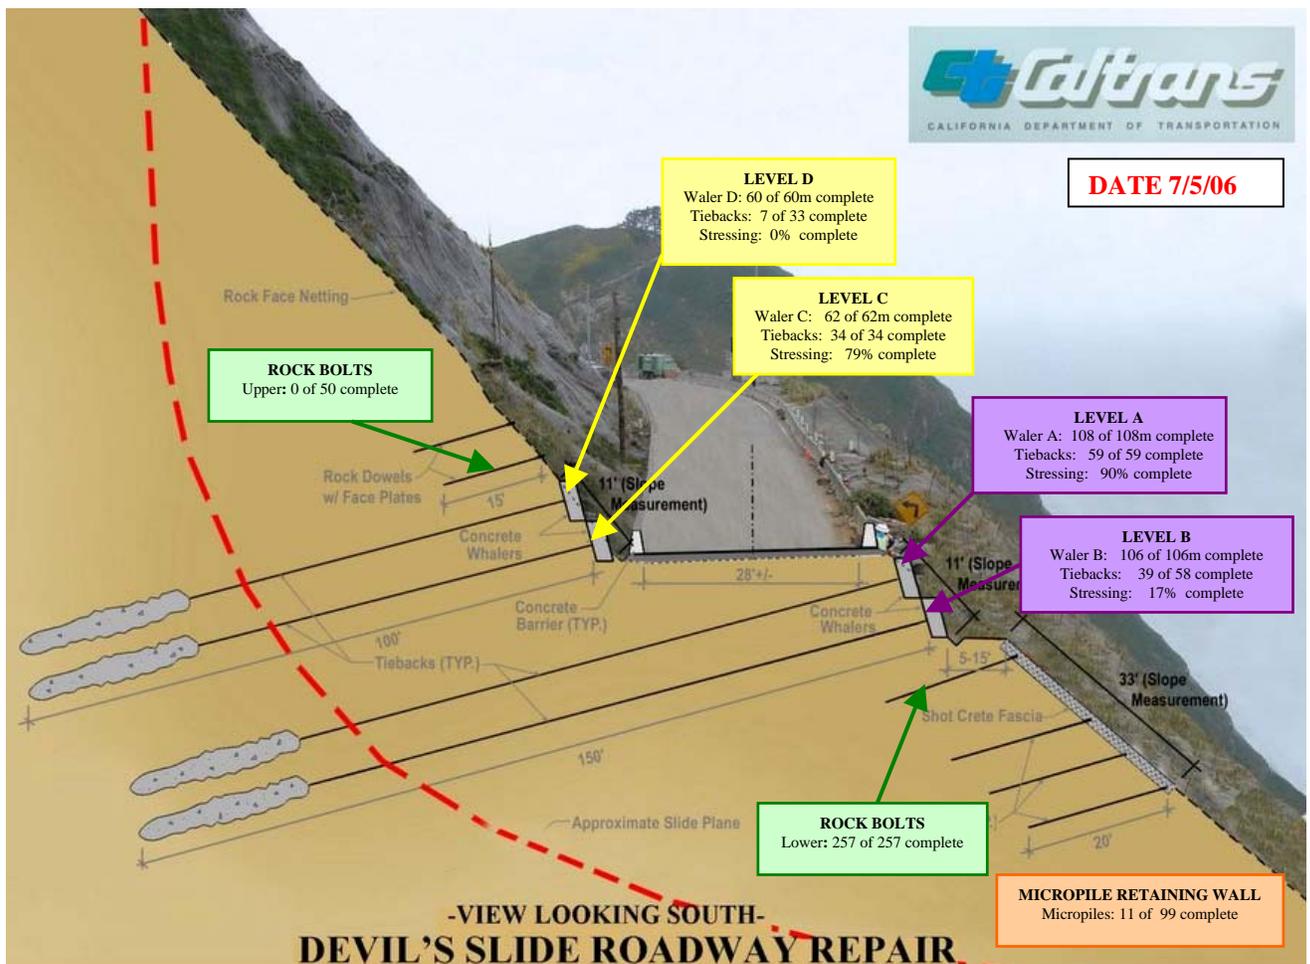
- Waler wall construction and tie back installation summary.

- Notes:
- 1) Quantity of upper rock bolts decreased from 82 to 50 following further evaluation by Caltrans Geotechnical engineers. This type of adjustment is expected for Design-Build projects where design changes take place concurrently with construction work.
 - 2) Quantity of micropiles changed for 100 to 99. Corrects an error in previous summaries.
 - 3) Tie back stressing measurement changed from number complete to % complete. This change better accounts for the re-stressing work necessary as a result of whaler wall movement after the tie back cables were initially tightened.
