**Daily Update**  
May 10

Devil's Slide (post mile 39.14)

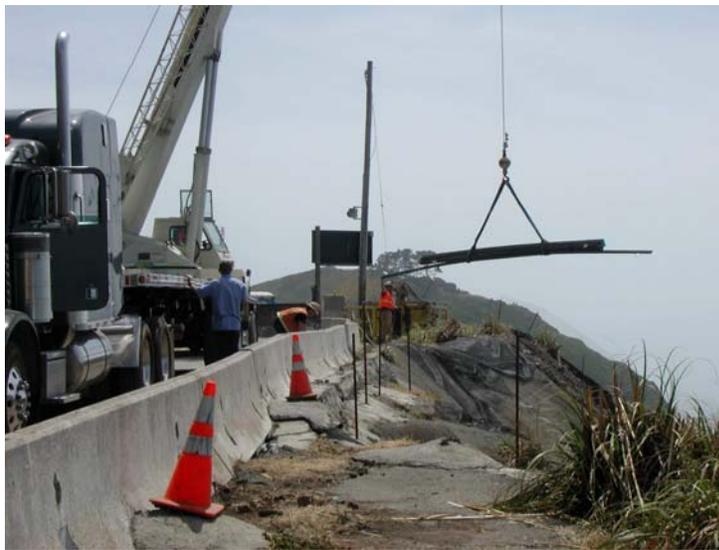
Rock dowels being lowered over the cliff in preparation for initial repair work
