# **INFORMATION HANDOUT**

**For Contract No. 12-0M4304  
At 12-Ora-261-0.0,3.5**

Photos of Drainage System 1 and Drainage System 36

12-Ora-261-0.0,3.5

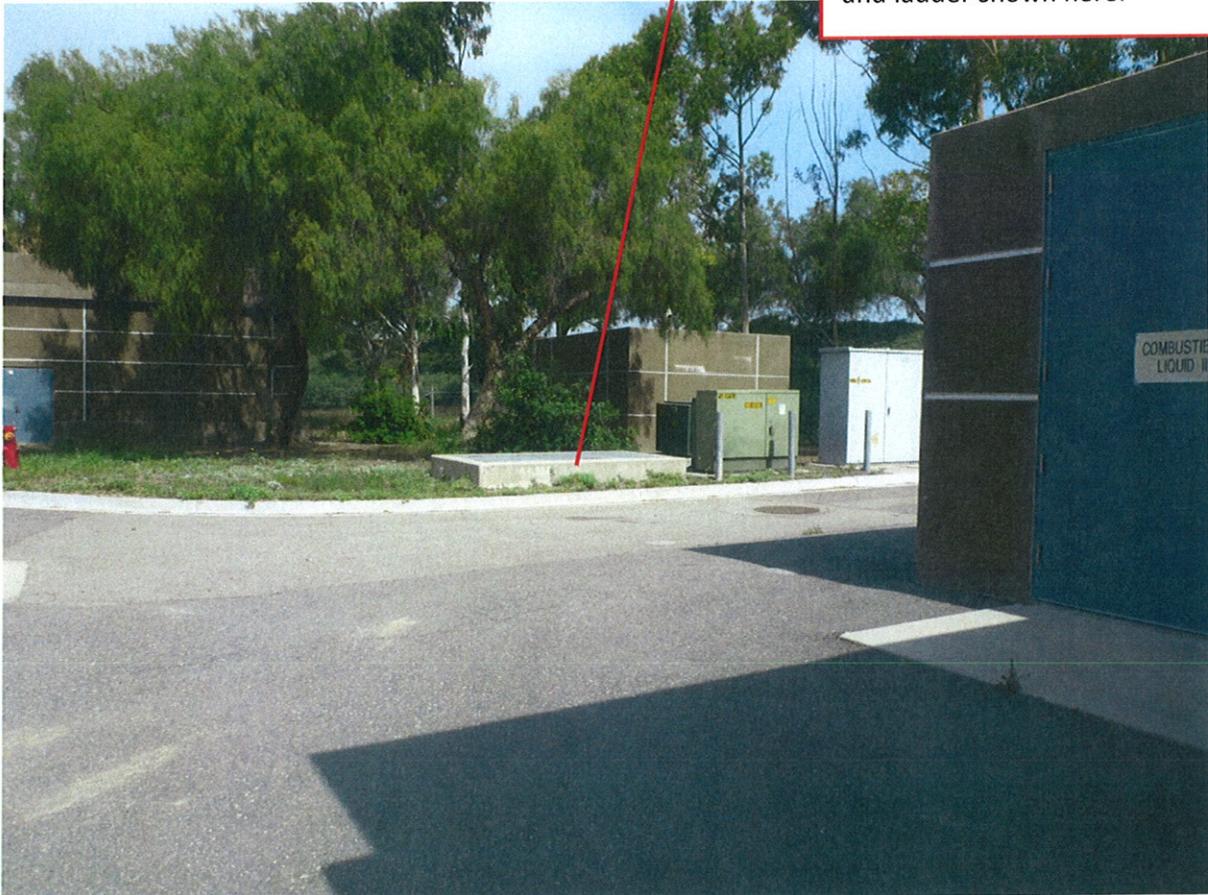
Photo #1

Photo looking northwest, showing the access location through the grated vault

This vault leads to the downstream (southeast) end of System 1 – segment c

Access available through the existing grated entrance vault and ladder shown here.

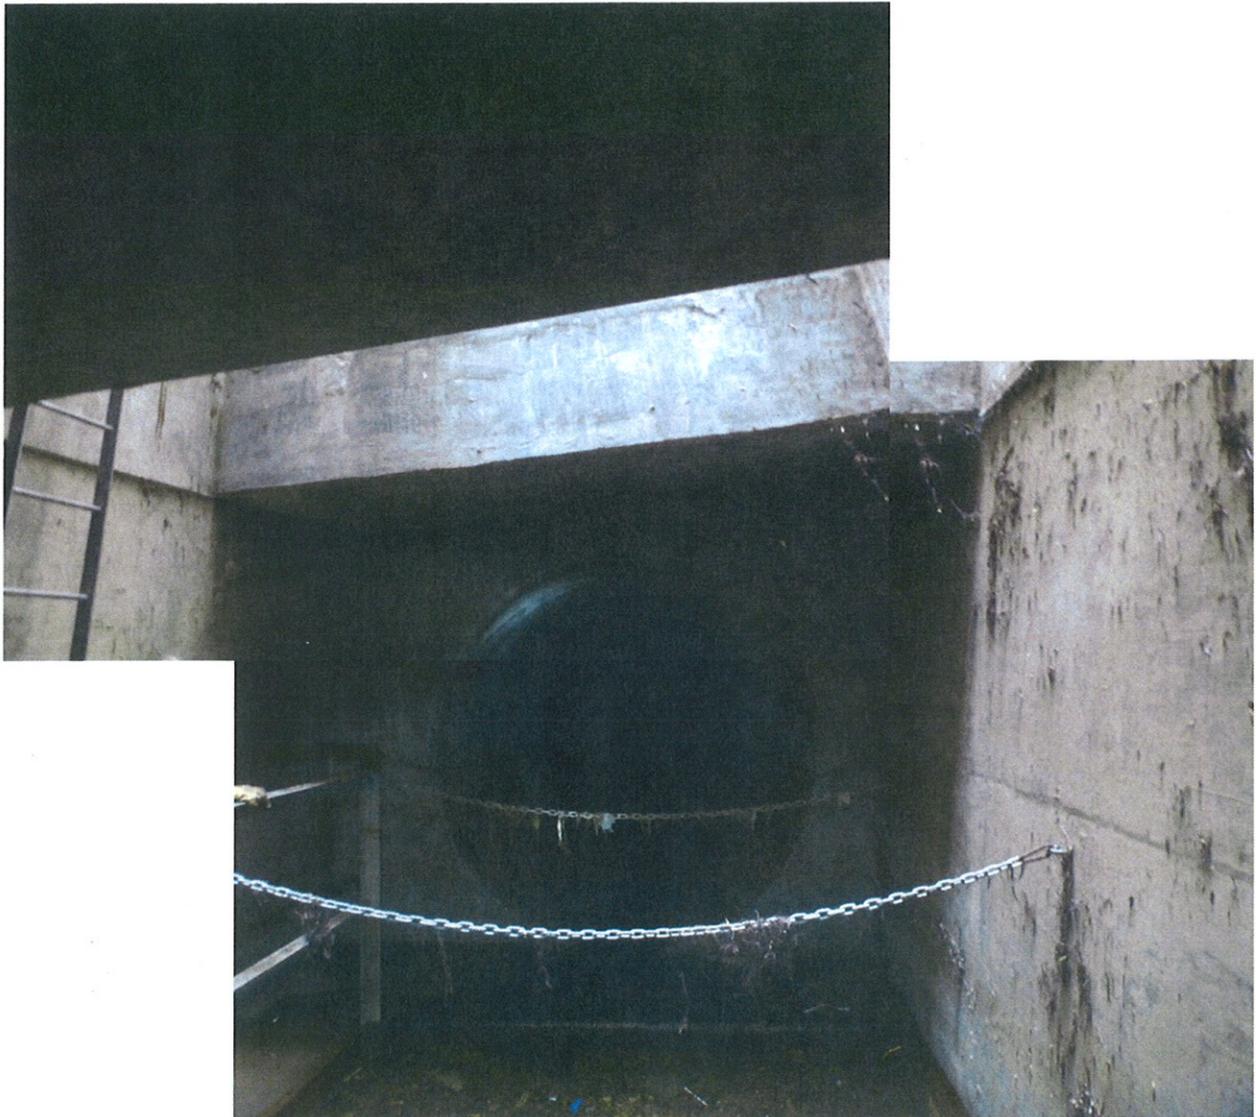
Photo #2

Photo showing the underside of the grated vault entrance with ladder; and pipe entrance of the existing 84" RCP (System 1 – segment c)

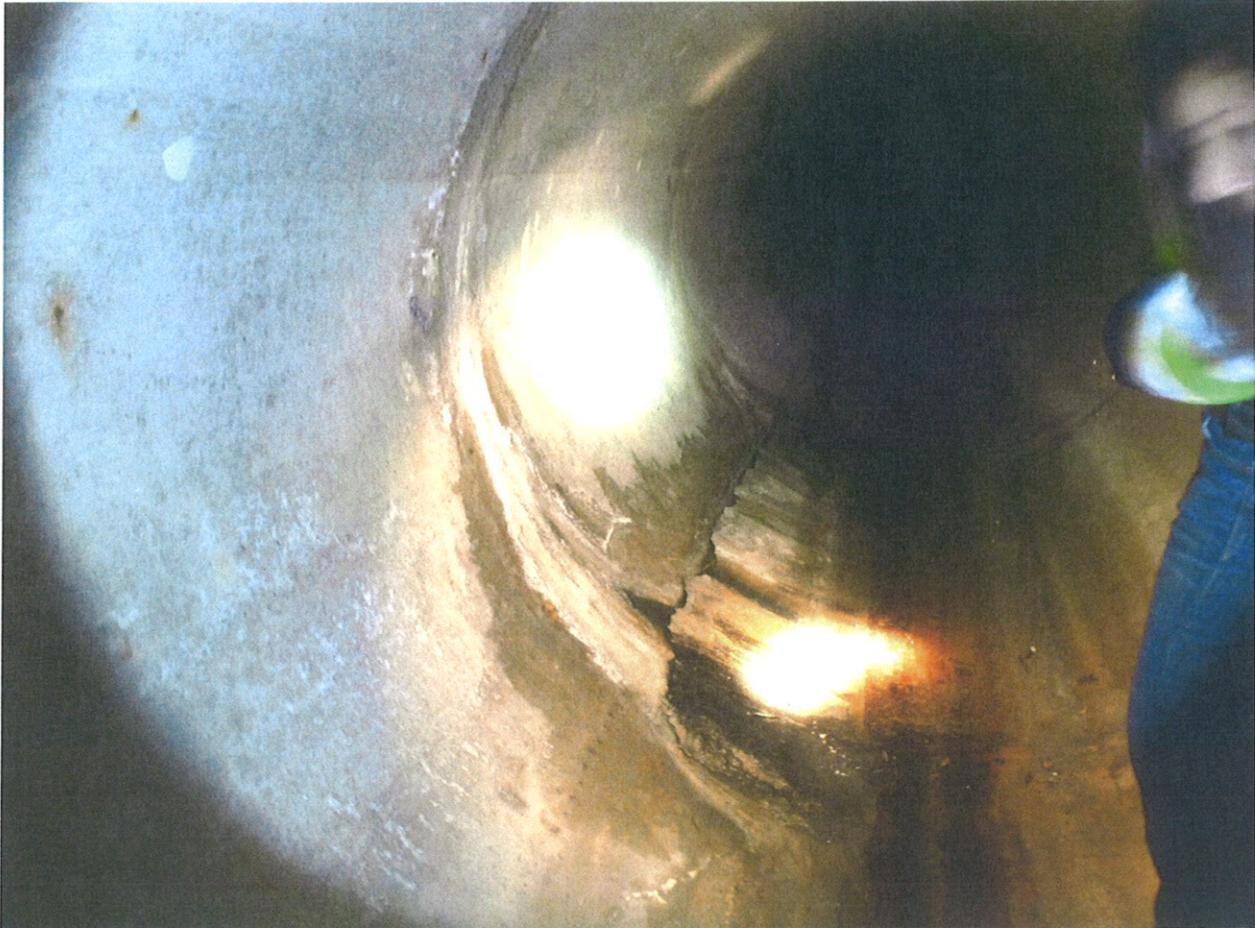
Photo #3

12-0M4304, Drainage System 1-Segment c  
Looking northwest (upstream), existing 84" RCP Culvert  
Near proposed pipe joint seal and spall repair area  
Photo taken 5/22/12

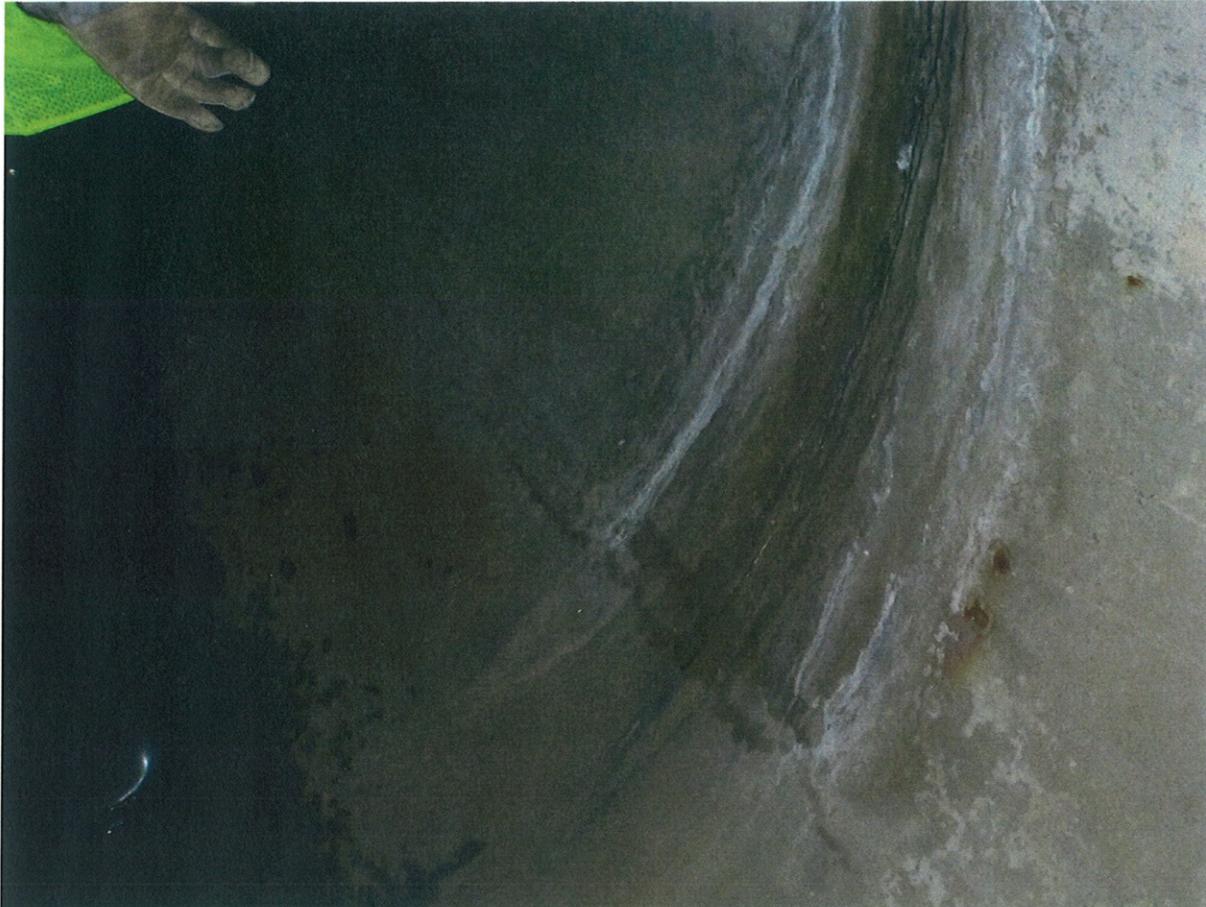
Photo #4

12-0M4304, Drainage System 1  
Looking northeast (upstream), existing 84" RCP Culvert  
Near proposed pipe joint  
Photo taken 10/30/12

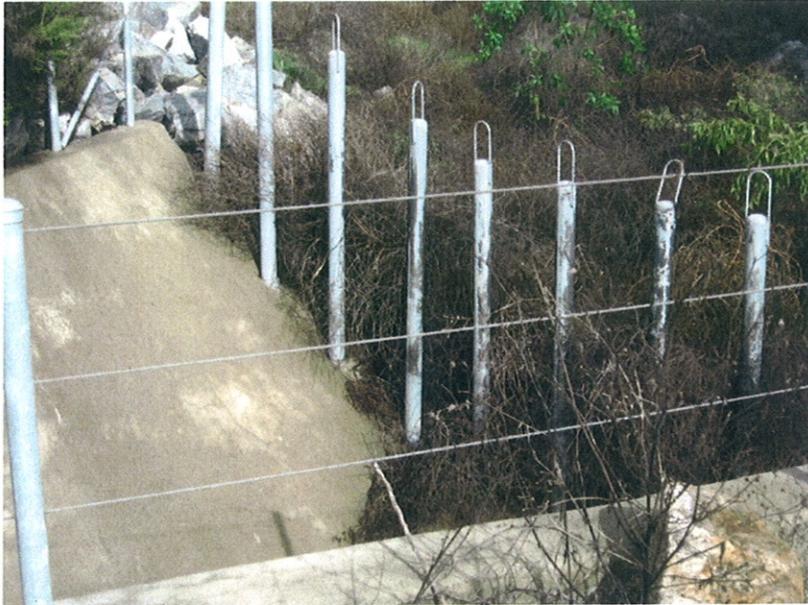
Photo #5

12-0M4304, Drainage System 36  
Existing 84" CMPA Culvert, at pipe entrance Stat 0+00

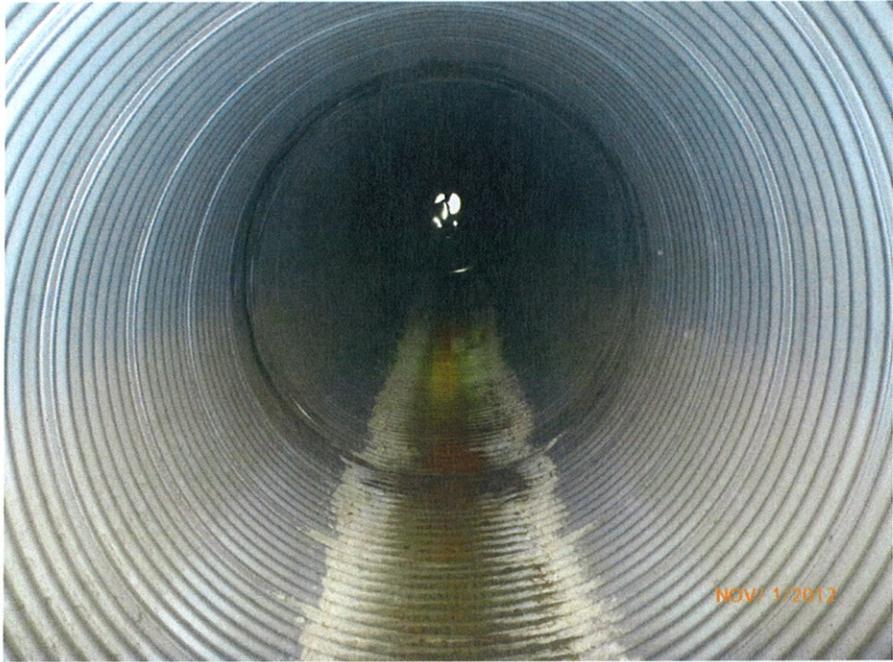
12-0M4304, Drainage System 36  
Looking southwest, existing 84" CMPA Culvert

Photo #7 - Pipe Joint Seal location

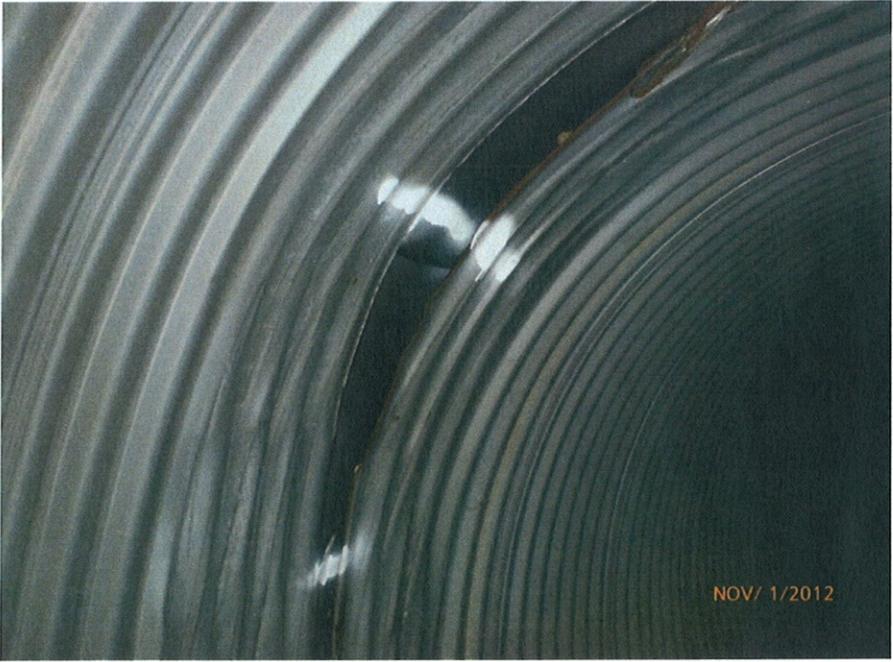
Photo #8 - Pipe Joint Seal location

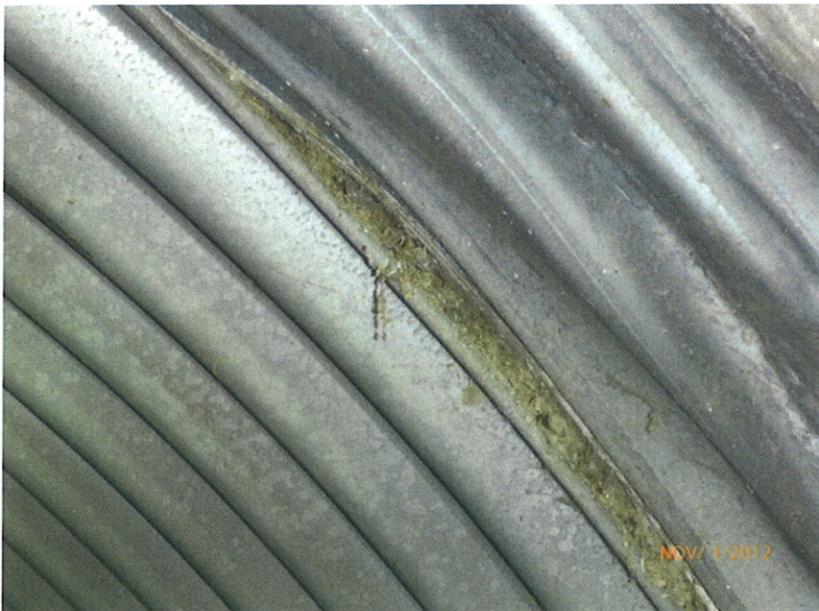
Looking northeast at existing 84" CMPA Culvert seam

Photo #10 - Proposed Patch Plate Location, typical

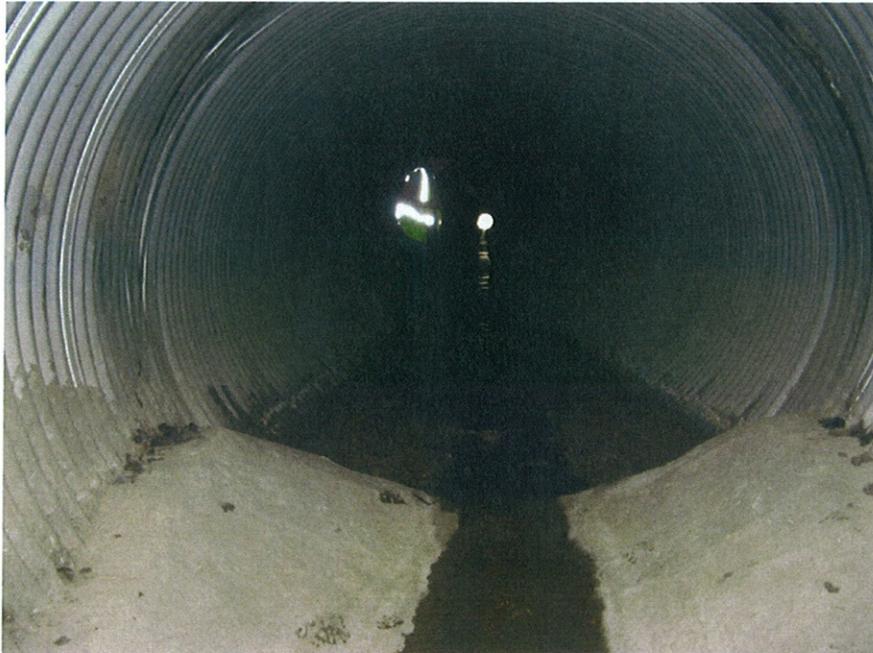
Photo #11 taken 9/25/08

12-0M4304, Drainage System 36-segment f  
Looking northeast at the junction of the existing and proposed invert paving location

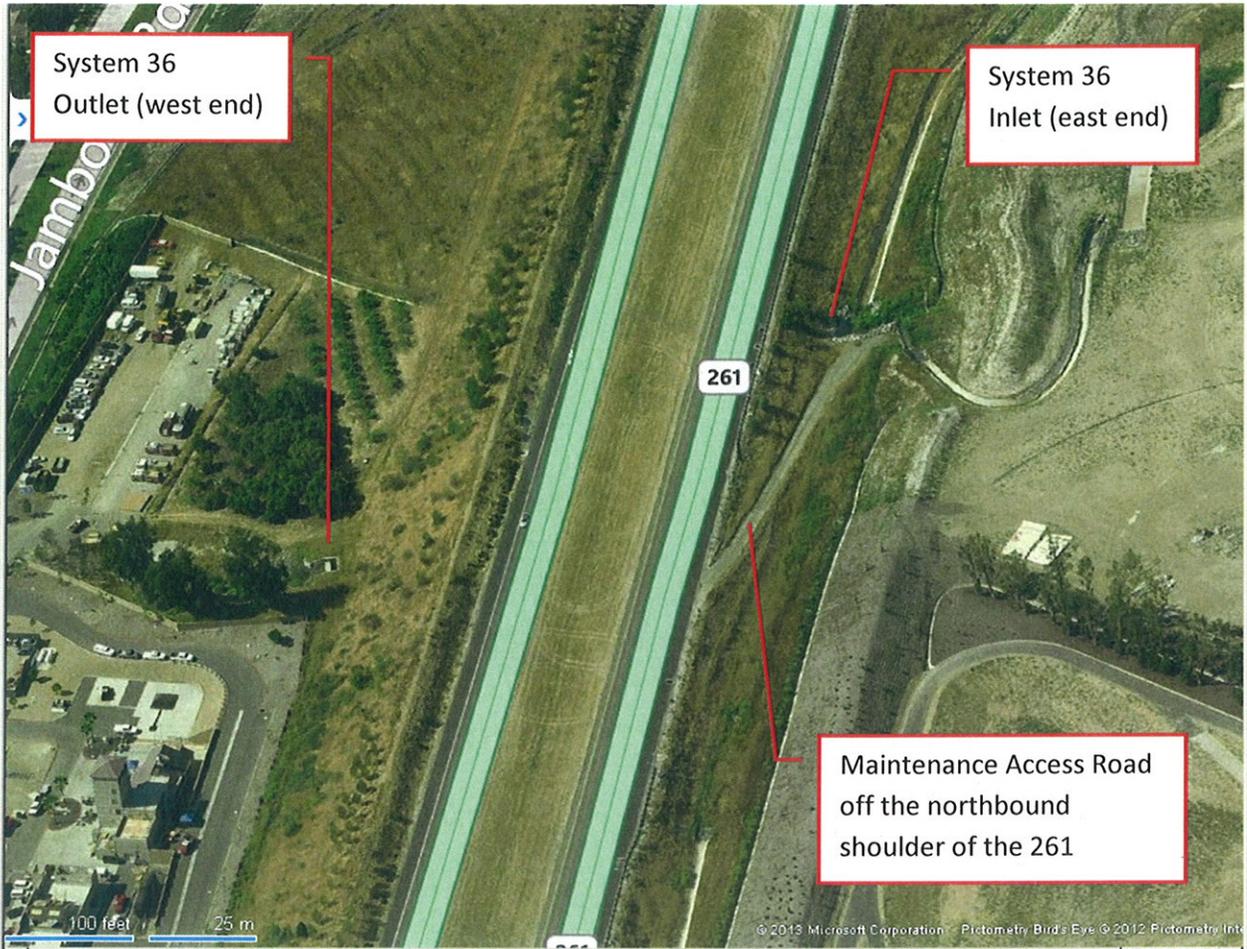
Photo #13 - Aerial view showing the inlet and outlet of the 84" CMPA culvert, and showing the maintenance access road off the northbound shoulder of the 261.
