U.S. Department of Transportation Federal Highway Administration- California Division- Title 23 Damage Assessment Form (DAF)		DAF No. - NAP - 0 1 7 - 0

Bridge Number : 21C0003
Facility Carried: TRANCAS ST
Location : 1.3 MI E SR 29
City : NAPA
Inspection Date : 09/12/2014

Bridge Inspection Report

STRUCTURE NAME: NAPA RIVER

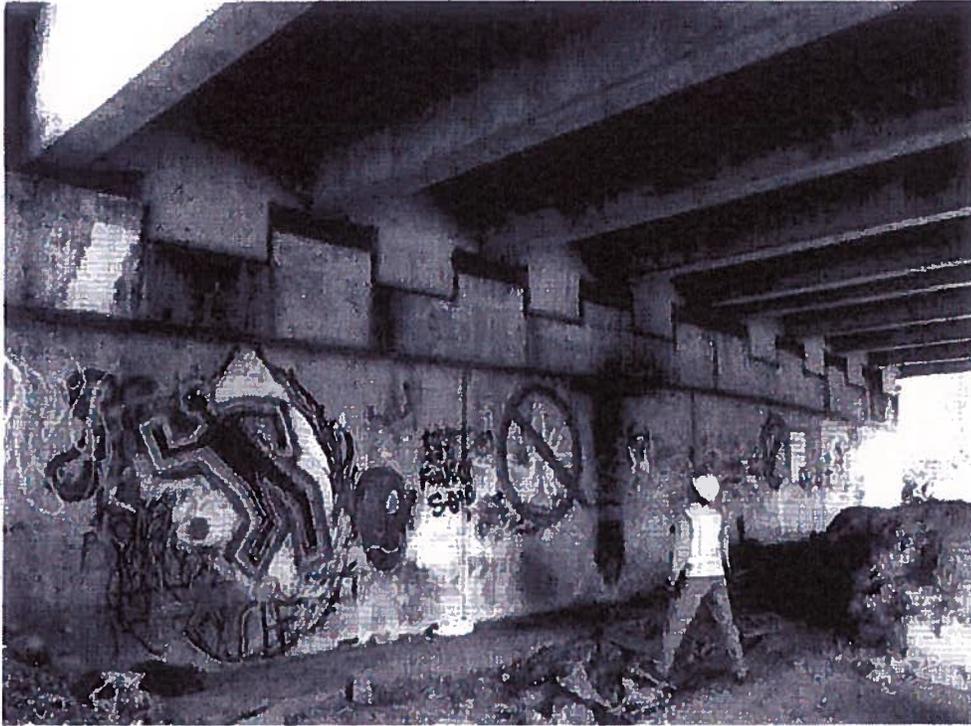
Photo No. 1
View of Abutment 1.

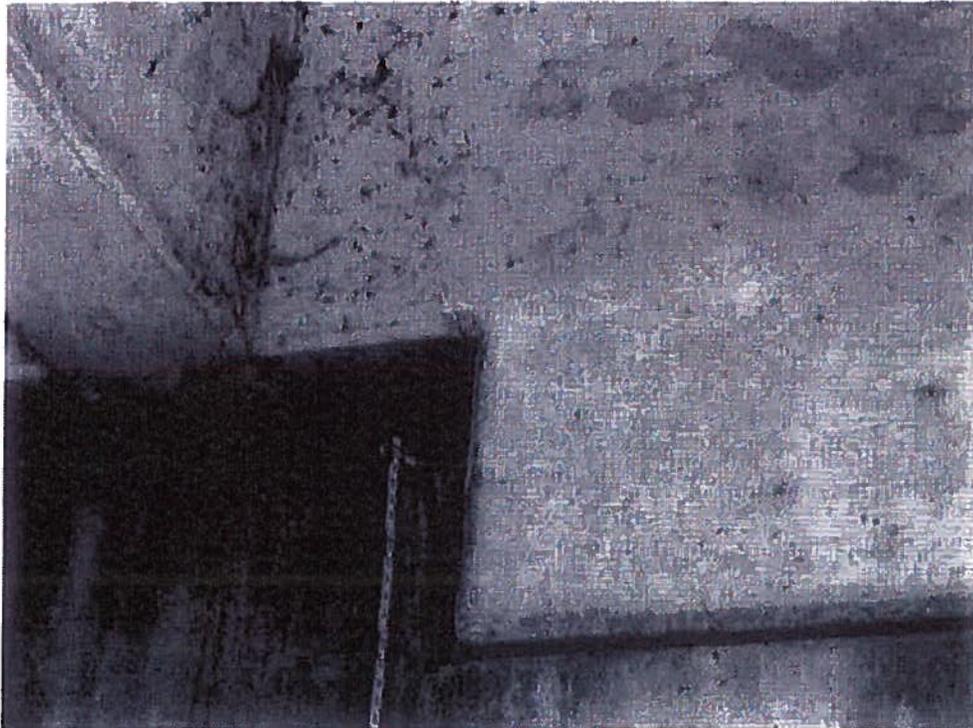
Cracks were observed in the following concrete shear keys at Abutment 1: Shear Key in Bay 1, Shear Key in Bay 6, and the Shear Key in Bay 7. The largest cracks measuring up to 1/8 of an inch wide, are in Bays 6 and 7. The crack in the Bay 1 Shear Key is less than 1/64th of an inch wide.

The cracks begin in the face of the diaphragm, approximately 12 inches above the interface with the shear key, and continue toward the bottom surface of the diaphragm where it intersects with the shear key. The cracks then extend downward into the shear key at a 45 degree angle until meeting the back surface of the shear key. The cracks continue at a 45 degree angle and extend up to 18 inches in length in the back surface of the shear key. See photos 1 thru 11.

The shear keys are intact and remain functional.

Photo No. 2
Close-up of crack in the Diaphragm and shear key in Bay 1.

Repair the cracks in the following shear keys by injecting them with epoxy:

- Shear Key, Bay 1
- Shear Key, Bay 6
- Shear Key, Bay 7

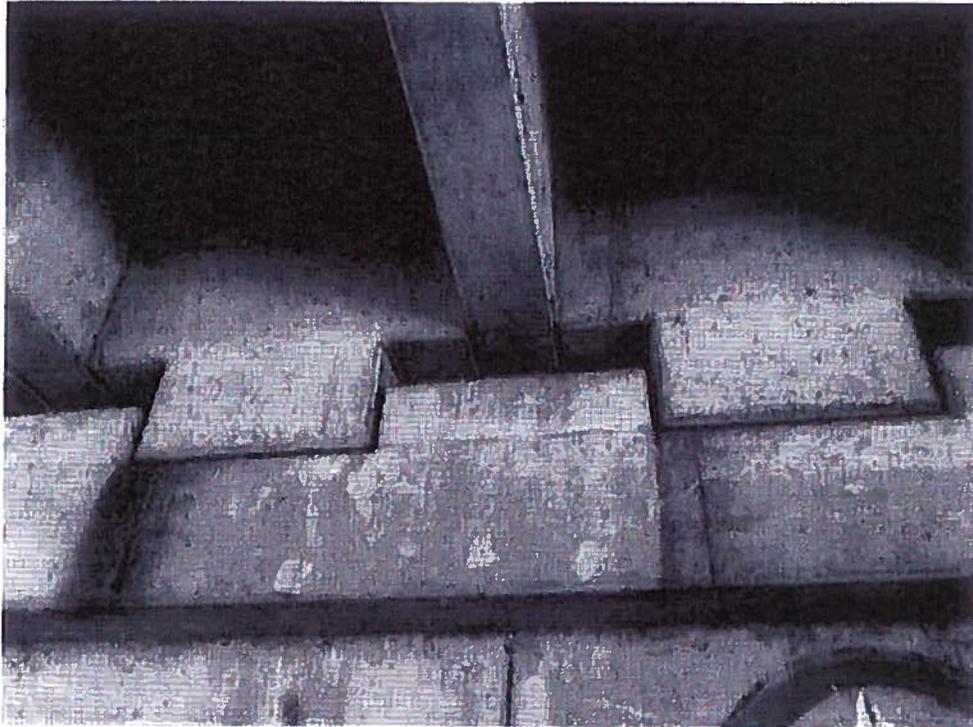
Photo No. 3

Cracks visible in the Diaphragms and shear keys in Bays 6 and 7.

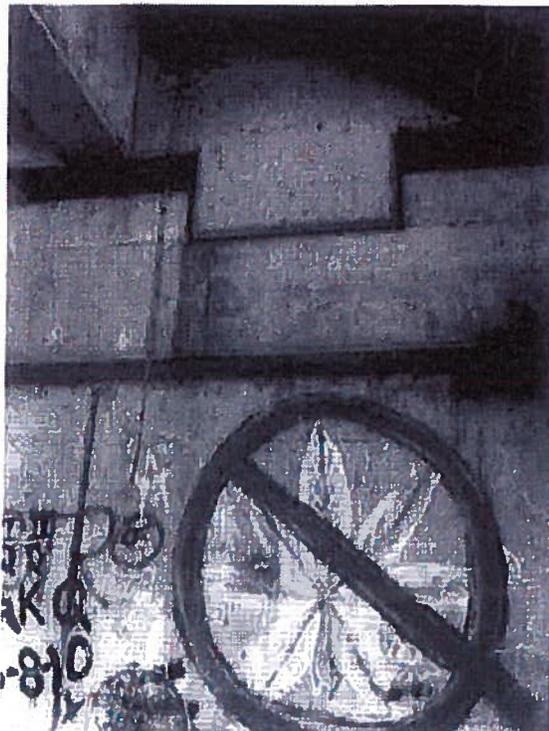
Photo No. 4

Crack visible in the Diaphragm and shear key in Bay 6.

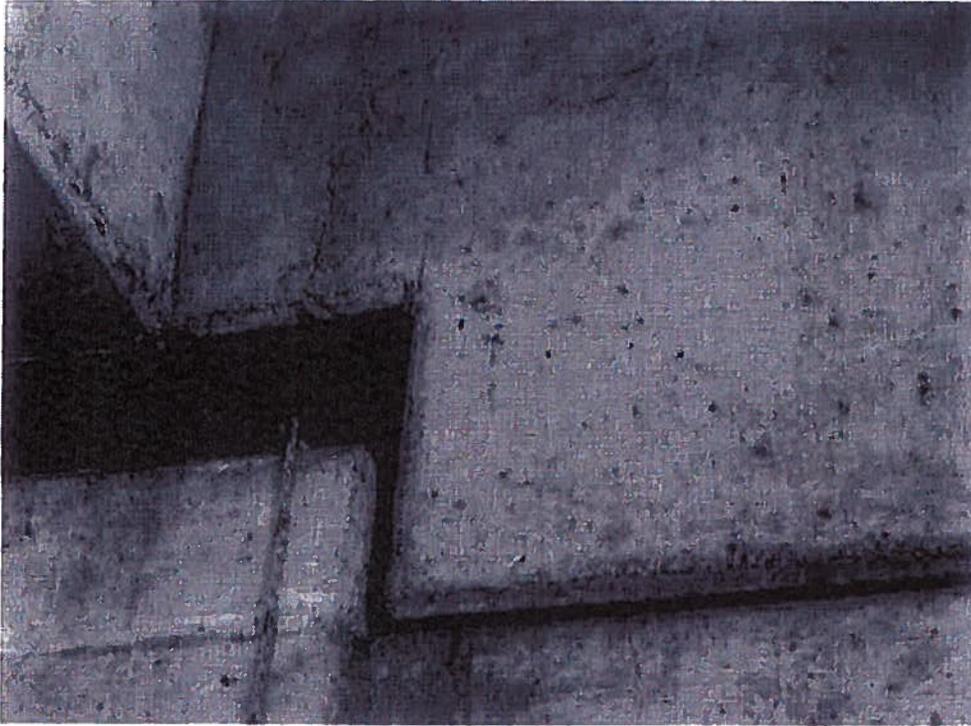
Photo No. 5

Close-up of crack in the Diaphragm and shear key in Bay 6.

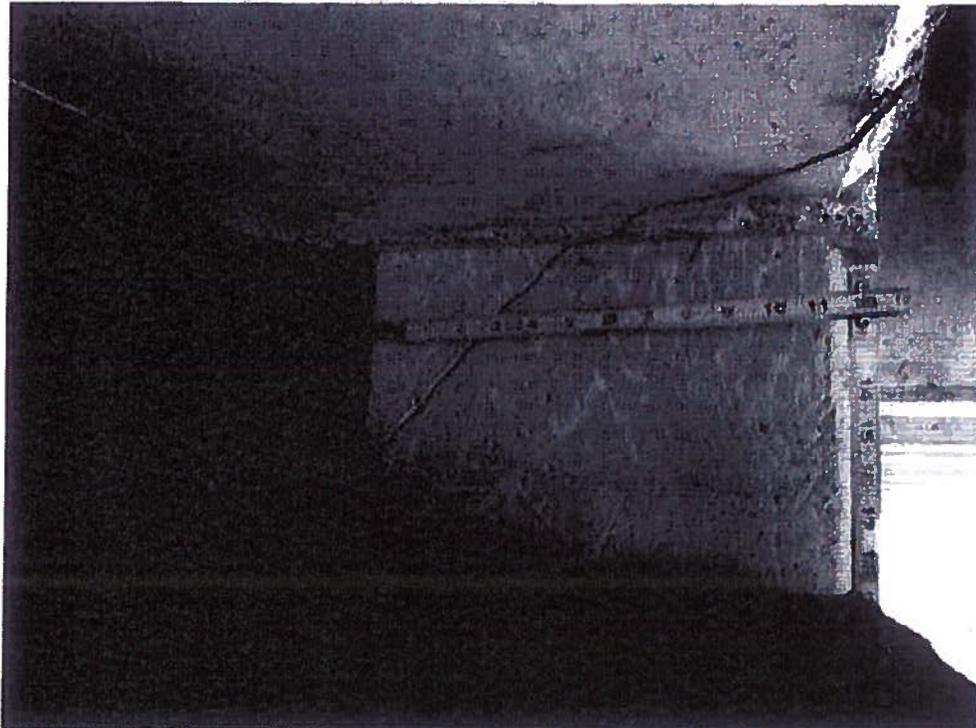
Photo No. 6

View of the crack extending from the diaphragm into the shear key in Bay 6 (side view).

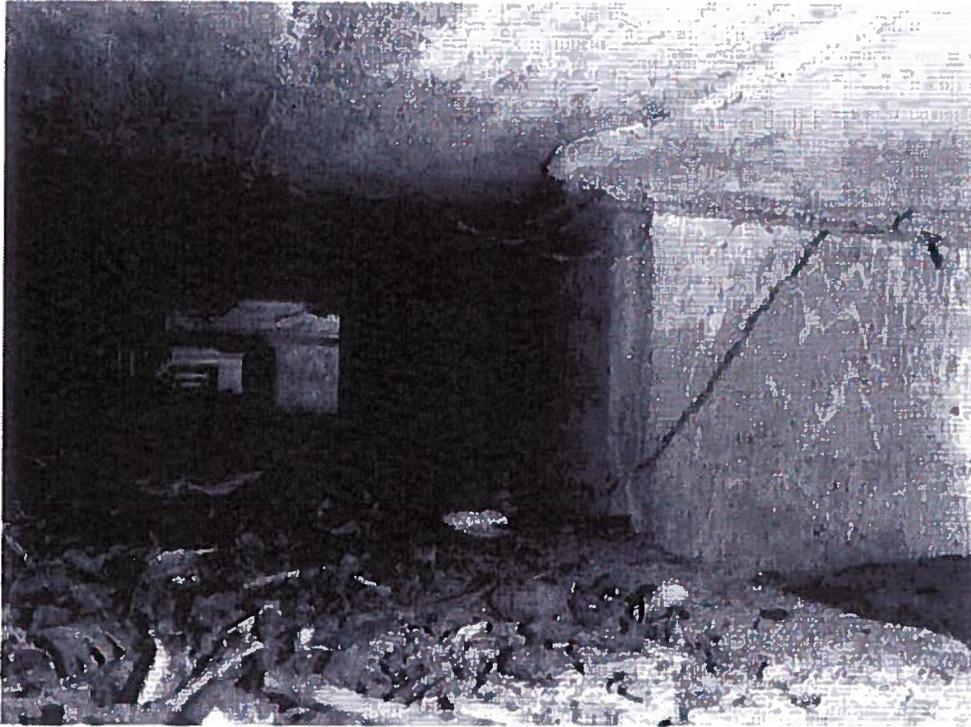
Photo No. 7

View of the back side of the shear key. The crack continues into the back face at 45 deg.

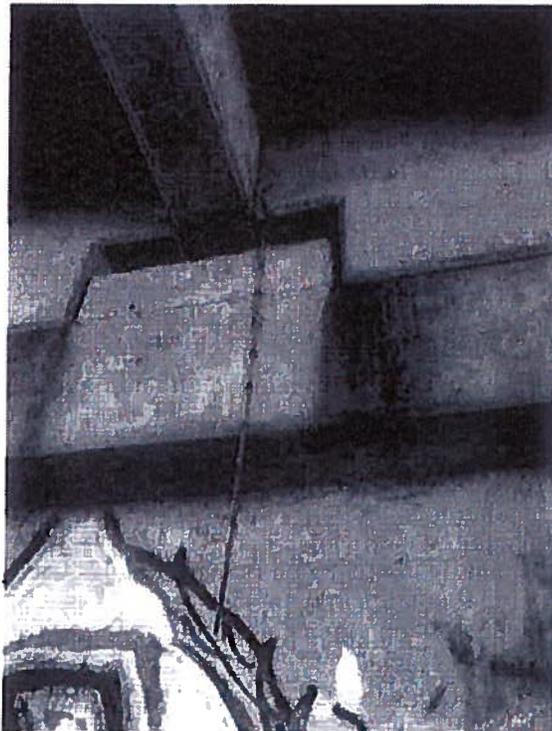
Photo No. 8

Crack visible in the Diaphragm and shear key in Bay 7.

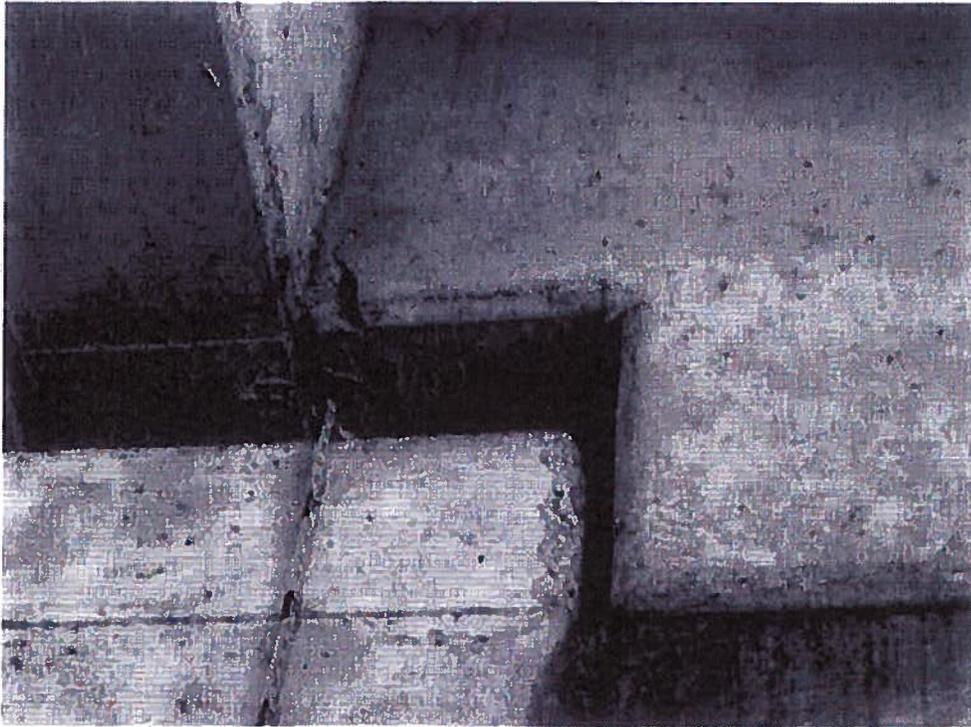
Photo No. 9

Close-up view of crack in the Diaphragm and shear key in Bay 7.

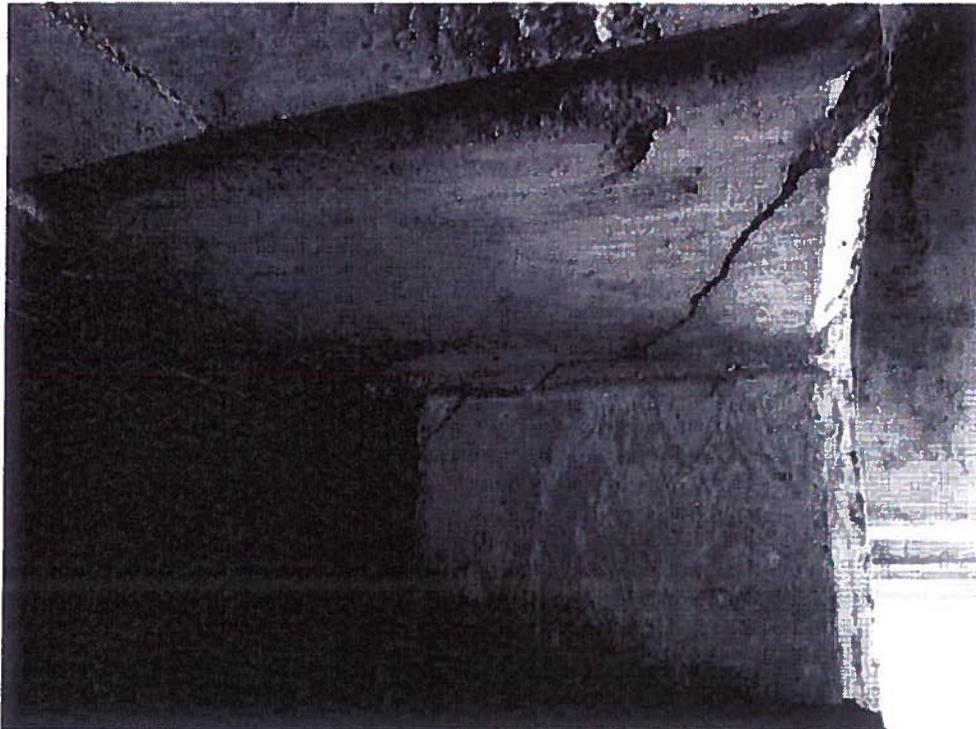
Photo No. 10

View of the crack extending from the diaphragm into the shear key in Bay 7 (side view).

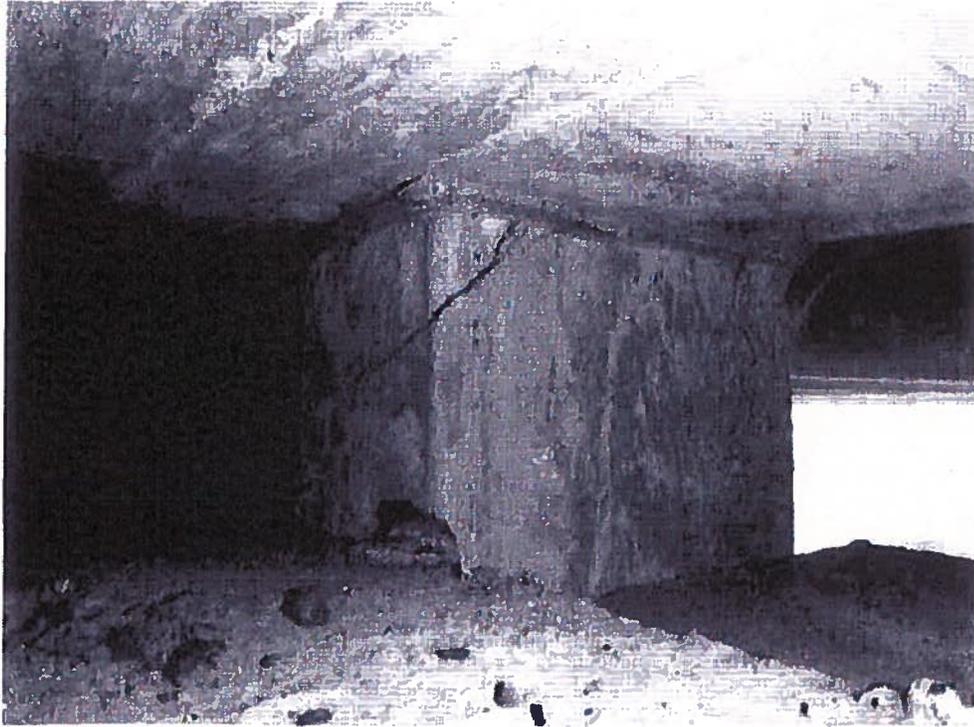
Photo No. 11

View of the back side of the shear key. The crack continues into the back face at 45 deg.
