U.S. Department of Transportation Federal Highway Administration- California Division- Title 23 Damage Assessment Form (DAF)		DAF No. <input type="text"/> - NAP <input type="text"/> - <input type="text"/> <input type="text"/> <input type="text"/> <input type="text"/> - <input type="text"/> <input type="text"/>
Applicant Napa County Public Works		County Napa Congressional districts 5
Location of Damage: Name of Road/Bridge: <u>OLD SONOMA ROAD CULVERT</u>		Incident Date (mm/dd/yyyy) <u>08/24/2014</u> Inspection <u>09/24/2014</u>
Per Site <input checked="" type="checkbox"/> or <input type="checkbox"/> Per Mile		Federal-aid Highway? Y for yes, if no, ineligible for ER funds <input type="checkbox"/> Y
PM Begin: <u>2.27</u> PM Length: <u>39.00</u> PM End: <u>2.27</u> (in feet)		Map No <u>5K12</u>
Road/Bridge Data: Bridge No. <u>        </u> Type: <u>        </u>		Functional Classification Type: MAJOR COLLECTOR

**Damage Assessment and Recommendations Report**  
**Old Sonoma Road MPM 2.27 Culvert**  
**03/17/15**

## INITIAL SUMMARY REPORT OF STRUCTURE

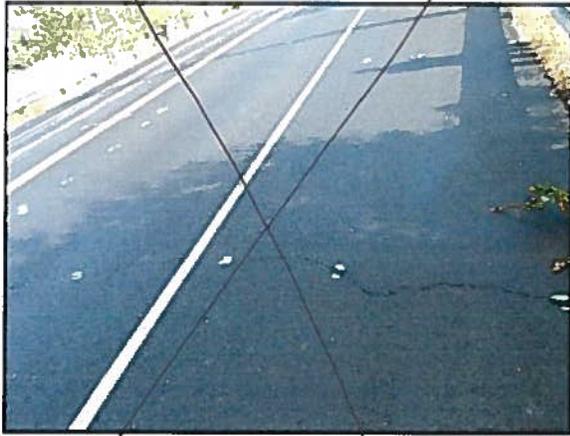
**Pavement cracks above culvert**

Cracks at the asphalt roadway surface above the culvert were also observed.

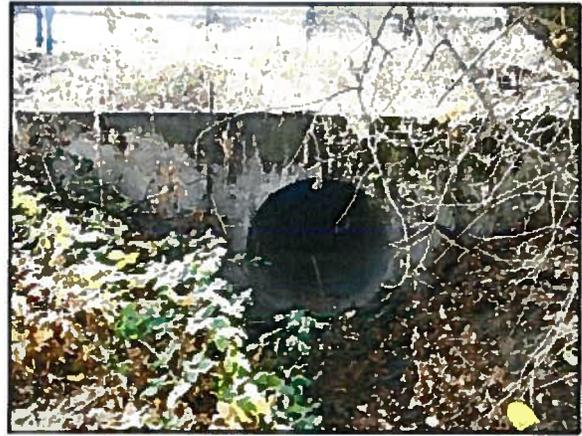
**Culvert Inlet**

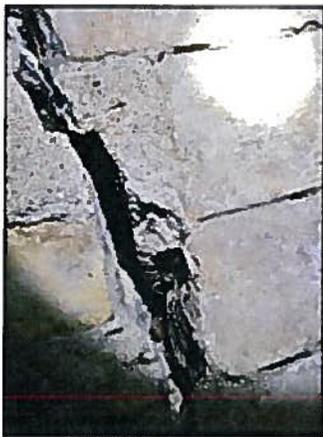
**Cracks in stone arch bridge**

Unreinforced mortared stone masonry construction is very susceptible to lateral seismic loads and displacements. Post-earthquake the structure experienced cracks in the mortar reducing bond capacity. Without tension reinforcement, lateral loading or displacements reduces the design compression within the arch element and when sufficiently large, would impose tension between the stones. With negligible tension capacity provided by the mortar bond, the mortared joints will crack and de-bond from the stones. Once the stones are de-bonded, continued seismic loading and displacements or gravity will loosen the de-bonded stones and the stones will fall from the arch. Because the masonry arch is a compression structure, missing stones reduces the vertical load capacity of the arch and weakens the arch. If sufficient stones fall from the arch, the arch culvert is susceptible to collapse under vehicular loading. In this bridge, we observed severe cracks. Extensive cracks along the entire perimeter of the existing stone masonry arch at various locations were observed. The cracks vary in width up to 1" wide.

Stone arch culvert repair will include adding new concrete shell around arch barrel. The new concrete shell will have concrete reinforcing. New concrete shell will be connected to existing stone arch barrel with drill & bond dowel. Existing cracks at stone arch barrel will be pressure grouted.

The repair option will consist of strengthening the stone arch portion with a reinforced concrete shell over the outside of the stone arch segment. Strengthening will need to be performed by replacing any missing stones and pressure grouting the cracks in the mortar between the stones, excavating around the stone arch segment to access the stone arch from the outside, drilling and bonding dowels into the back of the stones, placing a reinforced concrete shell around the outside perimeter of the stone arch culvert and tying the two structures together with the dowels. The reinforced concrete pipe culvert portion will be left as is since there is no damage to the concrete pipe portion. However the existing concrete culvert/barrel may not meet current hydraulic requirements, including fish passage/velocity requirements of regulatory agencies.

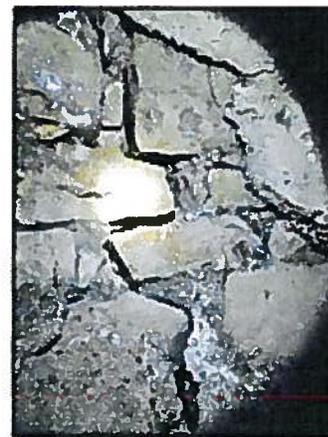
**Cracks in stone arch bridge**
