U.S. Department of Transportation Federal Highway Administration- California Division- Title 23 Damage Assessment Form (DAF)		DAF No. <input type="text"/> - NAP <input type="text"/> - <input type="text"/> <input type="text"/> <input type="text"/> <input type="text"/> - <input type="text"/> <input type="text"/>
Applicant Napa County Public Works		County Napa Congressional districts 5
Location of Damage: Name of Road/Bridge: CONN CREEK BRIDGE AT SKELLENGER LANE		Incident Date (mm/dd/yyyy) 08/24/2014 Inspection 11/19/2014
Per Site <input checked="" type="checkbox"/> or <input type="checkbox"/> Per Mile		Federal-aid Highway? Y for yes, if no, ineligible for ER funds <input type="checkbox"/> Y
PM Begin: _____ PM Length: _____ PM End: _____ (in feet)		Map No <input type="text"/> 5J42
Road/Bridge Data: Bridge No 21C0087 Type: RC Concrete	Functional Classification Type: MAJOR COLLECTOR	
Traveled Way: Width 17 Type: PCC <input checked="" type="checkbox"/> AC <input type="checkbox"/> Gravel <input type="checkbox"/>	Route # _____

Project ID.: DAF 18 CONN CREEK BRIDGE

Bridge Inspection Report

STRUCTURE NAME: NAPA RIVER OVERFLOW

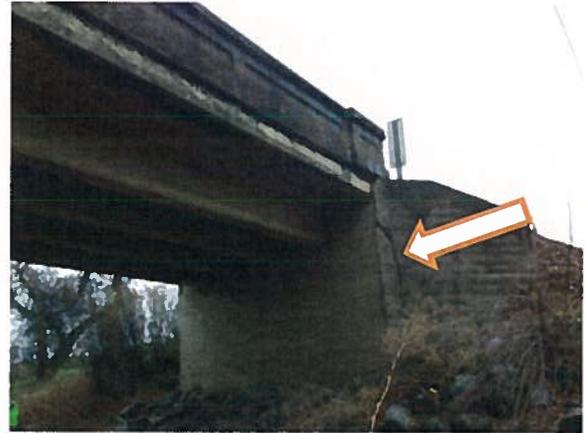
Vertical Crack at Abutment 4 Right Wingwall

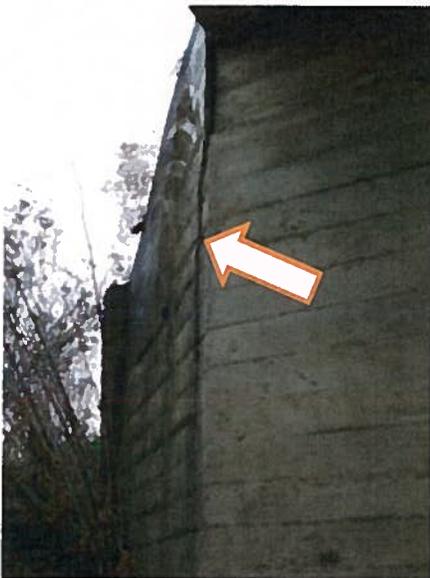
Vertical Crack at Abutment 4 Left Wingwall

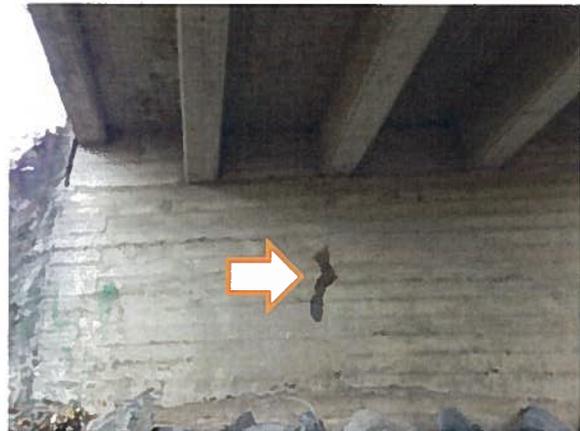
Hairline Vertical Crack at Abutment 4 Wall

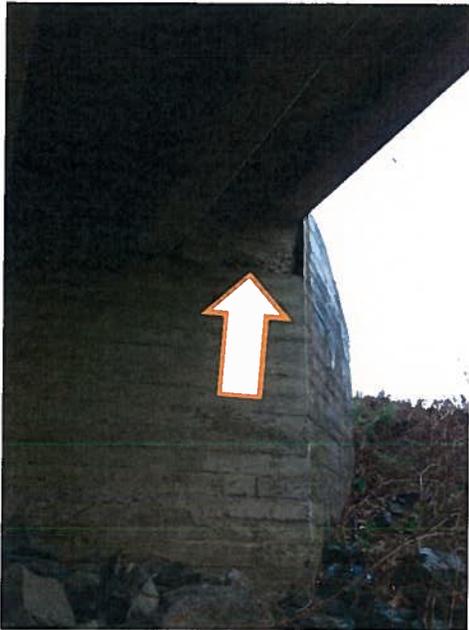
Concrete Spall at Abutment 1

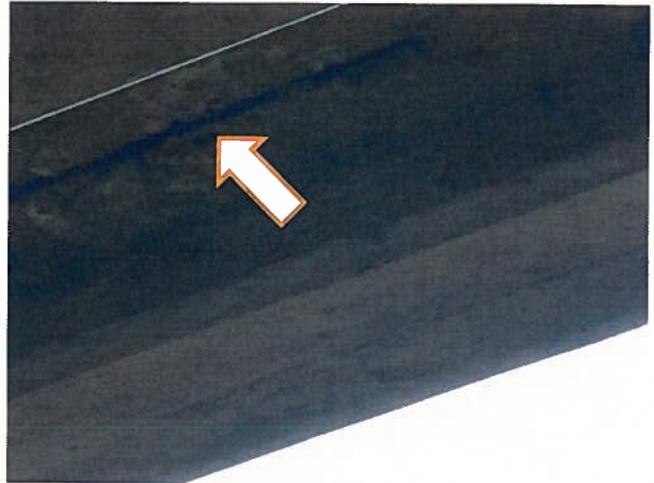
Concrete Spall at Underside of Deck

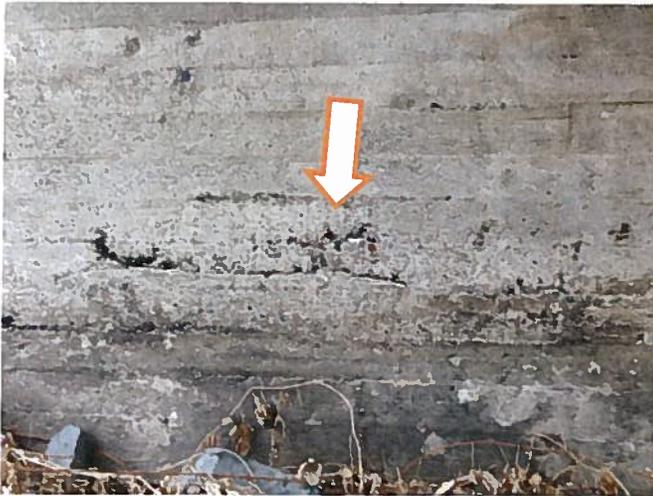
Concrete Spall at Abutment Wall

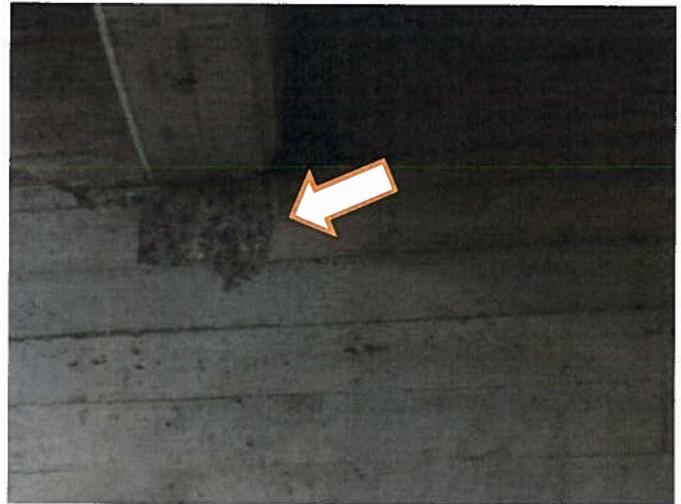
Concrete Spall at Abutment Wall

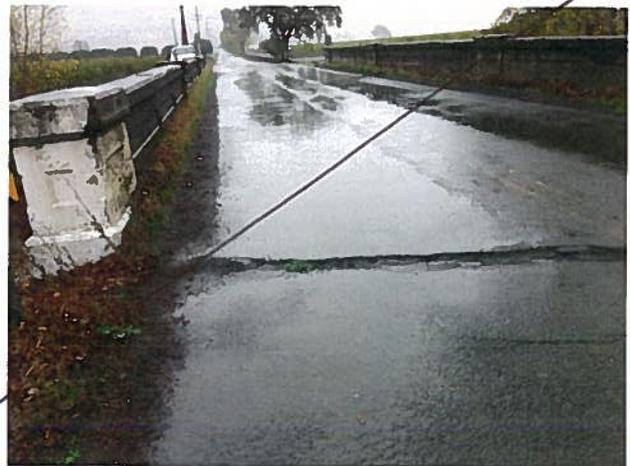
Pavement Crack above Buttress
