U.S. Department of Transportation Federal Highway Administration- California Division- Title 23 Damage Assessment Form (DAF)		DAF No. _____ - NAP _____ - 0 2 0 - 0	Sheet # 1 of 3 Federal Project # EO ER _____ ()
		Disaster No. CA 1 4 - 1 PR ER _____ ()	
Applicant Napa County Public Works		County Napa Congressional districts 5	Incident Date (mm/dd/yyyy) Inspection 08/24/2014 09/23/2014
Location of Damage: _____		Per Site <input checked="" type="checkbox"/> or <input type="checkbox"/> Per Mile	Federal-aid Highway? Y for yes, if no, ineligible for ER funds <input type="checkbox"/> Y
Name of Road/Bridge: Silverado Trail Box Culvert		PM Begin: 1.47 PM Length: 58.00 PM End: 1.47 (in feet)	Map No 5K13 Functional Classification Type: MAJOR COLLECTOR Route # _____
Road/Bridge Data:	Bridge No 21C0015 Type: CONCRETE CULV	Traveled Way: Width 22 Type: PCC <input type="checkbox"/> AC <input checked="" type="checkbox"/> Gravel <input type="checkbox"/>	Forest Hwy? Y/N <input type="checkbox"/> N Interstate? Y/N <input type="checkbox"/> N

Damage Assessment and Recommendations Report
Silverado Trail MP 1.47 Bridge
03/05/15

Bridge Inspection Report

STRUCTURE NAME: CONN CREEK

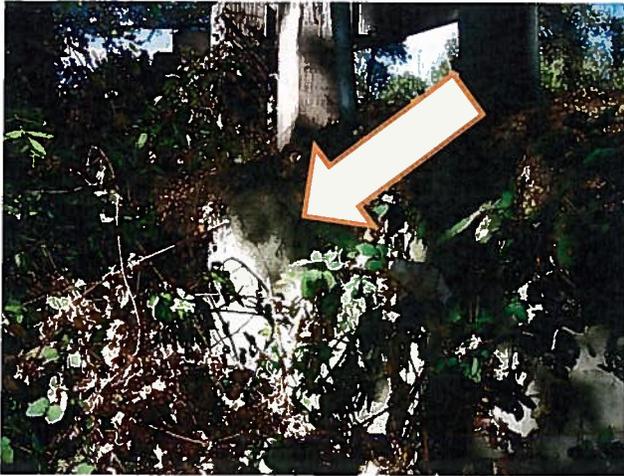
Crack in northwest wing wall.

Various cracks at several locations were observed and noted. Two full height vertical cracks up to 1.25" wide are observed at North abutment wall. One full height vertical crack is observed at South abutment wall. Diagonal crack is observed at the Northwest wingwall.

Bridge repair includes applying pressure grout at all the cracks observed at the abutment walls and wingwall.

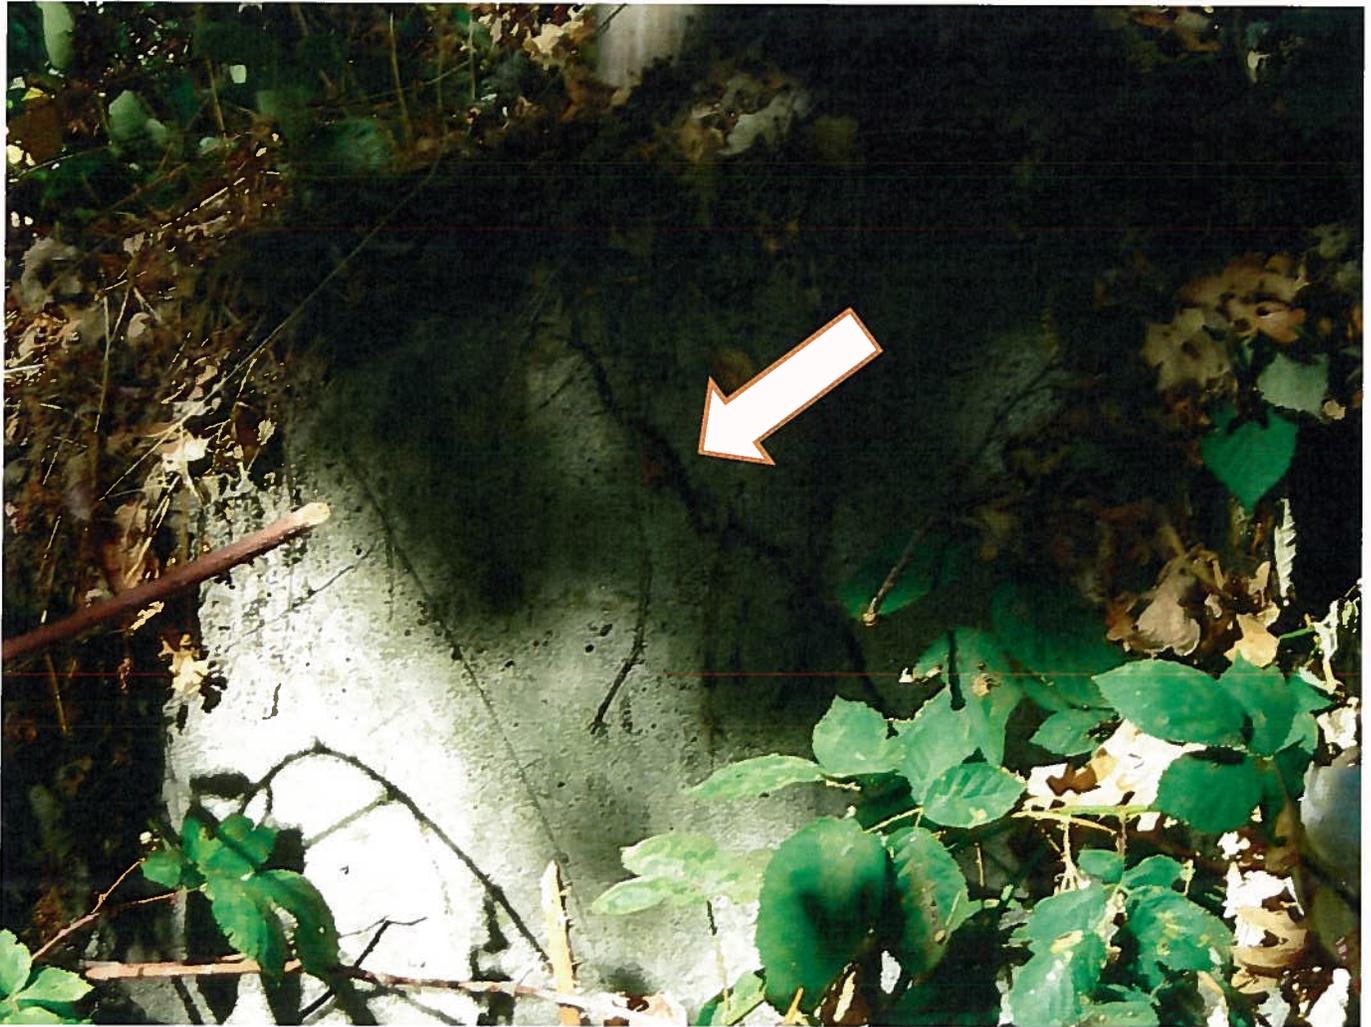
Closeup of crack in northwest wing wall.

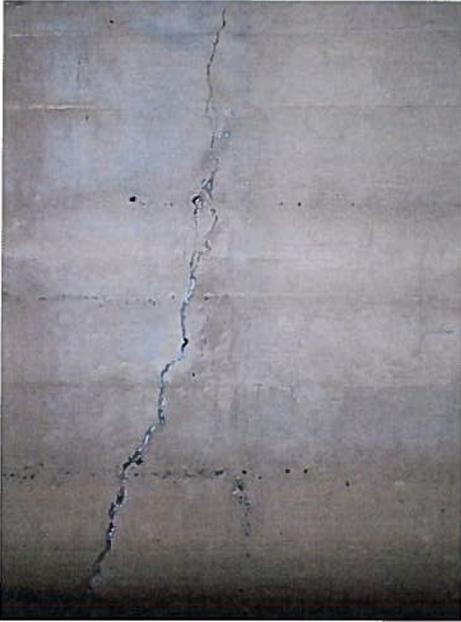
Crack A: Vertical crack, full height at exterior wall inside face of south wall of culvert.

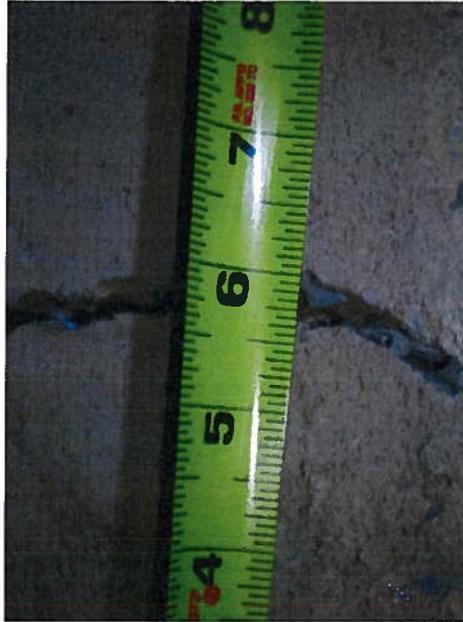
Crack A: Width of crack.

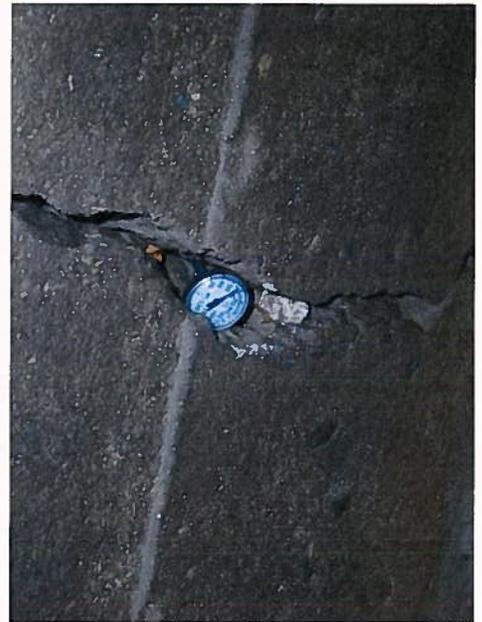
Crack A: Width of crack.

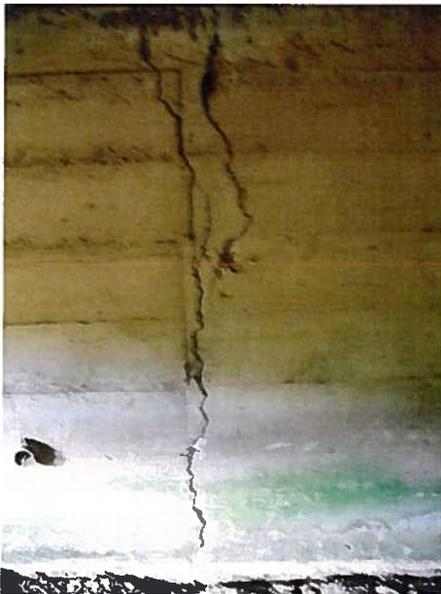
Crack B: Vertical crack full height at exterior wall inside face of north wall of culvert at cold joint.

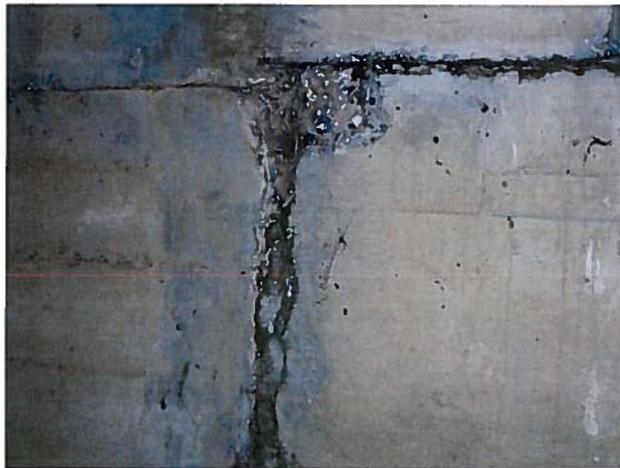
Crack C: Vertical crack full height at exterior wall inside face of north wall of culvert at cold joint.

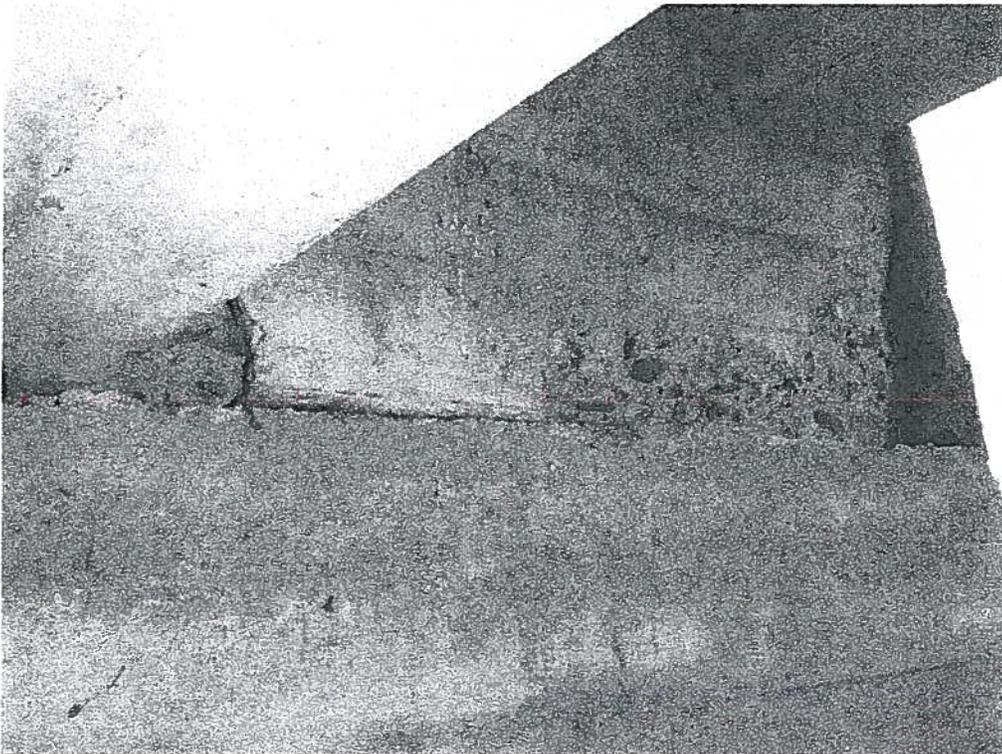
Photo No. 2

There is a large spall with incipient spall in the diaphragm of Abutment 1 between the two left exterior girders in Bay 1. The incipient spall measures approximately 1.5 ft x 2 ft. It is possible that this is earthquake damage from some previous seismic event (see attached photo No. 2).

Large spalls and incipient spalls in the RC end diaphragm at Abutment 1, left.

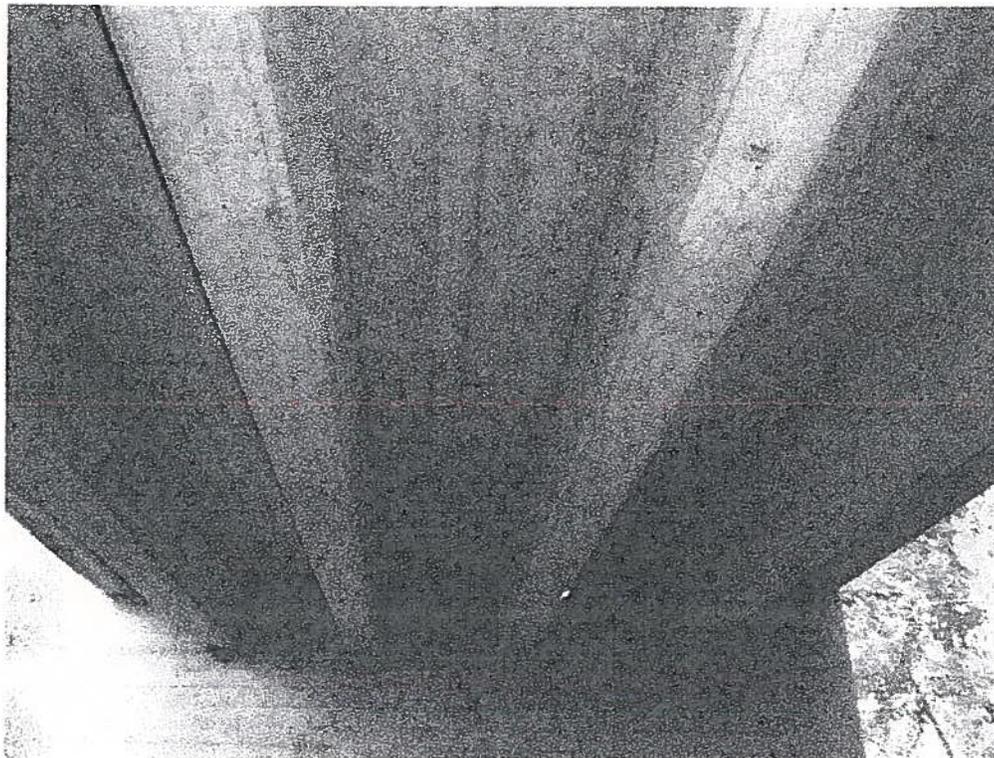
Photo No. 4

Soffit details.

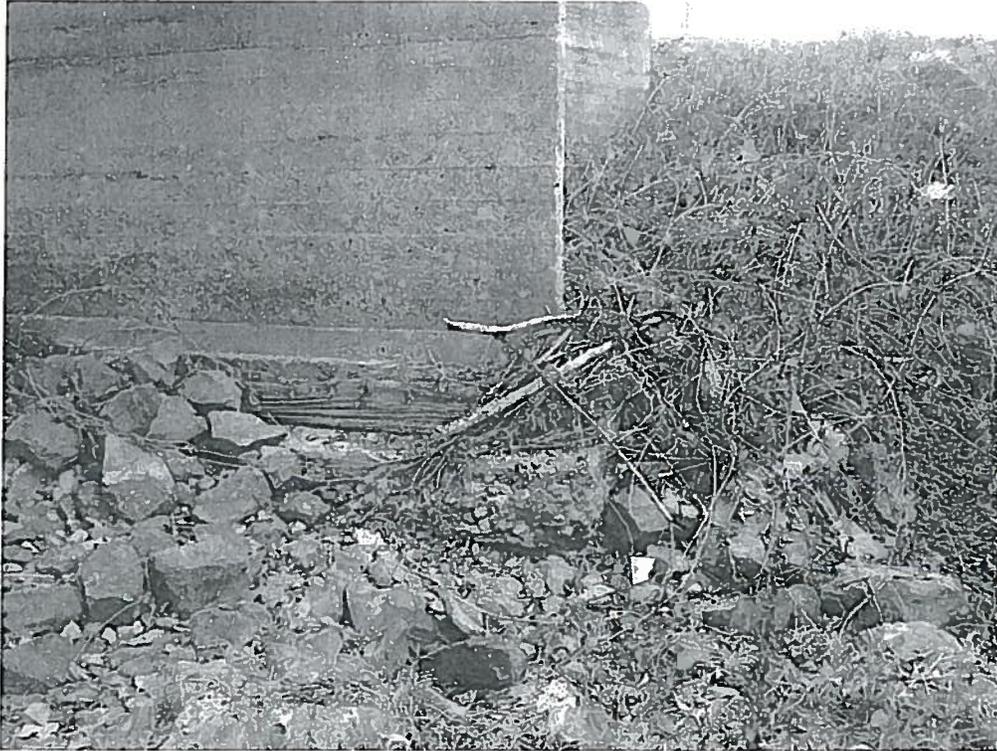
Photo No. 1

Exposed Pier 2 footing at upstream left

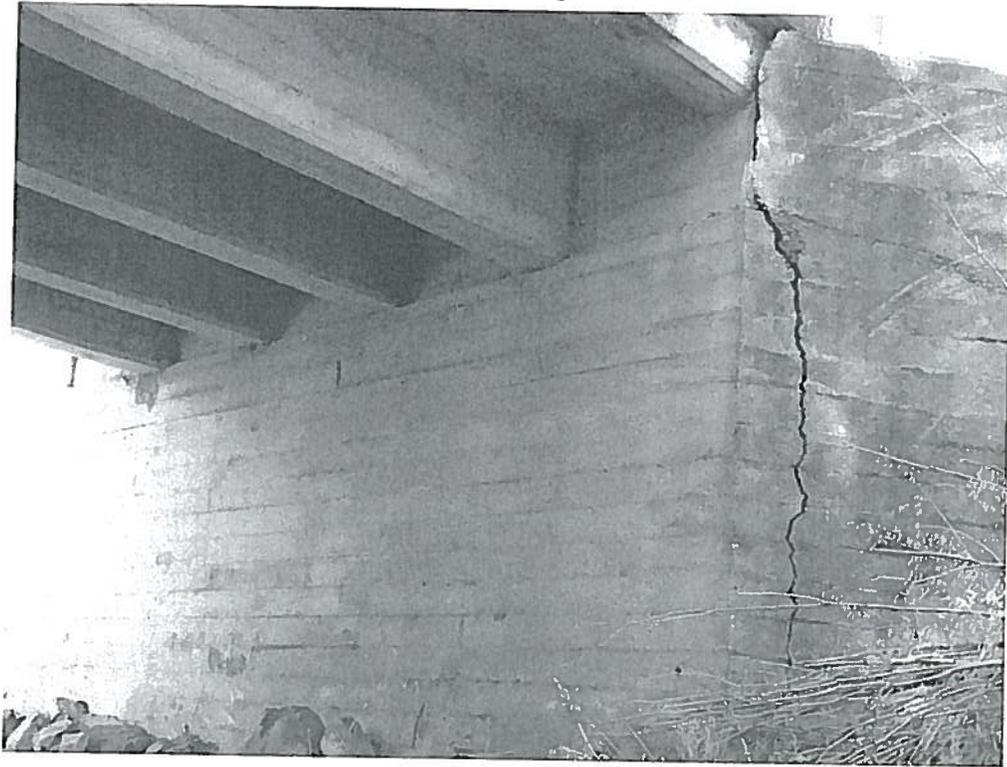
Photo No. 1

The Abutment 4 right wingwall has a 1 inch wide full height vertical cracks as the result of this seismic event. See attached photo 1.

Abutment 4 right wingwall vertical crack

Replace the Abutment 4 wingwalls.
