U.S. Department of Transportation Federal Highway Administration- California Division- Title 23 Damage Assessment Form (DAF)		DAF No. _____ - NAP _____ - 0 2 4 - 0	Sheet # 1 of 3 Federal Project # EO ER _____ ( )
Disaster No. CA 1 4 - 1 PR ER _____ ( )		Applicant Napa County Public Works	County Napa Congressional districts 5
Location of Damage: _____ Per Site <input checked="" type="checkbox"/> or <input type="checkbox"/> Per Mile		Incident Date (mm/dd/yyyy) 08/24/2014	Inspection 09/23/2014
Name of Road/Bridge: Silverado Trail Box Culvert		Federal-aid Highway? Y for yes, if no, ineligible for ER funds <input type="checkbox"/> Y	
PM Begin: 0.16 PM Length: 14.00 PM End: 0.16 (in feet)		Map No 5K13	
Road/Bridge Data: Bridge No _____ Type: Conc Box Culvert		Functional Classification Type: MAJOR COLLECTOR	
Traveled Way: Width 38 Type: PCC <input type="checkbox"/> AC <input checked="" type="checkbox"/> Gravel <input type="checkbox"/>		Route # _____	Forest Hwy? Y/N <input type="checkbox"/> N Interstate? Y/N <input type="checkbox"/> N

**Damage Assessment and Recommendations Report**  
**Silverado Trail Rd MP 0.16 Culvert**  
**03/16/15**

## INITIAL SUMMARY REPORT OF STRUCTURE

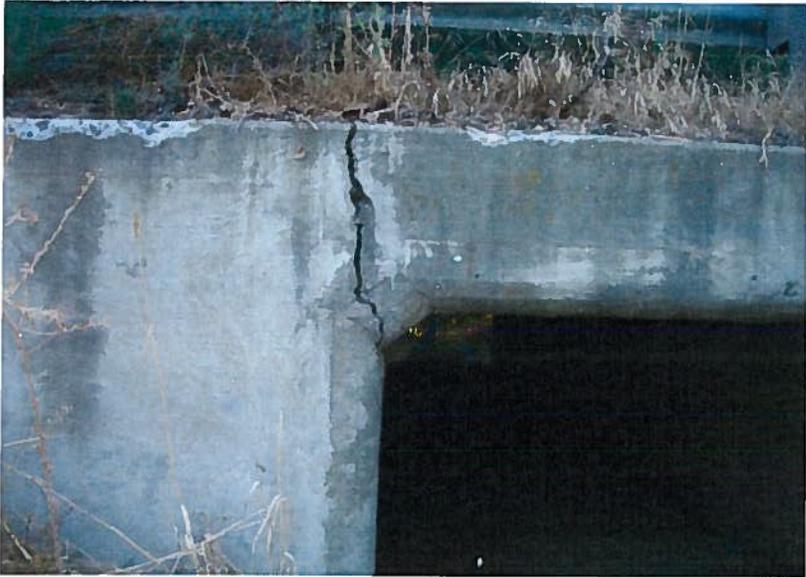
Shear crack at header on northwest side of culvert

Vertical crack at deck and exterior wall connection were observed at Northwest side of structure. Vertical crack at deck and interior wall connection at Southwest side of structure were also observed. Transverse crack was observed at roadway surface.

Culvert repairs include replacing 5' section of the existing concrete box culvert with new reinforced concrete box culvert. Excavation, backfill, and existing culvert removal will be required prior of placing the new concrete box culvert. Drill and bond dowels will be used to connect the new concrete box culvert to the existing culvert.

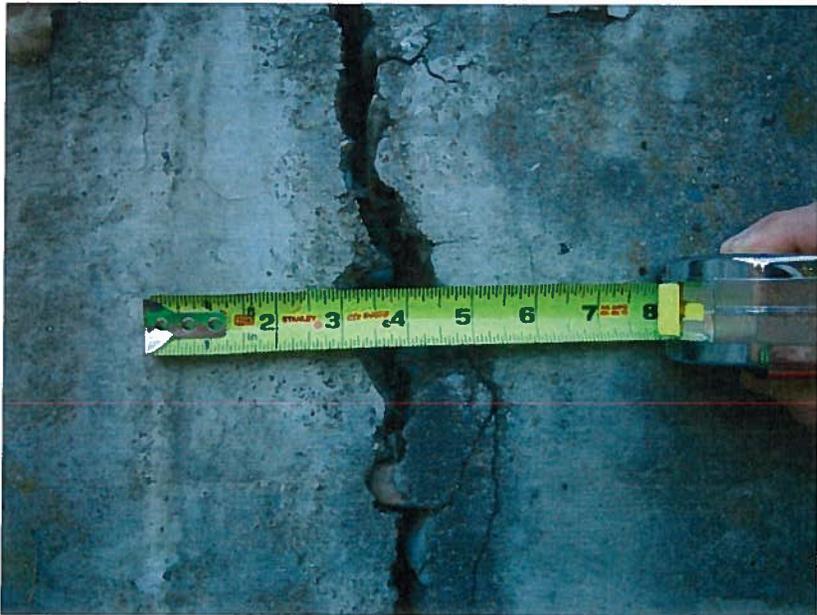
Crack width measurement

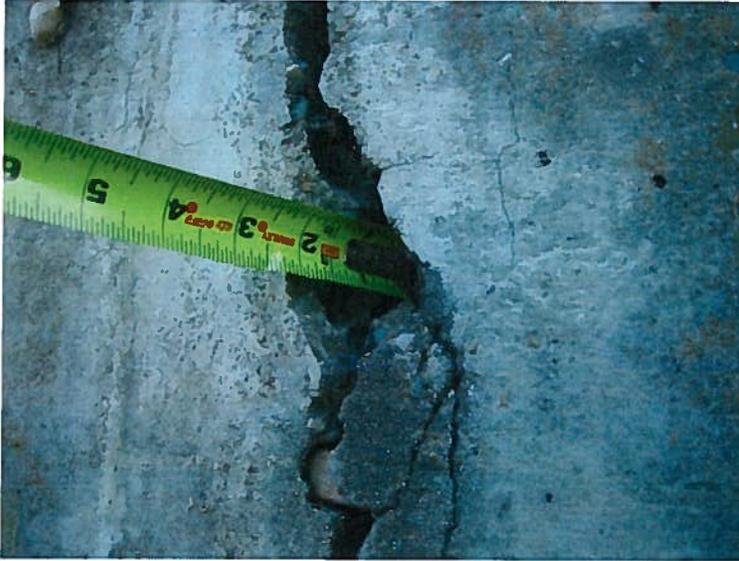
Depth of crack

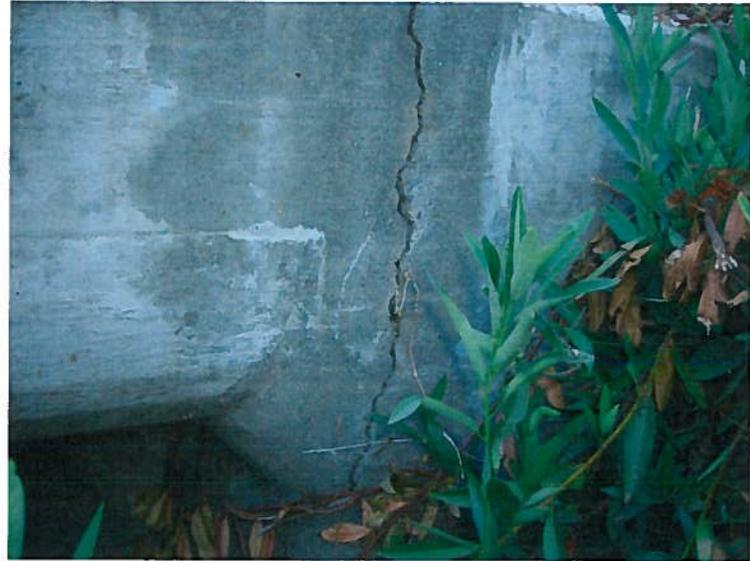
Close up of shear crack on SouthWest side of culvert

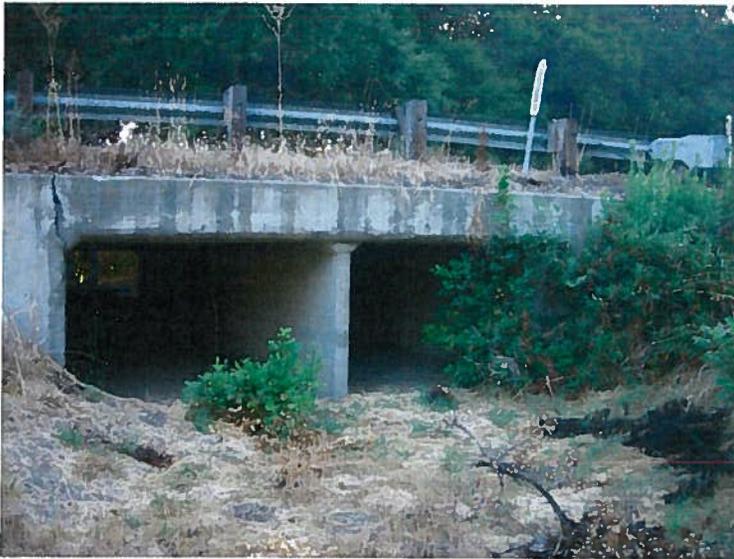
General view looking east toward culvert
