U.S. Department of Transportation Federal Highway Administration- California Division- Title 23 Damage Assessment Form (DAF)		DAF No. <input type="text"/> - NAP <input type="text"/> - <input type="text"/> <input type="text"/> <input type="text"/> <input type="text"/> - <input type="text"/> <input type="text"/>

ITEM #38 FROM BRIDGES AND CULVERTS SPREADSHEET					
SILVERADO TRAIL 122' N OF 7764, MP 10.64 (REF: District 2, Structure 45) LOP 233; DAF 25					3/9/2015
CULVERT REPAIR

Damage Assessment and Recommendations Report
Silverado Trail Rd MP 010.64 Culvert
03/16/15

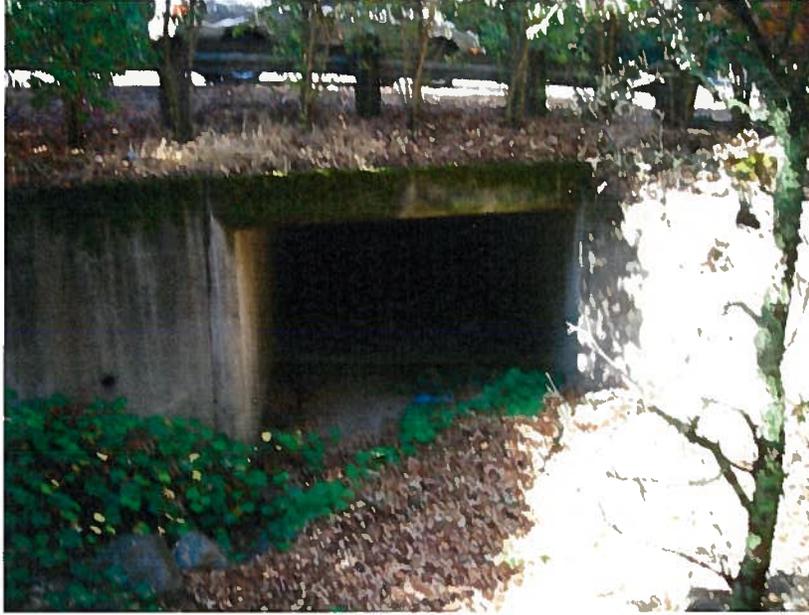
View of east side of culvert

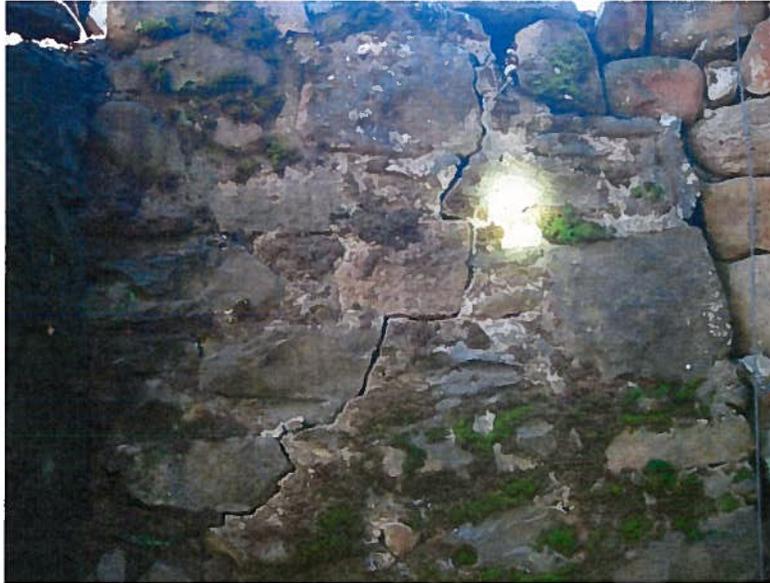
Southwest wingwall made of cement and rock is cracked from bottom to top in step fashion

Crack from top to bottom in steps fashion was observed in the Southwest stone masonry wingwall.

Culvert repairs include strengthening the existing cracked wingwall by adding new concrete wall behind the existing wingwall. Drill and bond dowels will be used to tie the existing wingwall and new concrete wall together. Crack at the existing stone masonry wingwall will be repaired with pressure grout.

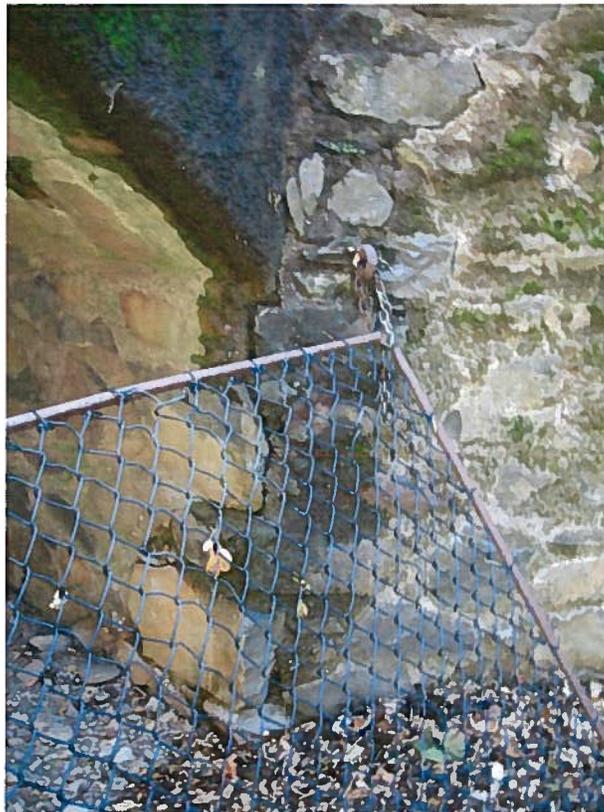
Southwest wingwall made of cement and rock is cracked from bottom to top in step fashion
