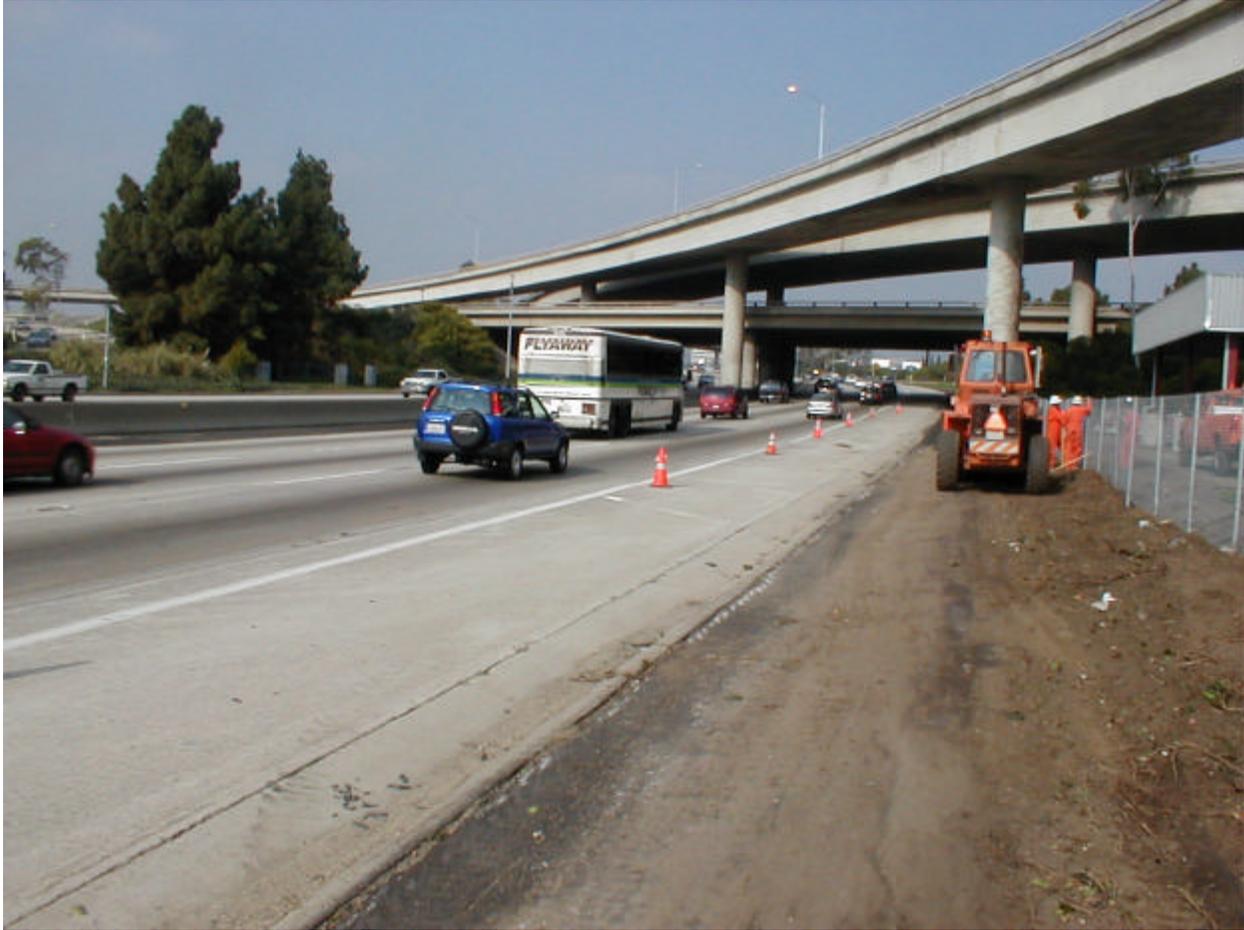
Priority 1 - View looking north along I-405 northbound at I-405/I-10 interchange. Right side of photograph shows an example of failed setback criteria from edge of the traveled way (minimum setback of 30 feet) and from bridge structures (minimum setback of 100 feet).

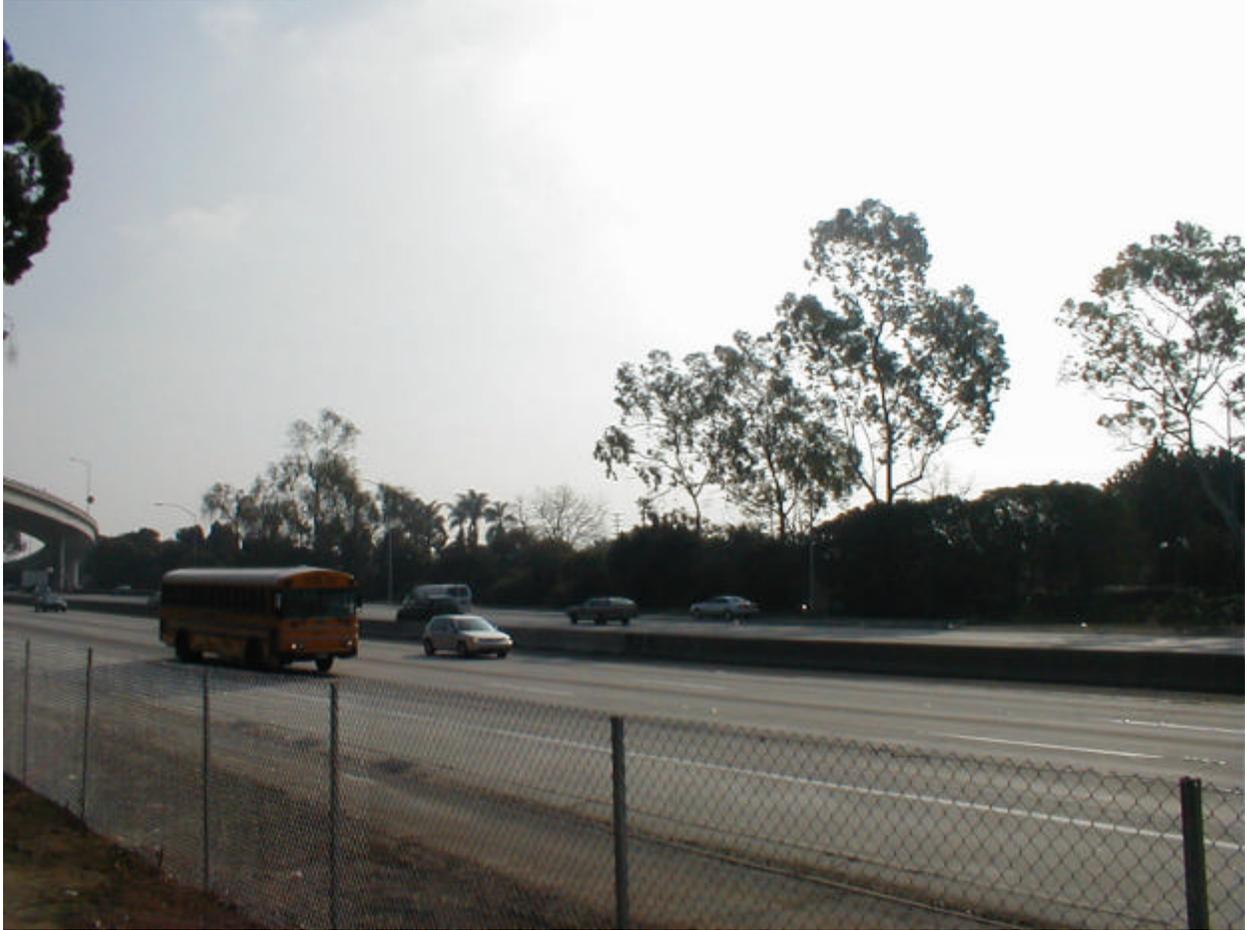
Priority 2 - Upper left side of photograph shows I-405 southbound island area. An example of combined failed criteria of setback from edge of the traveled way (minimum setback of 30 feet) and excessive slope inclination (maximum gradient of 15%).

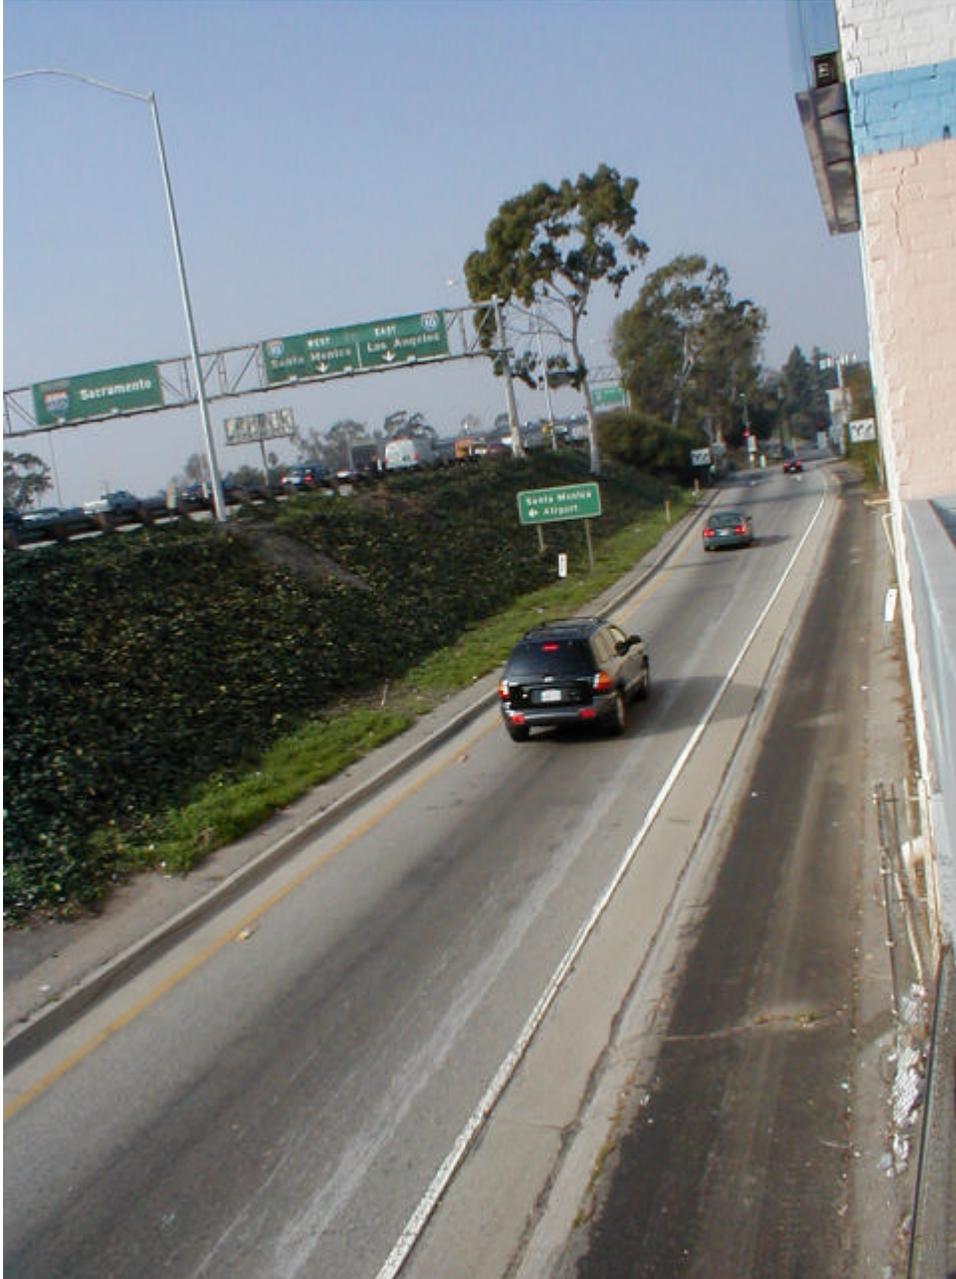
Priority 2 - View of southbound lanes south of 10/405 interchange. Photo shows an example of failed setback criteria from edge of the traveled way (minimum setback of 30 feet) and from the edge of the pavement (minimum of 20 feet).

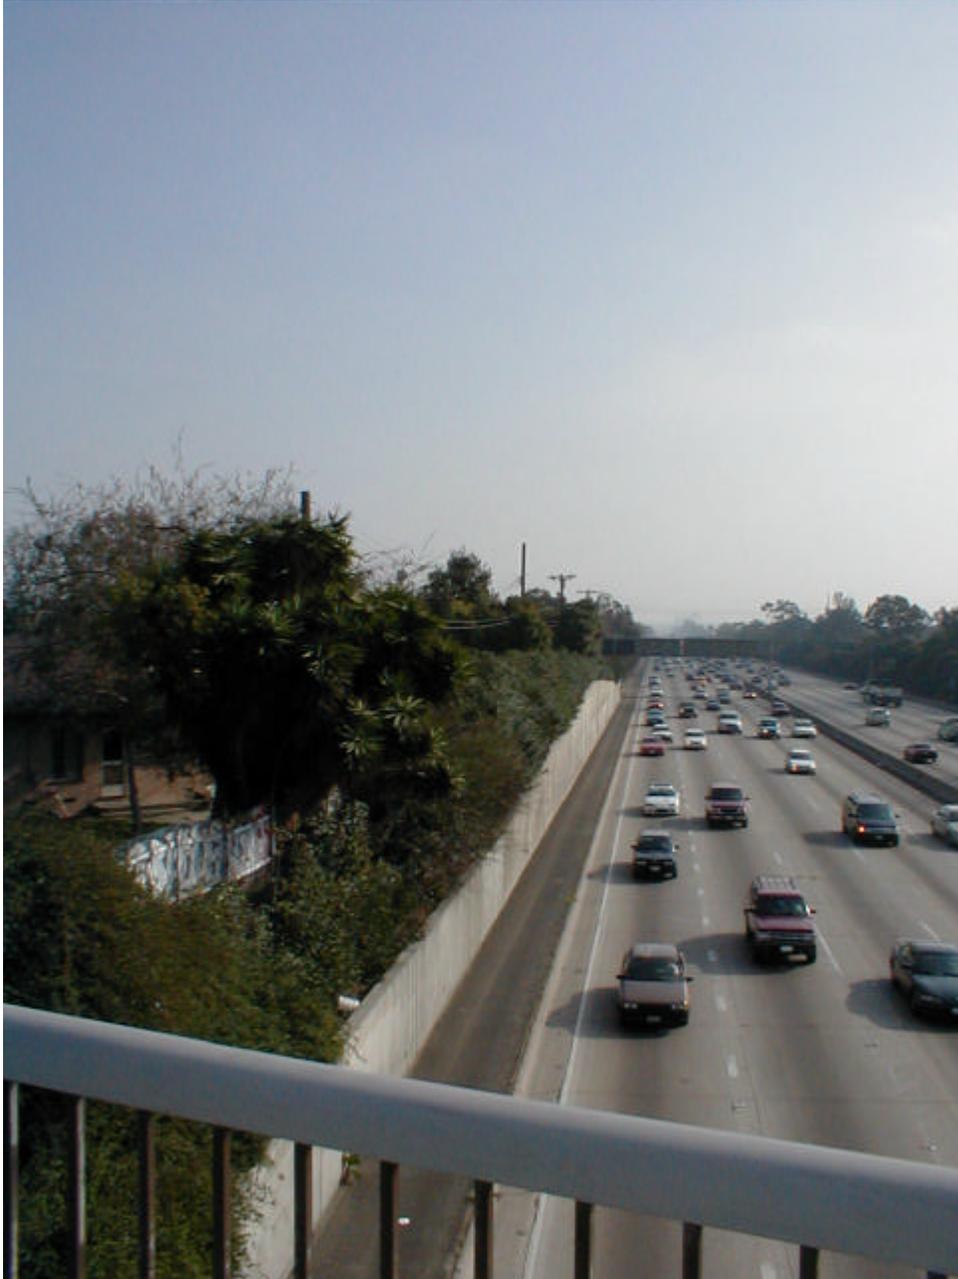
Priority 1 - View of I-405 northbound just south of 405/10 interchange. Photo shows an example of failed setback from highway pavement and slopes (minimum setback of 20 feet), from the edge of the traveled way (minimum setback of 30 feet), and excessive slope inclination (maximum gradient of 15%).

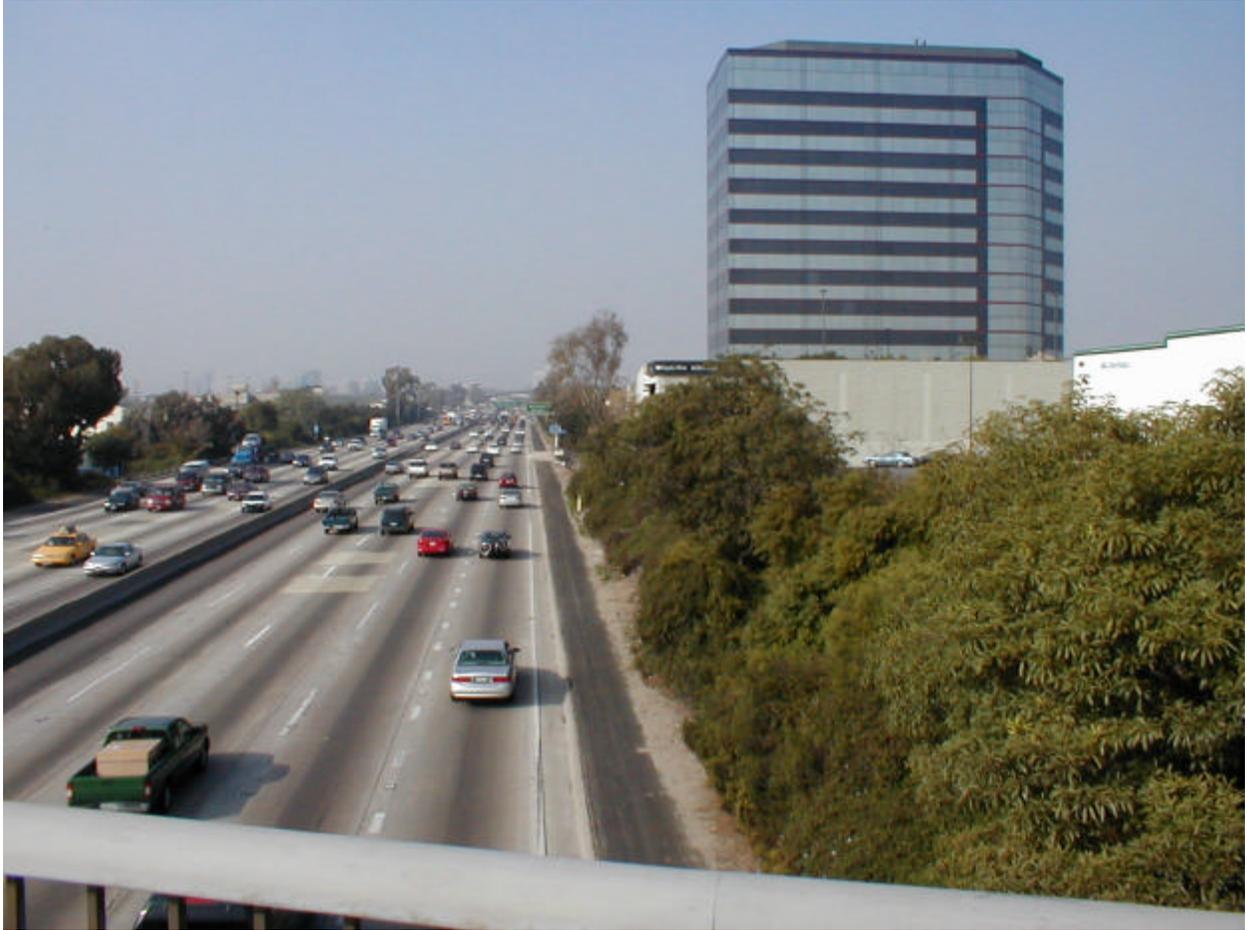
Priority 1 – View looking south along I-405 northbound lanes at Palm overcrossing. Photo shows an example of high topography, failed setback criteria from the edge of the traveled way (minimum setback of 30 feet), and excessive slope inclination (maximum gradient of 15%).

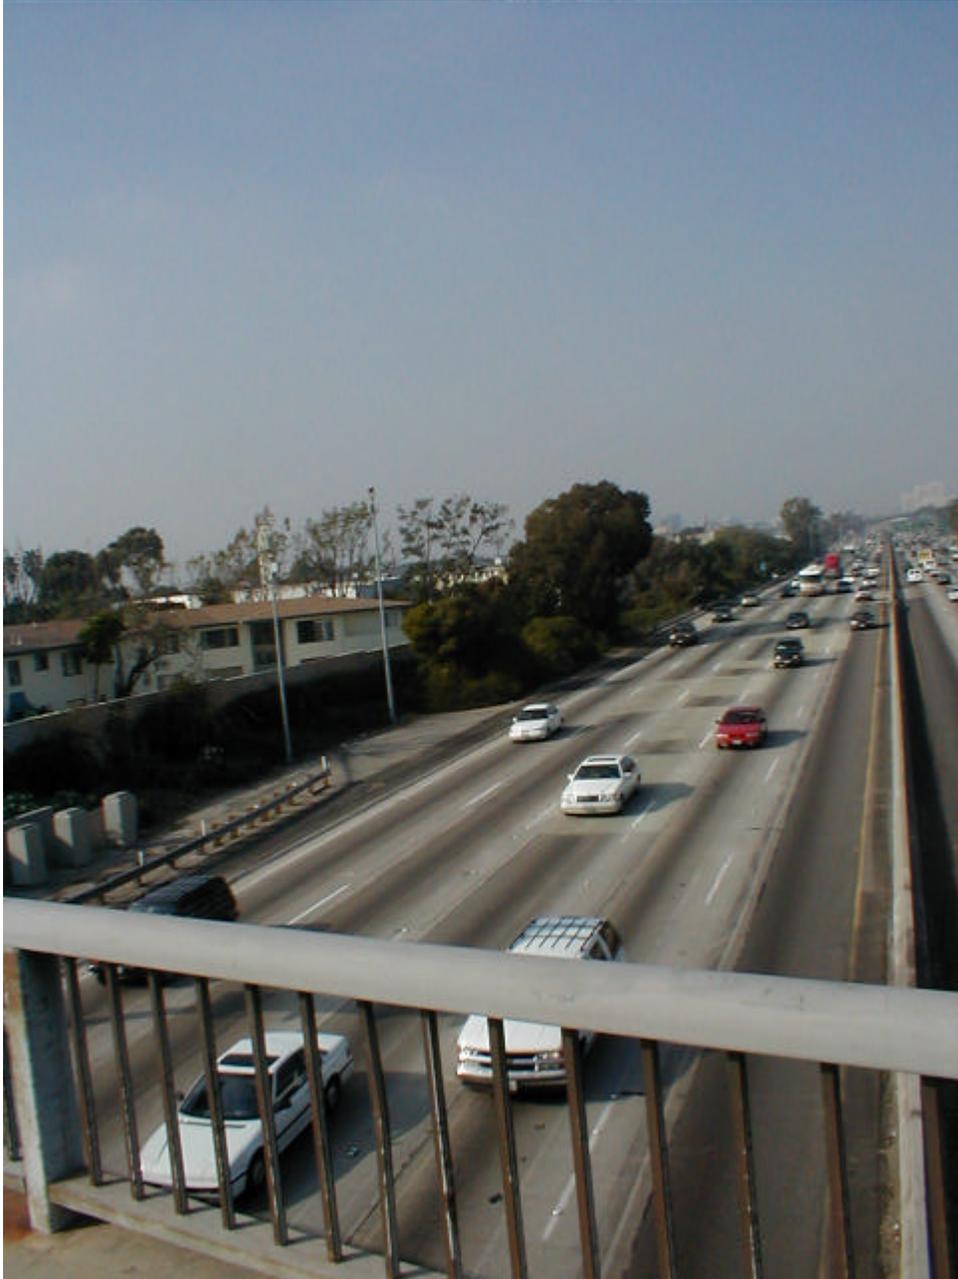
Priority 1 – View looking north from Palm Ave. overcrossing along I-405 northbound lanes. Photo shows an example of failed setback criteria from the edge of the traveled way (minimum setback of 30 feet) and from the edge of the pavement (minimum setback of 20 feet).

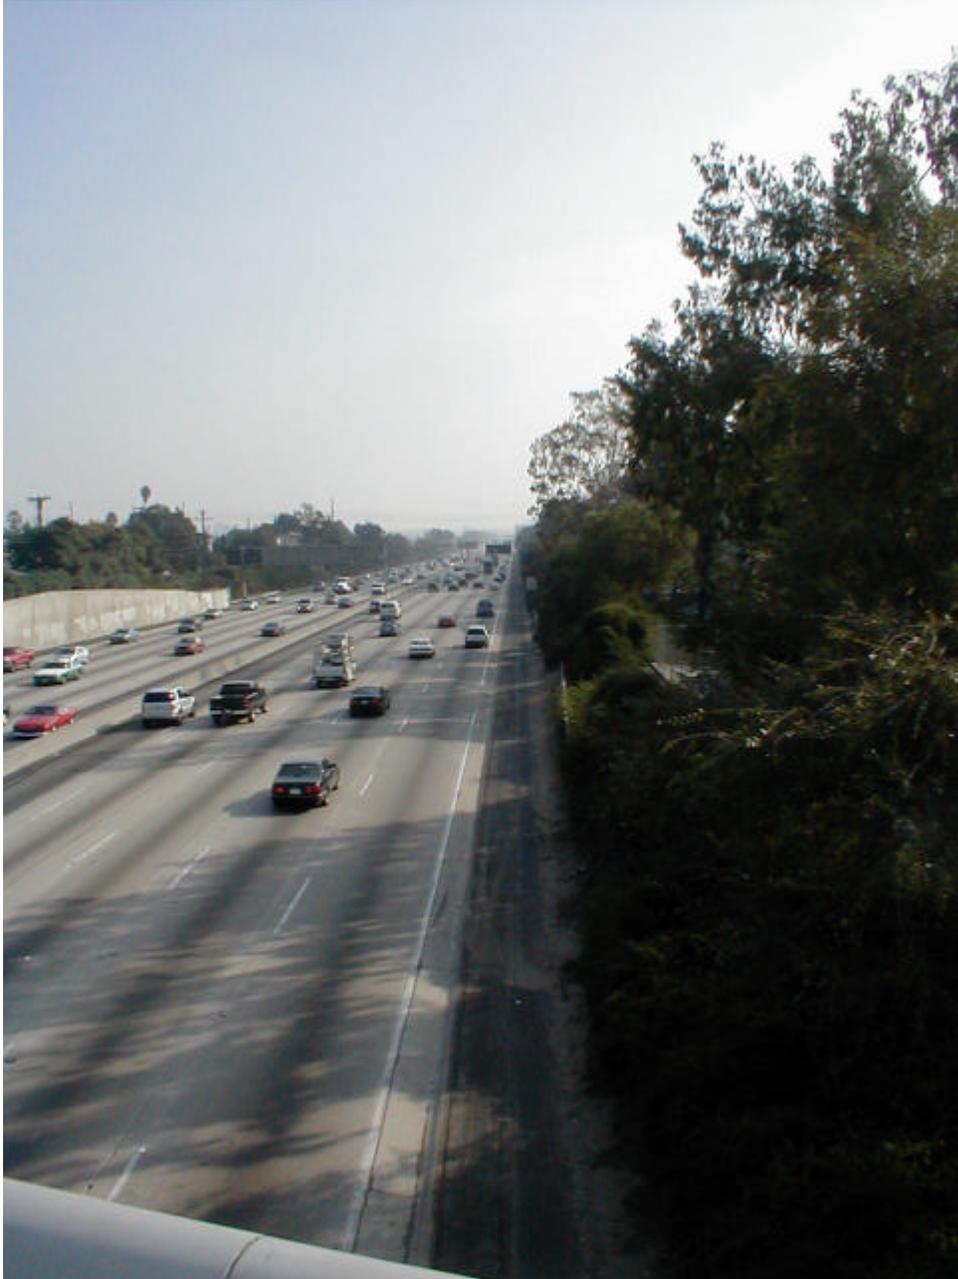
Priority 2 - View looking north from Palm Ave. overcrossing along I-405 southbound lanes. Photo shows an example of failed setback criteria from the edge of the traveled way (minimum setback of 30 feet) and from the edge of the pavement (minimum setback of 20 feet).

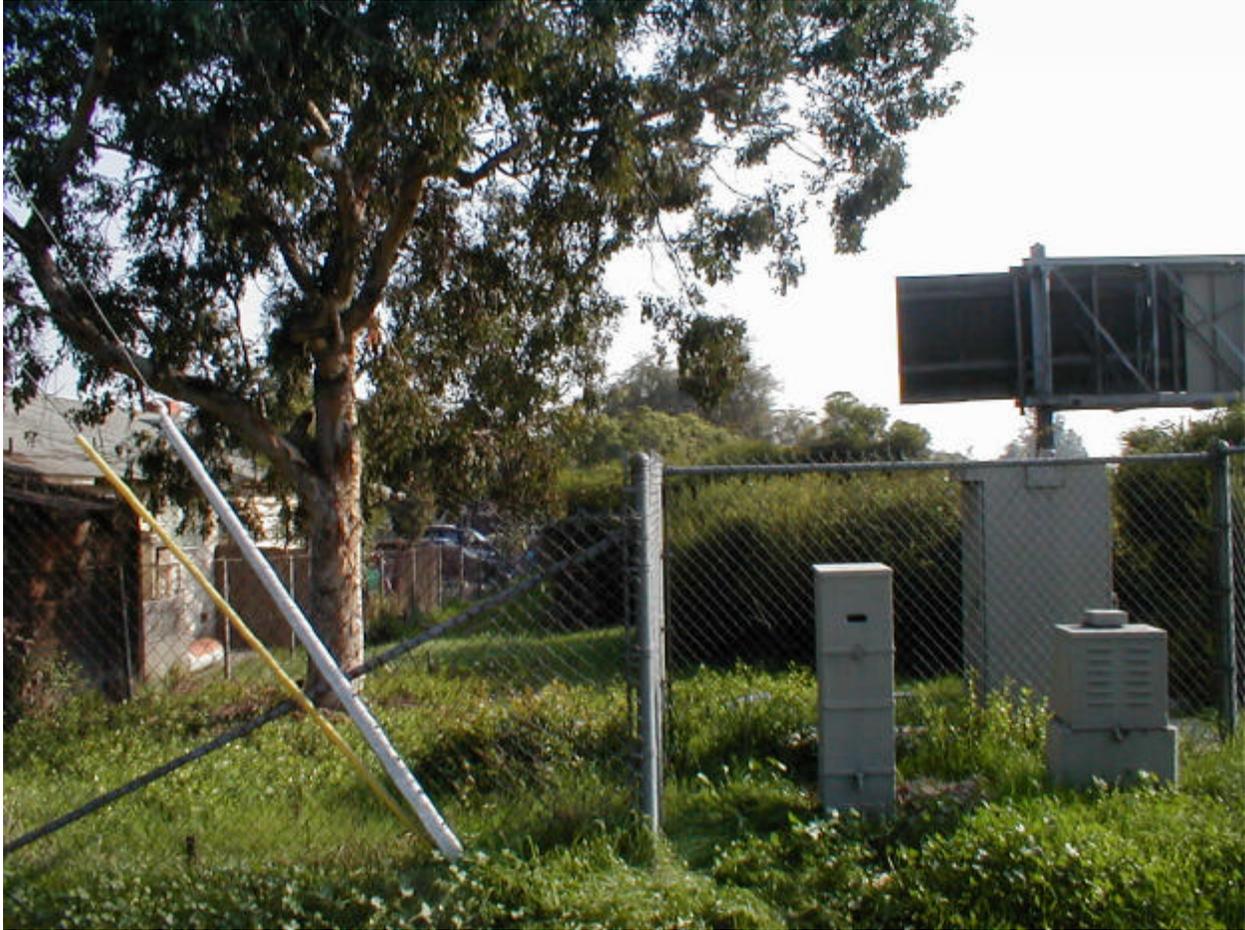
Priority 2 - View looking south from Palm Ave. overcrossing along I-405 southbound lanes. Photo shows an example of high topography and of failed setback criteria from the edge of the traveled way (minimum setback of 30 feet) and from the edge of the pavement (minimum setback of 20 feet).

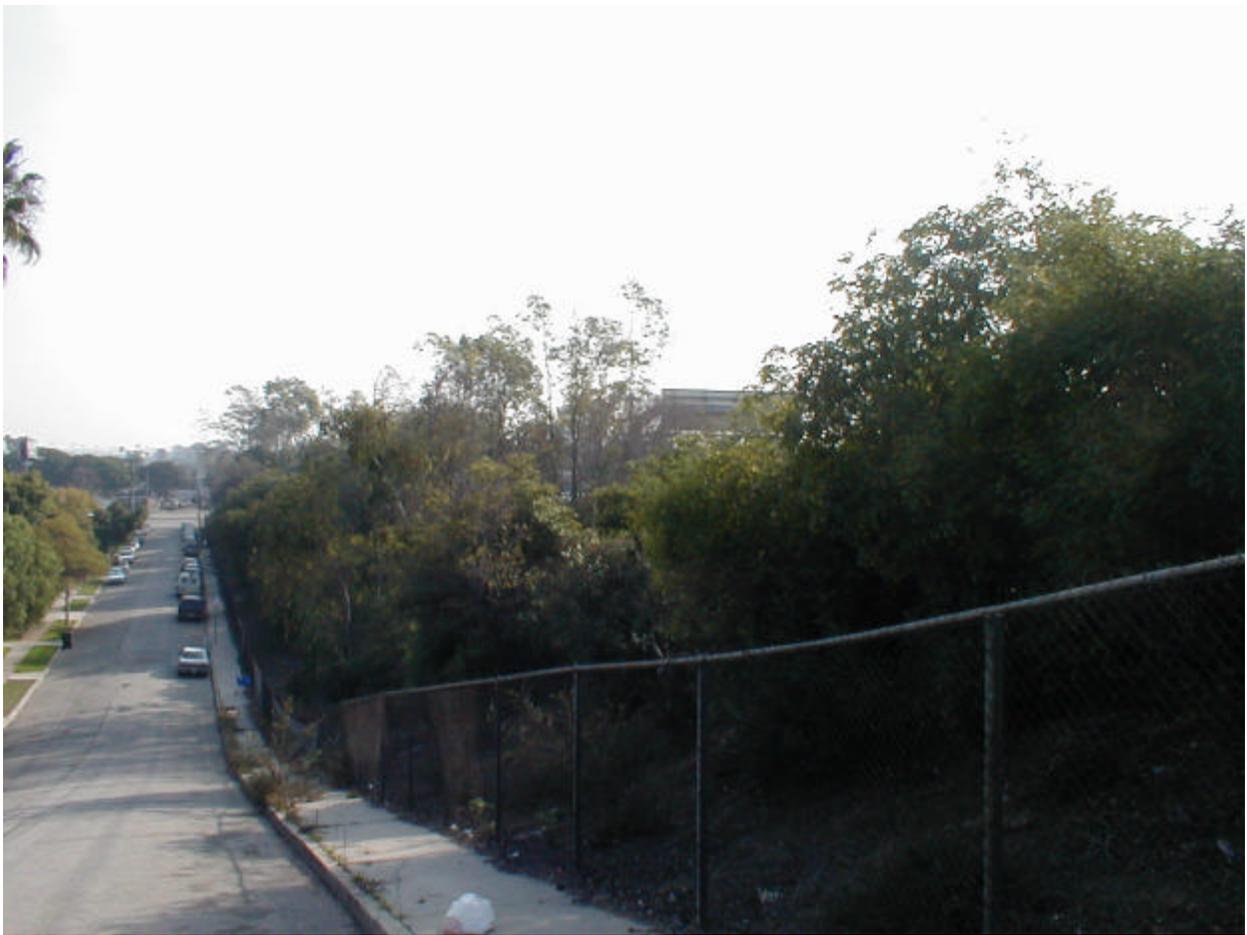
Priority 1 – View towards the south from Charnock Road along I-405 northbound. Photo shows an example of high topography and failed setback criteria from the edge of the traveled way (minimum setback of 30 feet) and from the edge of the pavement and buildings (minimum setback of 20 feet).

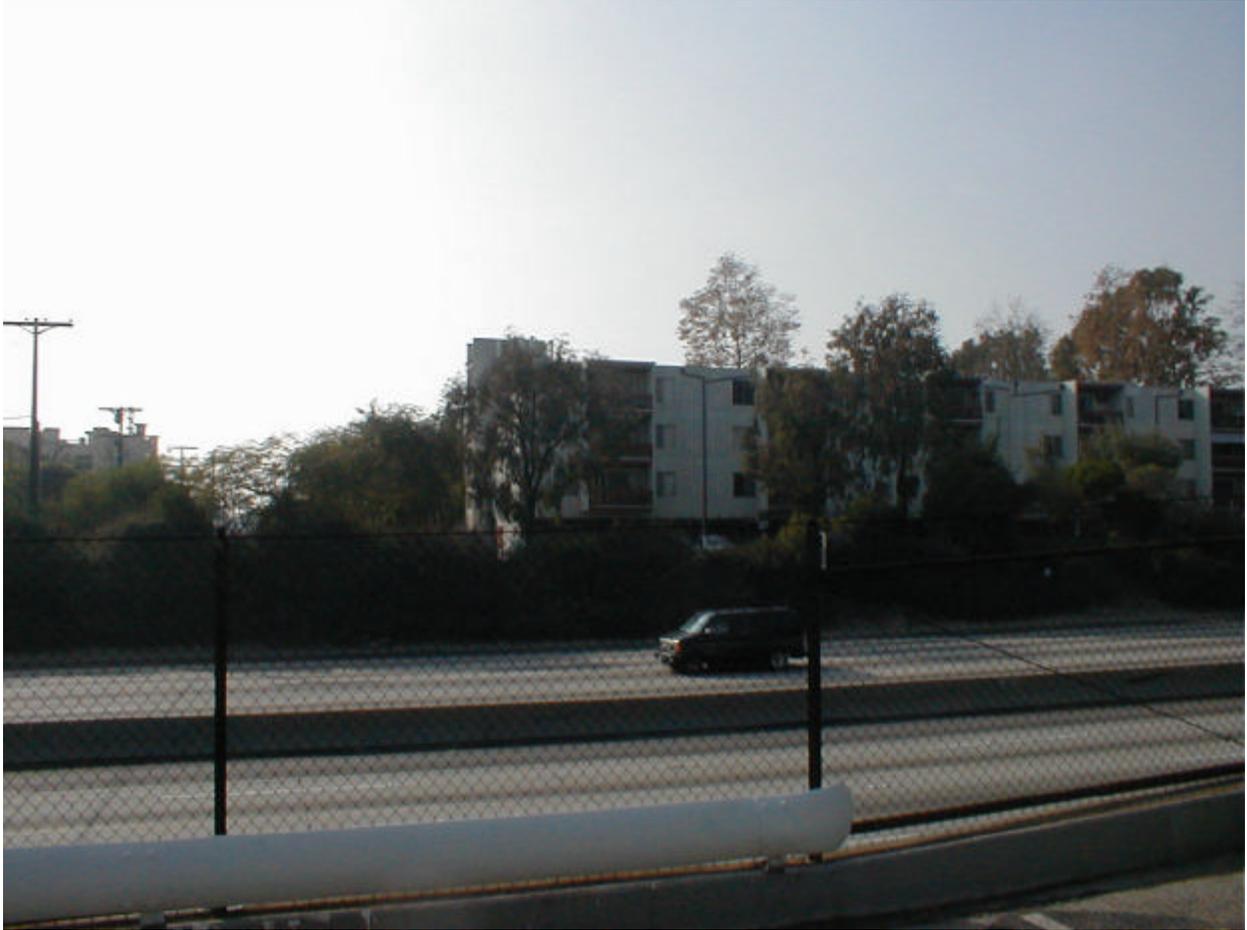
Priority 1 – View looking south along Tuller Avenue towards Venice Blvd. Photo shows a topographic high area along I-405 north of Venice Blvd.

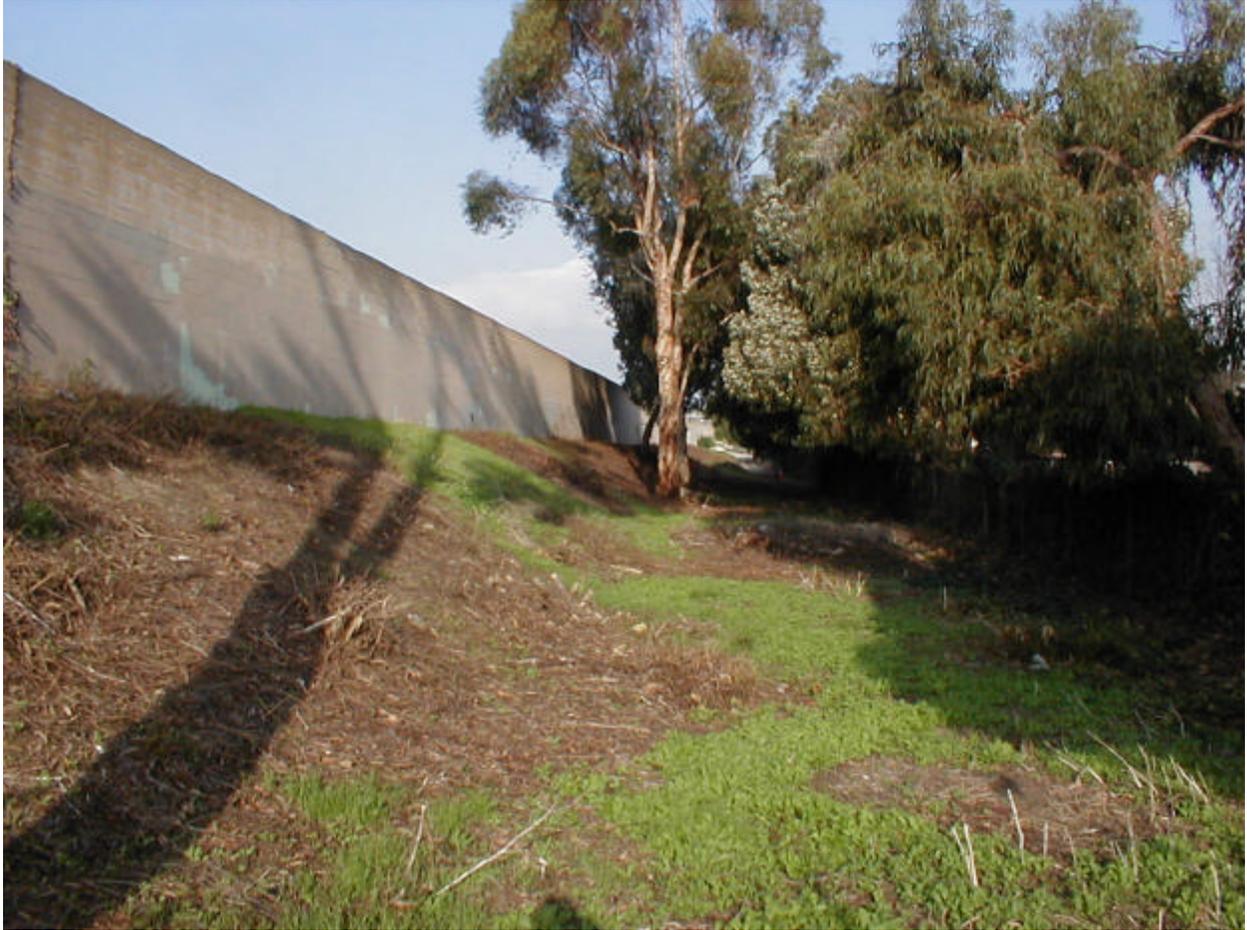
Priority 2 - View of I-405 southbound lanes opposite Charnock Avenue. Photo shows an example of failed setback criteria from the edge of the traveled way (minimum setback of 30 feet) and from the edge of the pavement (minimum setback of 20 feet).

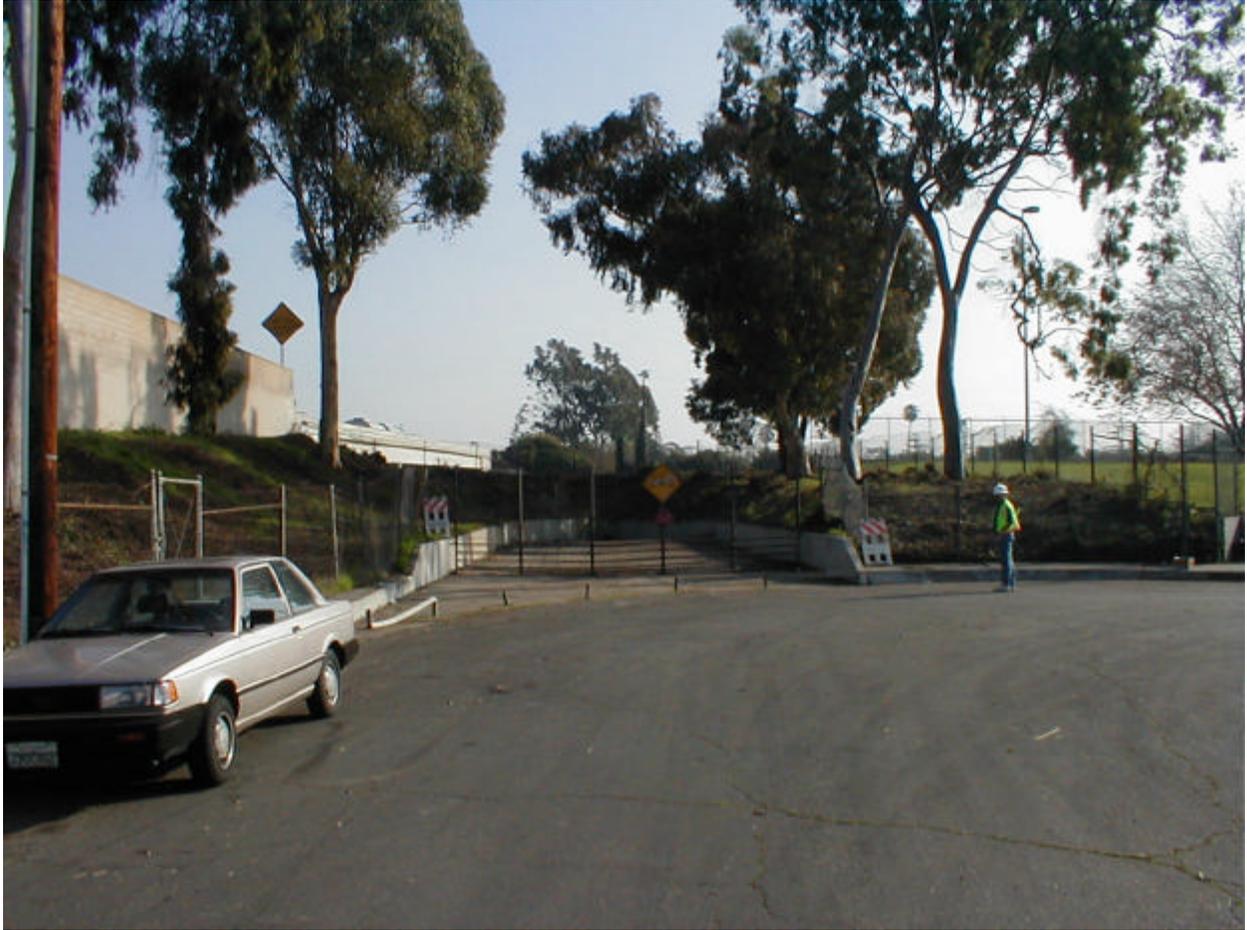
Priority 1 - View looking north along I-405 northbound, north of Ballona Creek. Photo shows an example of failed setback from the edge of the pavement (minimum setback of 20 feet) and excessive slope inclination (maximum gradient of 15%).
