Interstate 405
PM 2.9 to PM 9.0

DOWEL BAR RETROFIT EVALUATION

DISTRICT 12
Orange County
Interstate 405
Contract Number: 12-0A1104

September 2002

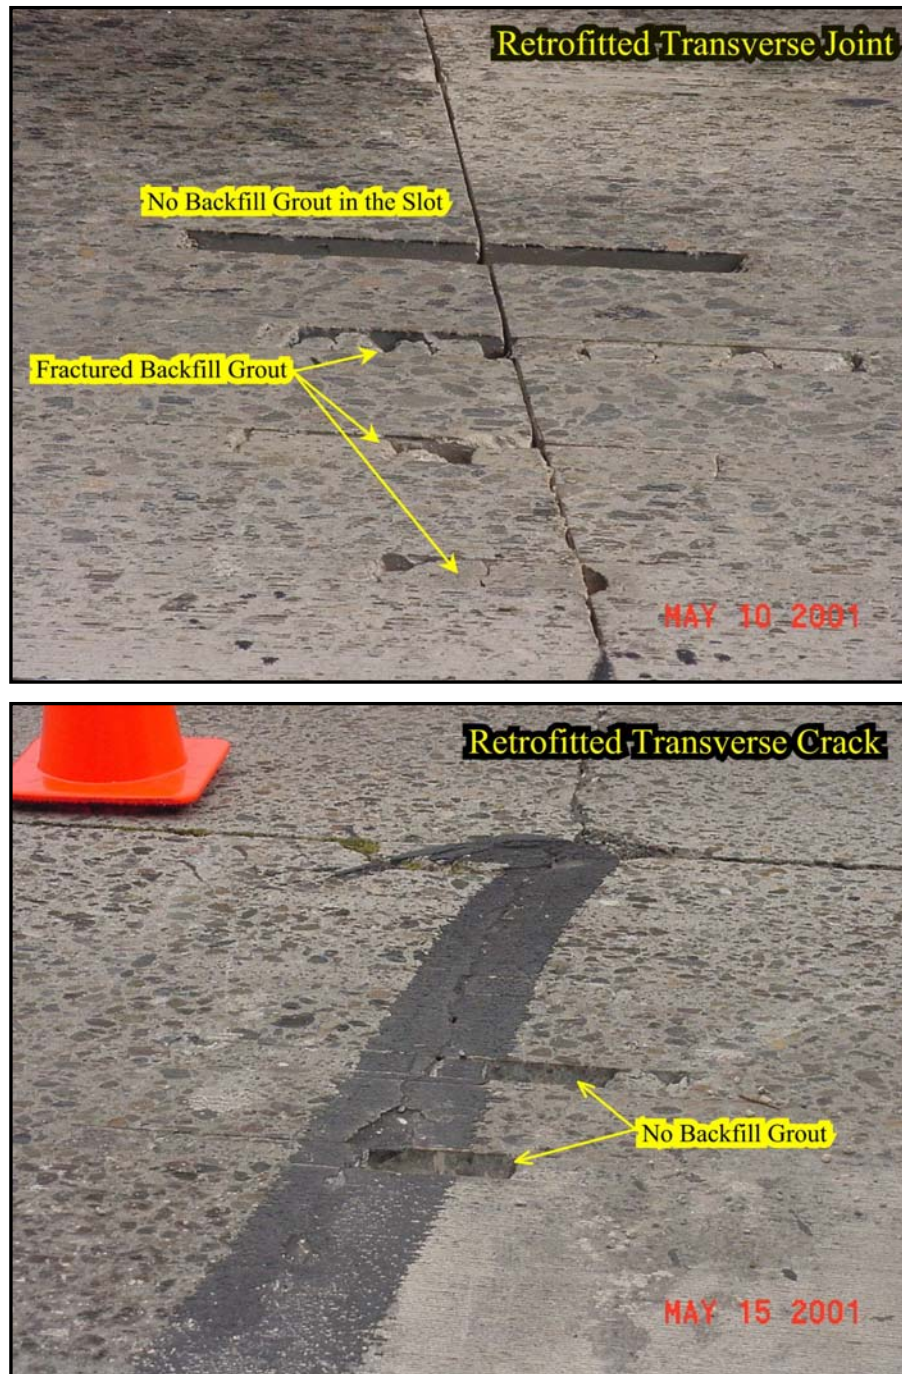
Figure 5. Loose Backfill Grout

Pavement inspections were performed on Thursday, May 10, 2001 and May 15, 2001. Several panels along the retrofitted segment were examined. The backfill grout at some dowel bar installations was fractured and loose in the slot. At other locations, the backfill was missing completely, exposing the dowel bar.

Fast setting grout should be mixed in accordance with the manufacturer's instructions. The contractor and inspectors should be aware that the available working time of the grout is limited. Grout batches should be sized so that the entire batch can be used, placed, and consolidated within the allowable working time. The grout should be vibrated with a small hand held vibrator capable of thoroughly consolidating the grout material into the slot and around the dowel bars. Any material that cannot be placed and consolidated within that time should be discarded.

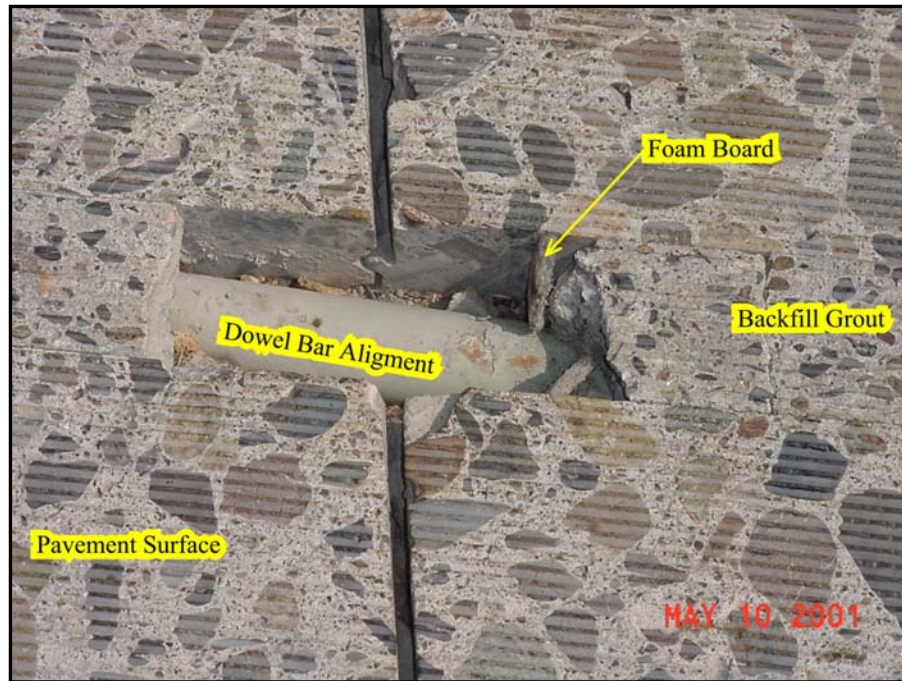
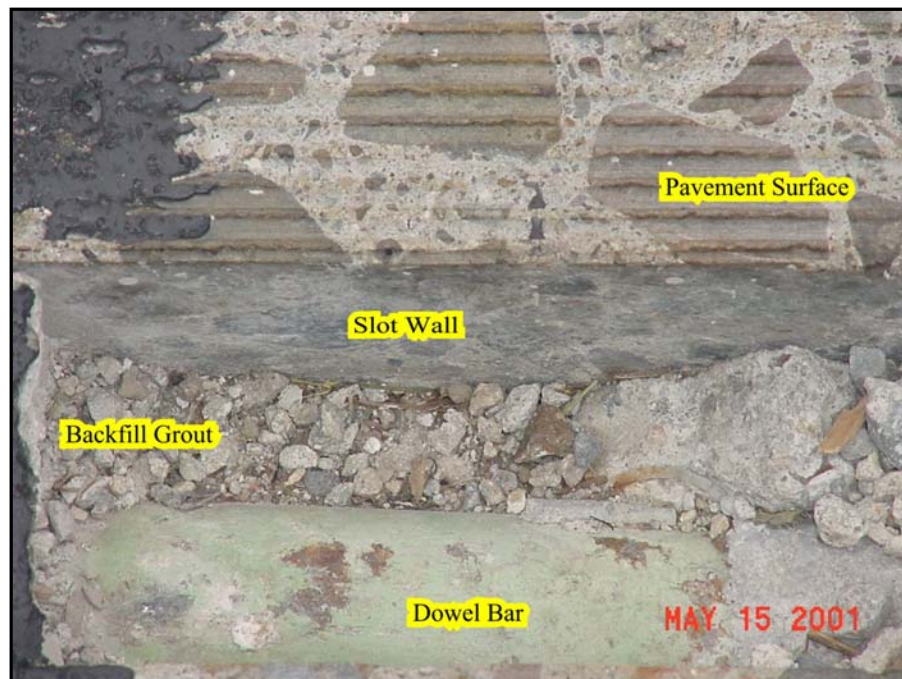
Figure 6. Exposed Dowel Bars

At locations where the grout was missing it could be seen that the bond between the grout and pavement had failed. The exposed dowel bars appear to be too close to the pavement surface and vertically misaligned.

In order to affectively provide load transfer, the dowel bars should be placed in accordance with the project plans and special provisions for successful long-term performance.

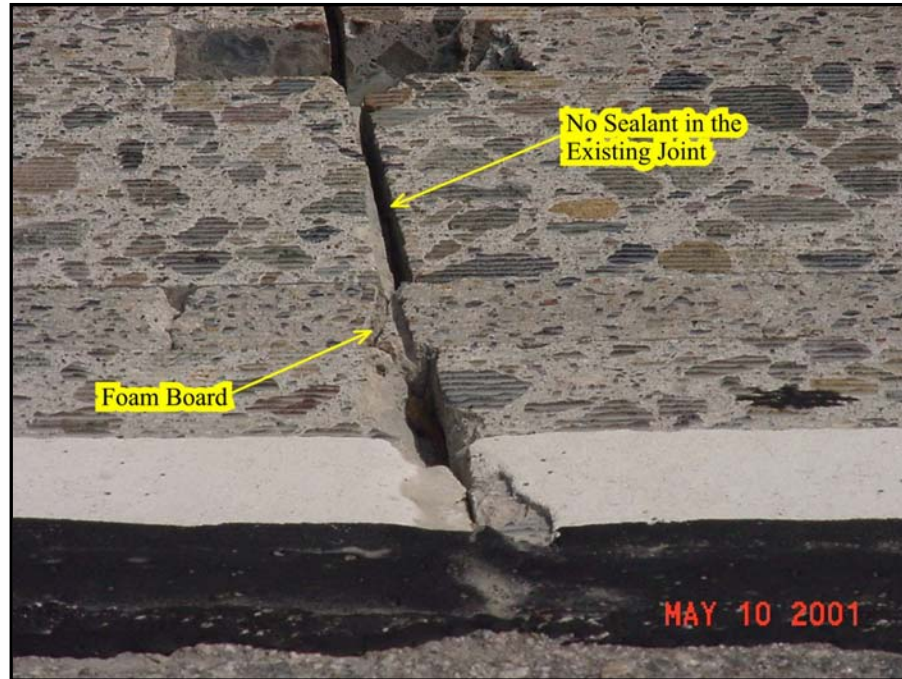
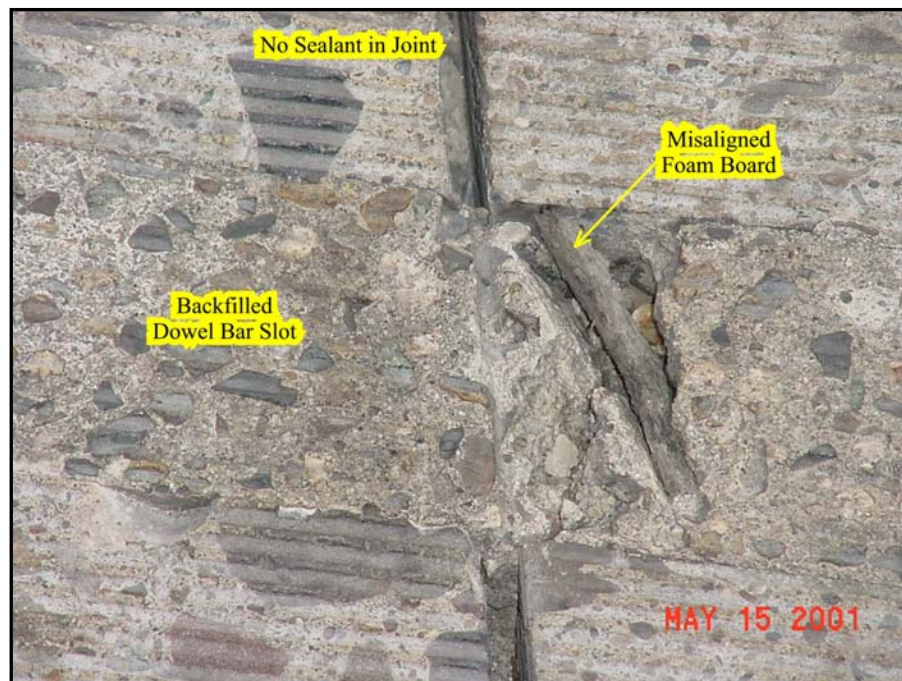
Figure 7. Misaligned Foam Board

Foam boards were not aligned with the existing transverse joint. The joints were not filled with backer rod and joint sealant.

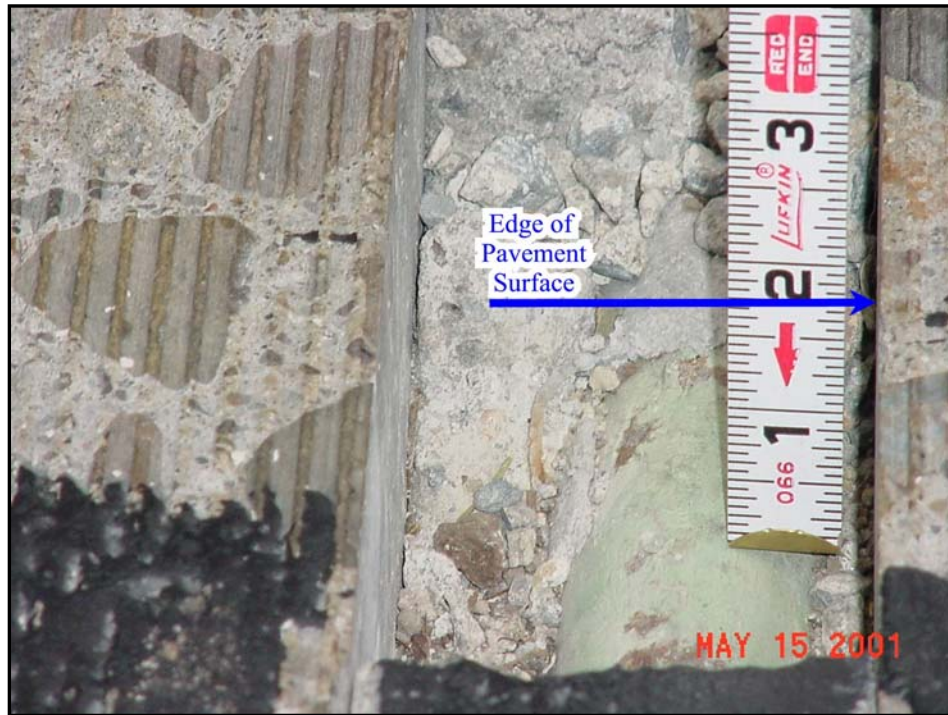
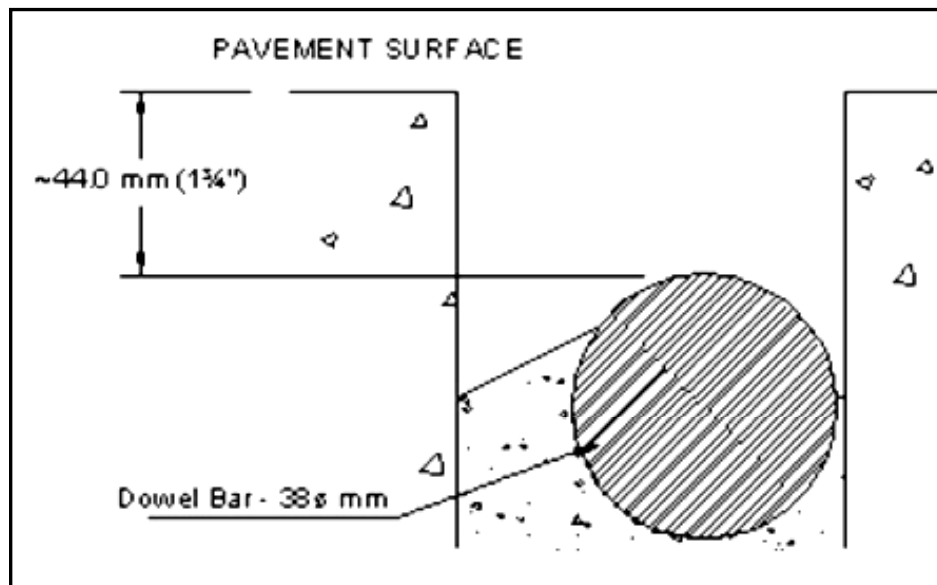
Figure 8. Dowel Bar Placement

A closer examination of an exposed dowel bar at the transverse crack revealed that the dowel bar was approximately 44-mm (1¾-in.) from the pavement surface and is not centered in the slot.

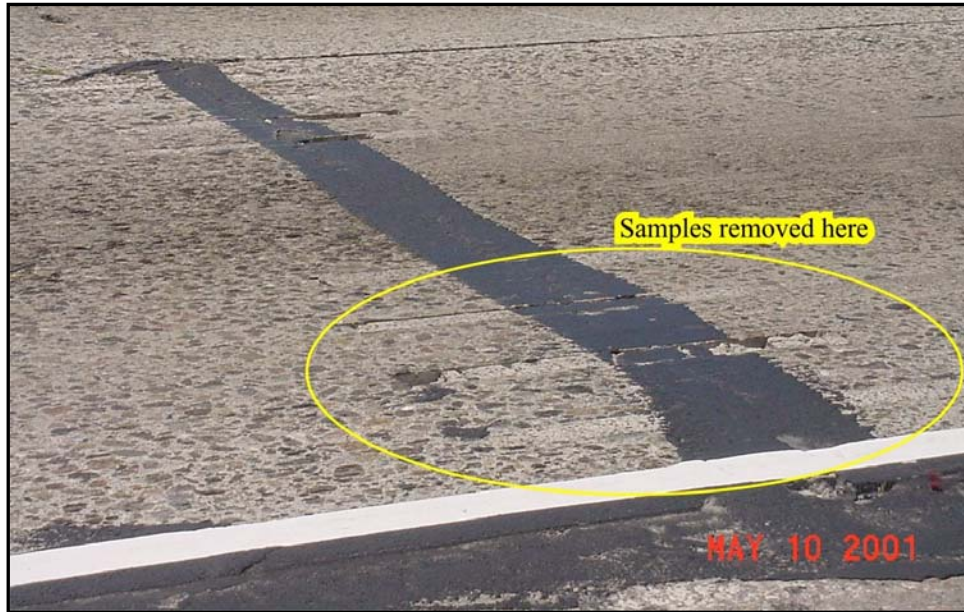
Figure 9. Retrofitted Transverse Crack

The dowel bar installations, shown in Figures 9 & 10, were removed from a retrofitted transverse crack in the northbound section of the project. Each of the three samples is about 1 m (3.28-ft) long, 0.3 m (1-ft) wide, and the full depth of the pavement.

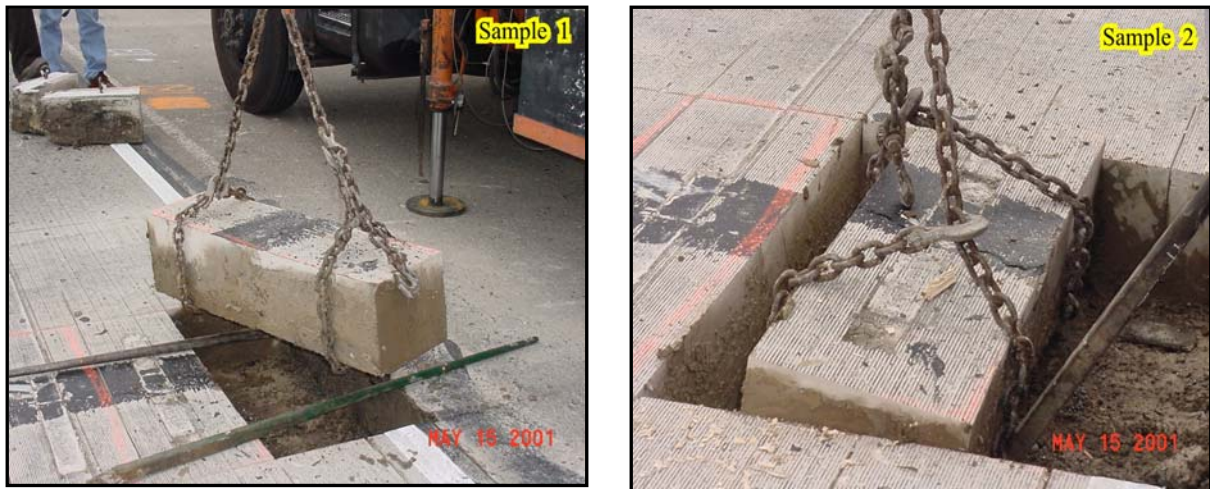
Figure 11. Removing Samples 1 and 2

Sample 1 was intact and had no noticeable damage or deterioration in the retrofit slot. Sample 2 had considerable damage/deterioration in the retrofit slot; multiple transverse cracks were visible in the backfill grout. Portions of the grout had loosened and dislodged from the slot. Sample 3 also had damage/deterioration in the retrofit slot, but not as extensive as that of Sample 2. Transverse cracks were also visible in the backfill grout. The samples were removed as shown in Figure 11 and placed on a pallet.

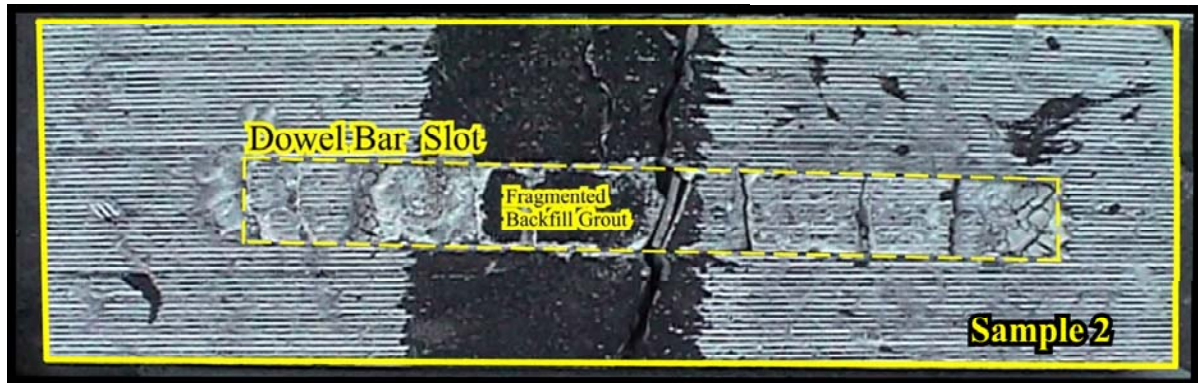
Figure 13. Sample 2 at TransLab

In Sample 2, the crack opening width measured 15-mm ($\frac{5}{8}$ -in).

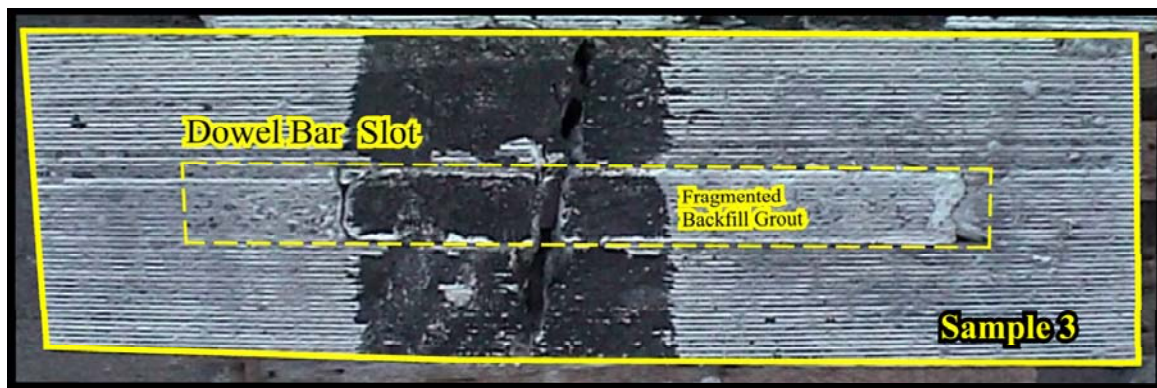
Figure 14. Sample 3 at TransLab

In Sample 3, the crack opening width measured 20-mm ($\frac{3}{4}$ -in).

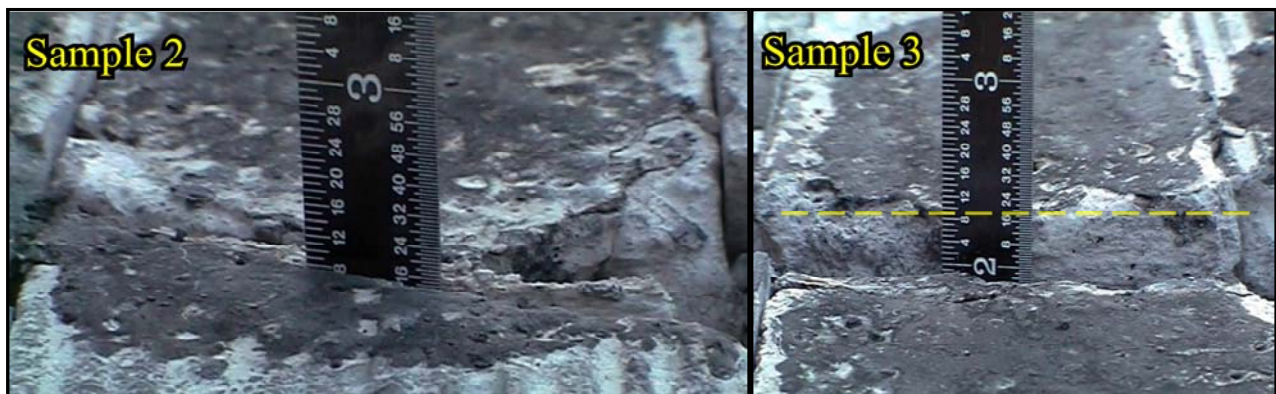
Figure 15. Preliminary Measurements – Dowel Bar below Pavement Surface

In Samples 2 and 3, the dowel bar was visible through the crack opening at the midpoint. In both samples, preliminary measurements showed it to be about 57-mm ($2\frac{8}{32}$ -in) below the surface.

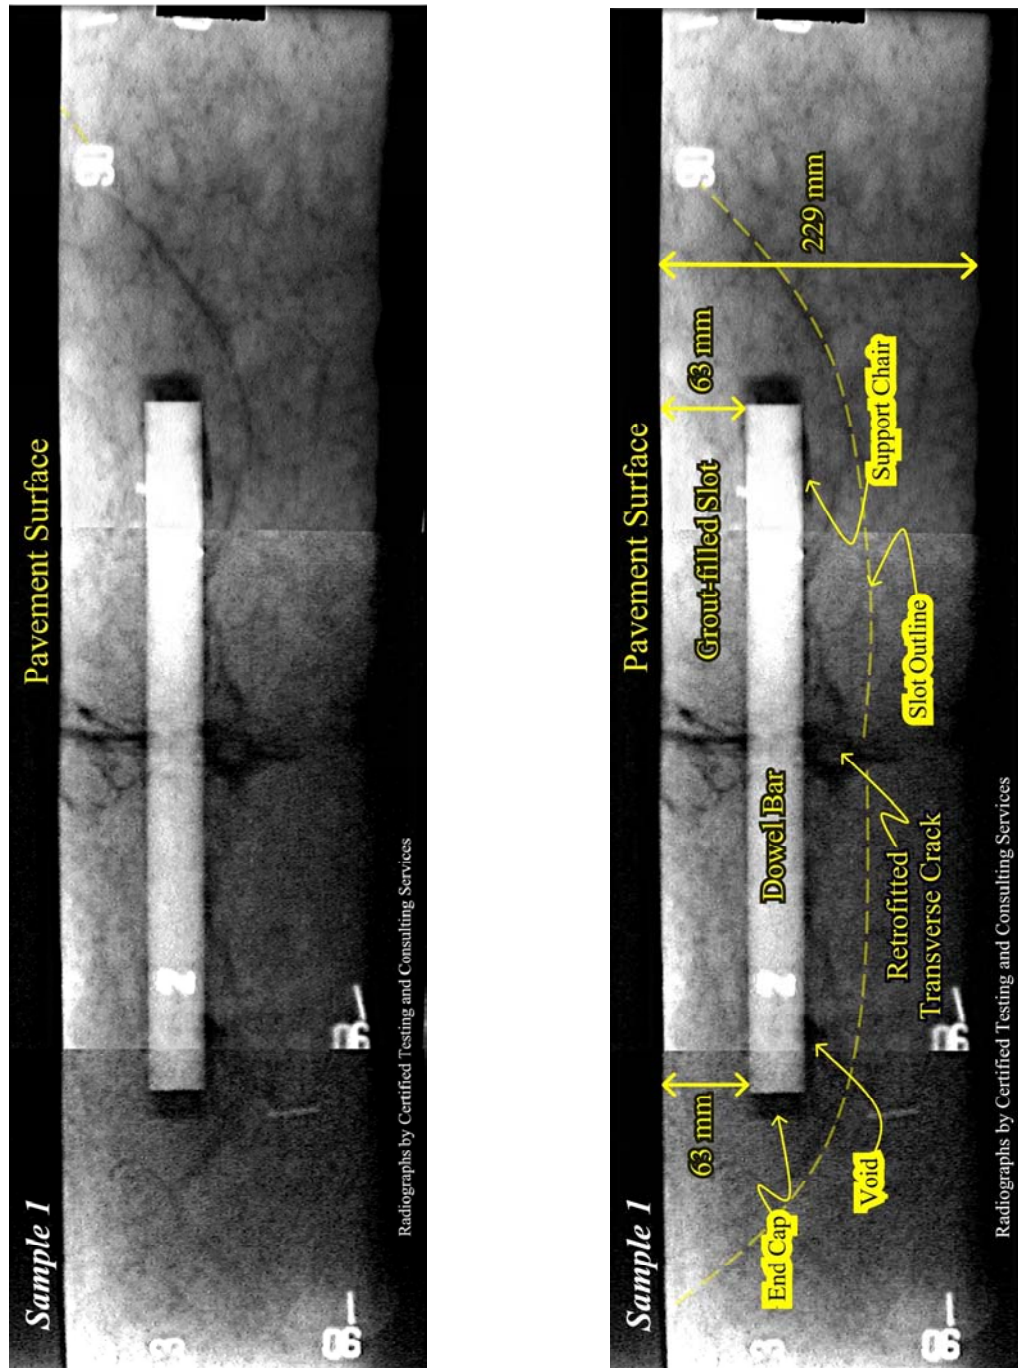
Figure 17. X-ray Composite of Sample 1

The X-rays for Sample 1 show the dowel bar at approximately 63-mm (2½-in) below the pavement surface, which places the centerline at 82-mm (3¼-in).

According to the project special provisions," The center of the dowels shall be placed at a depth of 100-mm +6 (4-in + $\frac{1}{4}$) below the concrete pavement surface on the leave side of the transverse joint before grinding has been completed".

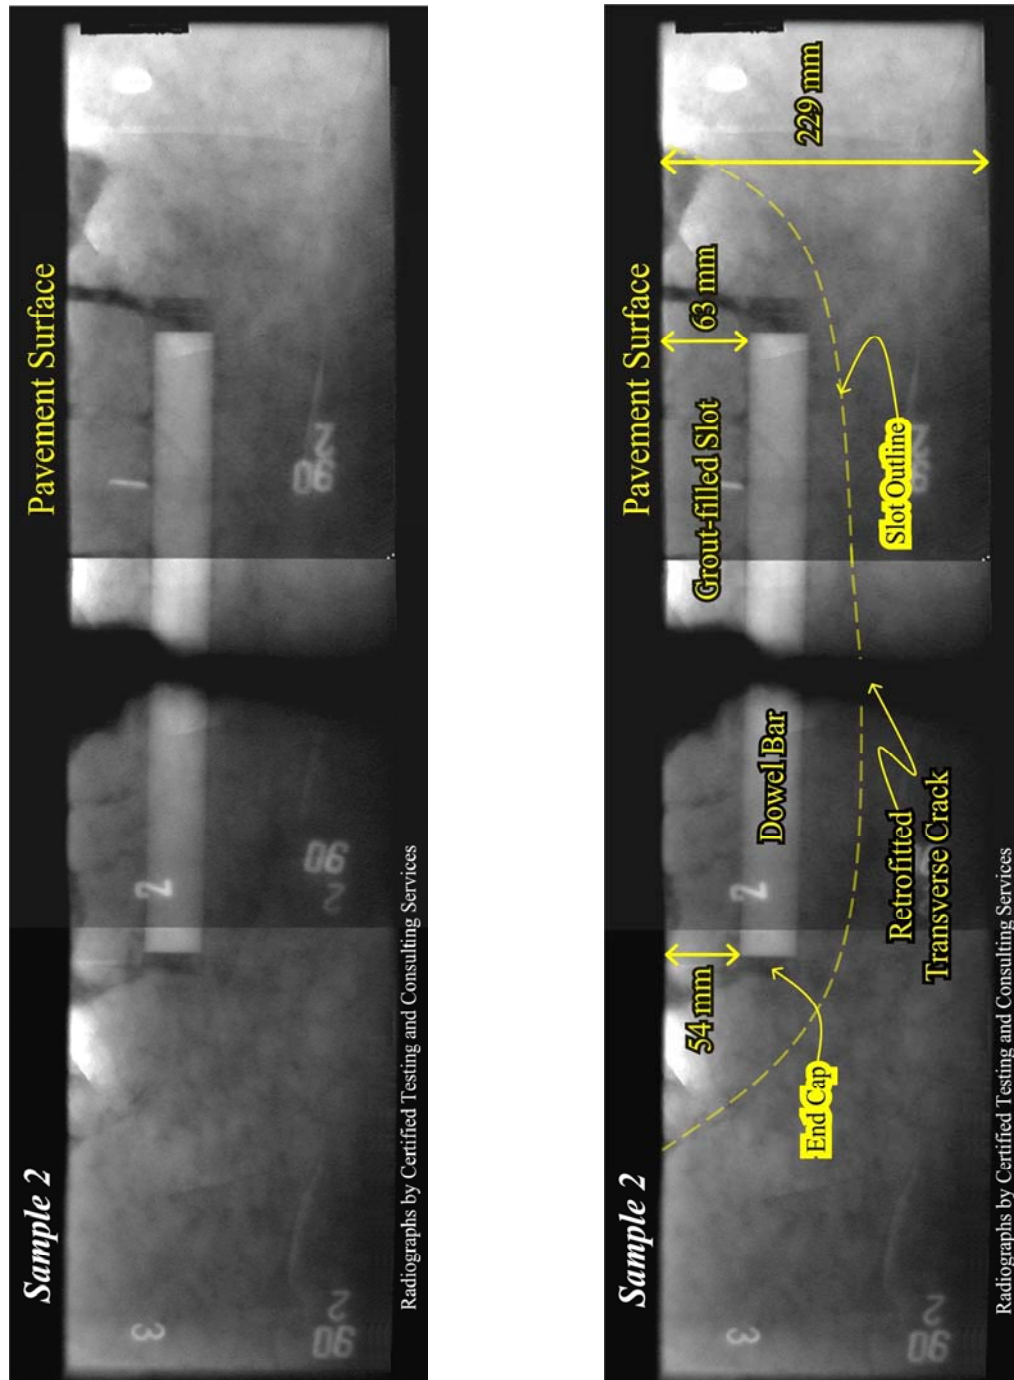
Figure 18. X-ray Composite of Sample 2

X-rays for Sample 2 show the dowel bar in a tilted position. One end is at 54-mm (2 $\frac{1}{8}$ -in) below the pavement surface and the other end at 63-mm (2 $\frac{1}{2}$ -in).

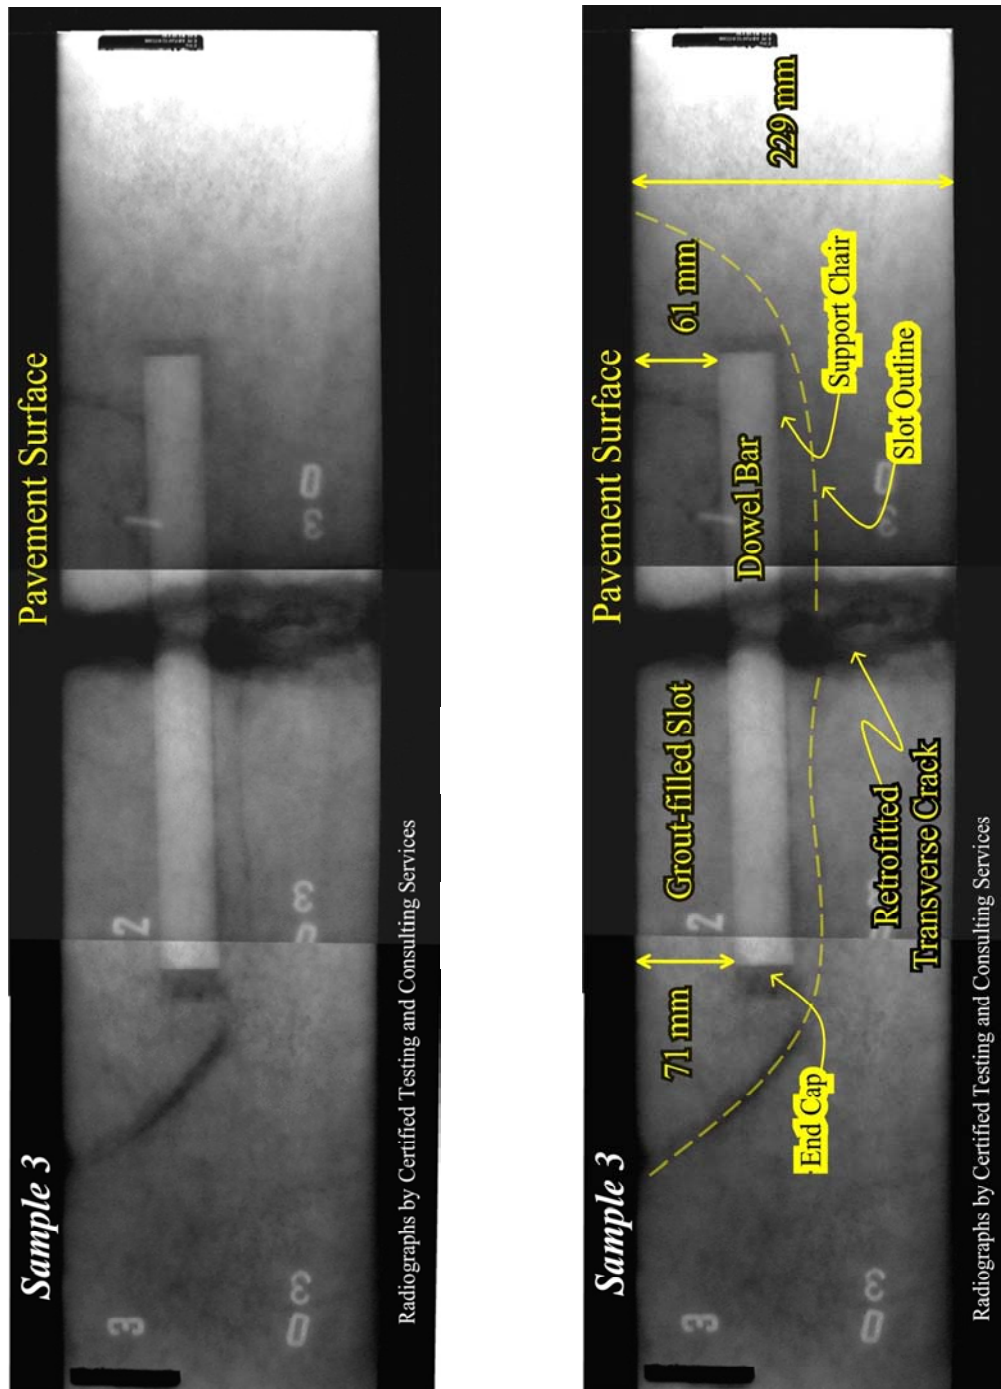
Figure 19. X-ray Composite of Sample 3

X-rays for Sample 3 also show the dowel bar in a tilted position. One end is at 71-mm ($2\frac{7}{8}$ -in) below the pavement surface and the other end at 61-mm ($2\frac{3}{8}$ -in).

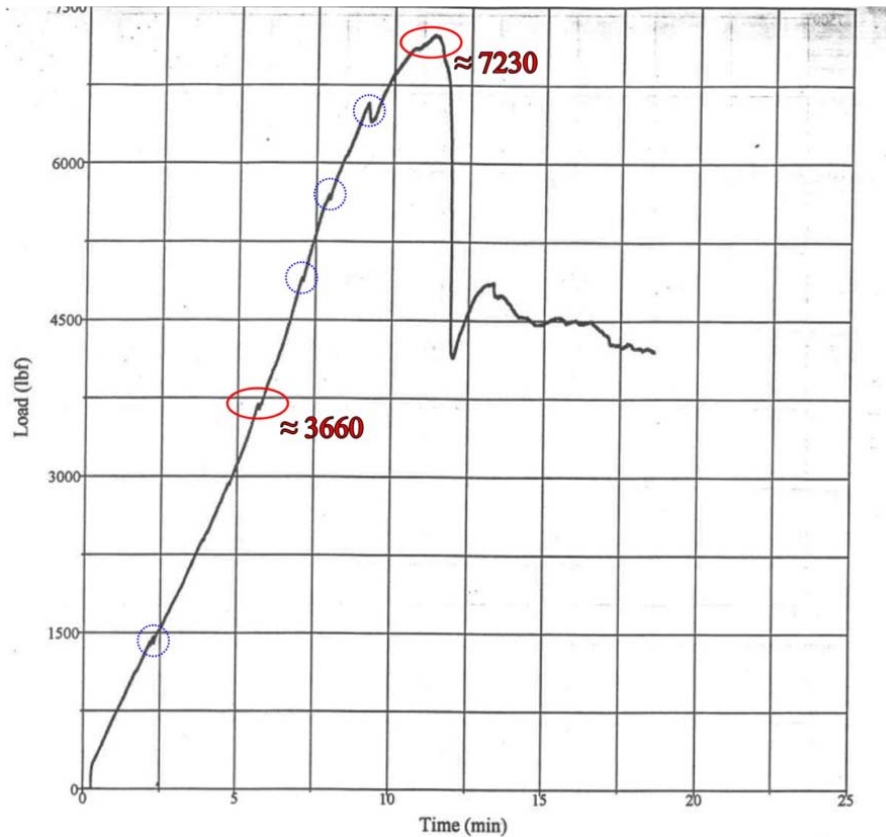
Figure 21. Load Test Results - Sample 1

During the test, there were several times where minor drops in loading occurred (Figure 21). These drops most likely correspond to a portion of the grout breaking free and then, through sliding friction, contributing to the additional load on the sample. For this reason, the load value at first drop, $\approx 3,660$ lbf, is considered in the analysis of the apparent shear strength (Appendix A). The shear stress between the grout and concrete was determined to be 99.2 psi (684 kPa).

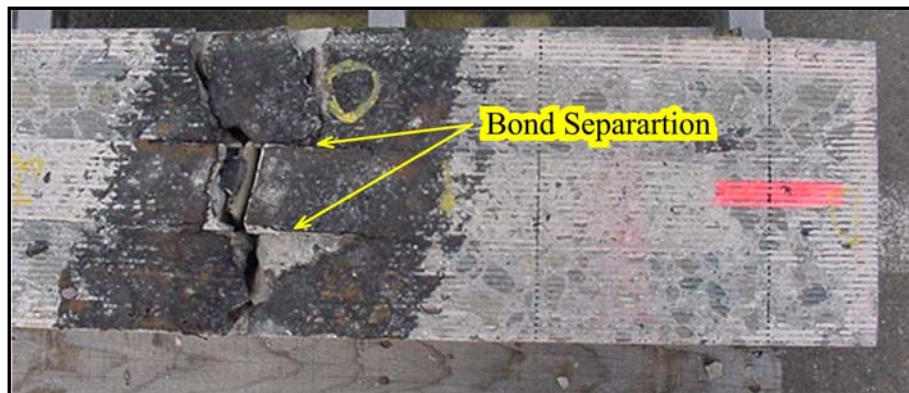
Figure 22. Sample 1 after Testing

At the area of failure, there was a distinct separation between the backfill grout and the existing concrete (Figure 22).

The slots should be vacuumed and sandblasted to remove any remaining debris and all surfaces should be cleaned and dried to ensure a strong bond between the backfill grout and the existing concrete.

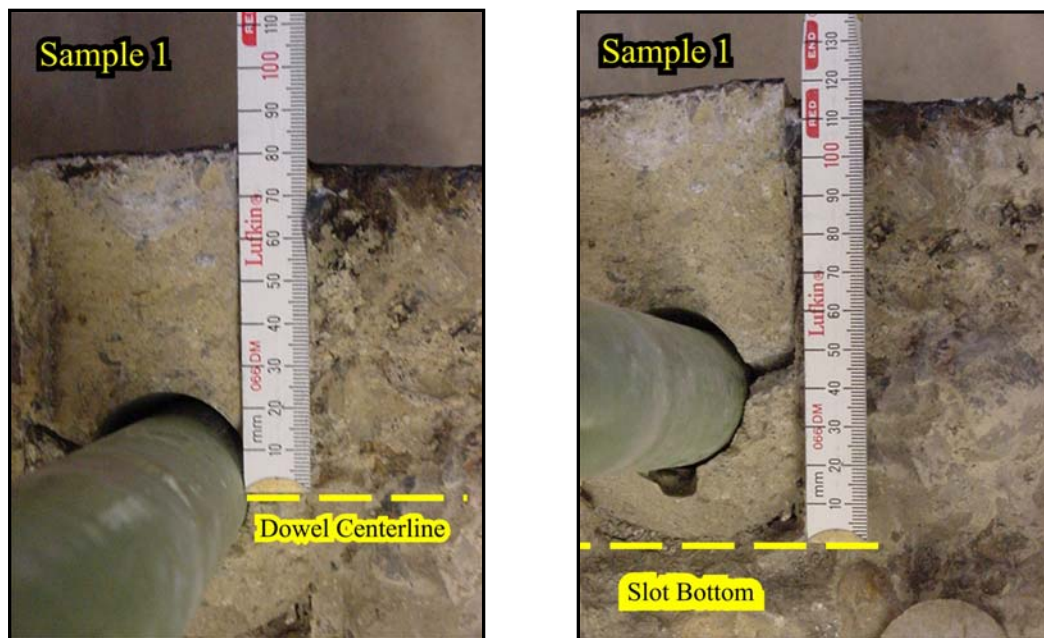
Figure 24. Cross-Section – Sample 1

Sample 1 was examined after the bond strength test. The centerline of the dowel bar was about 79-mm (3 $\frac{1}{8}$ -in) below the pavement surface; the top was 60-mm (2 $\frac{3}{8}$ -in) below.

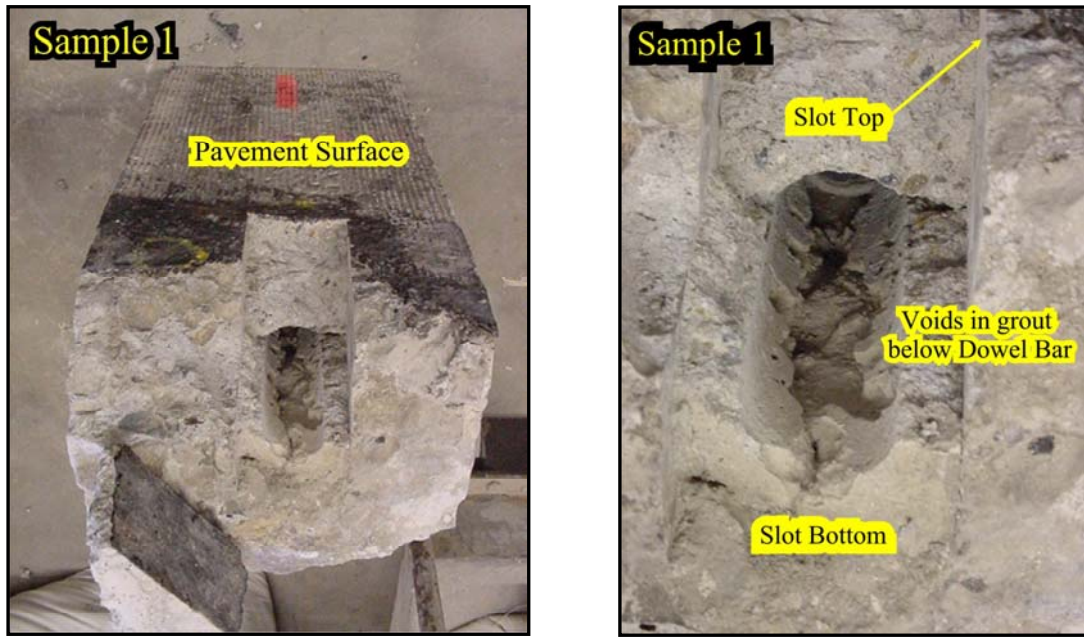
Figure 25. Grout around Dowel Bar – Sample 1

X-rays showed the top of the dowel bar to be at 63-mm (2½-in) below the surface. The bottom of the slot was approximately 117-mm (4⅝-in) below the surface (Figure 25).

The backfill grout below the dowel bar had numerous voids, indicating it was poorly consolidated after being placed.

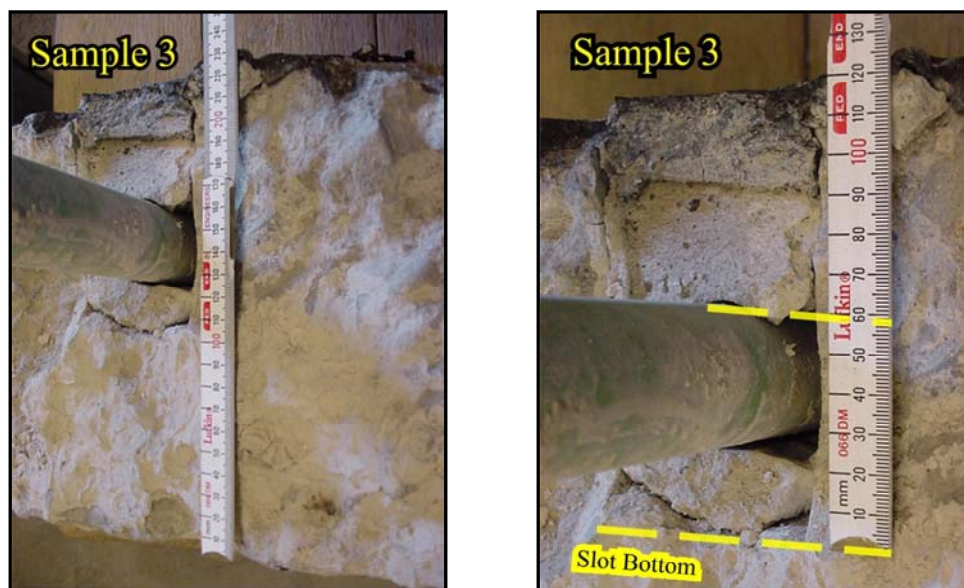
Figure 26. Cross-Section – Sample 3

Sample 3 was also examined. The top of the dowel bar was about 63-mm (2½-in) below the pavement surface; the centerline was 82-mm (3¼-in) below. The bottom of the slot was approximately 119-mm (4⅝-in) below the surface.

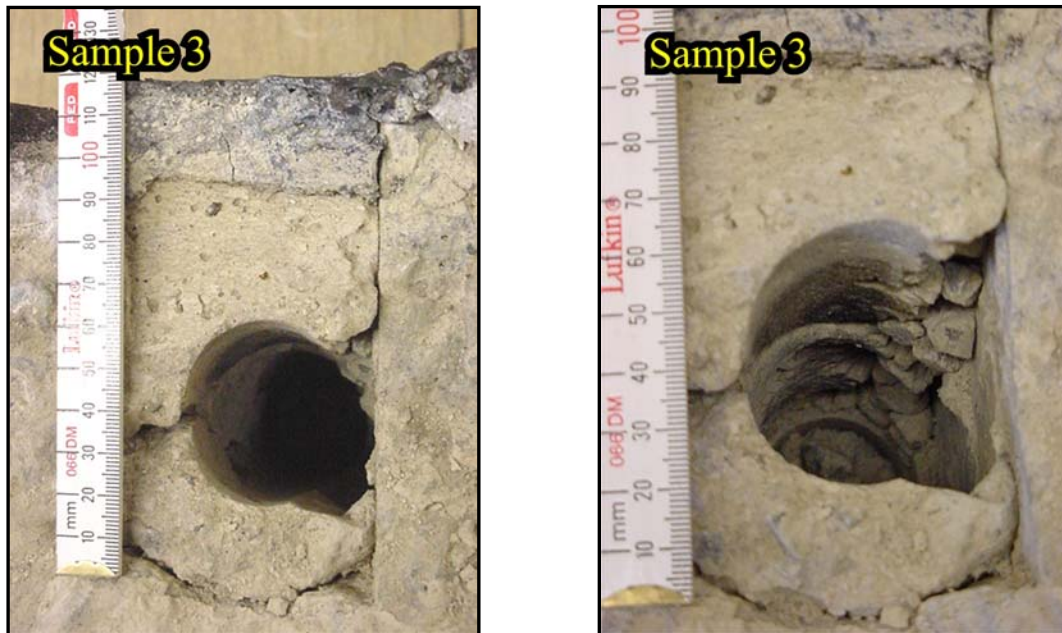
Figure 27. Grout around Dowel Bar – Sample 3

The backfill grout around the dowel bar had numerous voids.

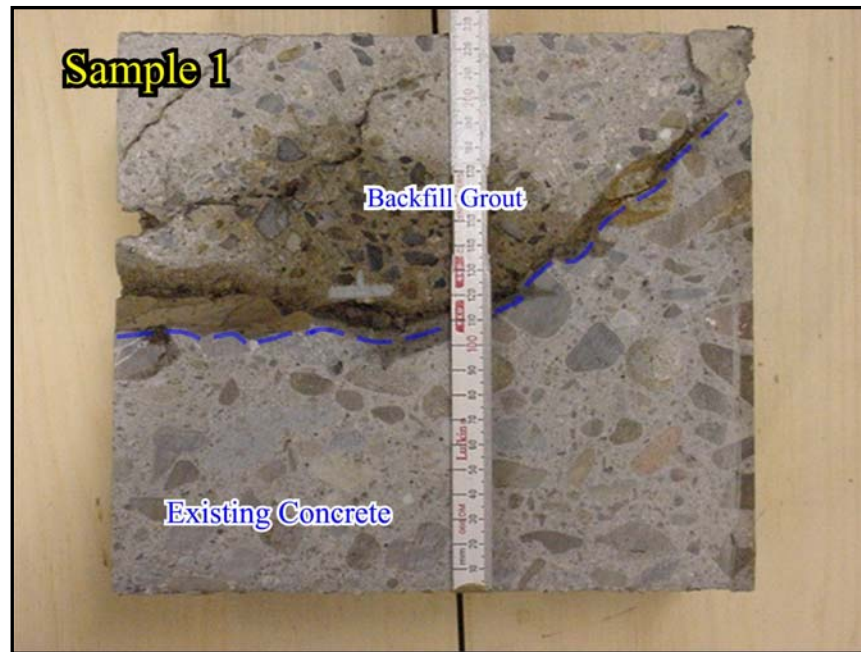
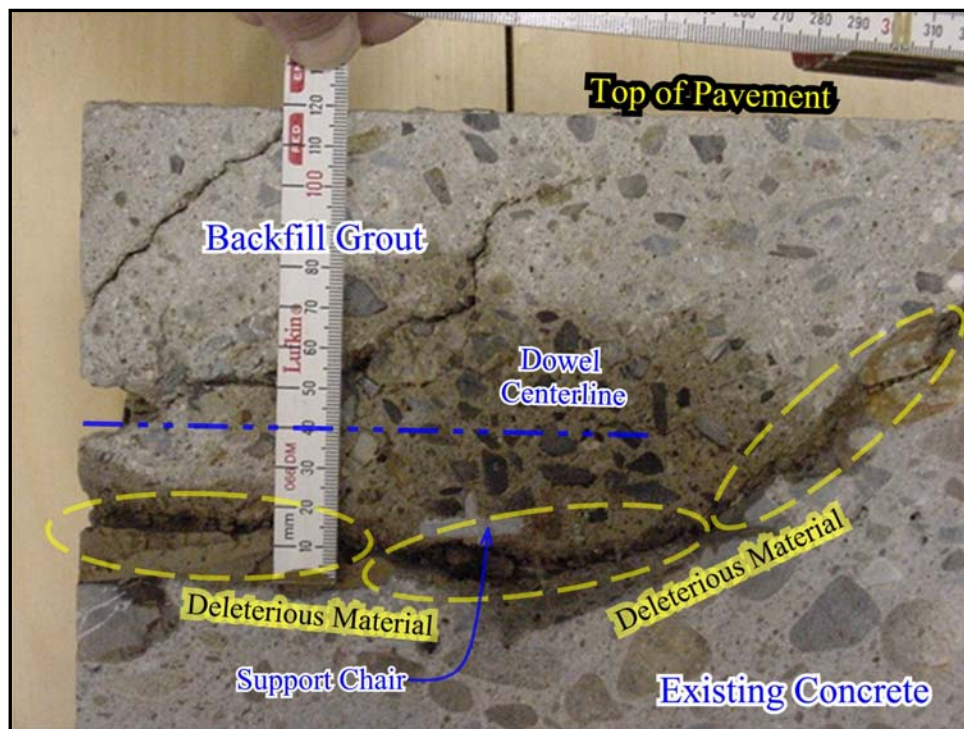
Figure 29. Slot Profile – Sample 1

In Sample 1, an inspection of the slot revealed deleterious material between the backfill grout and the existing concrete (Figure 29).

The bottom of the slot was approximately 119-mm (4⁵/₈-in) below the pavement surface. The dowel bar centerline was about 79-mm (3¹/₄-in) below.

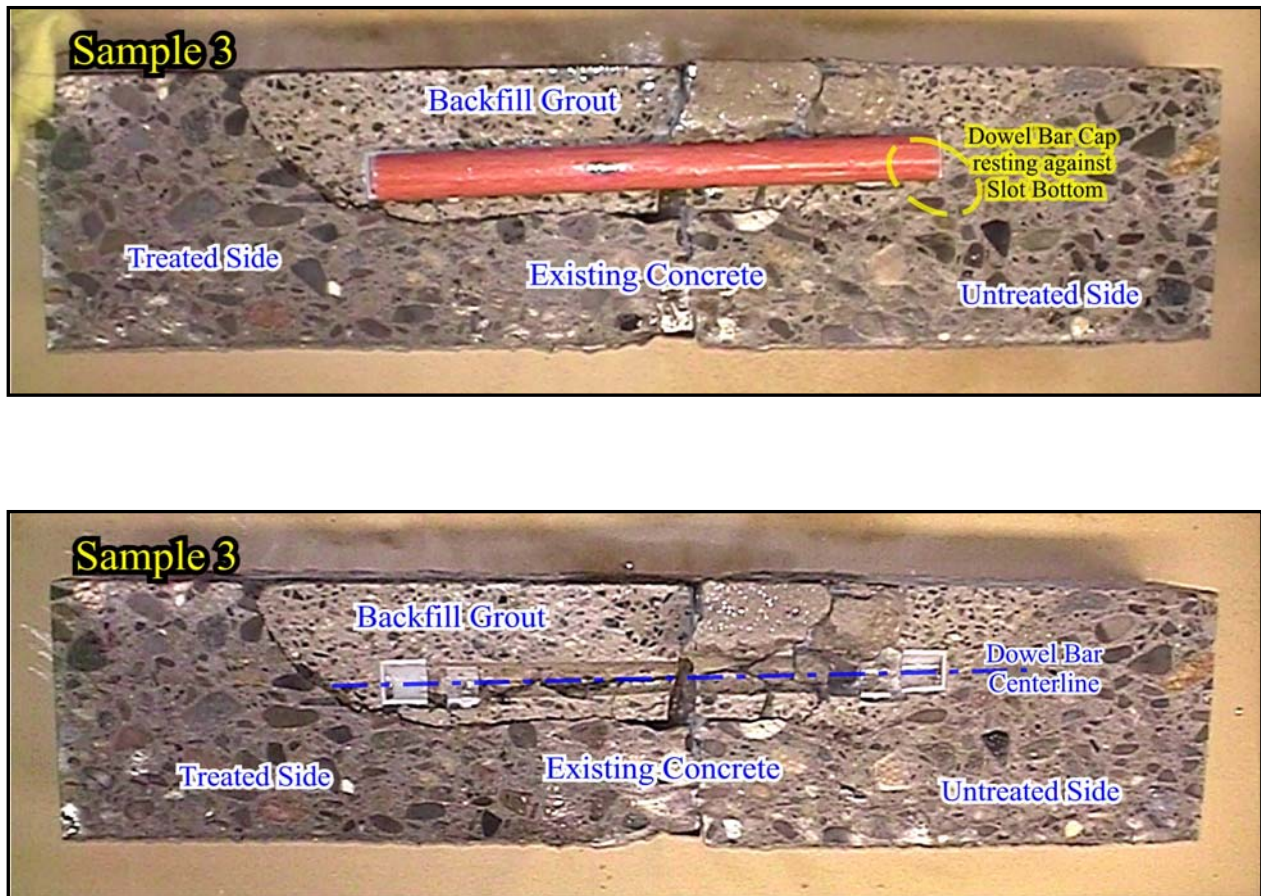
Figure 30. Slot Profile – Sample 3

Some of the backfill grout in one half of Sample 3 broke apart, as it was being sawcut. The retrofit slot in the other half was treated with methacrylate to keep the grout intact.

The two halves were placed side-by-side to display the slot profile (Figure 30)

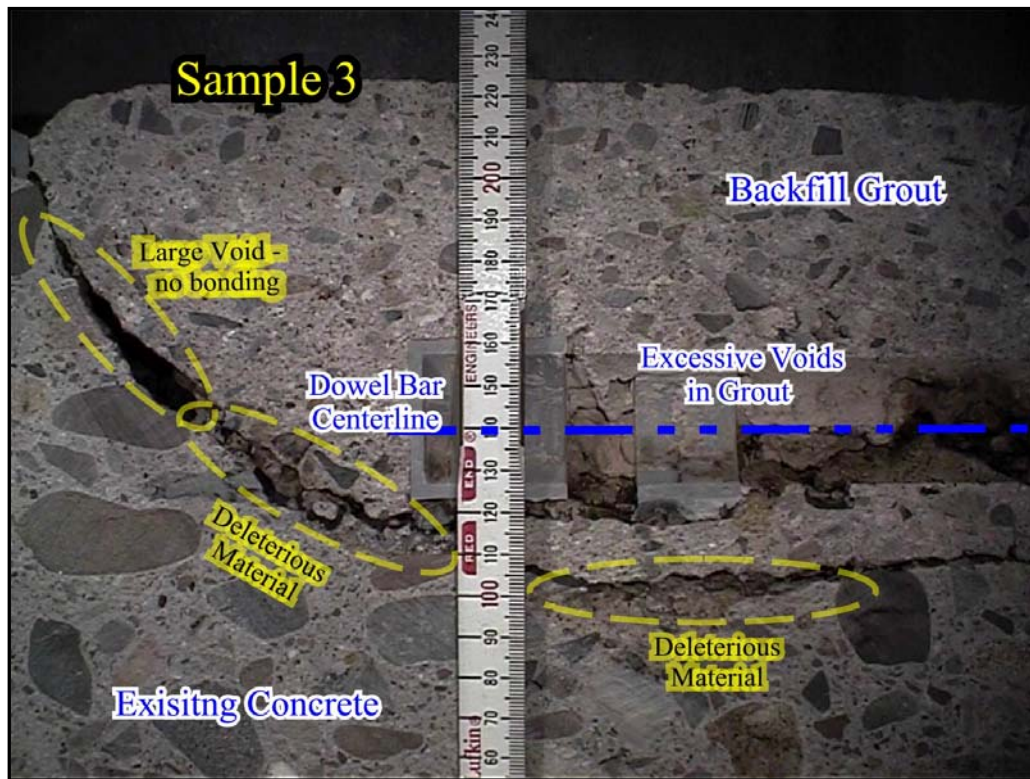
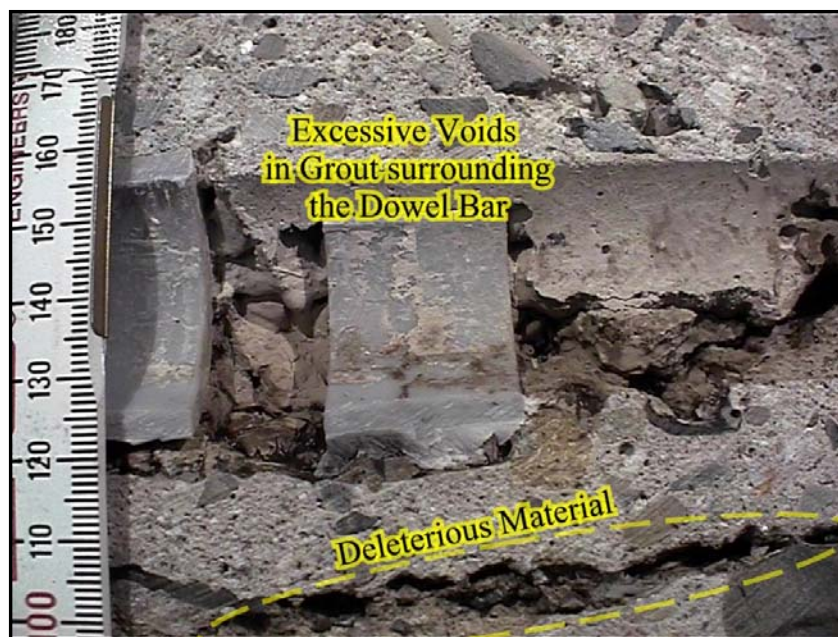
Figure 31. Profile-Treated Side

Figure 31 is a close-up of the treated (left) side. Deleterious material was found between the backfill grout and the existing concrete. The grout surrounding the dowel bar was fragmented and had numerous voids.

The bottom of the slot was approximately 120-mm (4¾-in) below the pavement surface. The dowel bar centerline was about 88-mm (3½-in) below.

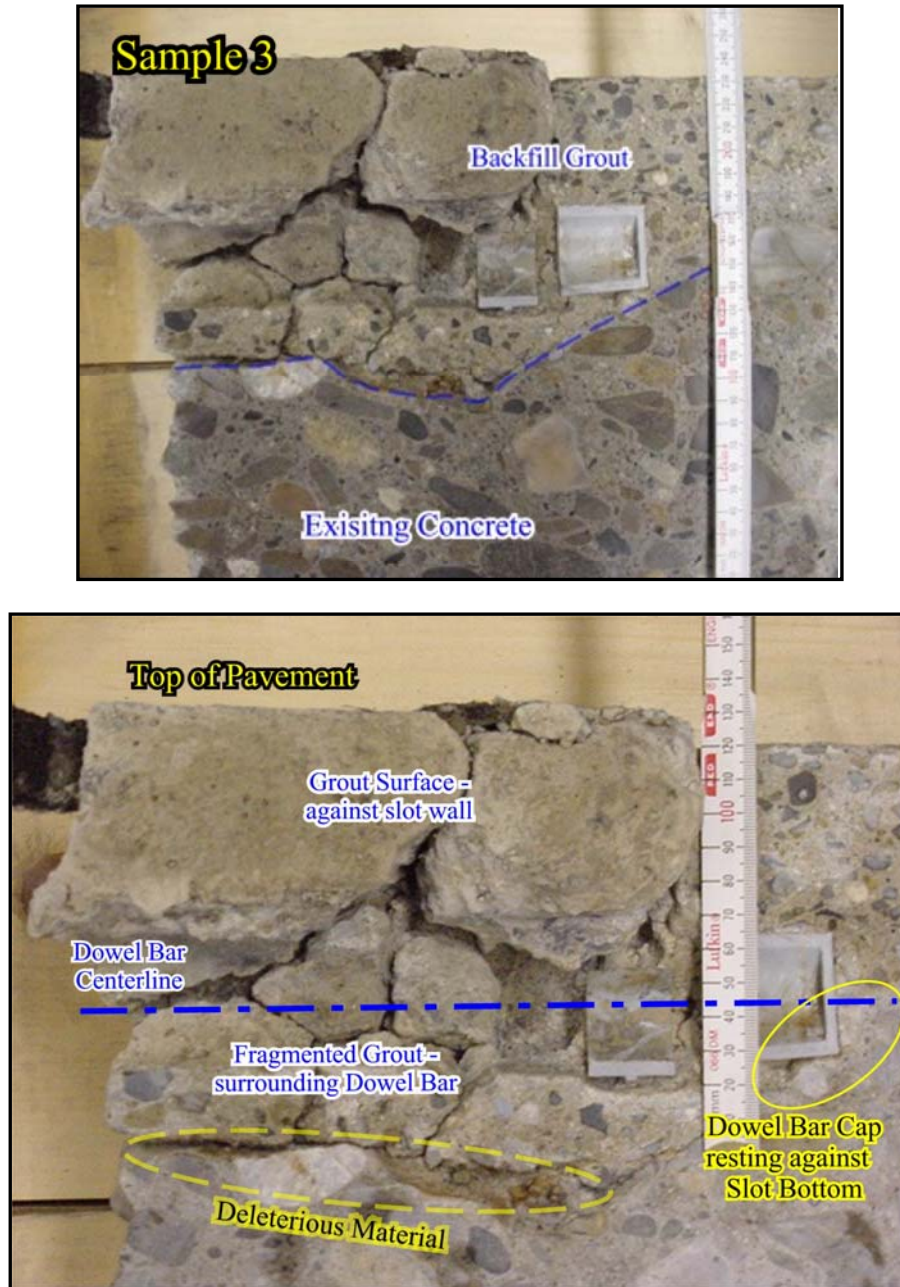
Figure 32. Profile-Untreated Side

Figure 32 is a close-up of the untreated (right) side. Deleterious material was also found between the backfill grout and the existing concrete. The grout surrounding the dowel bar was fragmented and had numerous voids.

The bottom of the slot was approximately 120-mm (4³/₄-in) below the pavement surface. The dowel bar centerline was about 76-mm (3-in) below.
