## Lessons Learned from the February 27, 2010 Maule, Chile Earthquake

By Mark Yashinsky, Caltrans Office of Earthquake Engineering

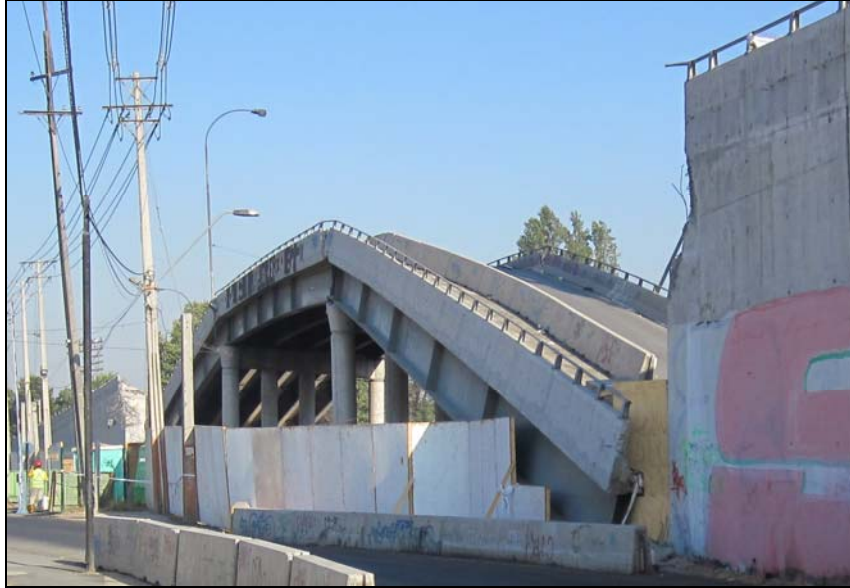
Most of the damage we saw was caused by lack of restraint along the load path and not enough seat length. Caltrans current seismic criteria requires balanced structures with large seats, good continuity of reinforcement, and well-confined ductile members. This would prevent the kind of collapse that occurred on the Quiliera Overhead (Figure 2).

**Figure 2. Collapsed Two-Span Quiliera Overhead in Santiago.**

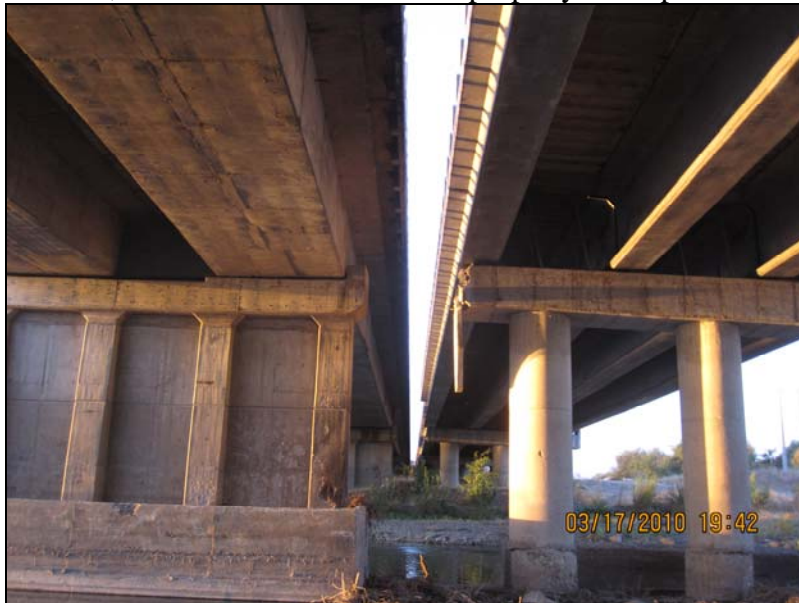
In the 1990s Chile wanted to grow its infrastructure, even though they were lacking in funds. Their solution was to privatize most of their major highways and expressways. Unfortunately, this resulted in bridges that did not include as many seismic resisting details as those used in older bridges. Almost all of the damage we saw was to bridges built in the late 1990s, after the roads became the property of corporations.

**Figure 3. Puente Perqui Lauquen Carrying Route 5.**

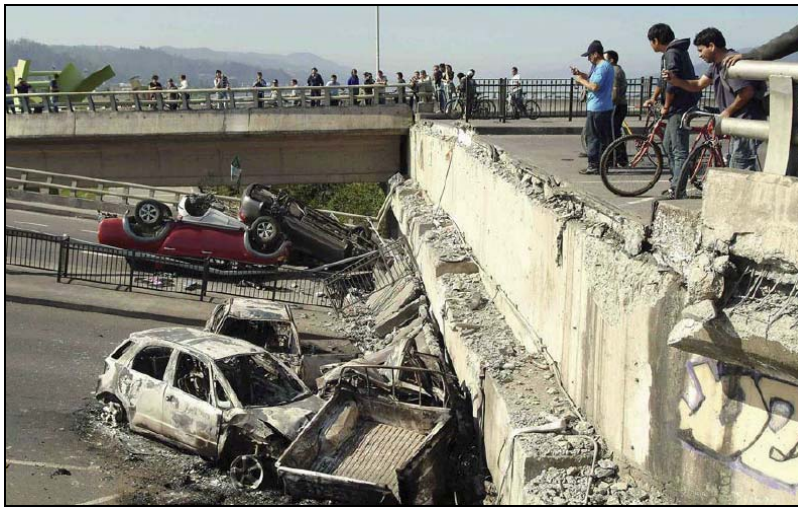
**Puente Llacolén** was the newest bridge across the Rio Bio Bio. It was meant to carry traffic from adjacent streets and highways across the river and so it had stiff structures at both ends to accommodate several ramps and connectors. It is likely that the more flexible ramps had large displacements during the earthquake and moved out of phase with the stiff, eastern end of the bridge. As a result several of the ramps became unseated during the earthquake (Figure 4). This stopped all traffic across the river until temporary (Bailey) bridges could be erected over the fallen spans to allow one or two lanes of traffic to flow in each direction. We want adjacent frames of bridges to have about the same stiffness, mass, and period so they can move in-phase and so stiffer elements don't carry too much force. A better solution for these connectors is what we call an 'Urban Interchange' such as Caltrans designed for the Carmenita Interchange in Norwalk, where an effort was made to make all the frames have about the same stiffness.

**Figure 4. Collapsed connectors to the Puente Llacolén (photo courtesy of the Japan Society of Civil Engineering (JSCE)).**

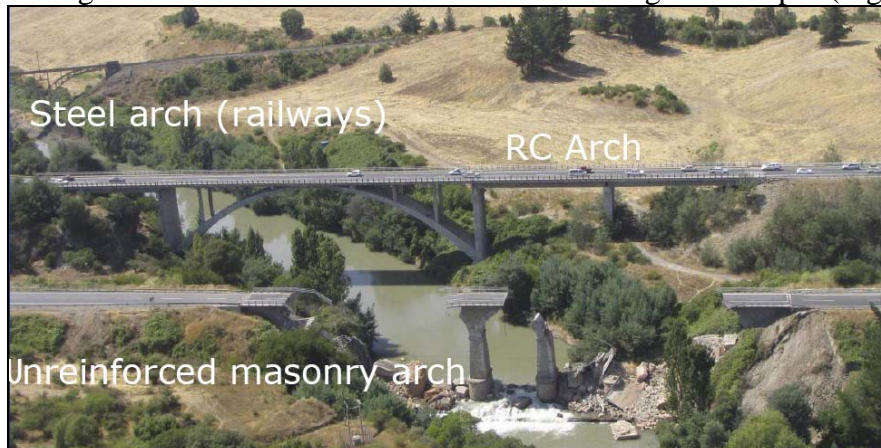
Because the Rio Clara Bridge was built in 1870 and had survived many large earthquakes, we might assume that it was highly resistant to earthquakes despite being a masonry bridge. However, strong ground motion can vary and it wasn't until the most recent earthquake that ground motion occurred that caused the bridge to collapse (Figure 5).

**Figure 5. Collapsed Puente Rio Claro (photo from JSCE Team).**

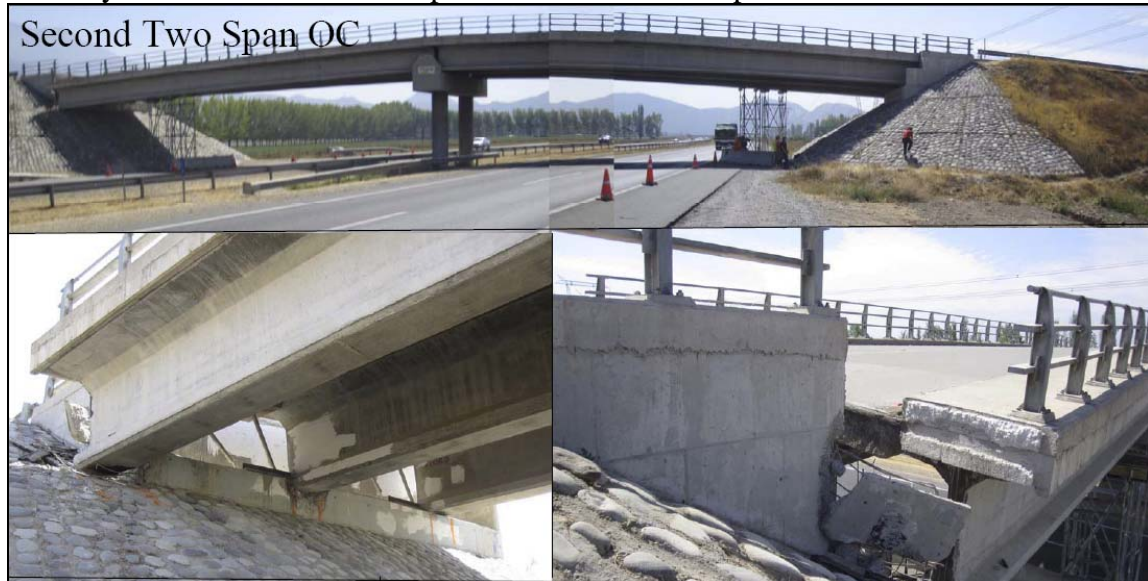
We tried to stop and look at all the damaged two span overcrossings we saw while driving on Route 5. Every one of these damaged structures, even those with little or no skew, had rotated about a vertical axis at the center pier (Figure 6). Since we traditionally perform a linear static analysis of each bent (without twisting), this behavior needs to be carefully studied to see how it impacts Caltrans' seismic procedures.

Figure 6. Twisting of a Two-Span Overcrossing on Route 5.

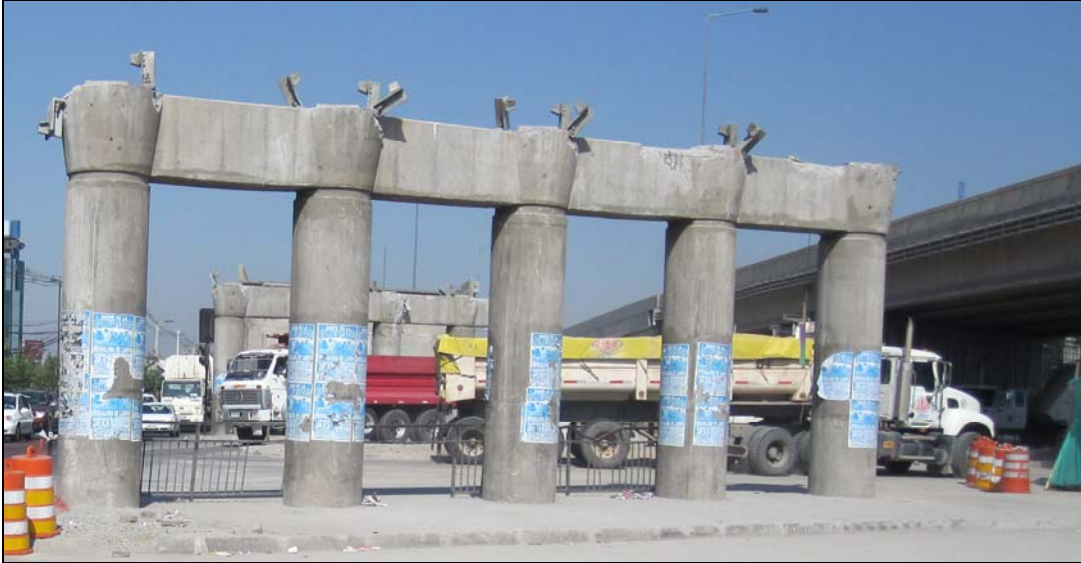
Most major expressways have been widened to include an older and a newer bridge standing side by side. In almost every case either the newer bridge with poor seismic details collapsed (Figure 8) or an older bridge that had a short seat or other bad details collapsed. We seldom saw both bridges collapse, which was fortunate since it allowed traffic to squeeze onto the remaining bridge without a major detour.

**Figure 8. New bridge with poor details collapsed while older parallel bridge (to the right) remained standing and was still in use on Vespucio Norte in Santiago.**

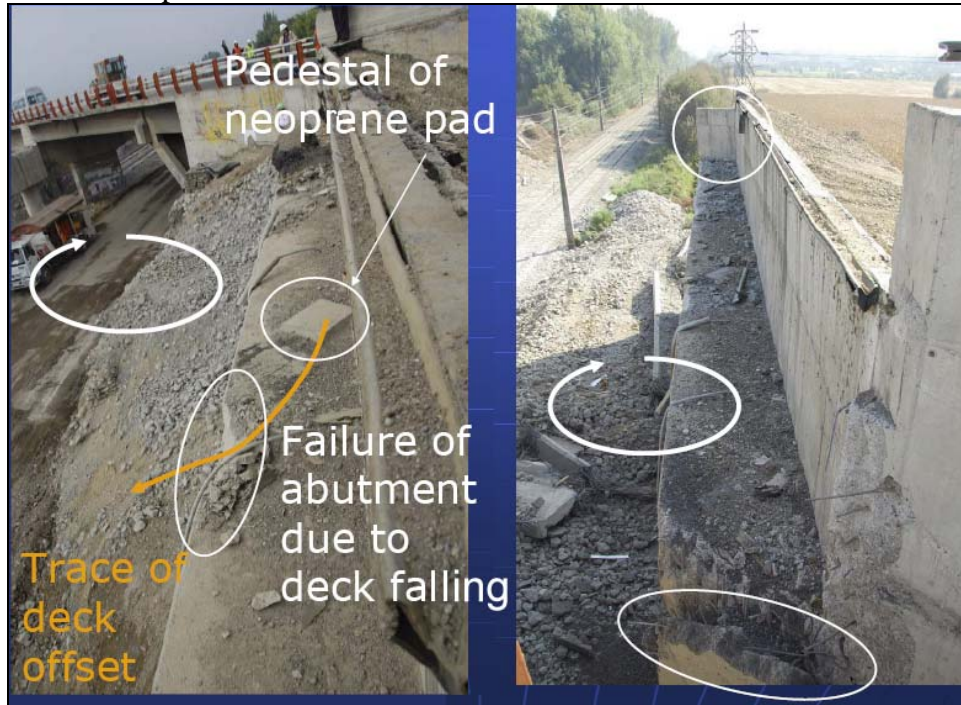
For a variety of reasons (geometric boundary conditions, bias in direction of displacement, eccentric location of mass, etc.) we see a lot of unseated skewed bridges after earthquakes (Figure 10). The lesson would be to provide very large seats on skewed bridges and also to perform research into this issue.

**Figure 10. Puente Perquacauen, a single span skewed bridge on Route 5, became unseated and collapsed during the Maule Earthquake (photos courtesy of JSCE).**

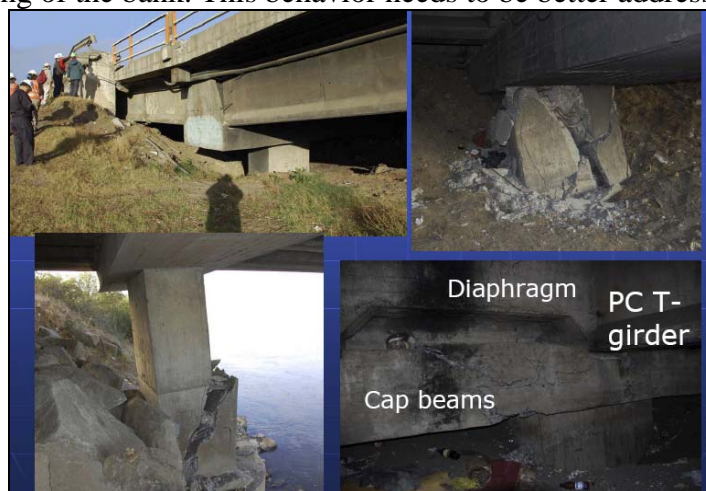
Puente Juan Pablo II is an older bridge and it is one of the few examples of bridge column damage that we saw during the earthquake. The eastern end of this long bridge moved towards the river, breaking a short stiff two-column bent at the water's edge due to lateral spreading of the bank. This behavior needs to be better addressed by Caltrans.

**Figure 11. Lateral Spreading Damage at Puente Juan Pablo II (photos from JSCE).**
