October 30, 2007 Alum Rock Earthquake

At 8:05 PM on October 30, 2007 an earthquake struck at lat. 37.432°N and long.121.776°E, about seven miles east of the city of Milpitas. The earthquake had a moment magnitude of 5.6 and it ruptured at a depth of five miles.

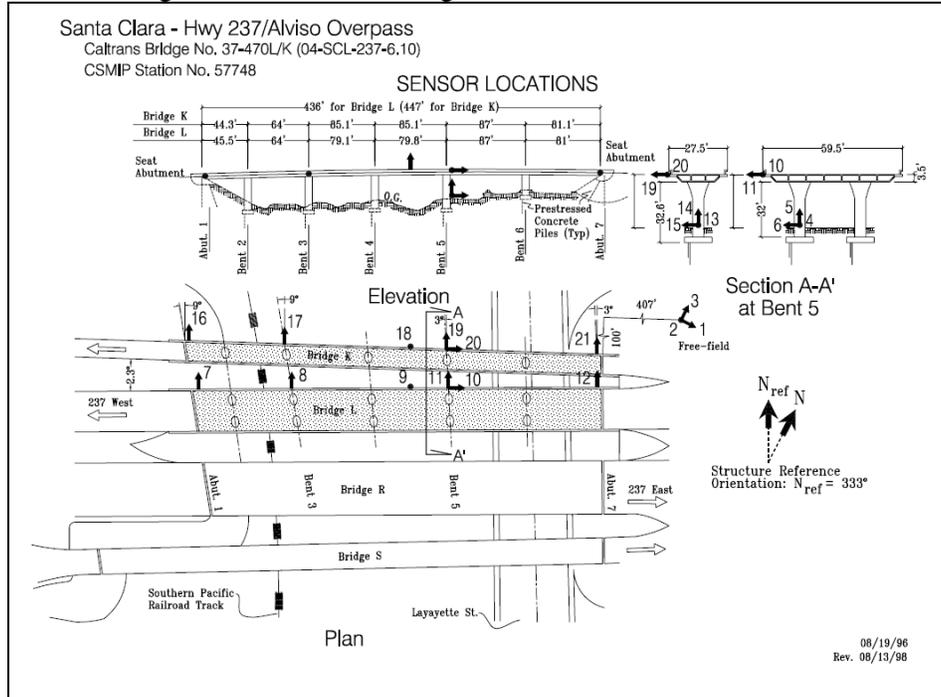
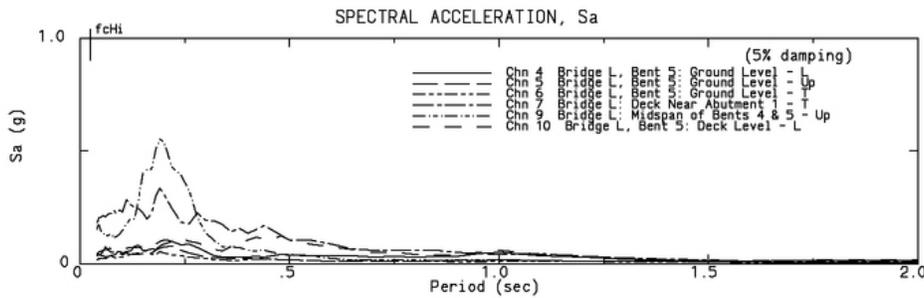
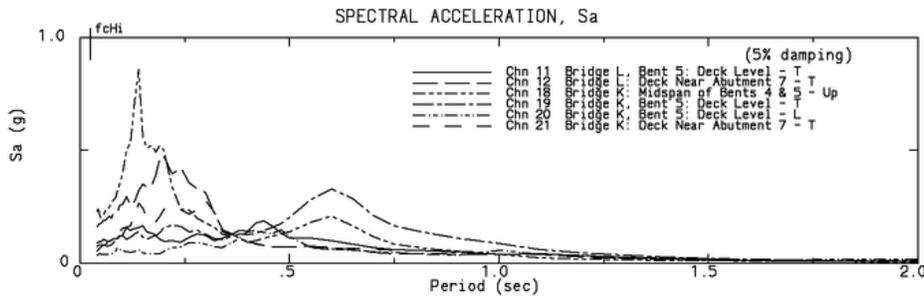
Caltrans had several instrumented bridges that recorded motion from this earthquake. The Highway 237/Alviso Overpass (37 0479L/K) at N37.418° W121.973° includes two six-span reinforced concrete box girder bridges crossing over the Southern Pacific Railroad tracks and a city street. It is 17.5 km from the epicenter (just west of Milpitas). The free field instrument was damaged, but the structure had a peak horizontal acceleration of 0.19g recorded on the bridge deck.

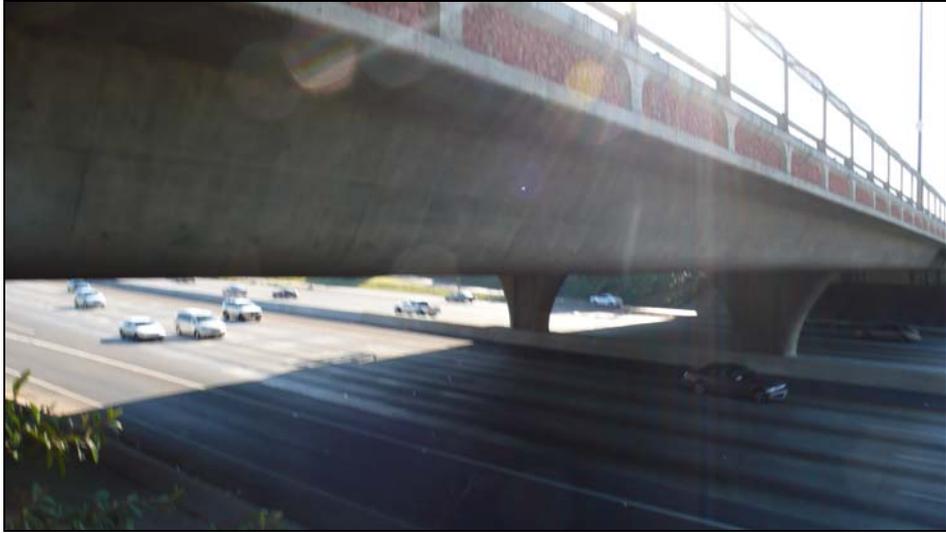
Alum Rock OC.

On the next page are photos of three of the bridges that were inspected. Alum Rock OC (37 0290) is a two span concrete box girder bridge on a two-column bent that carries city traffic over I-680. Miquelita Creek Bridge (37C 0511) is a 3-span T-girder bridge on concrete piers. Upper Penitencia Creek Bridge (37C 0135L/R) was a modern 3-span slab bridge on concrete piers. We saw no signs of damage or movement on these bridges.
