Damage to Grier St. POC [Br. #53-1158] Post-Earthquake Investigation Team Report

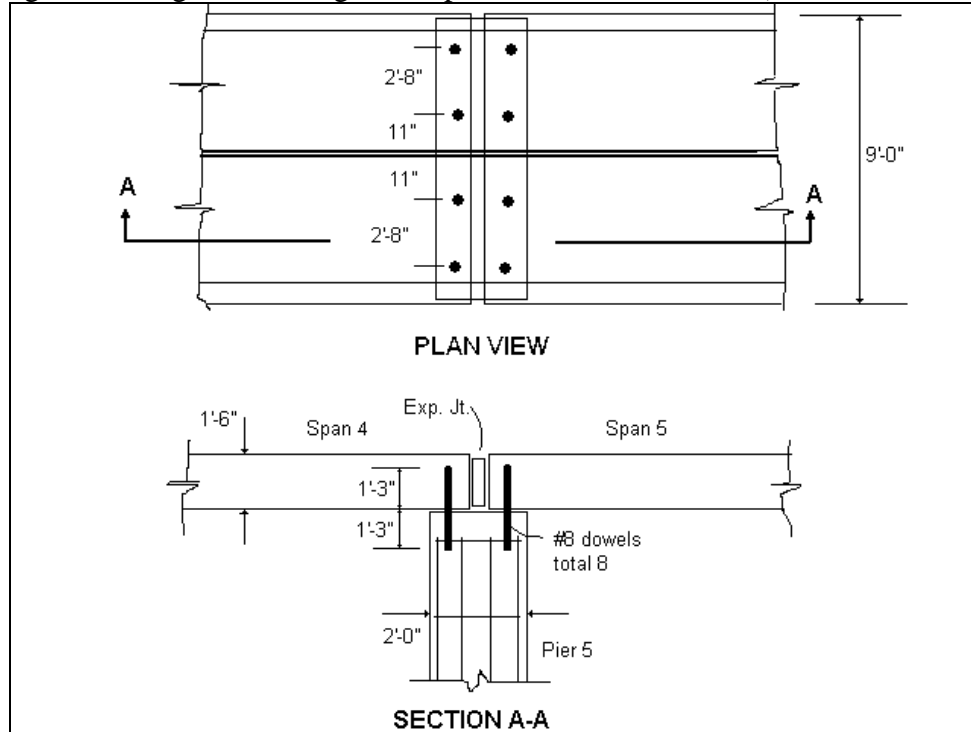
Figure 3 Support Connection at Pier 5.

The Grier St. POC is located at Post Mile 1.2 on Route 71 in Los Angeles County in the city of Pomona. This bridge is a simply supported eight span precast prestressed voided slab pedestrian overcrossing bridge. The precast slabs (two 4 ft. wide slabs placed side by side) are supported on rectangular reinforced concrete pier bents and seat type abutments. The top of the pier is only two feet wide, and this seat is shared by adjacent spans, making the seat width slightly less than one foot (Figure 3) The two precast slabs are doweled and grouted to the piers with 2 - # 8 bars each (total of four grouted dowels at each end of a span) at both supporting piers (Pier 4 and Pier 5). The precast slabs are

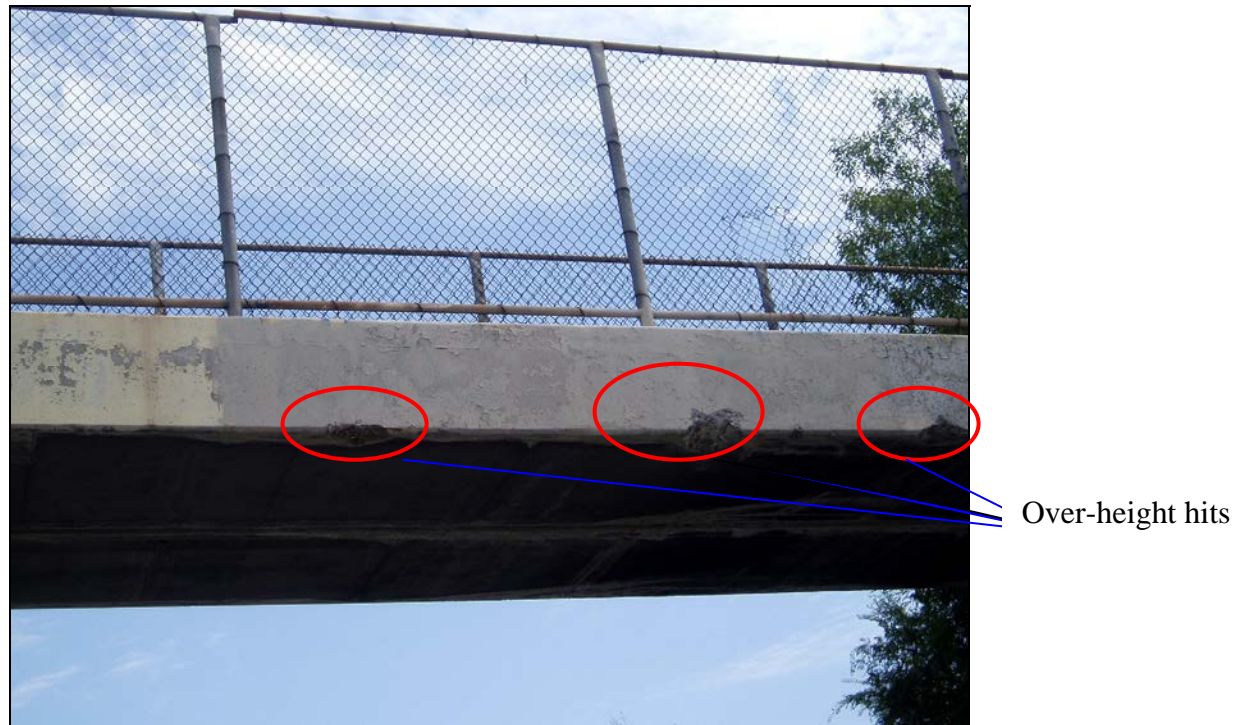
- A. BIR 8/23/2000:
Records showed the structure appears to be in good condition.
- B. BIR 8/13/2002:
Records revealed a spall due to an over-height hit over the NB lane (Span 5) and a similar hit spall over the SB lane (Span 4). The spall at Span 4 appears to be larger than that at Span 5 (200%). Also, it was noted that the bridge was proposed to be removed under project EA 07-21060 in fiscal year 2005.

- C. BIR 8/20/2004:
Records showed the structure appears to be in good condition.
- D. BIR 8/16/2007:
Records showed numerous over-height hit spalls over the NB lane (Span 5). The report did not mention the three pocket spalls on Span 4 (SB lane), as shown in Figure 4 (taken on 8/4/2008). In addition, the bridge has been identified as one of the bridges requiring work to comply with the Americans with Disabilities Act (ADA) requirements. Note that the earlier contract to widen the northern segment of Route 71 wherein this POC was to be removed (EA 07-21060) was never completed, and thus the POC remains in service.

Figure 4 Damage to superstructure from over-height hits in Span 4

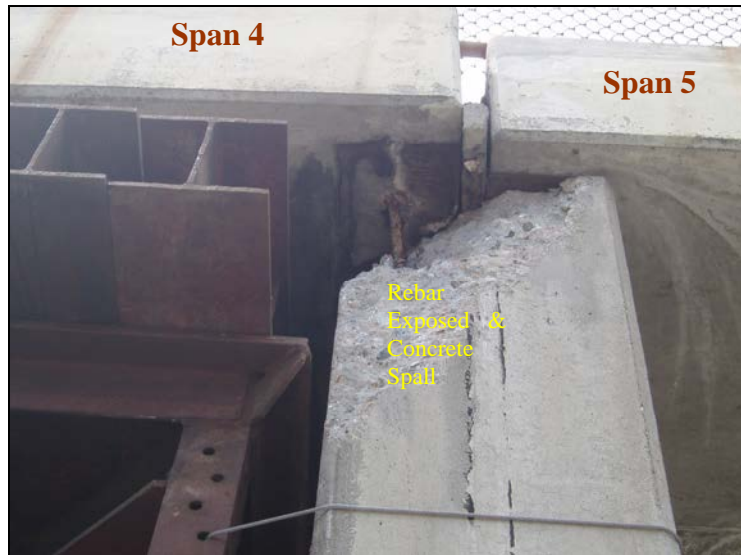
Concrete spalled at both ends of the top of Pier 5 supporting the Span 4 slab, exposing one dowel at each side. The two exterior dowels at each end of the are bent and the Span 4 slab exhibited a permanent transverse displacement of about 3 to 4 inches (toward the Southeast direction), as shown in Figure 5.

Figure 5 Concrete spalls at the southwest corner of Pier 5; note the evidence of corrosion on the dowel connecting the superstructure voided slab to the pier

- It is theorized that previous over-height truck hits on Span 4 may have induced cracks at the top of Pier 5. The ground motions from the Chino Hills Earthquake on 7/30/2008 placed further demands on the weakened connection, spalling the concrete and resulting in the bending of the connection dowels.

The extent of transverse displacement at the piers does not seem to affect the overall structural stability, and no imminent collapse is anticipated at this time. The structure is currently closed. In addition, Span 4 is supported with temporary falsework at Pier 5.

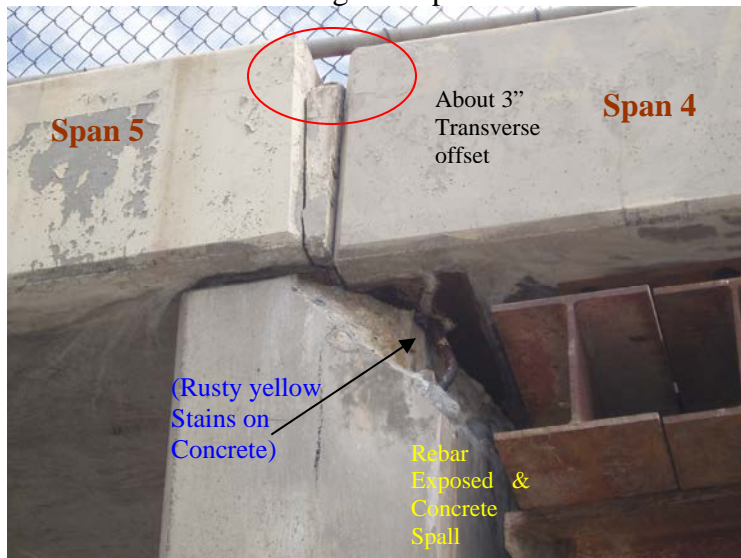
The exposed spalled area of concrete at the Northwest end of the Pier 5 seat exhibits rusty yellow stains (Figure 6). The exposed stains indicate that the area was cracked prior to the Chino Hills Earthquake. In addition, rust was observed on the two exterior dowels, which are now bent. The previous concrete cracking at the top edges of the Pier 5 may be related to the truck over-height hits on the Span 4 slab.

Figure 6 Concrete spalls and stains at the northwest corner of Pier 5 (note stains).

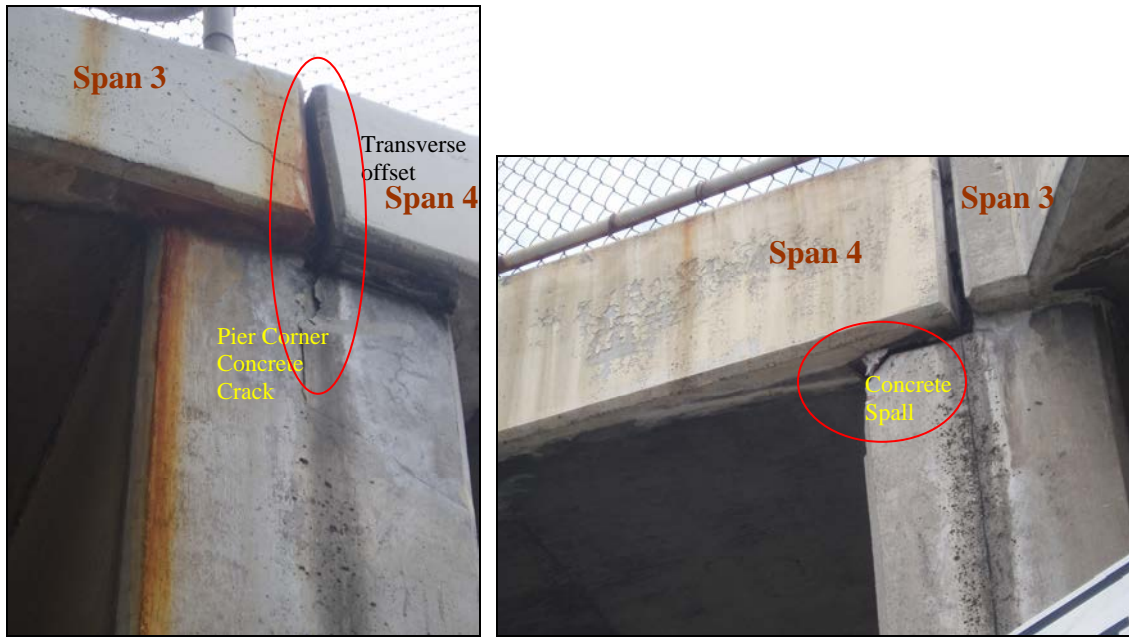
Concrete spalls and cracks were observed at the top the piers supporting the Span 4 slab. Small pieces of concrete (triangular shapes) had fallen off and cracks were visible at the exterior face of Pier 4. Similar to Pier 5, the slab in Span 4 had a permanent offset, displacing transversely (toward the Southeast direction) at Pier 4.

The ground motion pushed the Span 4 slab transversely, bent the dowels, and induced transverse displacement on Span 4 (Figure 7). The major observed failures were bending of the dowel bars connecting the super structure slab with the pier, and concrete cracking and spalling at the corners of the piers supporting Span 4.

Figure 7 Concrete cracking and spalling at Pier 4 under Span 4.

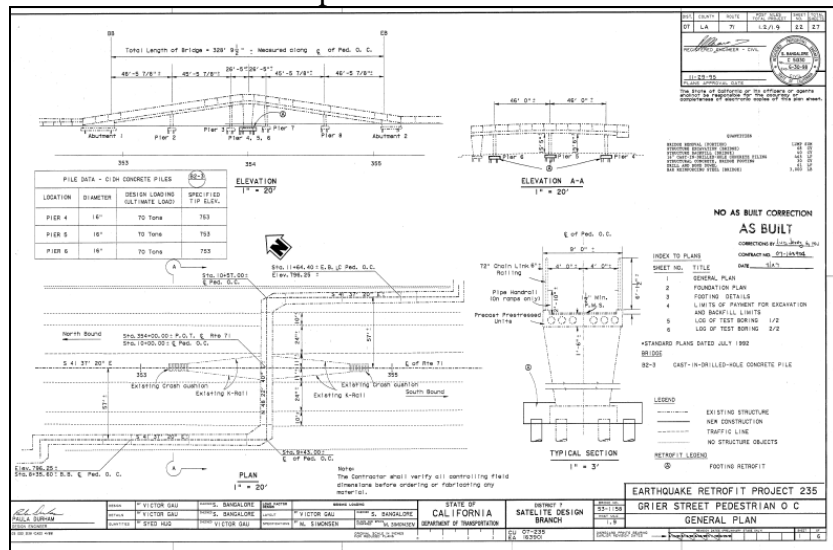
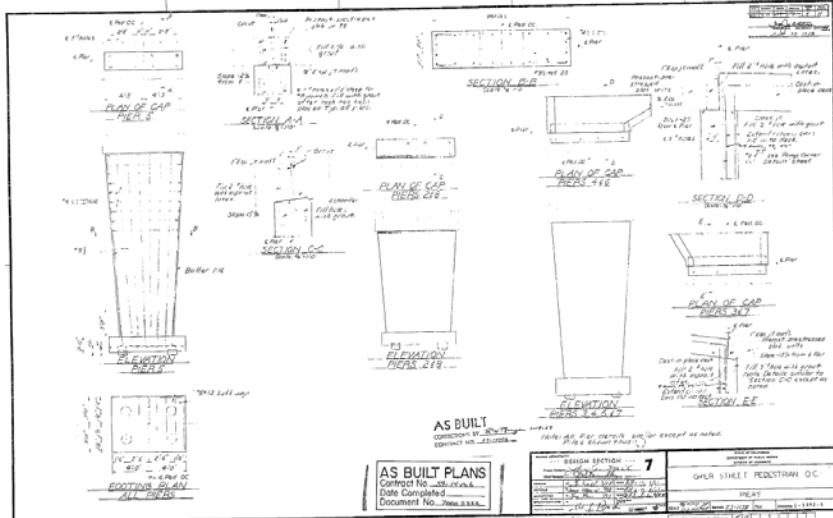
Attachment 1: As Built Plans

- The dowels may not be strong enough to resist the transverse displacement.
- The transverse reinforcement for the piers, as shown in the plan and elevation details for Pier 5 on the as-built plans, are #4 ties @ 12" with the top one foot of the pier apparently not reinforced transversely (unconfined). This is substantiated by the fact that there is no evidence of transverse reinforcement in the cracked sections near the top of the pier. The superstructure to pier connection dowels are embedded into this top 1 foot of unconfined concrete. The lack of confinement allowed cracking and spalling of the top of the pier and the subsequent reduction in the dowel shear capacity.
