M e m o r a n d u m

File: 07-LA-05, PM 44.41
0000001016 6SSCN
LA Aqueduct Penstock
Bridge No. 53-1012

Subject: Evaluation of Fault Rupture Potential, Los Angeles Aqueduct Penstock, Los Angeles County

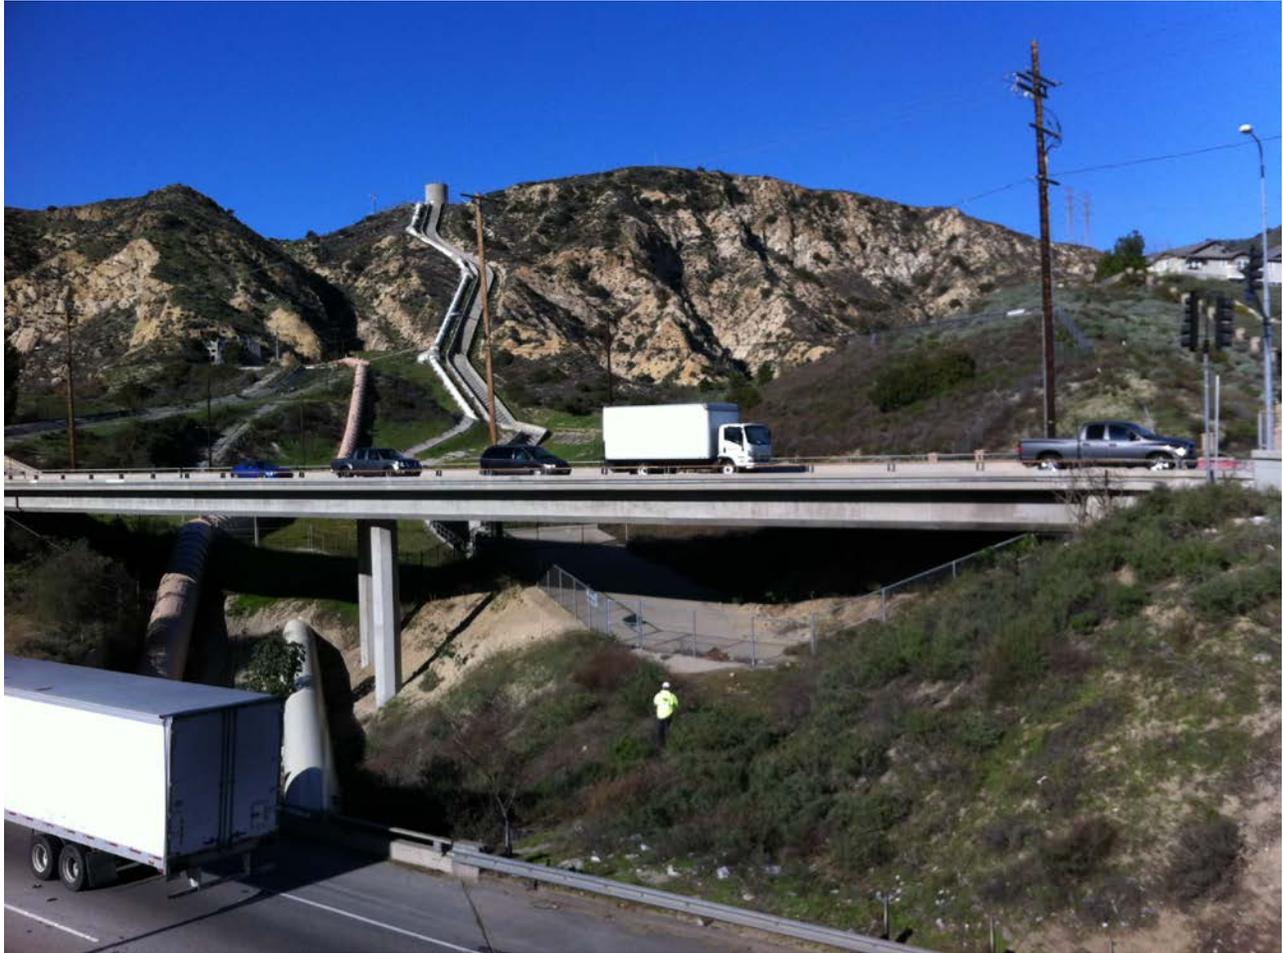
LA Aqueduct Penstock Bridge was built in 1970, and repaired in 1974 for earthquake damage after spalling and cracking in abutment walls (Elliott and Nagai, 1973) during the February 9, 1971 **M**6.6 San Fernando Earthquake (Figures 1 and 2). The bridge is 70 feet long and 319 feet wide. The bridge is not a top grade structure, and is a single span RC T-beam structure with RC closed end backfilled strutted abutments, all supported on concrete and steel piles. A “rigid inclusion” effect was noted in surveys along the freeway alignment (Figure 3).

Figure 1. Looking east from atop Balboa Blvd OC at LA Aqueduct Bridge #53C-316. Penstock is covered and in the center of photo near Doug; Penstock is on the left. See Figure 6 for plan view.

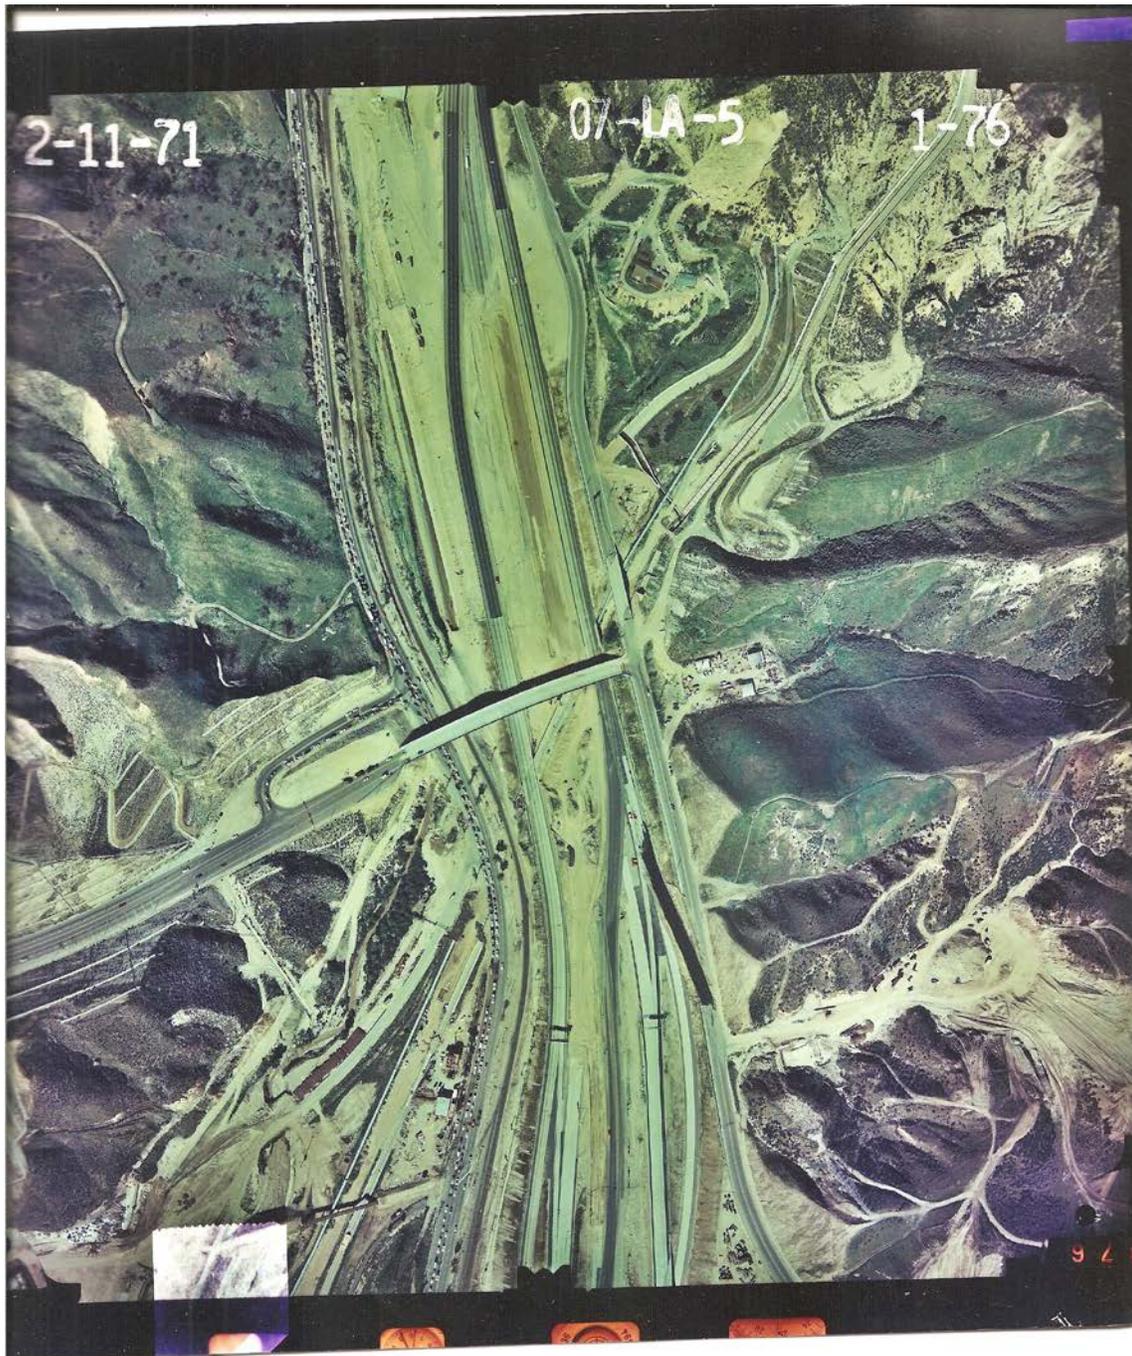
The nearest fault to the Bridge is the Sierra Madre Fault Zone (Santa Susana fault), shown in Figures 4-7. At the latitude of the Bridge, the Santa Susana fault consists of north and south branches (the branch nearest the Bridge) and continues as two branches westward. During the 1971 San Fernando Earthquake, discontinuous ruptures as shown in figures 6 and 7 occurred both west and east of the Bridge. In particular the east-west trending rupture east of the Bridge was described as a “mole track” and as a fault with thrusting of Saugus formation (Sunshine Ranch member) over younger upper Saugus formation. This feature is not observable on air photos taken two days after the earthquake. What are visible in these photos are cracks in Foothill Blvd east and south of the Bridge which were repaired prior to the photos taken two months later. These cracks however are likely the result of road settlement.

Figure 2. Caltrans air photo taken two days post-earthquake. The Penstock is exposed across the I5 freeway alignment. Surface cracks were observed southeast of the Penstock on Foothill Blvd, and were likely the result of differential settlement.

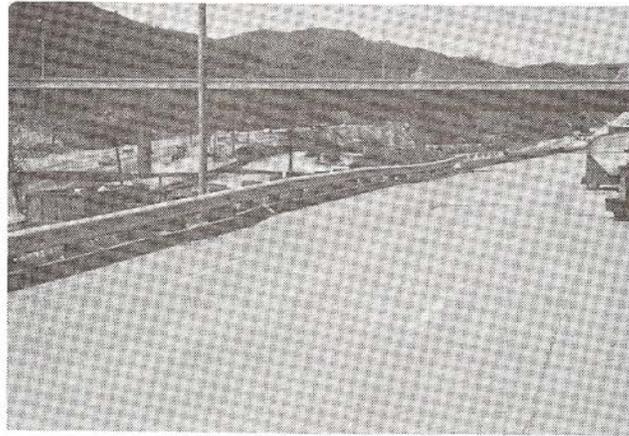
Photo 50. Looking northerly at undulating pavement of Route 5 caused by differential settlement. Balboa Boulevard Overcrossing structure is in background.

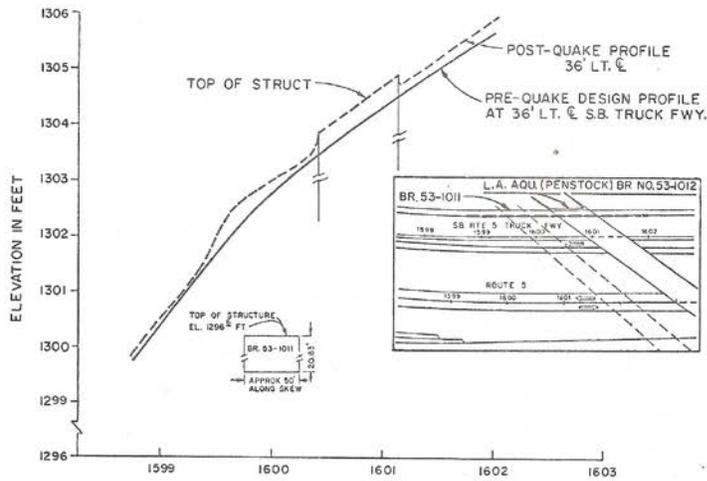
FIGURE 13

BEFORE AND AFTER QUAKE PROFILES
OF PAVEMENT SHOWN IN PHOTO 50.

Figure 3. Survey across structure showing rigid structure effect (Prysock and Egan, 1981).

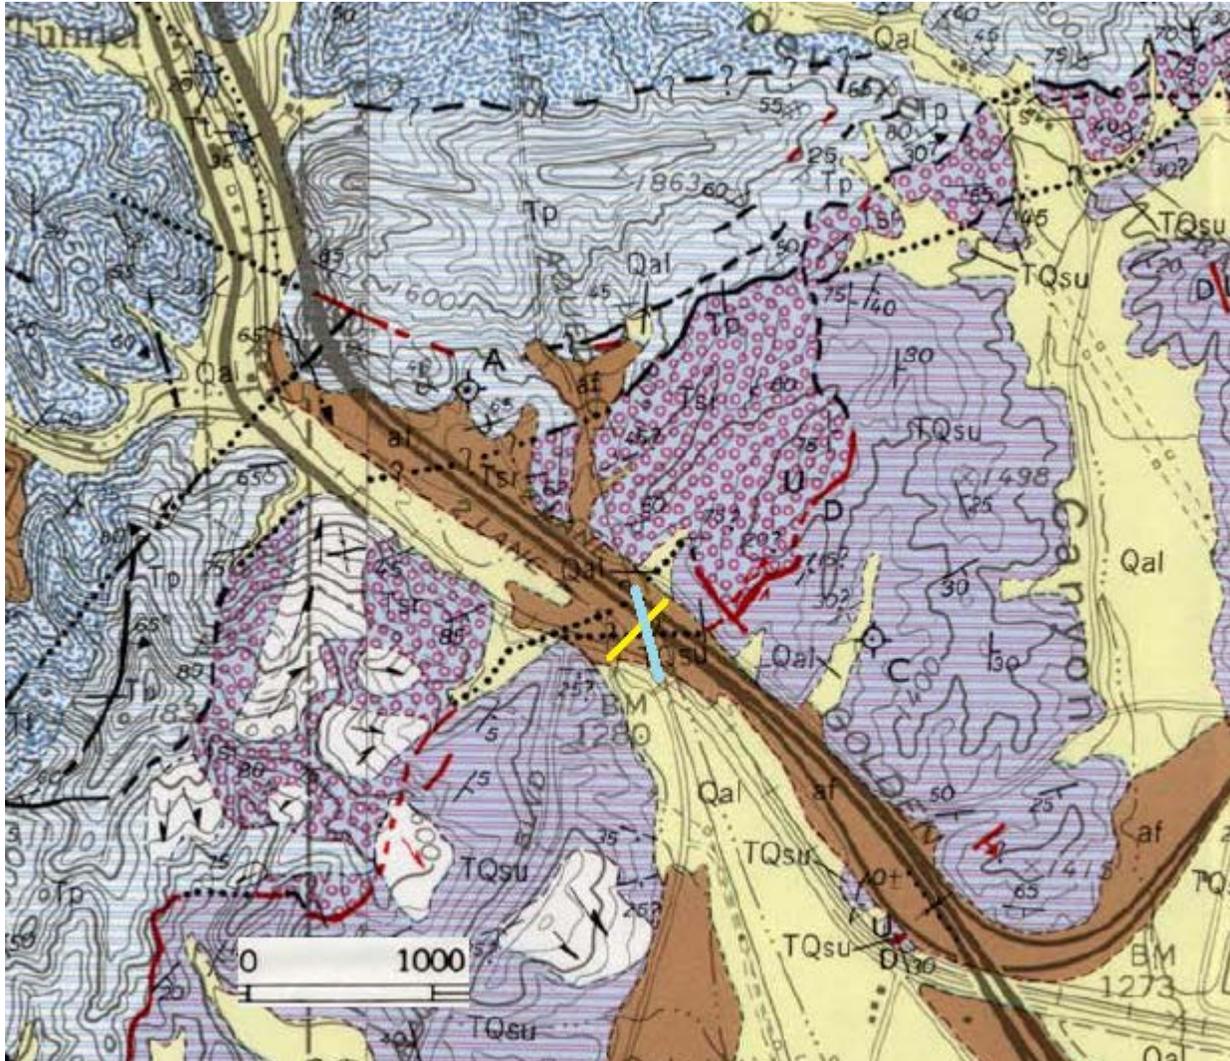
Figure 6, the geologic map, shows a concealed fault trace beneath the Bridge. Locations of concealed traces in this area are based on earlier mapping using oil industry data (Winterer and Durham, 1962). CGS connected the 1971 ruptures east and west of the freeway using this concealed trace. We consider the entire trace of the south branch to be active.

Figure 6. Geologic map of area. Blue line is Bridge and penstock location. Solid red lines represent positively identified/accurately located February 9, 1971 Earthquake fault ruptures. Black dotted lines represent concealed fault traces. U (upthrown block), D (downthrown block) (Barrows, 1975). Fault contact between the Tsr Saugus fm (Sunshine Ranch Member) on the north and the TQsu to the south.

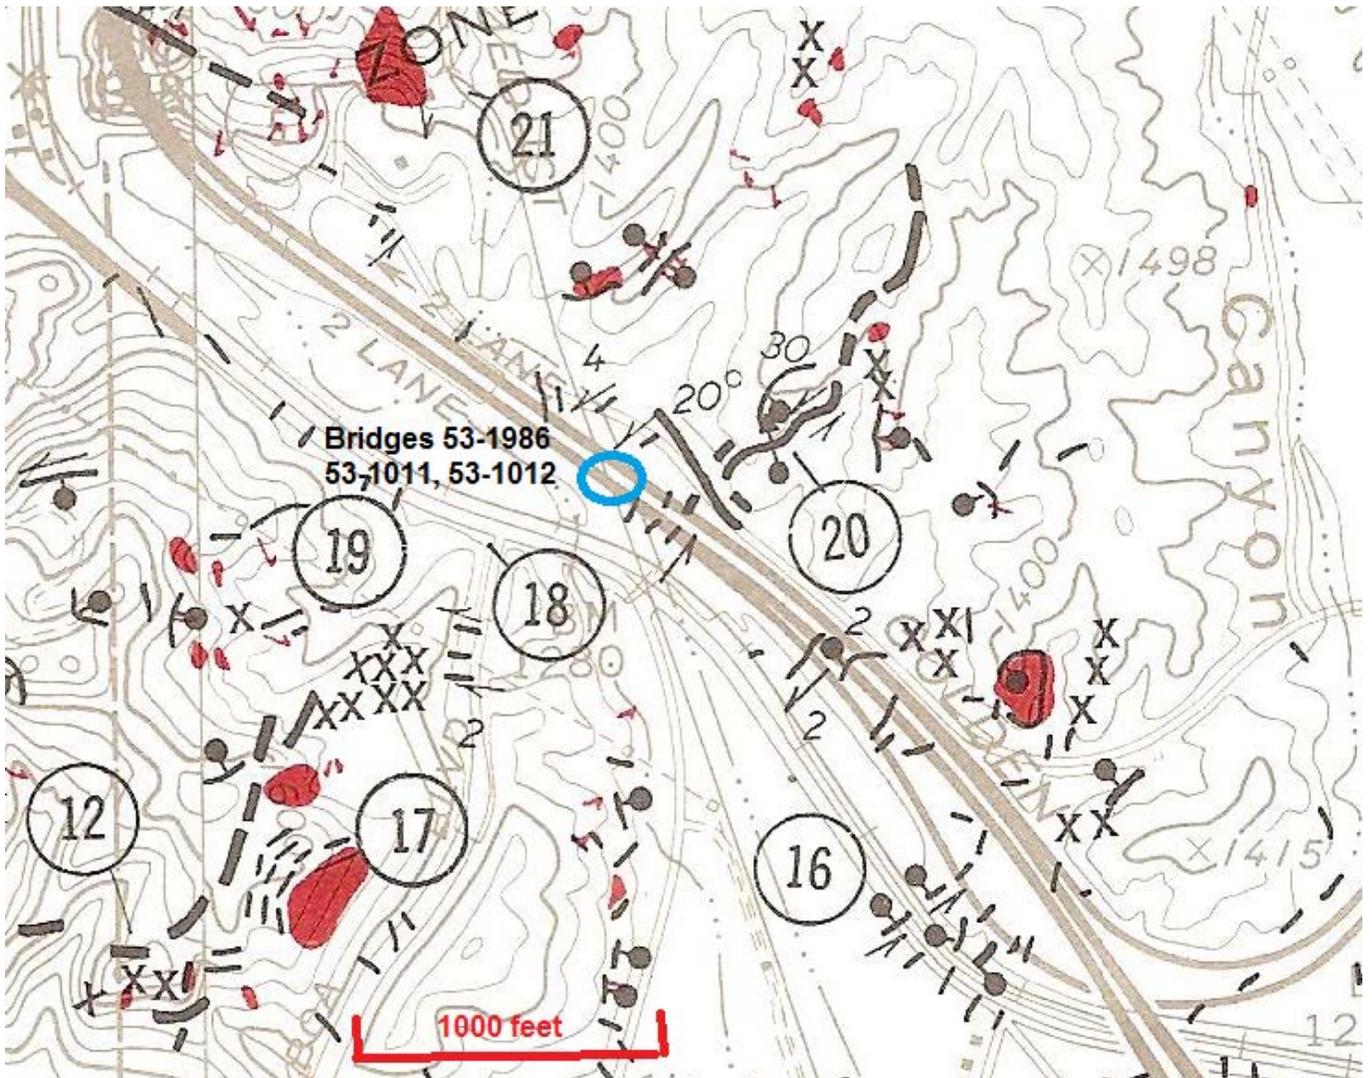
As much as 30 cm (12 inches) of lateral fault displacement was noted west of the Bridge on the south branch (Proctor et al, 1972). Vertical displacement on a single fault trace was not reported but likely the mole trace discussed above had some vertical displacement.

Figure 7. Location of 1971 San Fernando Earthquake surface cracks. (Barrows, 1974).

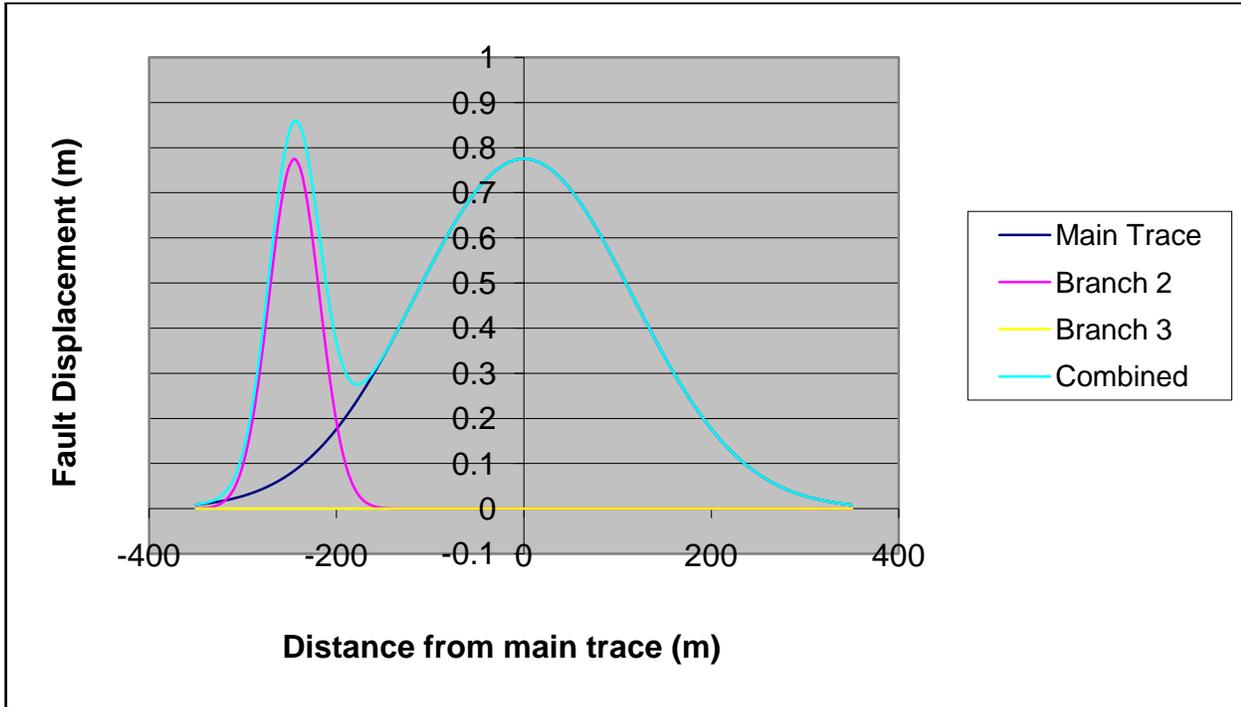
Results of the probabilistic analysis are shown in Figure 8. Probability of rupture is 0.38. Expected net fault rupture at the bridge is estimated at 0.775 meter (2.5 ft) probabilistically or 0.42 m (1.4 ft) deterministically. The probabilistic value should be used. The net probabilistic rupture can be separated into **vertical offset north side up of 0.63 m (2 ft) and horizontal movement toward the north of 0.44 m (1.4 ft). 0.3 m (1 ft) of offset in the lateral direction parallel to the bridge centerline should also be included in design.**

Figure 8. Results of PFDHA. The southern branch of the Santa Susana fault crosses beneath the bridge and is shown here as the “main trace.” That fault is weighted 50%. The northern branch of the Santa Susana fault is 245 m north of the bridge and is weighted 50% as well.
