Memorandum

File: 07-LA-14, PM 24.3
0000001016 6SSCN
Sierra Highway OC
Bridge No. 53-1013

Subject: Evaluation of Fault Rupture Potential, Sierra Highway Overcrossing, Los Angeles County

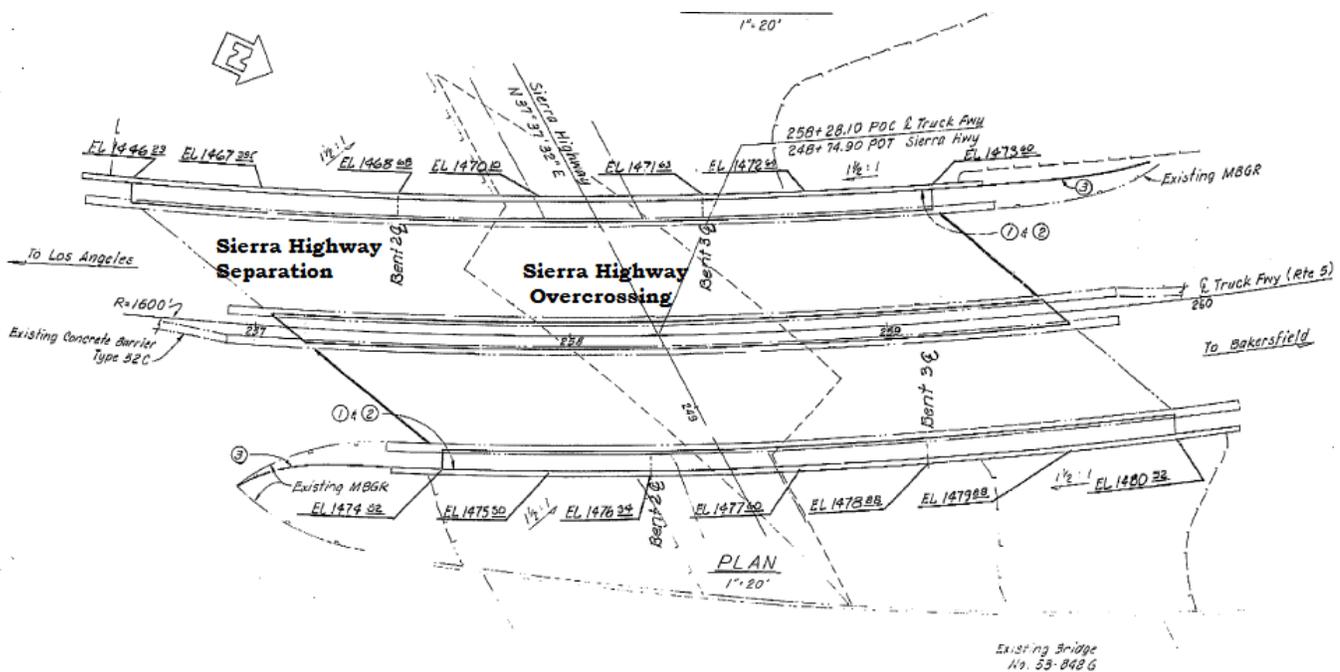
Sierra Highway OC was built in 1955 and is a single span bridge 124 feet long and 28 feet wide supported on spread footings. The OC is situated beneath Sierra Highway Separation (Br. No. 53-0848; addressed separately), and crosses over an abandoned ramp of Route 14 (Figure 1).

Figure 1. Sierra Highway Overcrossing lies beneath Sierra Highway Separation (53-848) and crosses an abandoned ramp of Route 14.

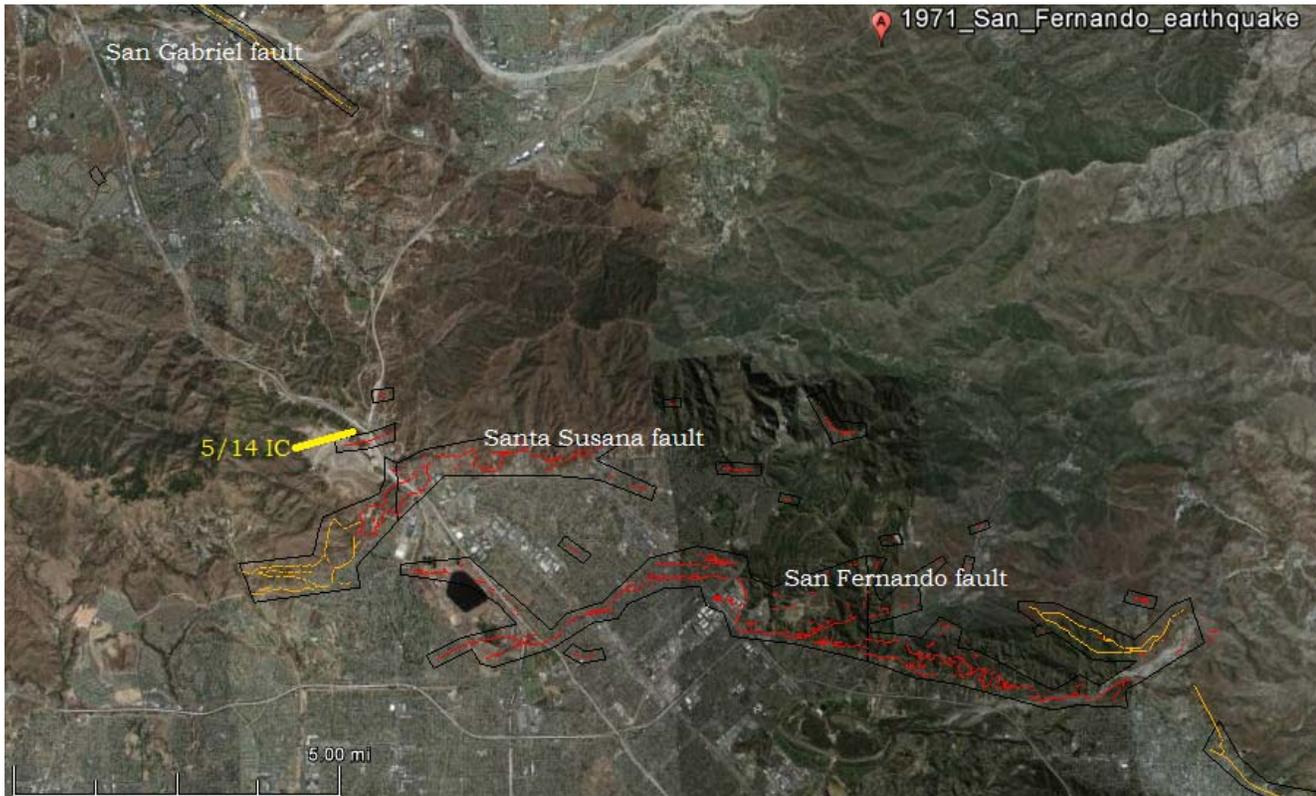
The Santa Susana fault (Figure 2) is part of the Sierra Madre fault zone and is historically active with the most recent rupture occurring in 1971. The Sierra Madre fault zone extends from the hills north of Simi Valley to north of San Dimas, and consists of several different faults distinguished by differences in orientation and age. The expected maximum magnitude earthquake for the Santa Susana fault is M6.8 (USGS, 2008) and slip rate is 6 mm/yr (Dawson and Weldon, 2012). The fault is reverse dipping about 55 degrees to the north, and sinuous in nature.

Figure 2. Area fault map.

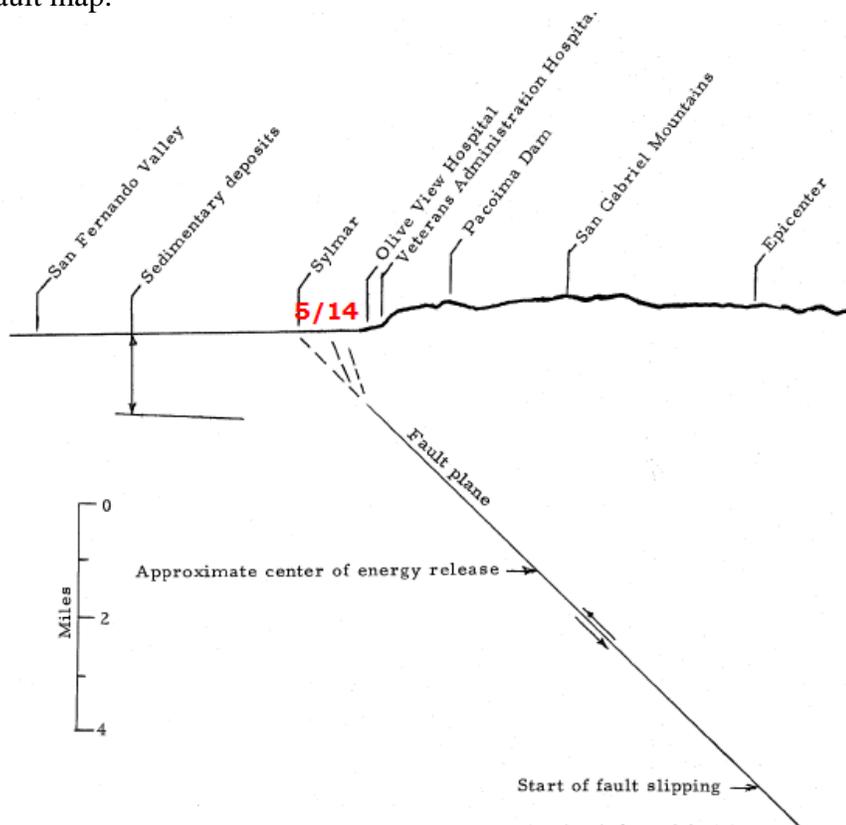
Figure 3 Schematic N-S cross-section showing inferred faulting.

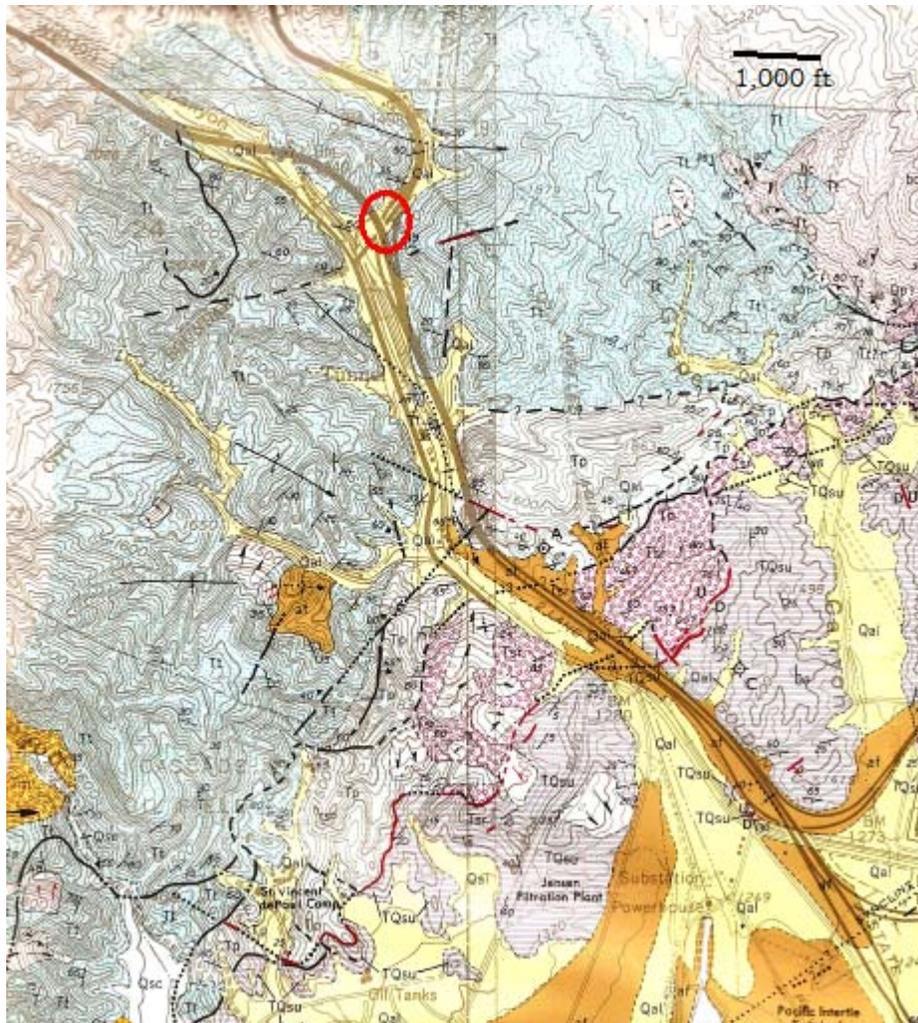
The February 9, 1971 M6.7 San Fernando (or Sylmar) earthquake damaged or destroyed many of the structures in that region. Figures 2 - 4 and literature reports (e.g., Sharp, in Oakshott, 1975) indicate that the majority of displacement during the earthquake occurred on primary traces of the Santa Susana and San Fernando faults. Although damage to the 5/14 Interchange was severe, as can be seen from Figure 3 these structures were on the hanging wall of the main fault and therefore subject to magnified shaking. Sierra Highway OC sustained no damage during the earthquake, whereas the bridge situated over the OC, Sierra Hwy UC (53-848L/R) had both

Figure 4. Mapping completed in 1971 by Barrows et al (Oakshott, 1975). 5/14 Interchange is circled in red. Small portion of eastern trace near the I/C is red indicating 1971 rupture or ground crack. Main traces of Santa Susana fault are shown south of the OC.

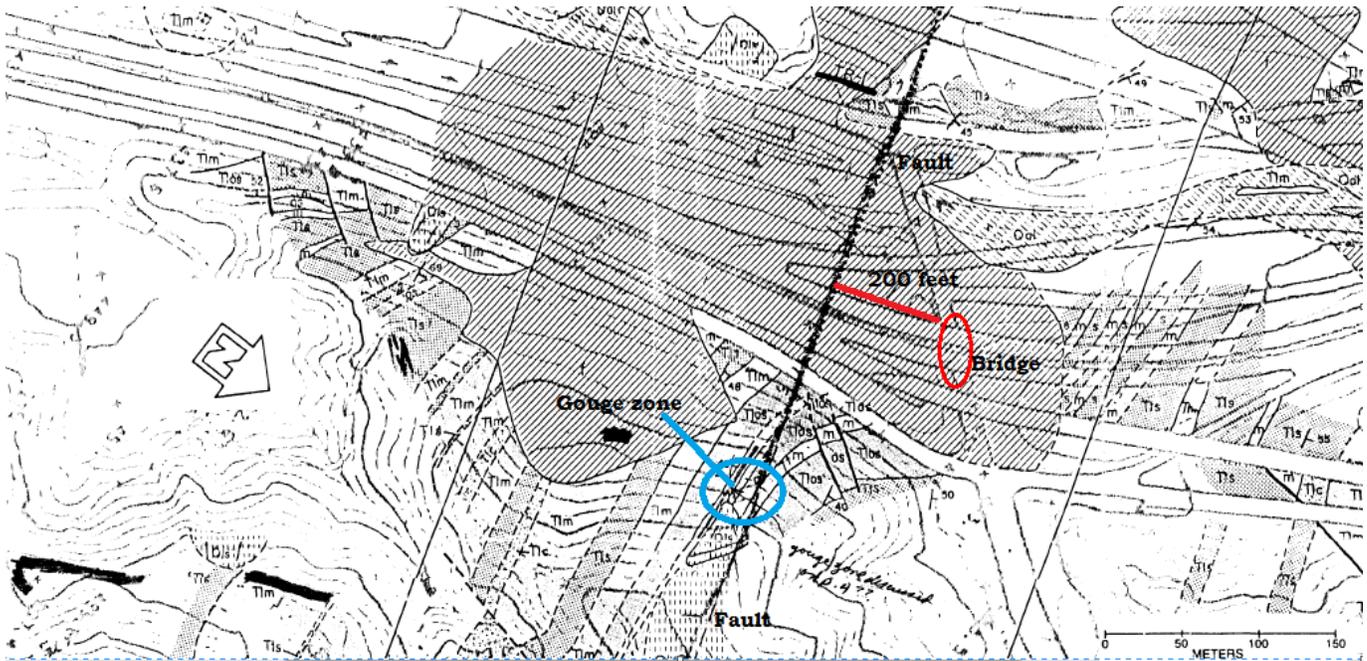
A fault evaluation was carried out by Caltrans geologist Tim Beck and others (1994) for the entire 5/14 Interchange. Detailed mapping led to the conclusion that the features south of the interchange that were mapped as faults were actually landslide scarps, with the gouge zone (Figure 5) representing a preferential slip plane. Caltrans noted this conclusion in a cover letter for the report to Earl Hart, CGS geologist in charge of the Alquist-Priolo (AP) Special Studies program. CGS geologist R. Saul (in Oakshott, 1975; cited in T. Smith, 1977) similarly indicated that the apparent faults were likely expressions of landslide scarps. Mr. Hart indicated that more work would be needed to eliminate the zone. A trench excavated for the Caltrans study failed to reach natural ground and no faulting was observed. No further work has been undertaken near the 5/14 Interchange.

Figure 5. Overcrossing is within red circle, north is to right. Stippling denotes fill; alternating solid light grey and white denotes continuous or slightly offset sandstone and shale beds. Short thick black lines denote ground cracks from 1994 Northridge earthquake. Long thick black line trending east-west denotes EFZ fault trace, located about 230 feet south of OC. EFZs are lines parallel to fault and on either side. Evidence of faulting found in Caltrans mapping is south of the mapped fault within the blue circle (Beck, 1994).

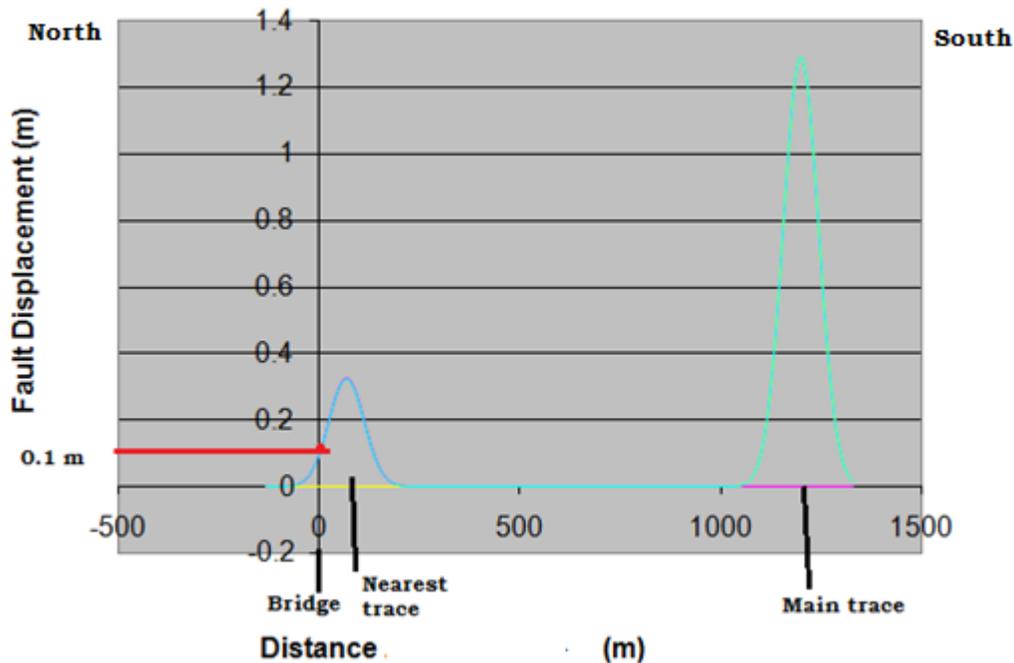
Based on the above observations, the potential fault mapped 230 feet south of the OC is at most a secondary trace of the Santa Susan fault and actually may not be a fault at all. Because the fault could not be definitively located, a probabilistic evaluation of fault rupture was performed per Moss and Ross, 2011 (Figure 6). Based on that evaluation, potential fault rupture at the OC is estimated at 0.1 m or 4 inches.

Figure 6. Four inches of displacement at OC (assumed 80% on main trace; 20% on nearest trace).

No additional work is recommended at this time.
