1. REPORT NO. FHWA/CA/TL-80/16		2. GOVERNMENT ACCESSION NO.		3. RECIPIENT'S CATALOG NO.	
4. TITLE AND SUBTITLE THE EFFECTIVENESS OF HORIZONTAL DRAINS				5. REPORT DATE June 1980

THE EFFECTIVENESS OF HORIZONTAL DRAINS

Study Made by ..... Engineering Geology and  
Technical Services Branch  
Under the General Direction of ..... Robert W. Reynolds, CEG  
Under the Supervision of ..... Marvin L. McCauley, CEG  
Principal Investigator ..... Duane D. Smith, CEG  
Report Prepared by ..... Duane D. Smith, CEG

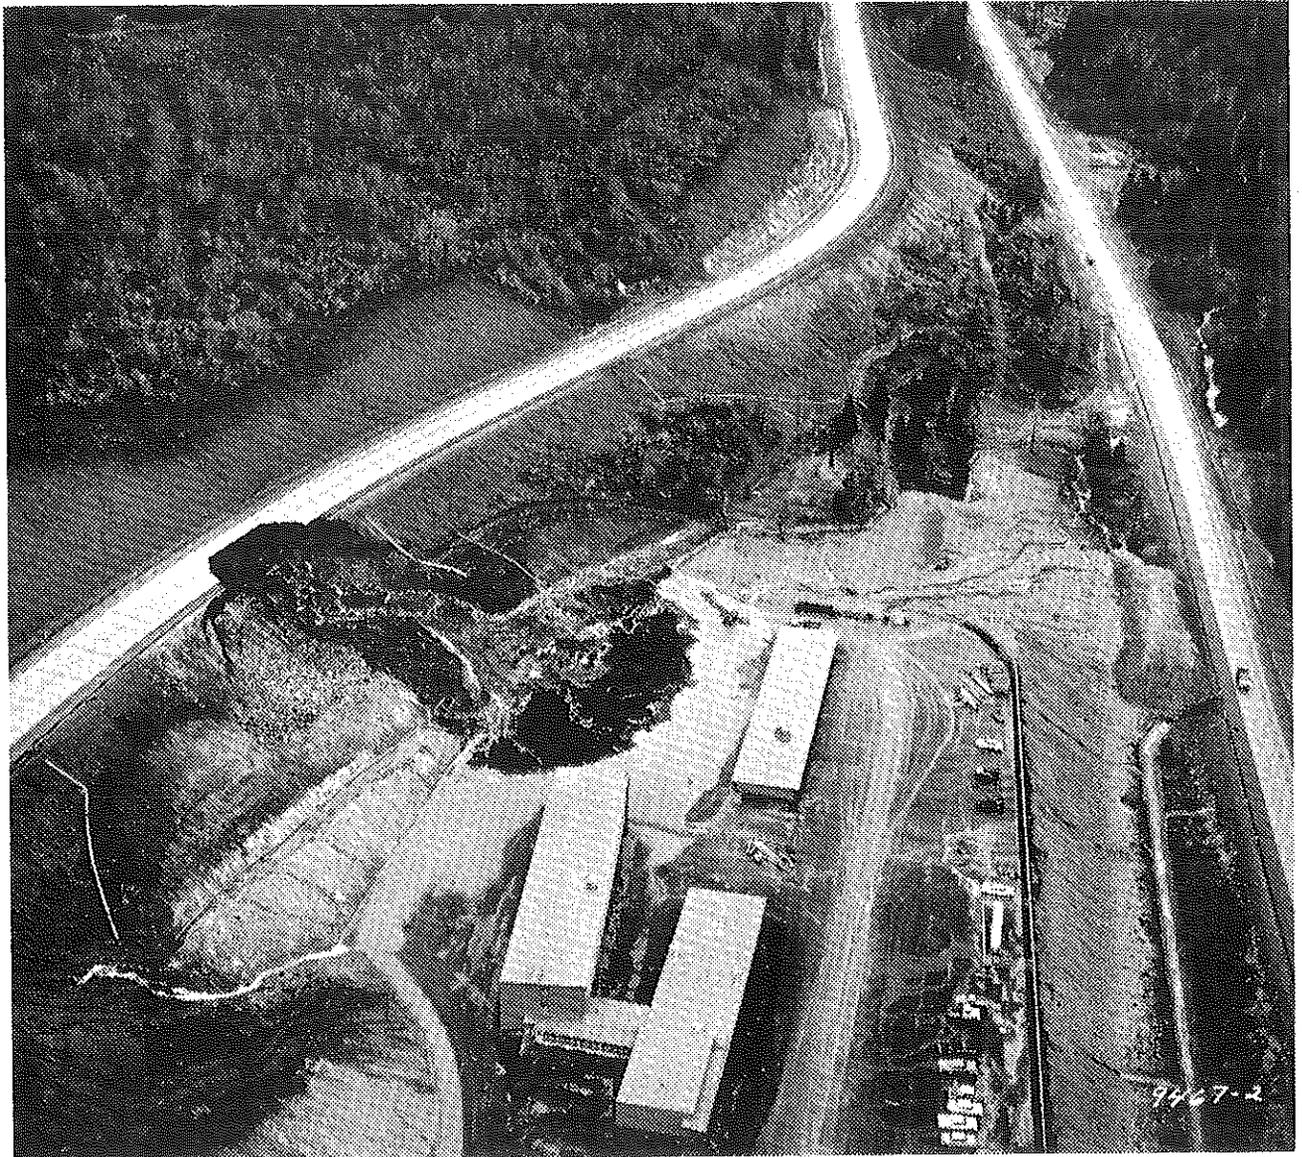
One of the slipouts was located directly above the maintenance station (Figure 4), while the other was located approximately one mile west of the maintenance station (Figure 5). All three lanes were affected by the failures, and traffic was rerouted over the westbound lanes.

Figure 4. Embankment failure at Whitmore Maintenance Station, February 1963.

Correction of the two failures consisted of stripping and removal of all failed debris, placement of permeable blankets over the foundations, replacement of the compacted embankments and the installation of horizontal drains.

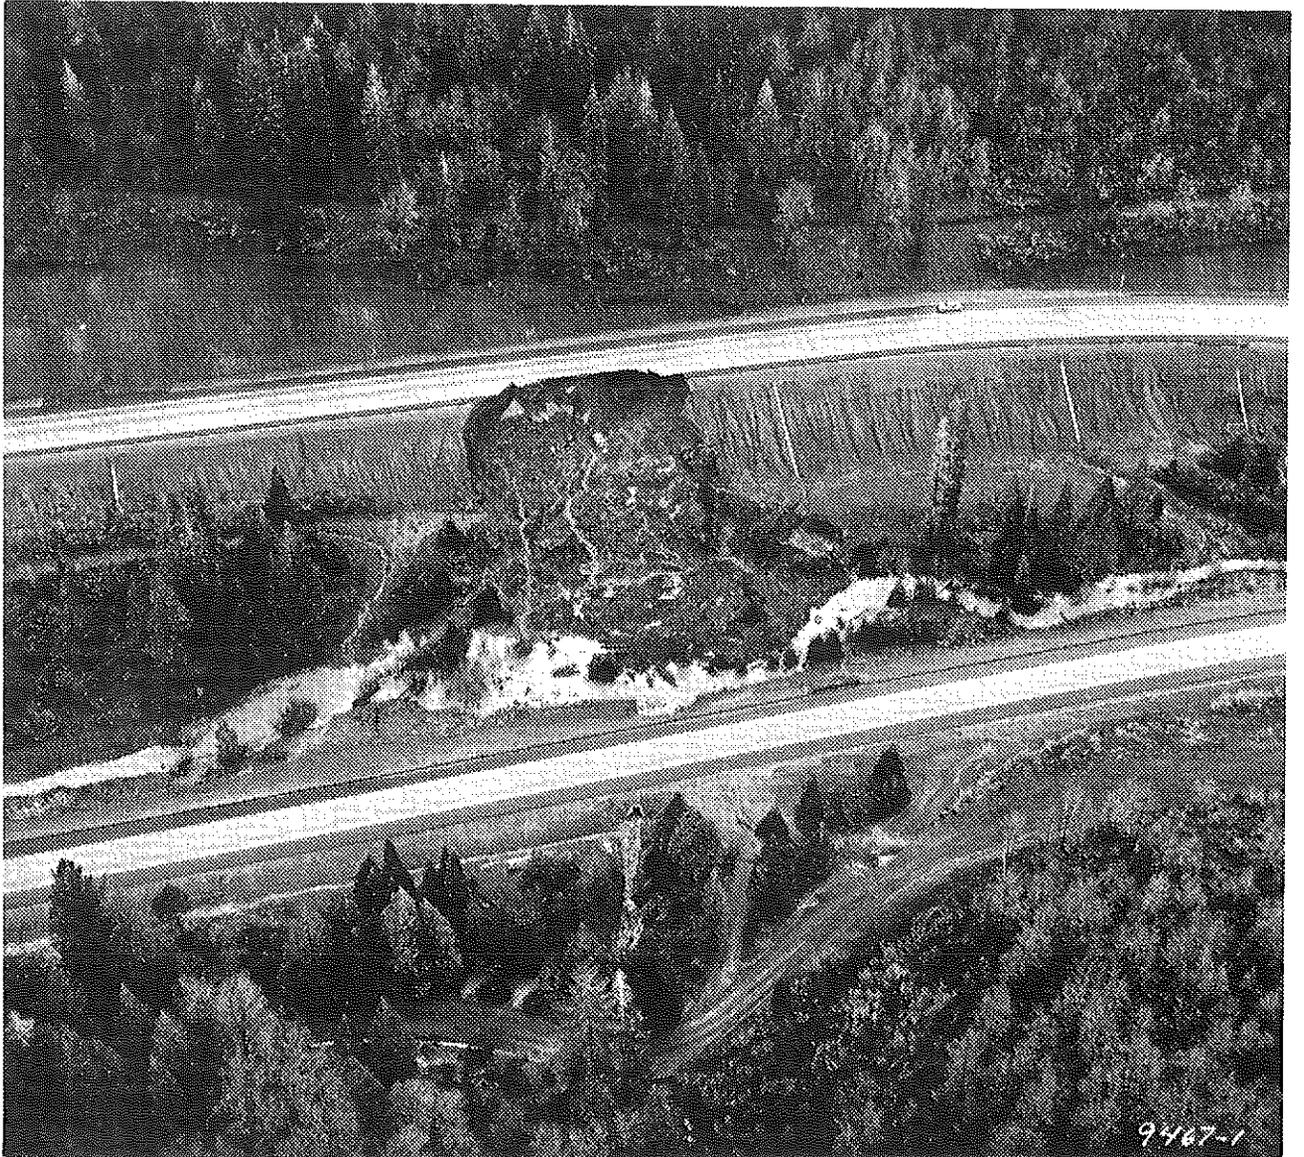
Figure 5. Embankment failure west of Whitmore Maintenance Station, February 1963.

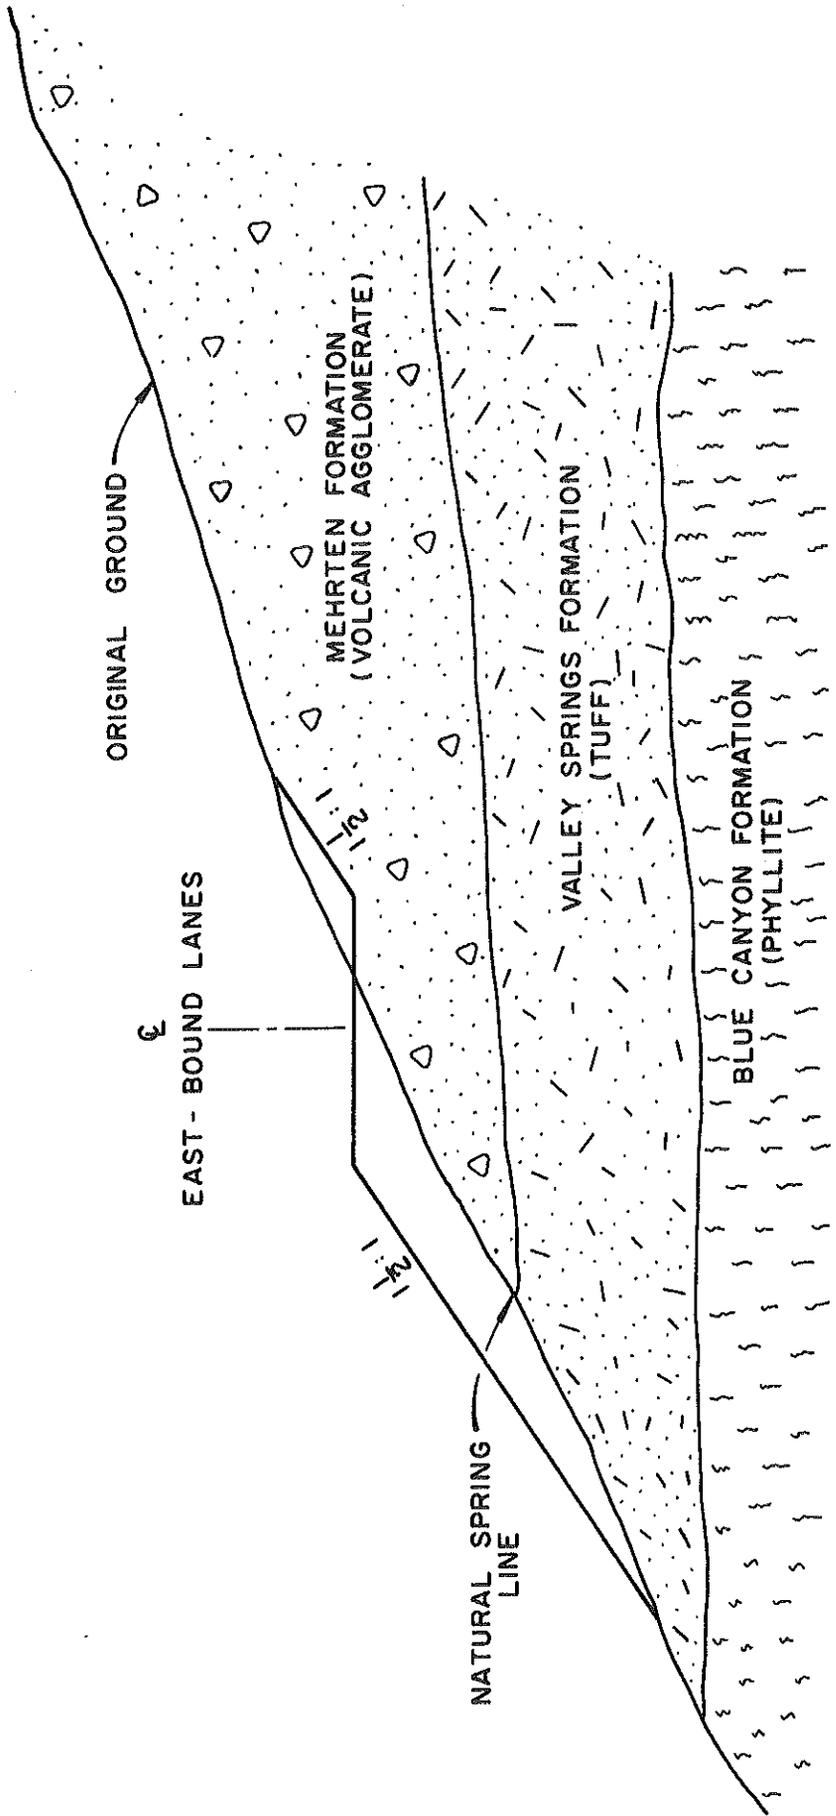
IDEALIZED GEOLOGIC CROSS SECTION AT WHITEMORE MAINTENANCE STATION  
 FIGURE 6

The contact between the agglomerate and tuff is characterized by an undulating plane which dips gently to the north or into the roadway (Figure 6). A natural spring line had developed over the years where water which had percolated through the Mehrten formation and then moved downslope along the interface of the two materials had surfaced where topographic relief had exposed the dipping plane. Placement of the side-hill embankments over this natural drainage feature restricted the groundwater movement, resulting in a buildup of head which was relieved when the saturated embankments failed and began to move downslope.

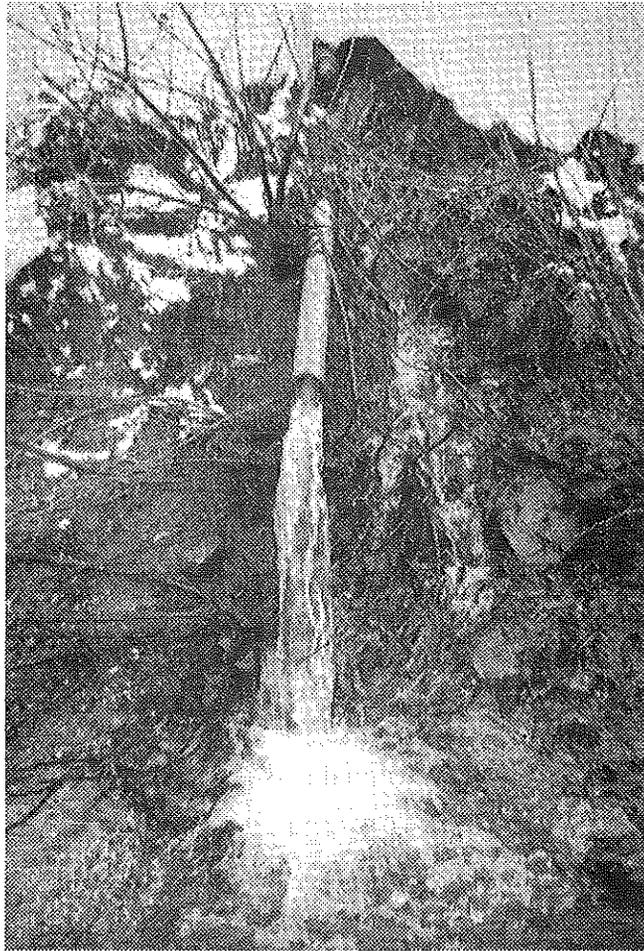
No distress of the roadway or embankments has been noted since their reconstruction and installation of the horizontal drains. Astounding amounts of water are observed flowing from the drains each winter (Figures 7 and 8). Total flows from the drains during the wet season are well in excess of one million gpd.

Figure 7. Whitmore drain flowing at capacity after 15 years service (photo 1978).

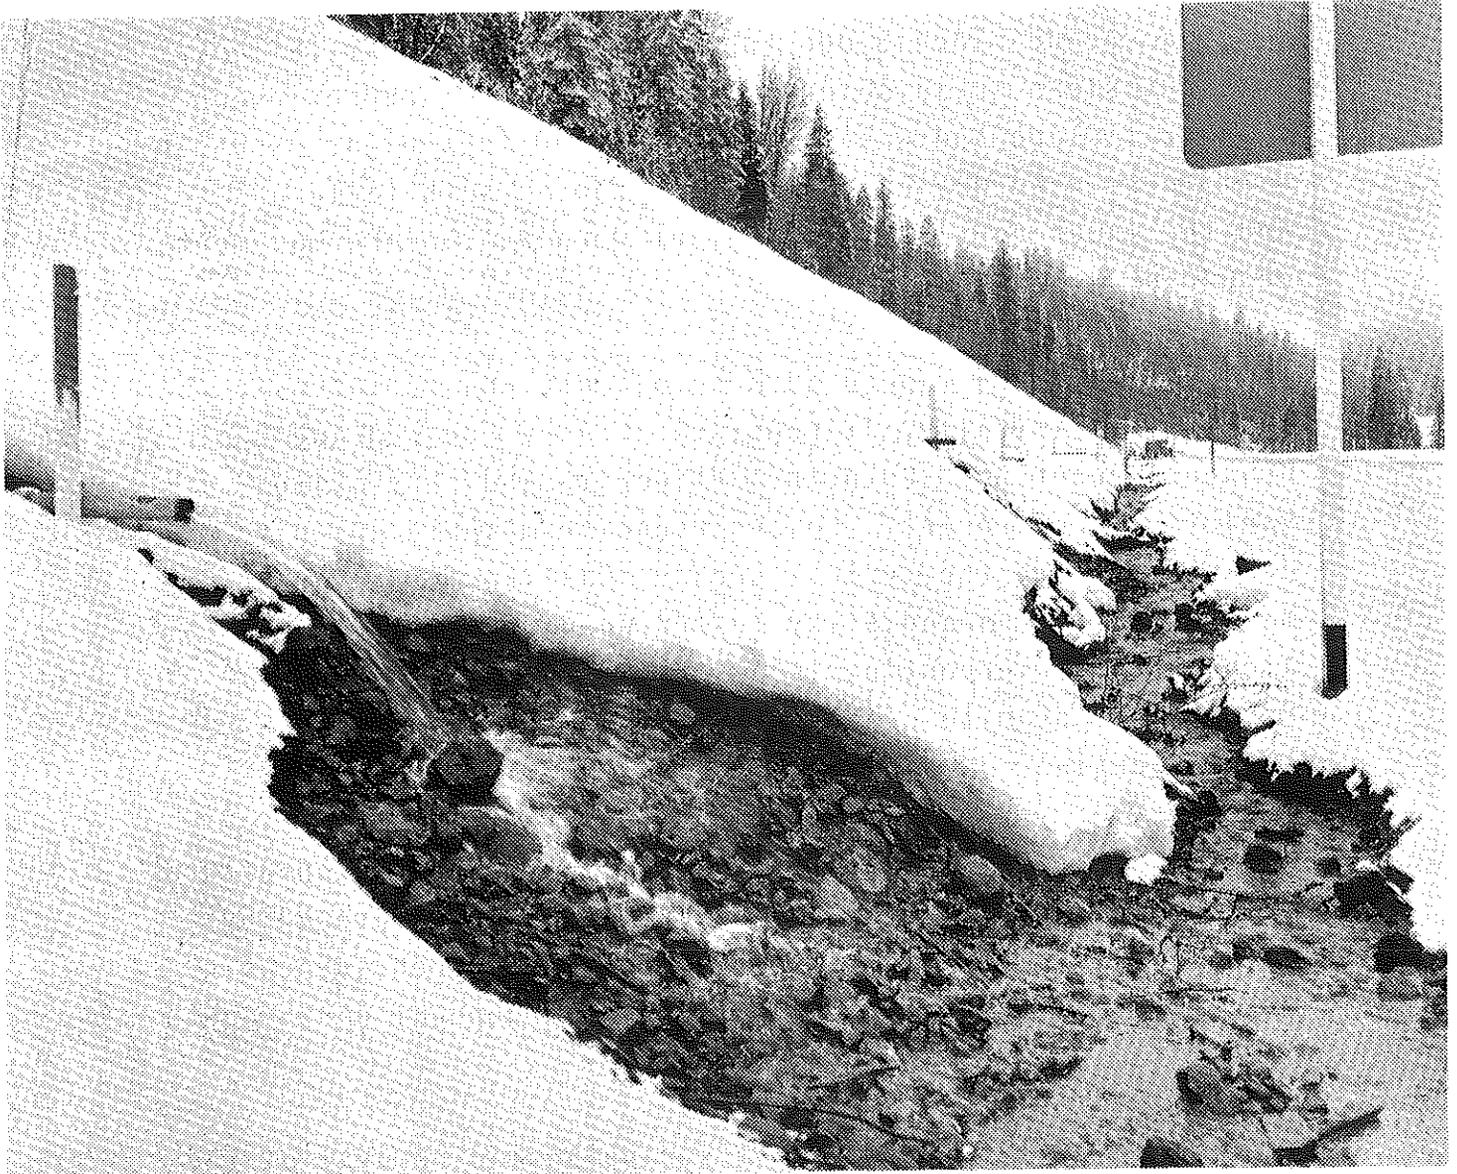
Figure 8. Typical winter flow of 17 year old drains at Whitmore Maintenance Station.

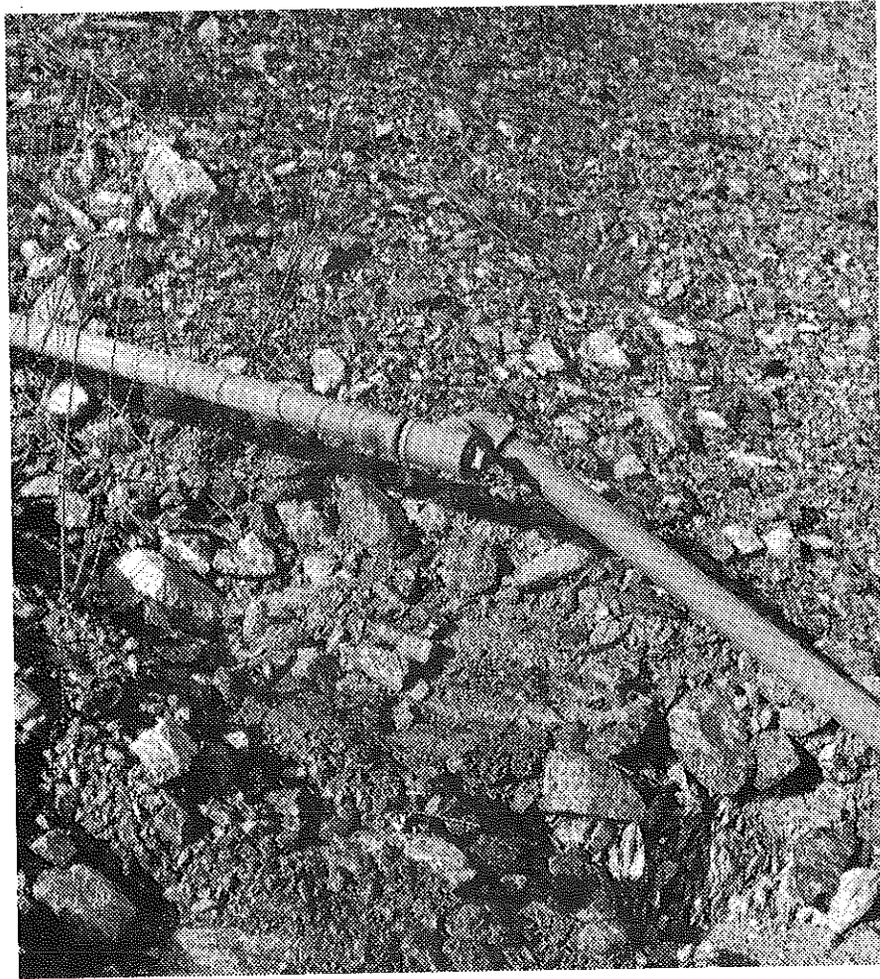
Because of the extremely sheared, foliated and broken nature of the rock, the surface of the cut slopes are covered by loose cobble and pebble size pieces of weathered serpentine (Figure 9). In-place outcrops suggest a general north-south orientation of the foliation.

Figure 9. Serpentine cut slope of San Andreas installation.

Slide corrections consisted of stripping and removal of the failed debris, laying back the slopes on a 2:1 ratio in the areas of movement and installing horizontal drains.

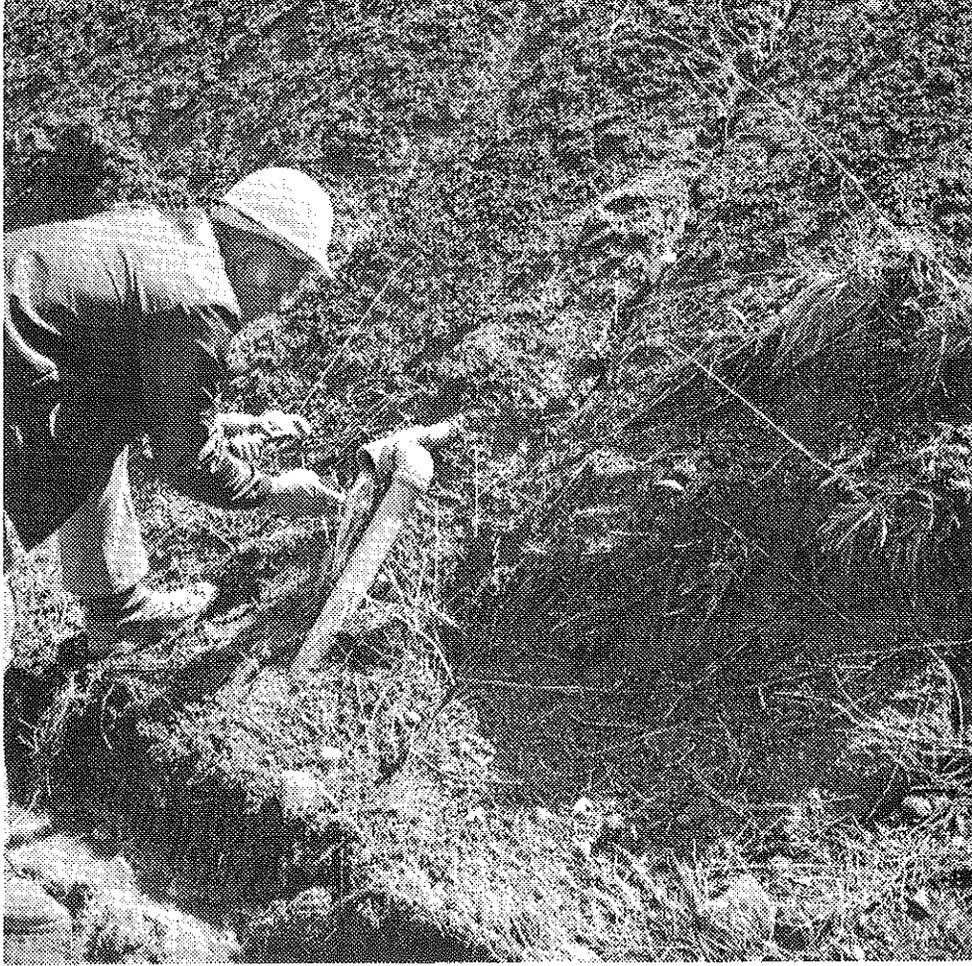
Ten horizontal drains were installed in late October and early November of 1969 (Figure 10). The drains ranged in length from 156 feet to 213 feet. Grades varied from 2 to 4 percent. Schedule 80, 1-1/2 inch diameter PVC casing

Figure 10. Pacific House. Examination of the first PVC drain casing installed in California. Photo March 1980.

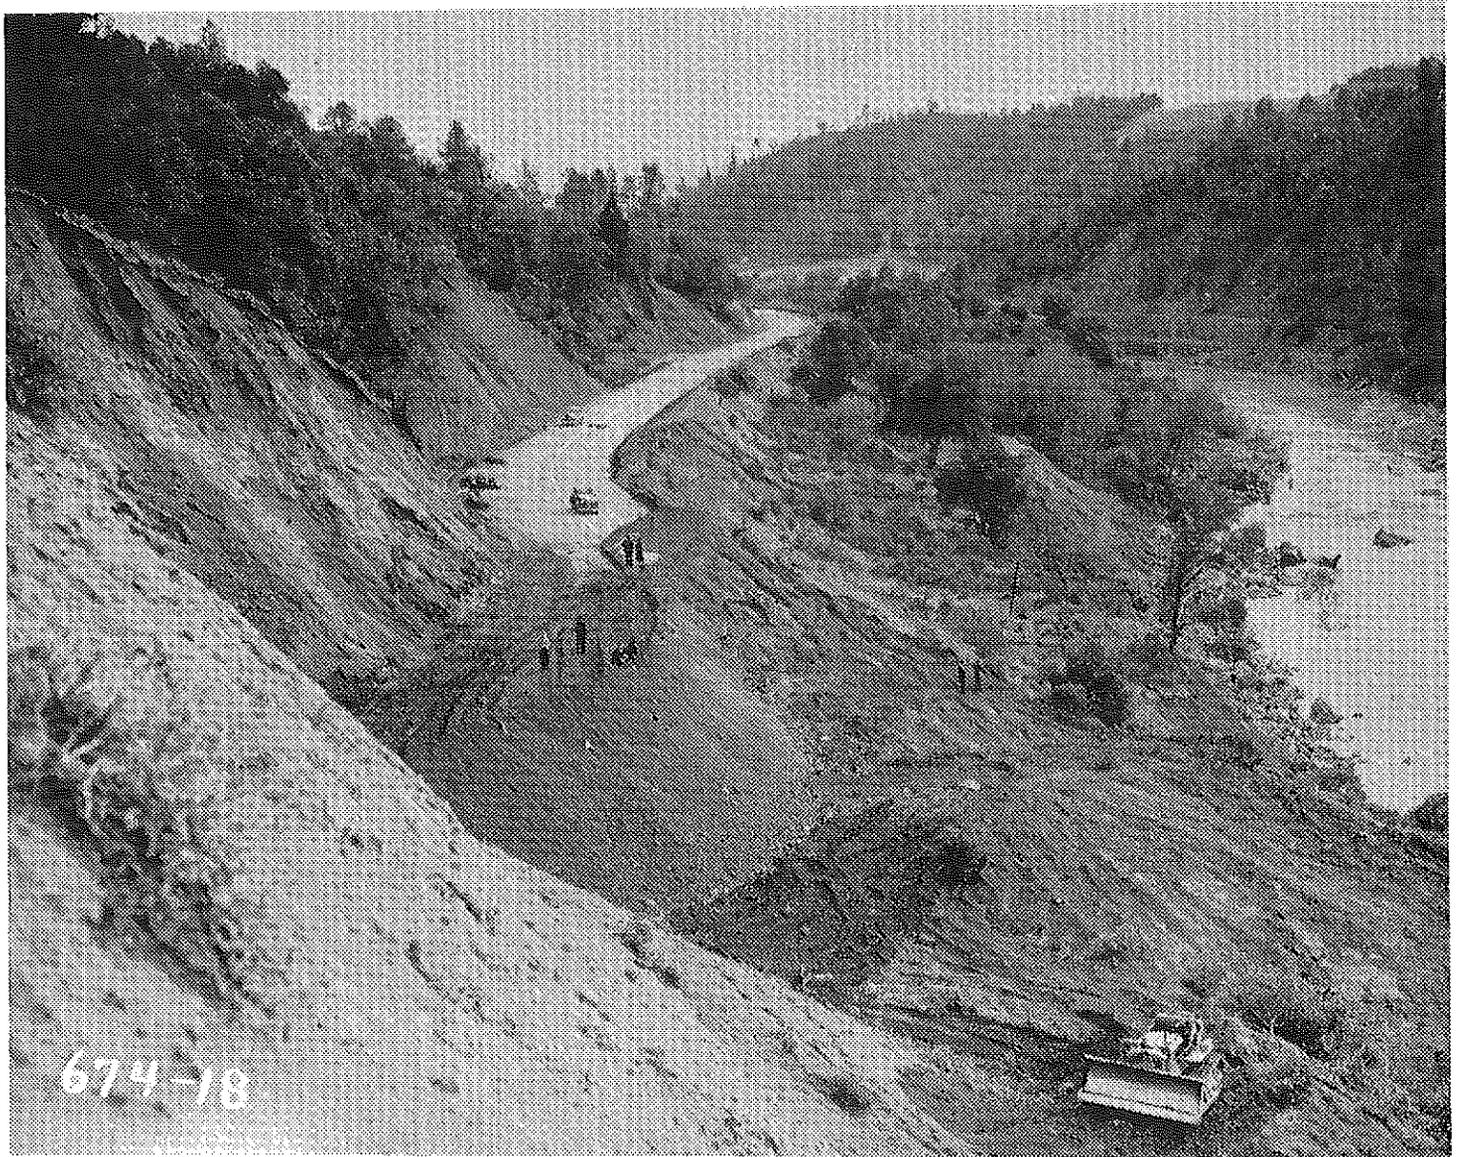
During extremely heavy rainstorms in February of 1941, a large landslide occurred on Highway 101, near Cloverdale, 90 miles north of San Francisco. Portions of a high cut slope and side-hill embankment in poorly bedded, sheared shale with minor lenses and beds of sandstone slid into the Russian River, severing approximately 1,100 feet of the roadway (Figure 11). Large quantities of water in the form of springs and saturated slide debris were associated with the failure.

Figure 11. Cloverdale Landslide, February 1941.

Corrective measures included a benched 1-1/2:1 cut slope and a reconstructed 2:1 embankment slope. Between March and June of 1941, 97 horizontal drains were installed using the "Hydrauger" equipment with 2-inch perforated steel casing placed in 4-inch drilled holes. The loose, broken

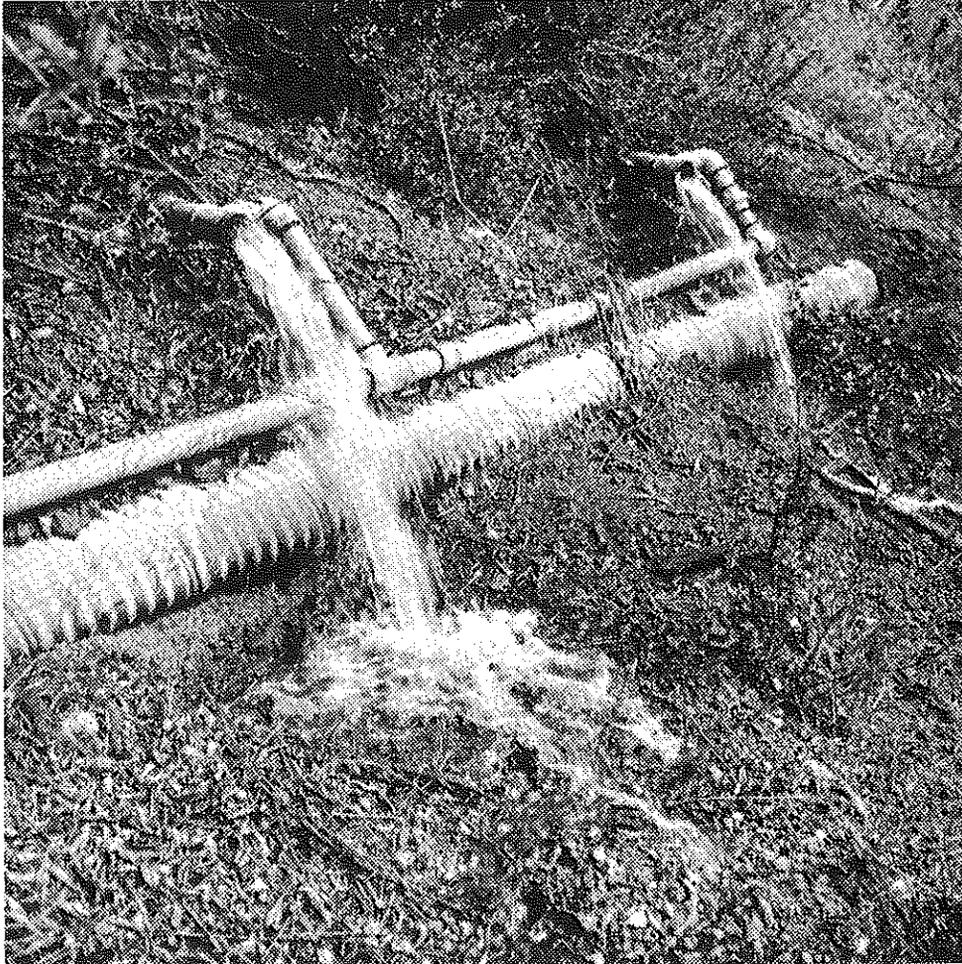
During October of 1956, 11 additional horizontal drains with an average length of 125 feet were installed in a slipout immediately south of the original failure. Initial flows totaled 261,989 gpd. More drains were recommended at that time to stabilize the large cut area. In 1959 these drains were installed by contract. Unfortunately, there is no record of the number of drains in this installation or their performance (Figure 12).

Figure 12. Cloverdale drains and collector system installed in 1959. Photo taken in March 1980.

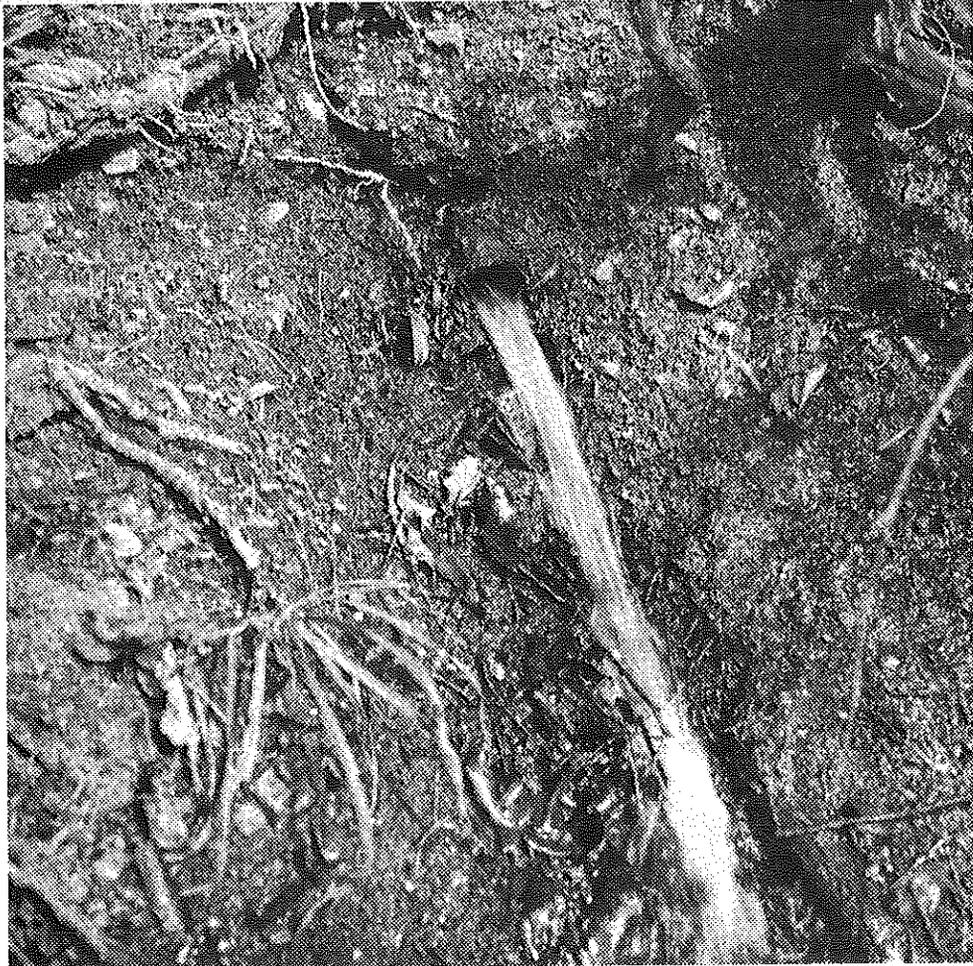
In 1974 the installation was again evaluated. Of the 147 drains examined, approximately 40 percent had flows. Many of the original drains installed 39 years ago were still functioning, one of which had a flow of 36,000 gpd. Most of the steel casings were severely rusted (Figure 13). Root growth from willows and other native plants had clogged many of the drains and the 8-inch collector system. Sloughing of the weathered slopes has buried many of the drain outlets on both the bench and at grade (Figure 14).

Figure 13. Rusted outlet of drain installed at Cloverdale in 1941. Photo taken in March of 1980.

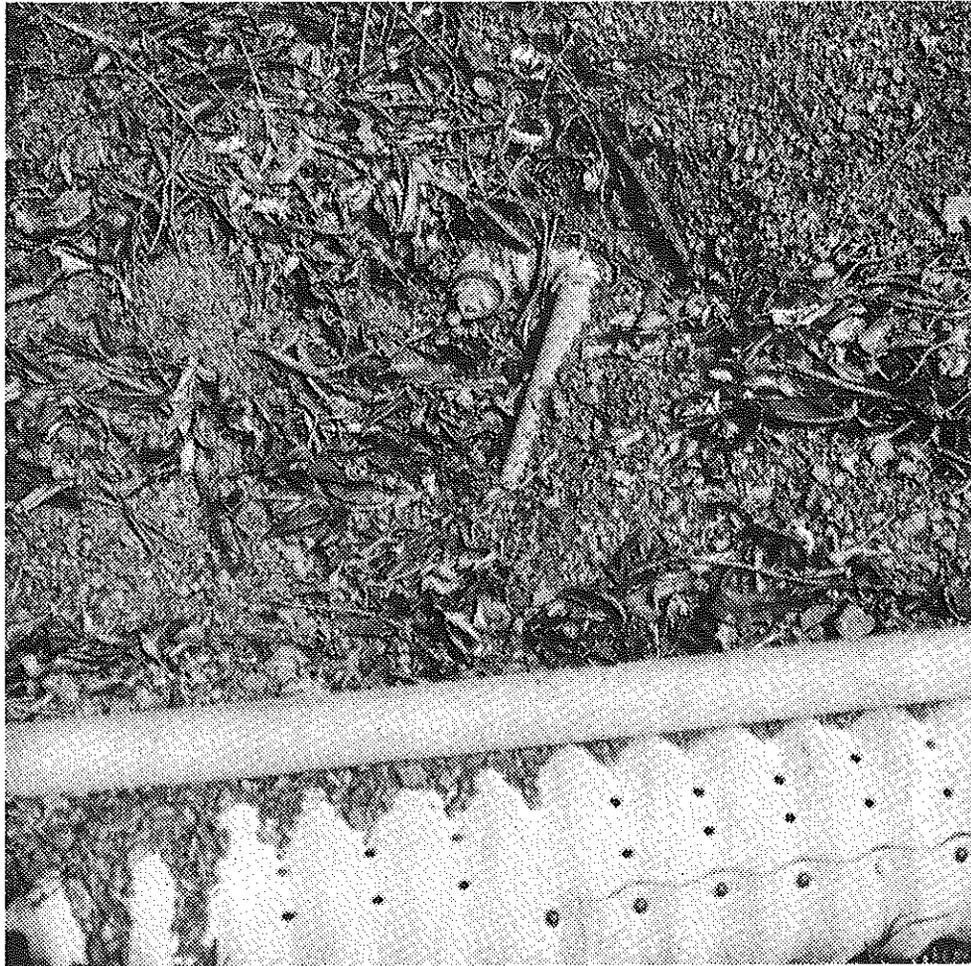
Figure 14. Buried drain at Cloverdale which was uncovered in 1974. Photo taken in March of 1980.

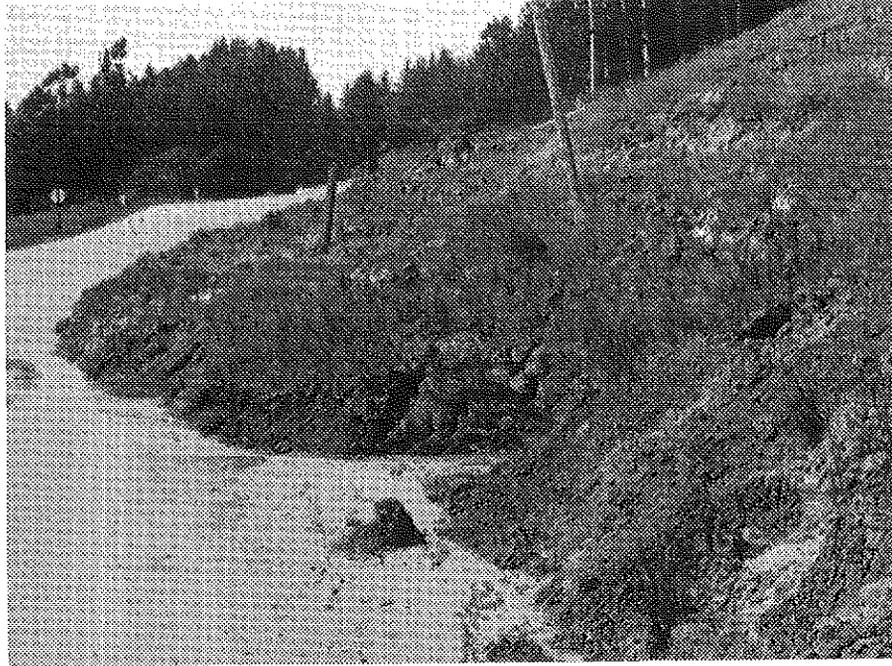
Drilling was very difficult. Initial attempts were totally unsuccessful for two major reasons. First, when the Aromas sands become wet, the original structure collapses and the sand "melts" and begins to flow (Figure 16). When drill rotation was stopped in this material, the pump shut off and the stem broken for the purpose of adding an additional section of new drill rod, the sand slurry would flow into the drill rod through the open drill bit, packing the entire string of drill rod. When drilling resumed, it was impossible to force the packed sand out of the drill rod and regain circulation of drill fluid.

Figure 16. Flow of Aromas sand across frontage road at La Selva Beach.

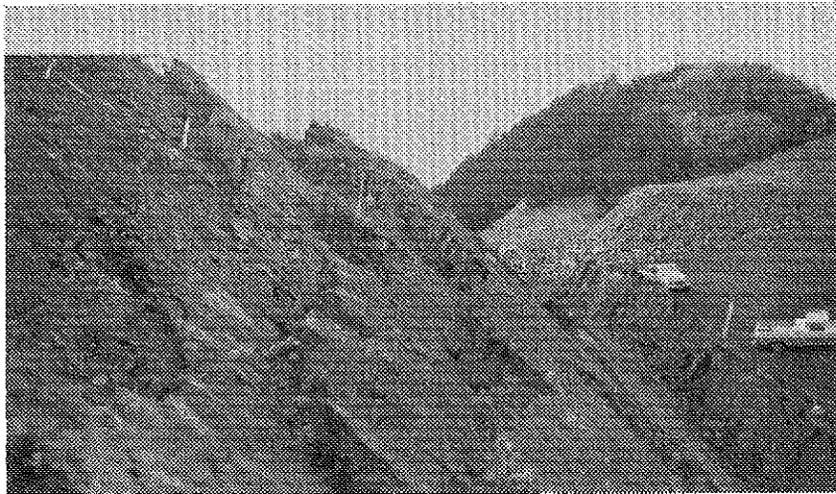
The initial failure occurred low on the cut as a shallow arcuate-shaped slump in highly sheared and broken black clayey gouge-like material. Extensive cracking then developed above the slump in thinly bedded shales and sandstone which dip steeply into the cut face. The cracks were roughly parallel to the roadway and occurred along the strike or trend of the sediments. As the lower portion of the slope was displaced toward the roadway, the overlying beds tilted toward the open cut. This movement developed along clayey bedding planes and was progressive in degree of displacement and distance from roadway (Figure 17). A significant reduction of lateral support by excavation, coupled with the introduction of surficial rainwater along clayey bedding planes greatly reduced the shear strength along these planes resulting in progressive cracking and

Figure 17. York Mountain failure during construction.  
November 1970.

block tilting. Groundwater was not evident at any time and did not appear to be a factor in the failure at that time.

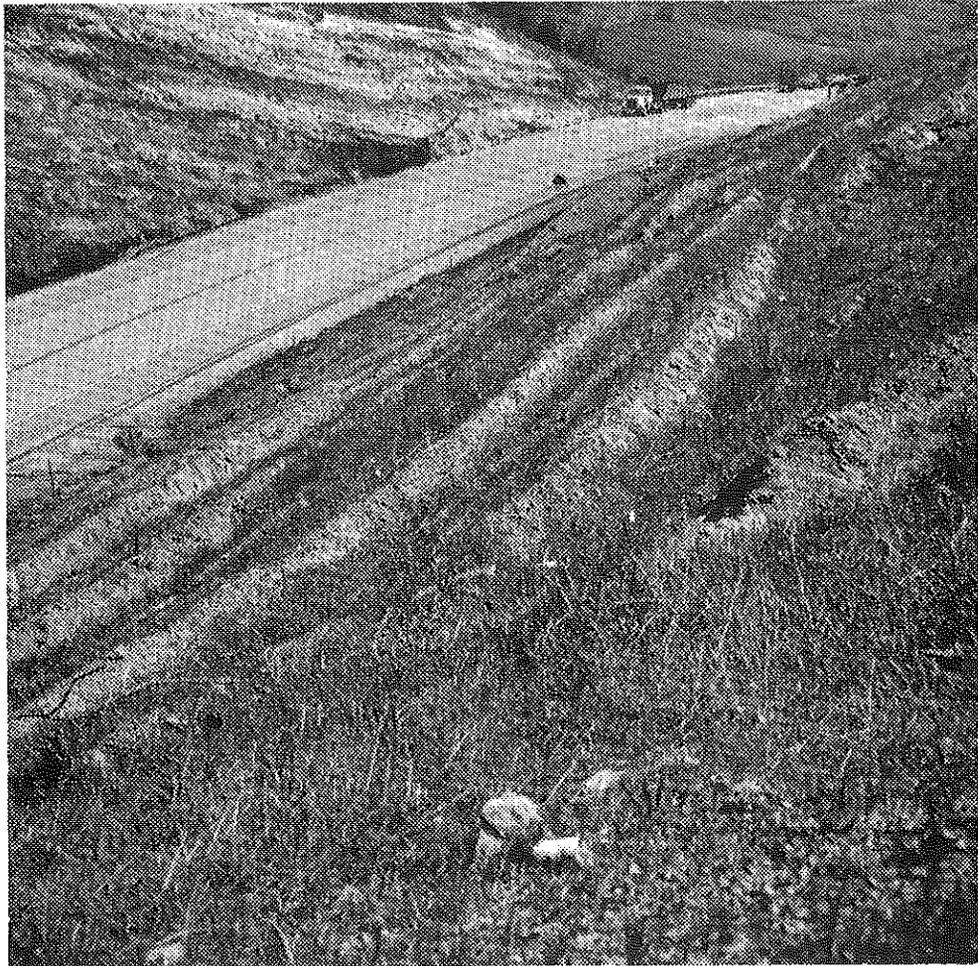
Figure 19. Progressive tilting of shale beds  
into roadway at York Mountain.  
Photo March 1980.

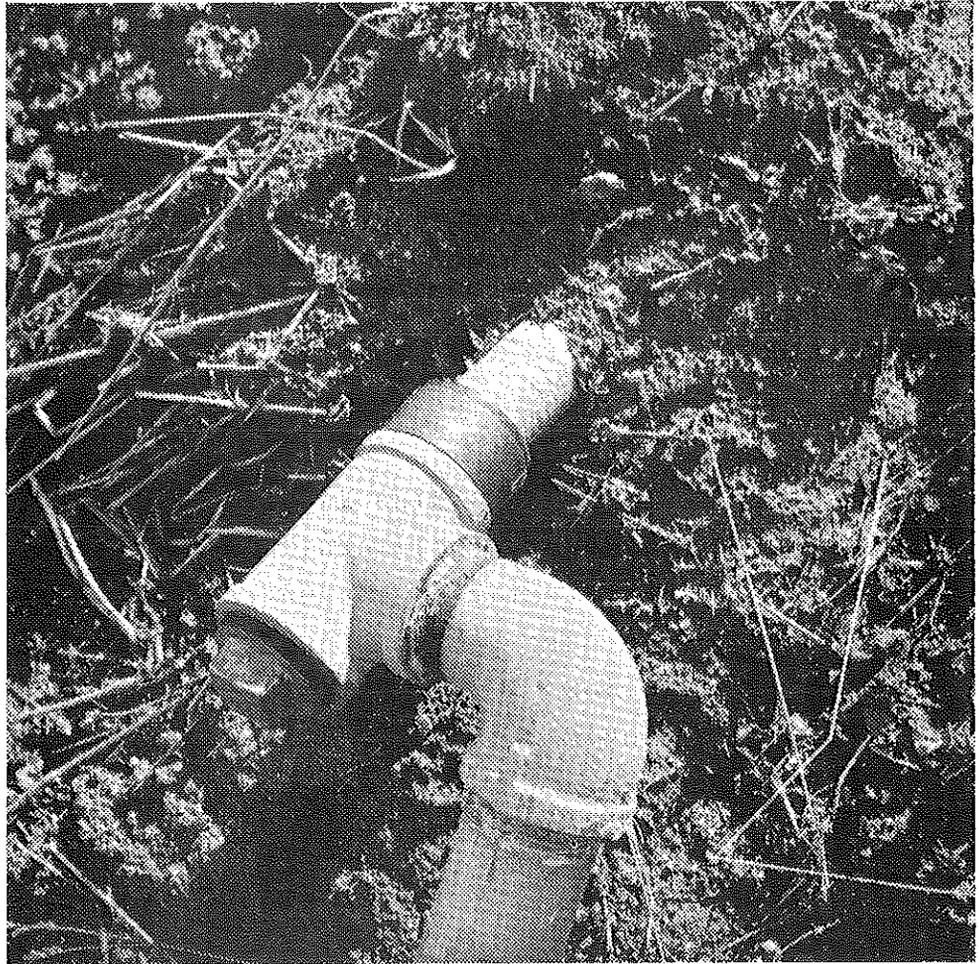
The Pacific House installation was selected for the research study because of this unique situation and because it is one of only a few that have been installed in granitic material. A field inspection of the 11 year old PVC showed that it is in excellent condition and should perform well for many more years. Slotted sections were used throughout the entire length of the drains allowing willow roots easy access near the outlet (Figure 20). The drains need cleaning, and a protective sleeve of galvanized pipe should be put over the outer 10 to 20 feet of drain to discourage root growth.

Figure 20. Slotted PVC casing installed at Pacific House in 1969. Photo taken in March 1980.

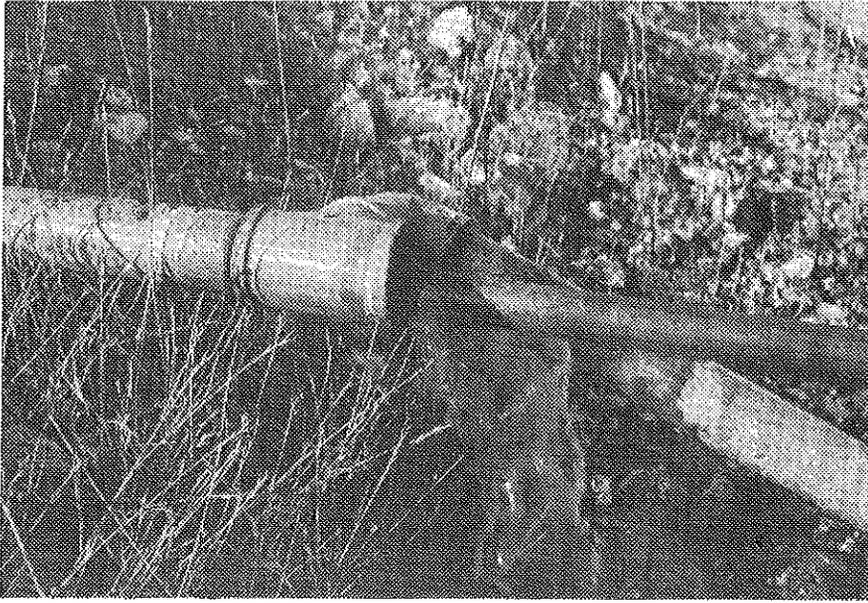
Figure 25. Cleaning system in operation. Note rust and silt encountered during flushing.
