Asbestos and Lead-Containing Paint Survey

ASBESTOS AND LEAD-CONTAINING PAINT SURVEY

**Butte County Bridges
(Bridge Nos. 12-0031 and 12-0141L/R)
Butte County, California**

**GEOCON PROJECT NO. S9300-06-76
TASK ORDER NO. 76, EA NO. 03-1E1101**

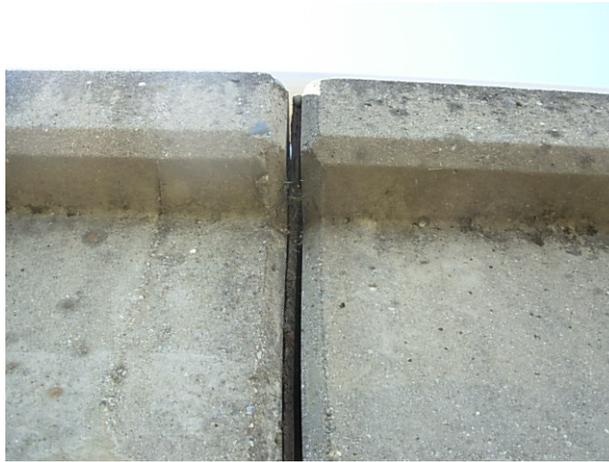
Photo 2 – Bridge 12-0141L/R joint fill material

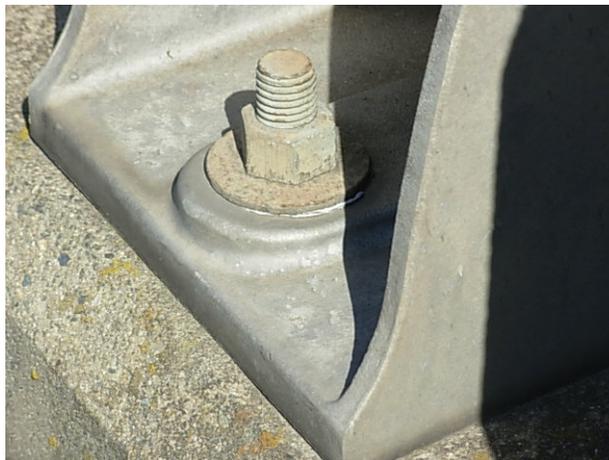
Chrysotile asbestos at concentrations of 2.50% and 3.25% was detected in samples representing nonfriable thread compound used on the barrier rail systems of Bridge 12-0141L/R. The asbestos content was determined using PLM point count analysis (400 points). We were not able to quantify the thread compound due to safety concerns (i.e., traffic).

Photo 3 – Bridge 12-0141L/R thread compound

NESHAP regulations do not require that asbestos-containing sheet piling or thread compound (Category I nonfriable/nonhazardous materials) identified during our survey be removed prior to demolition or be treated as hazardous waste. However, the disturbance of these materials is still covered by the Cal/OSHA asbestos standard (Title 8, CCR Section 1529). We recommend that a licensed contractor registered with Cal/OSHA for asbestos-related work perform any activities that would disturb the materials. Contractors are responsible for informing the landfill of the contractor's intent to dispose of asbestos waste. Some landfills may require additional waste characterization. Contractors are responsible for segregating and characterizing waste streams prior to disposal.

Geocon also recommends the notification of contractors (that will be conducting renovation or related activities) of the presence of asbestos in their work areas (i.e., provide contractor[s] with a copy of this report and a list of asbestos removed during subsequent activities). Contractors not trained for asbestos work should be instructed not to disturb asbestos during their activities.

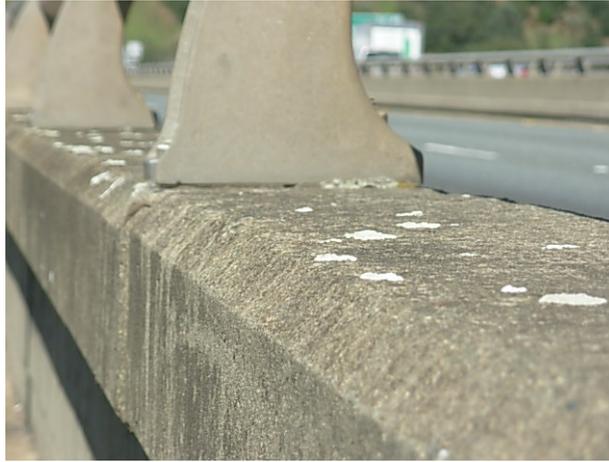
Chrysotile asbestos at a concentration of 40% was detected in a sample representing nonfriable sheet packing used as shims on the barrier rail systems of Bridge 12-0141L/R. We were not able to quantify the sheet packing due to safety concerns (i.e., traffic).

Photo 4 – Bridge 12-0141L/R barrier rail shims

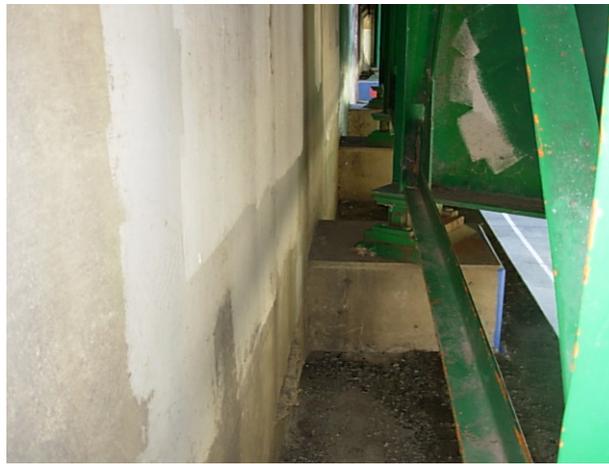
Photo 5 – Bridge 12-0141L/R bearings

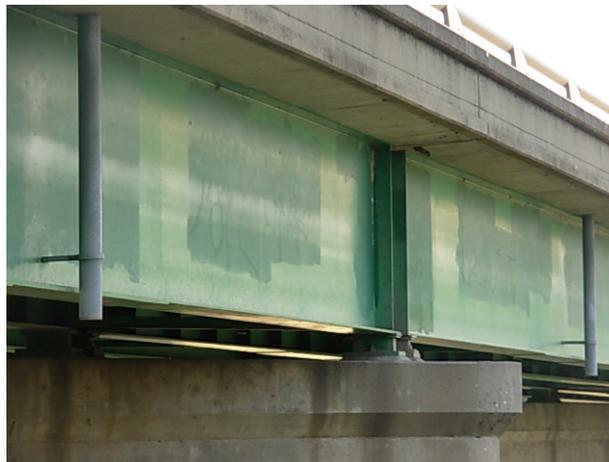
Samples representing intact green paint observed on the Bridge 12-0141L/R truss and girder systems exhibited total lead concentrations of 410,000 mg/kg and 440,000 mg/kg. The laboratory was not able to determine the soluble (TCLP) lead concentration of the paint.

Photo 6 – Bridge 12-0141L/R truss and girder systems

LCP identified during our survey would be considered a California hazardous waste if stripped, blasted, or otherwise separated from the substrate. In addition, separated LCP would be considered a RCRA hazardous waste until soluble (TCLP) analysis indicates otherwise.

The Cal/OSHA lead standard will apply to any maintenance, renovation, or demolition activity that disturbs LCP identified during our survey. In accordance with Title 8, CCR, Section 1532.1(p), written notification to the nearest Cal/OSHA district office is required at least 24 hours prior to certain lead-related work.

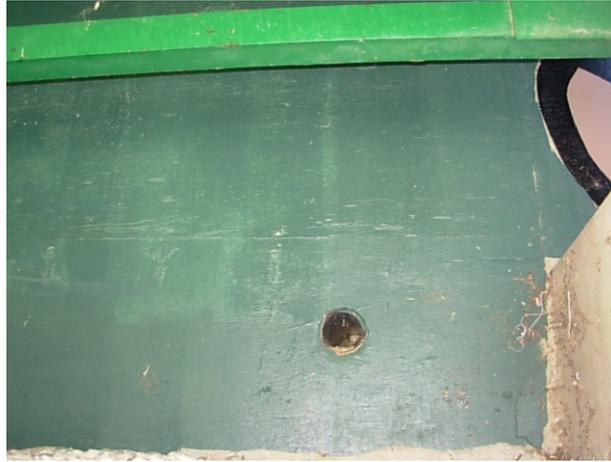
Photo 7 – Bridge 12-0141L/R drainpipe (non-suspect)

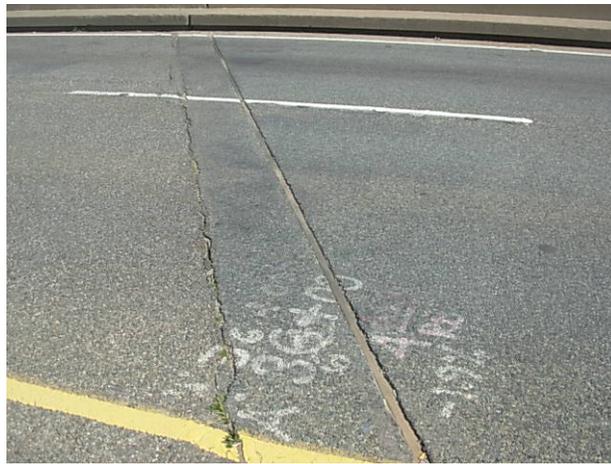
Photo 8 – Bridge 12-0141L/R deck joint (non-suspect)

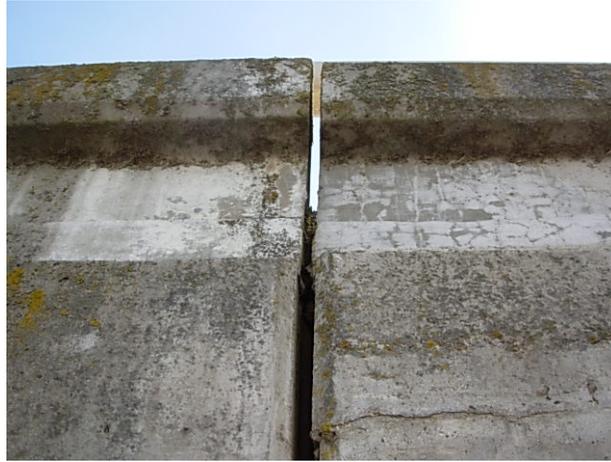
Photo 10 – Bridge 12-0031 joint fill material

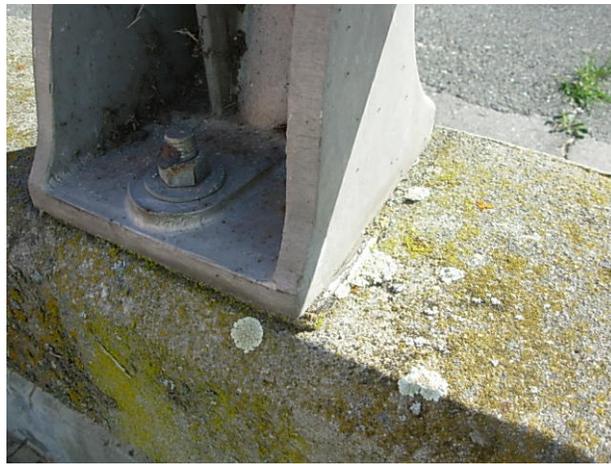
Chrysotile asbestos at a concentration of 30% was detected in samples representing nonfriable sheet packing used as shims on the barrier rail systems of Bridge 12-0031. We were not able to quantify the sheet packing due to safety concerns (i.e., traffic).

Photo 11 – Bridge 12-0031 barrier rail shims

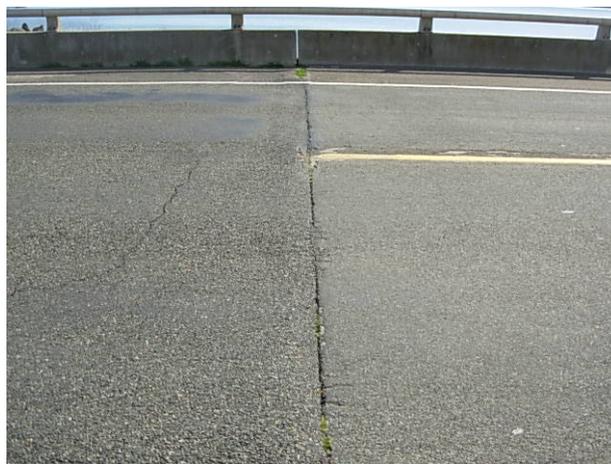
Photo 12 – Bridge 12-0031 deck joint (non-suspect)
