**FOR CONTRACT NO. 030000598
03-3M7604**

INFORMATION HANDOUT

PHOTOGRAPHS

03-NEV, PLA-20-VAR

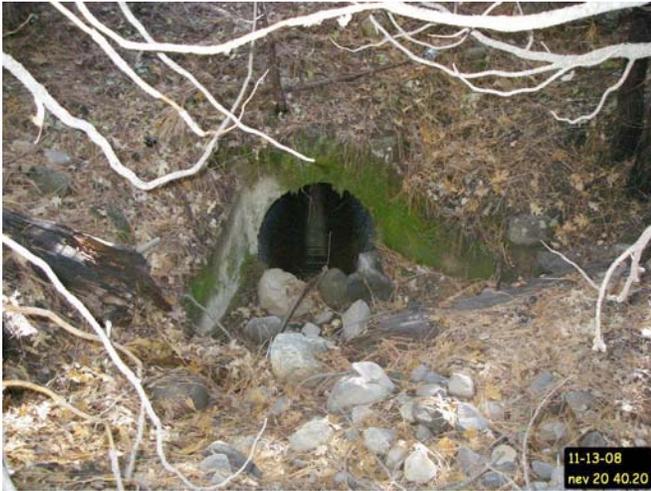
Inlet: 30" cmp with headwall

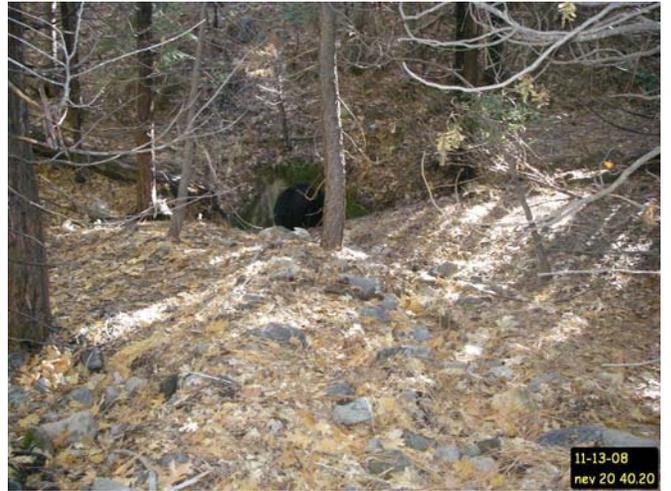
Area around inlet

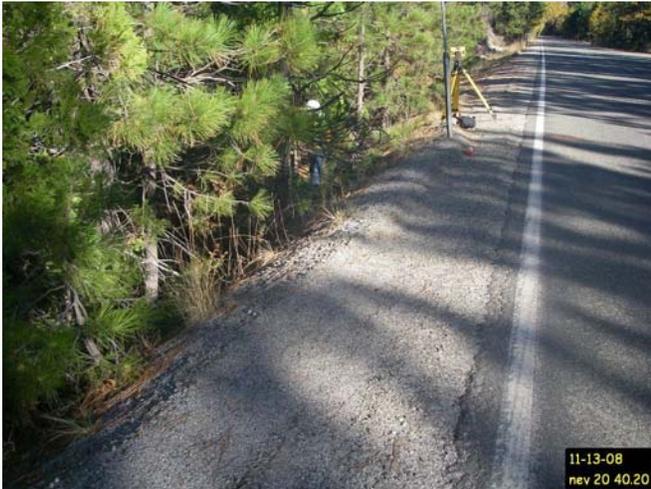
West of culvert looking east on north side of 20

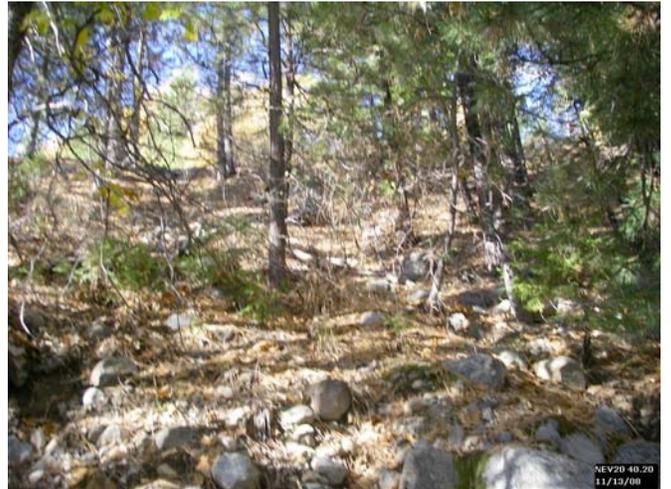
Outlet: note steep terrain

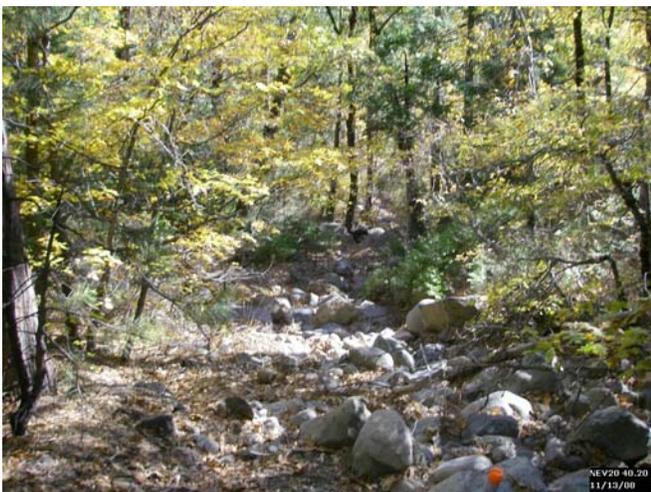
Outlet: native rocks dissipate the flows

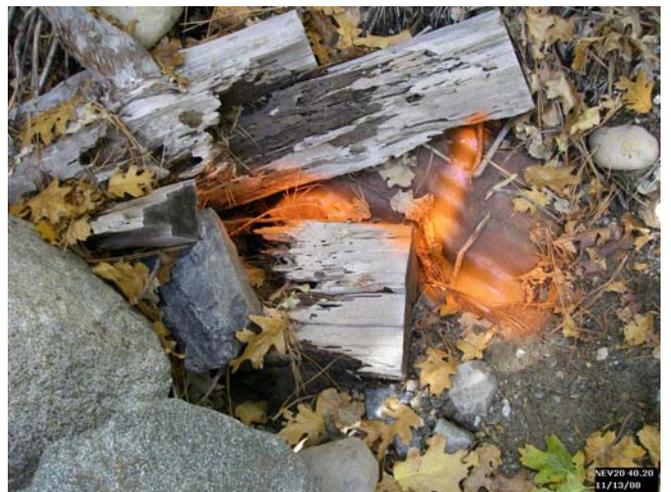
Outlet: crushed and covered w/ debris

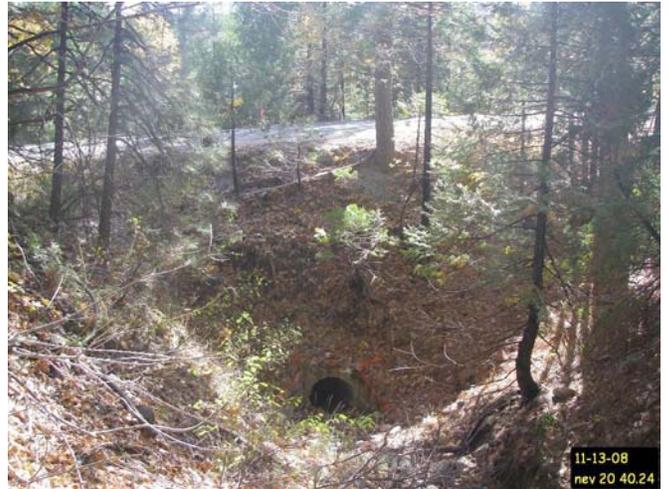
Inlet: shows 30" cmp with headwall

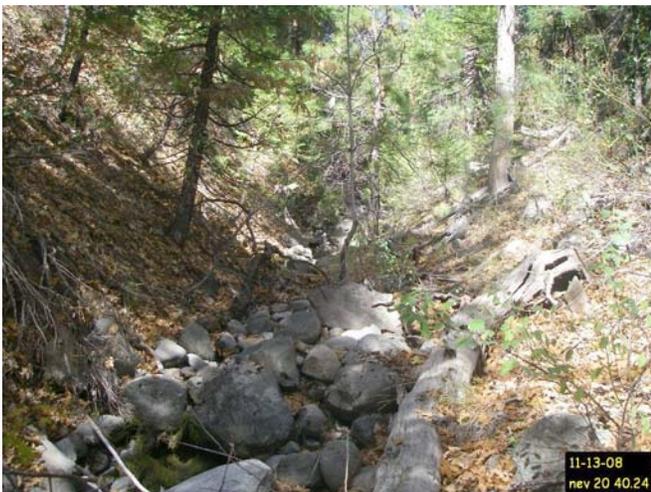
Inlet: view from inlet looking upstream

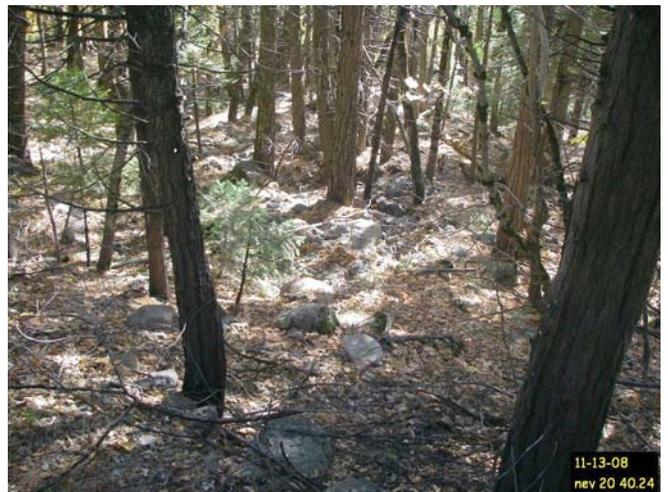
Outlet: vicinity of outlet

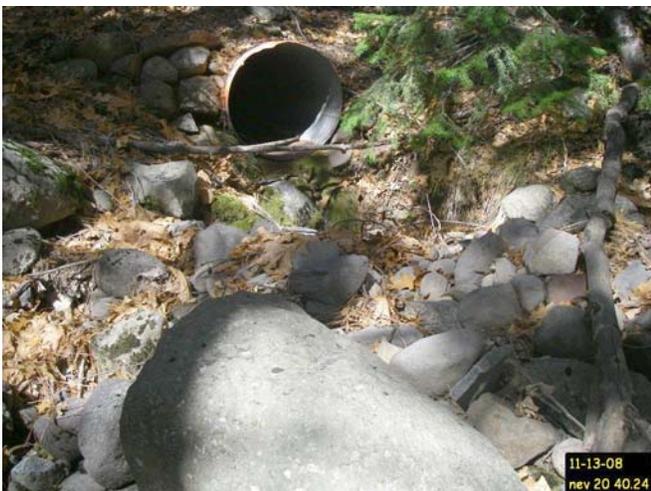
Outlet: note existing rocks

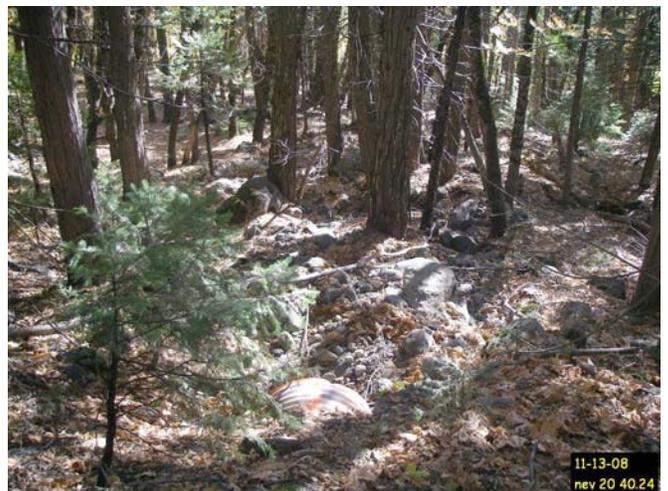
Outlet: native rocks below outlet

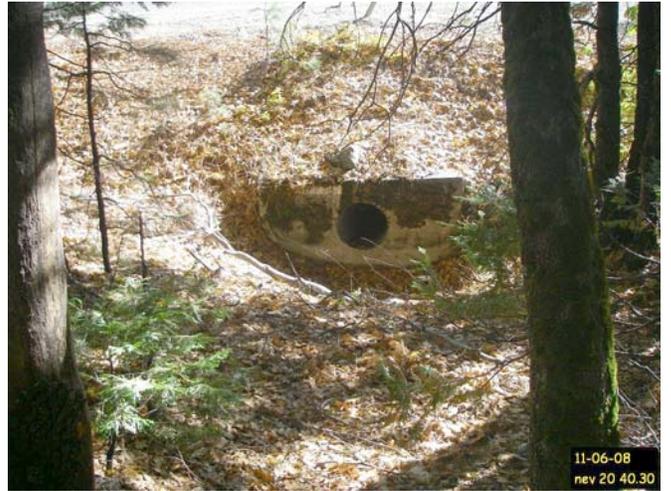
Inlet: upstream looking down- 24" cmp & headwall

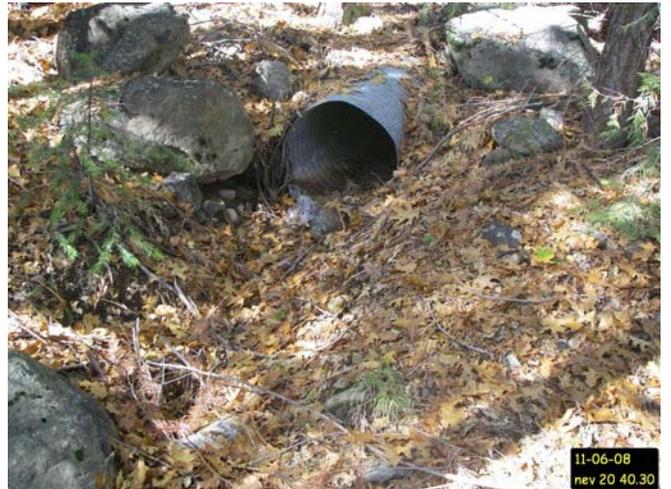
Outlet: flow is unobstructed

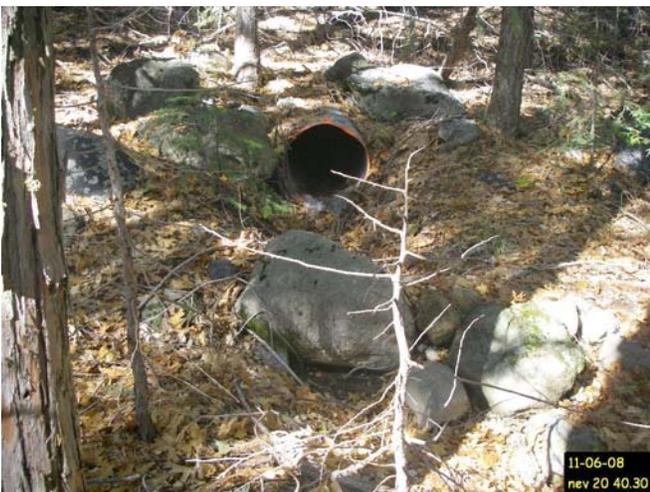
Outlet: area below outlet

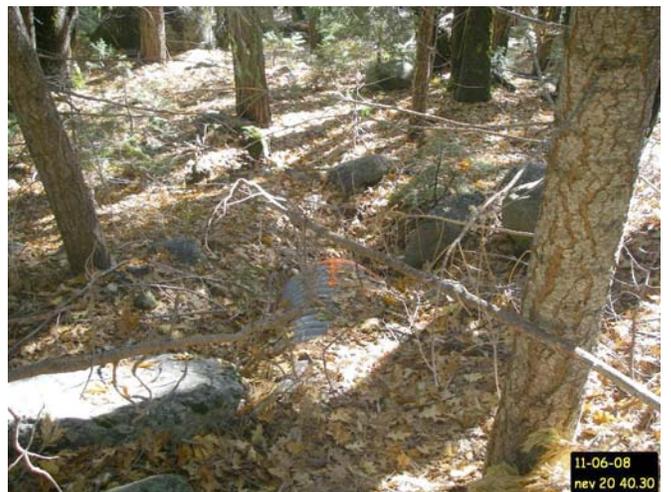
Outlet: above outlet looking down hill

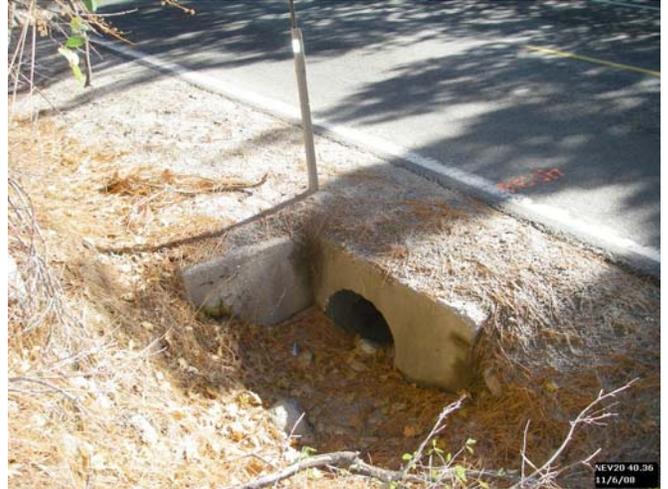
Inlet: L headwall with 24" cmp

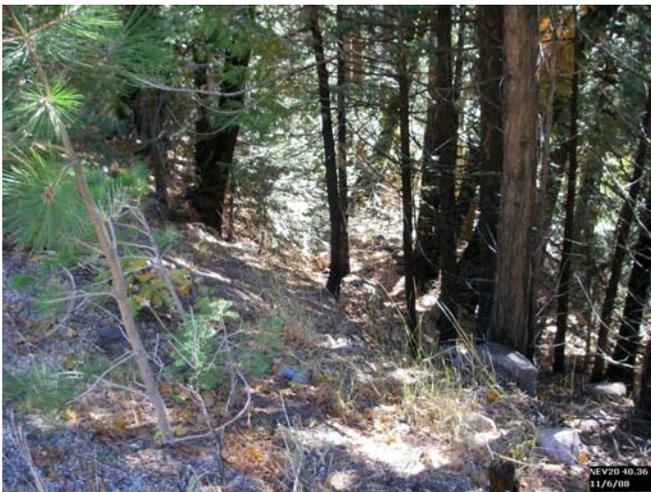
Outlet: skewed alignment, view from roadway

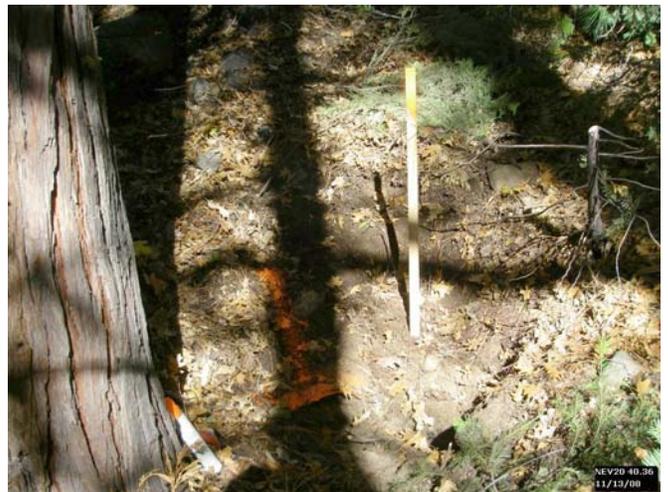
Outlet: difficult to find- look for lath and paint

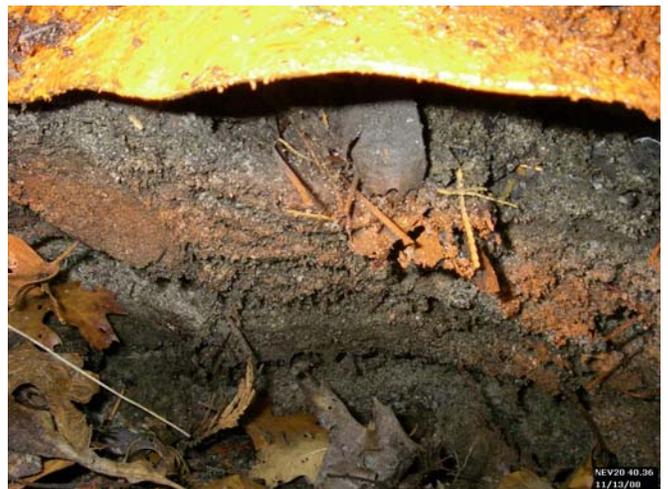
Outlet: culvert was plugged @ outfall (close up)

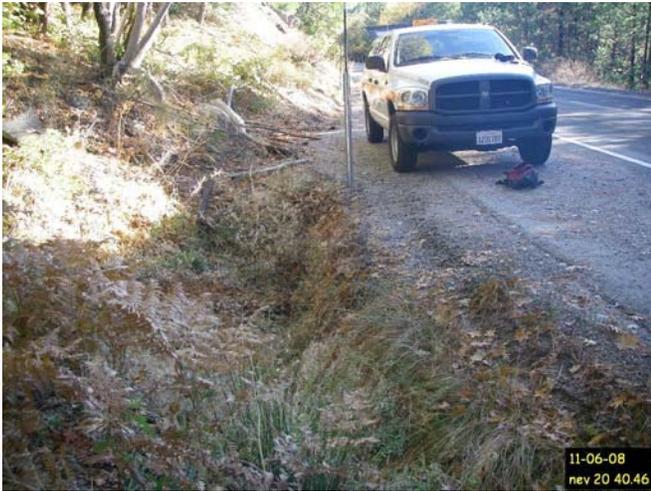
Inlet: west of culvert looking east from north side

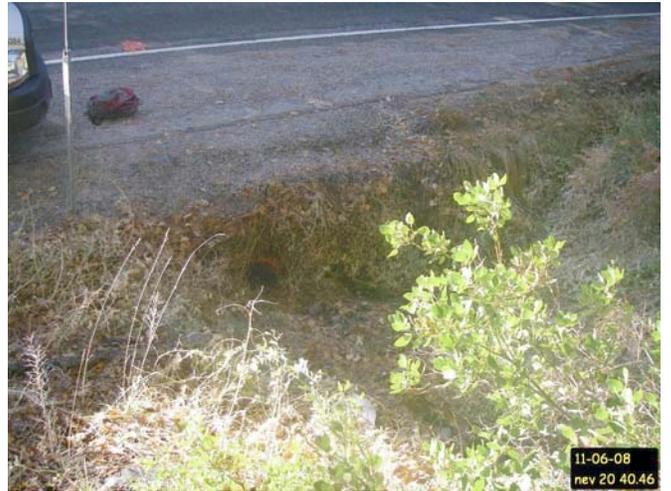
Inlet: above culvert... inlet has orange paint

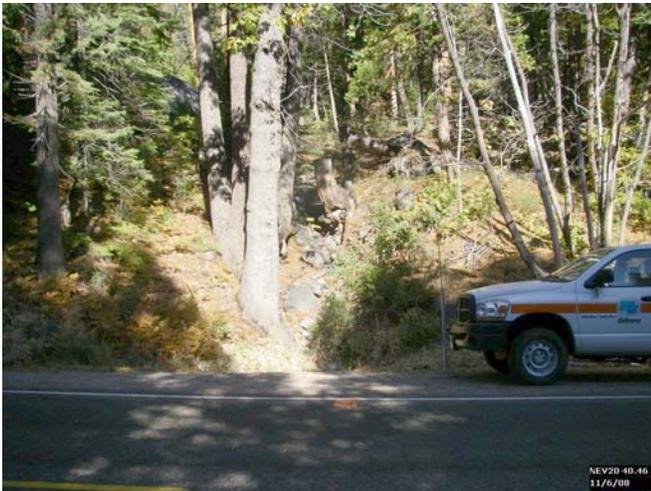
Inlet: area directly above inlet

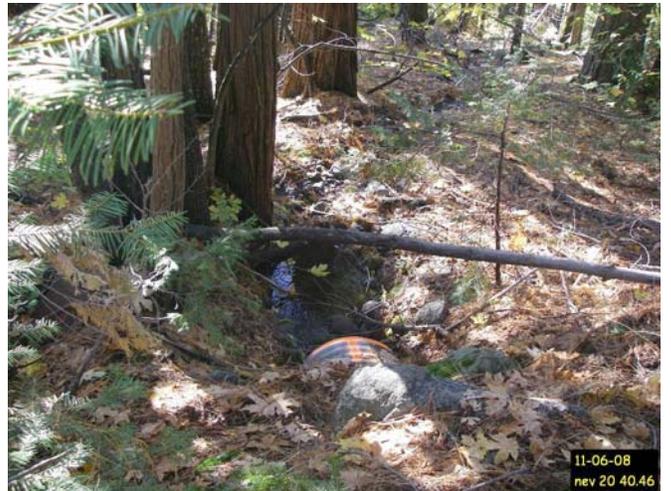
Outlet: above outlet looking downstream

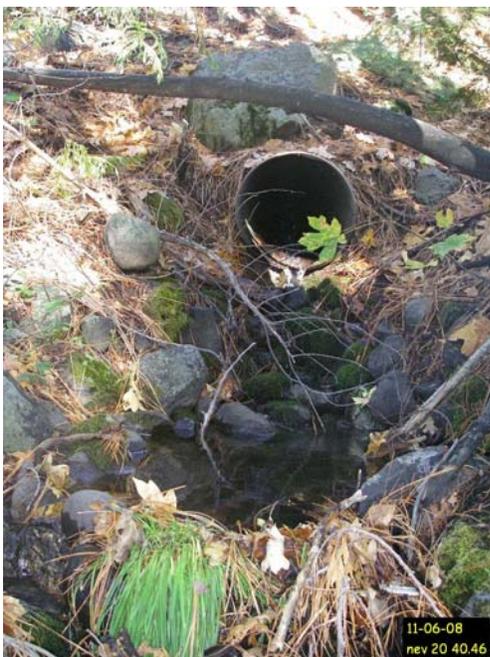
Outlet: 24" cmp

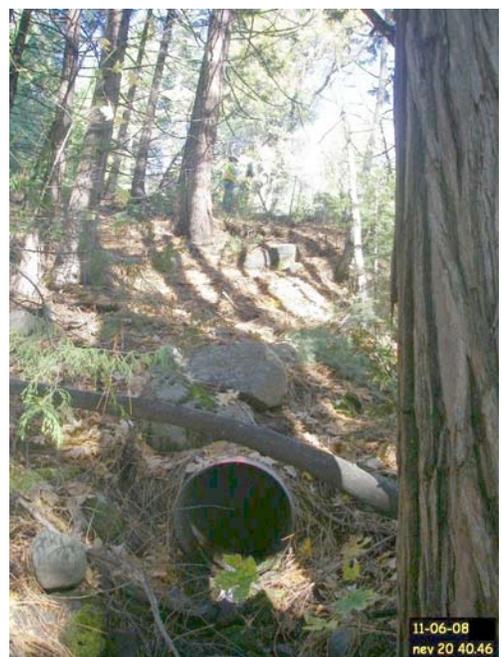
Outlet: note surveyor on roadway

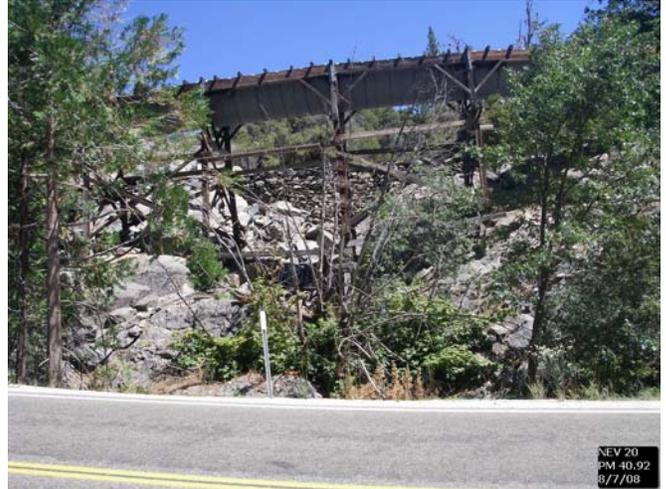
Inlet: view upstream; flume is outside our ROW

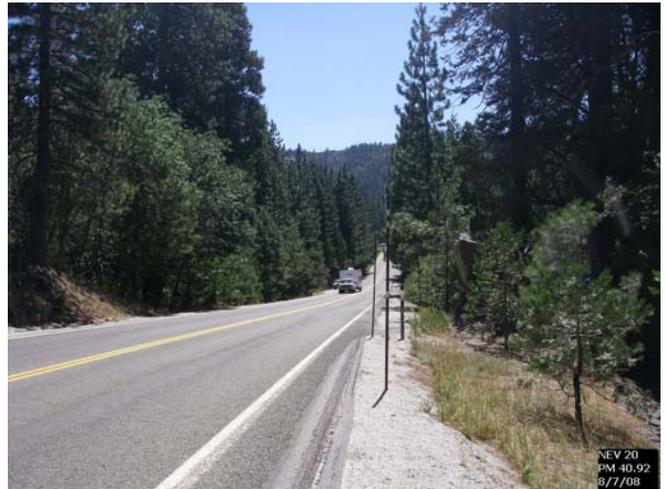
Outlet: looking east towards Bear Valley

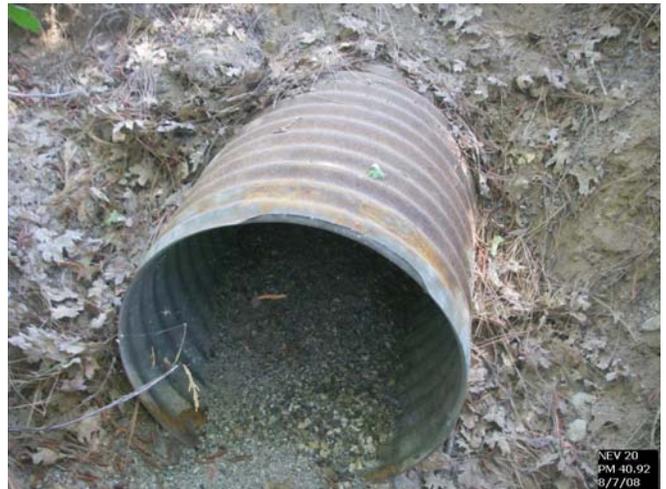
Outlet: 24" cmp

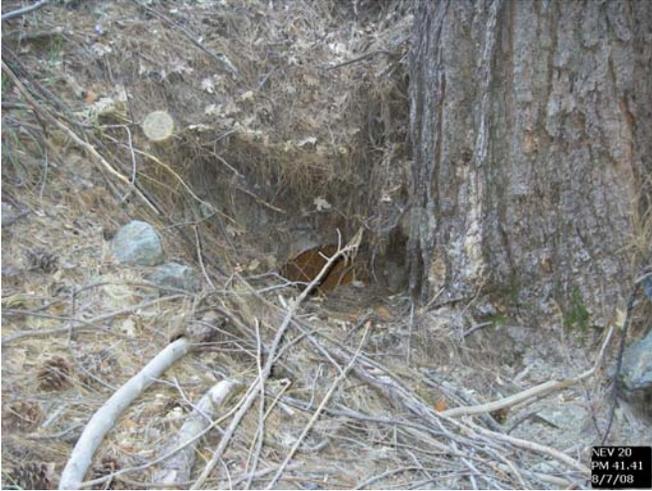
Inlet: partially buried by embankment and debris

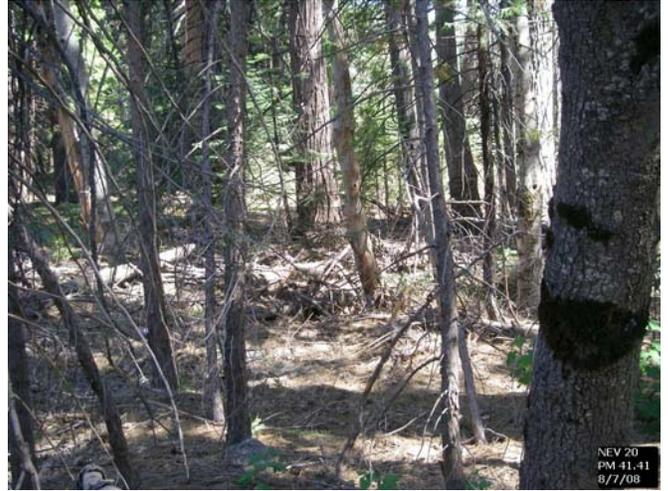
Inlet: vicinity of inlet

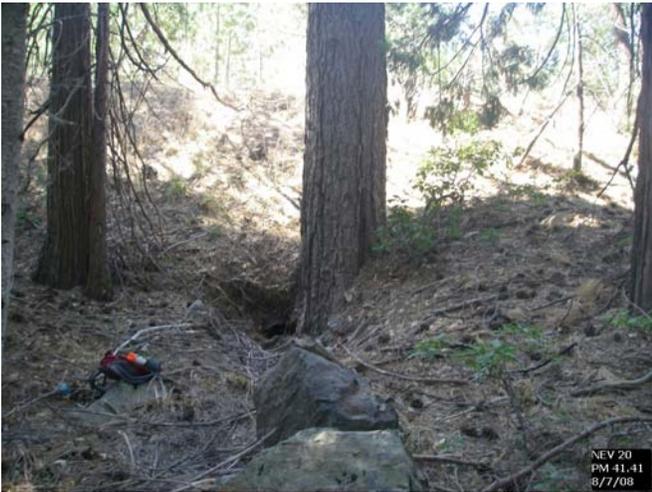
Inlet: looking back @ inlet; note roadway above

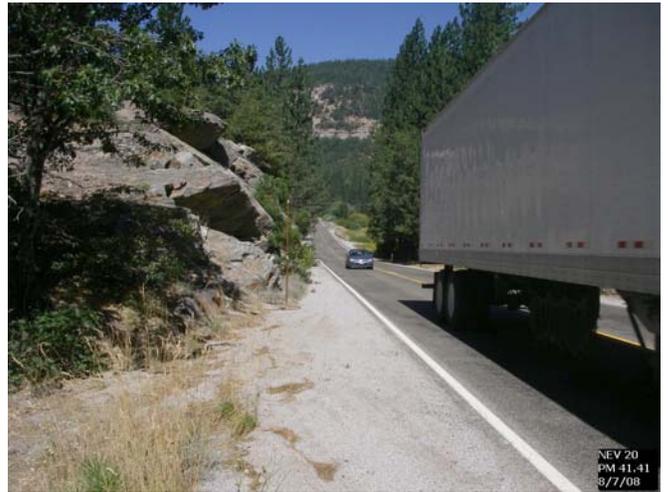
Outlet: @ east end of Bear Valley

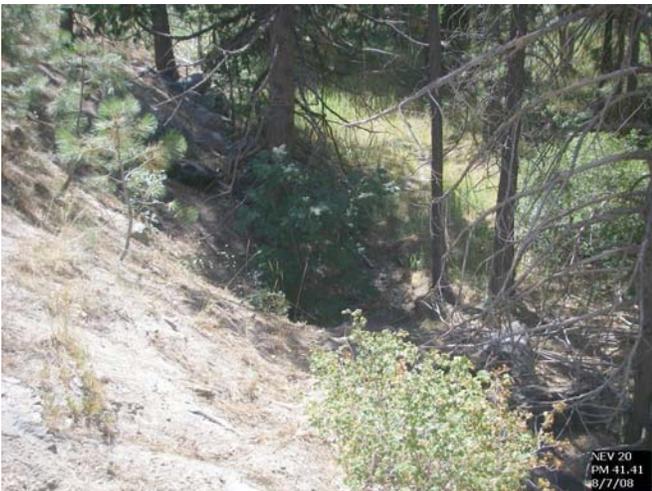
Outlet: looking down from slope above

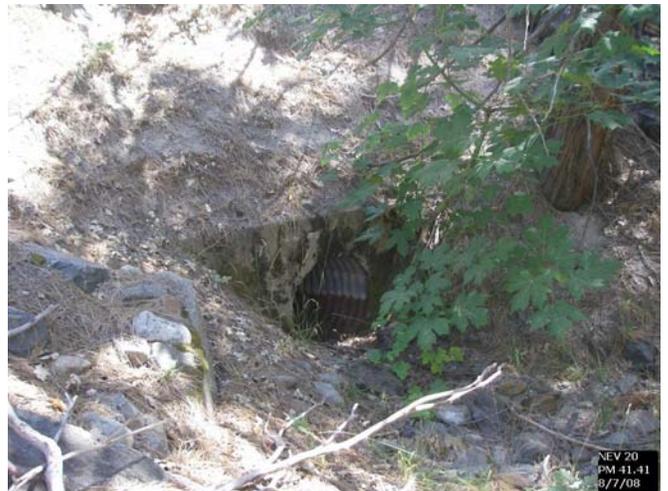
Outlet: headwall with 24" cmp

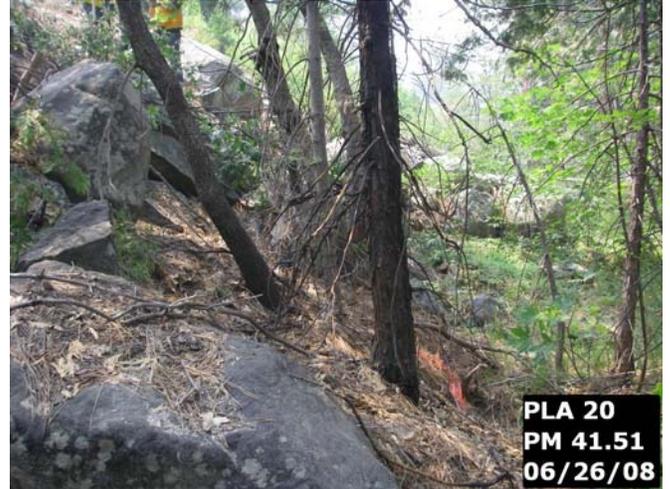
Inlet: notice orange paint @ inlet

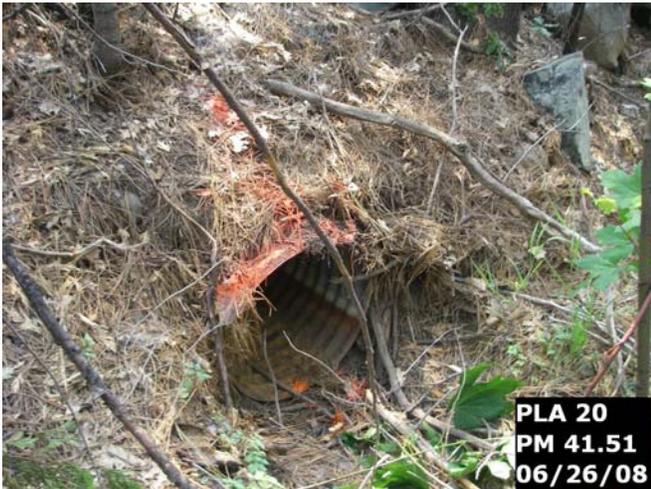
Inlet: fair amount of corrosion in 24" culvert

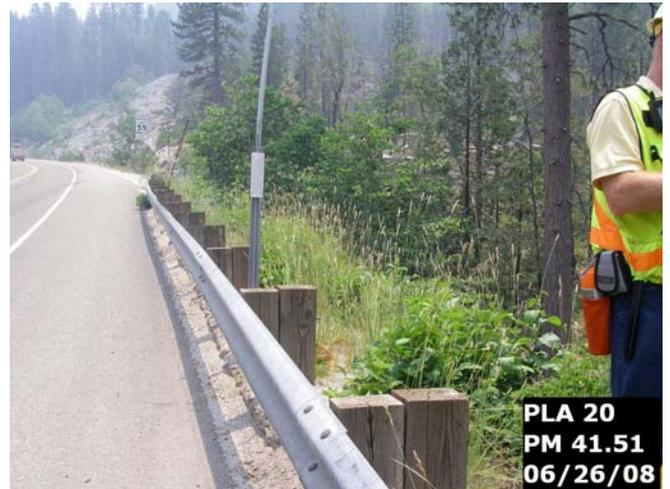
Outlet: looking east

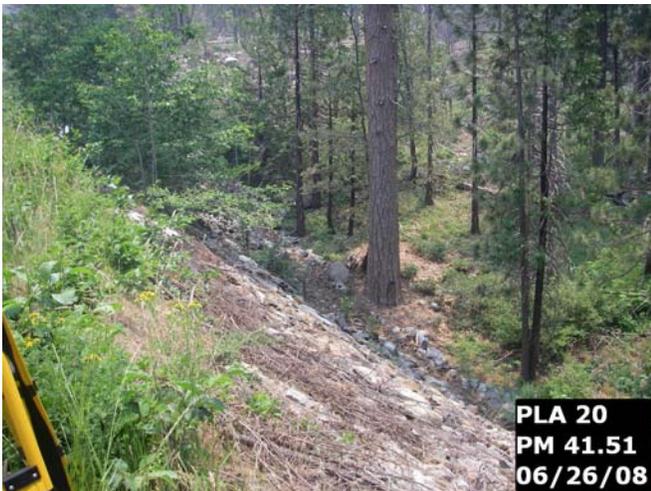
Outlet: looking down from shoulder at outlet

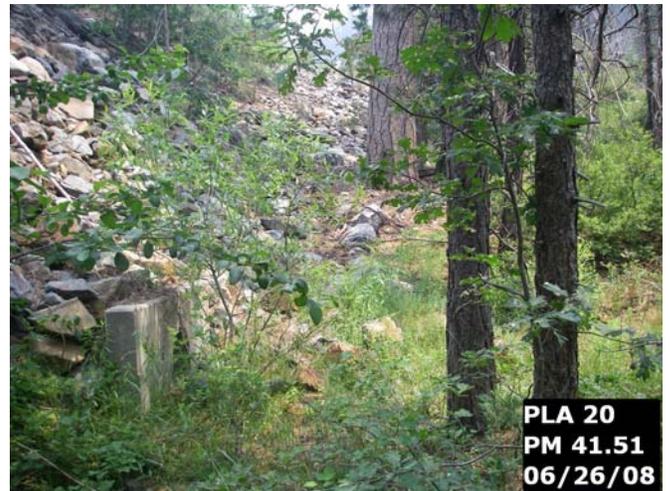
Outlet: notice headwall on left @ toe of slope

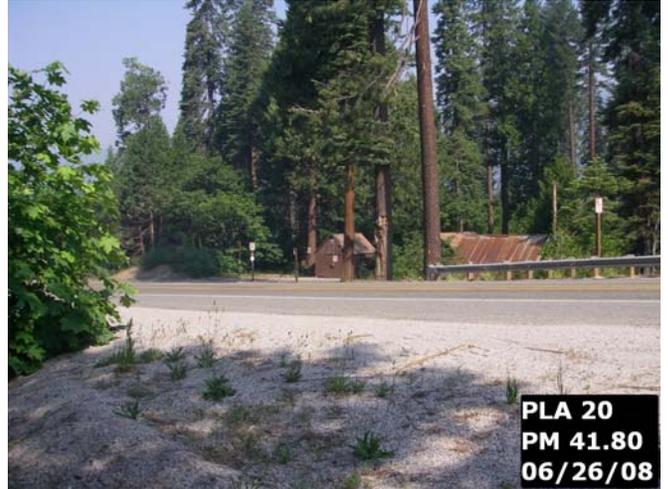
Inlet: view from inlet- str's @ Bowman Lake Rd.

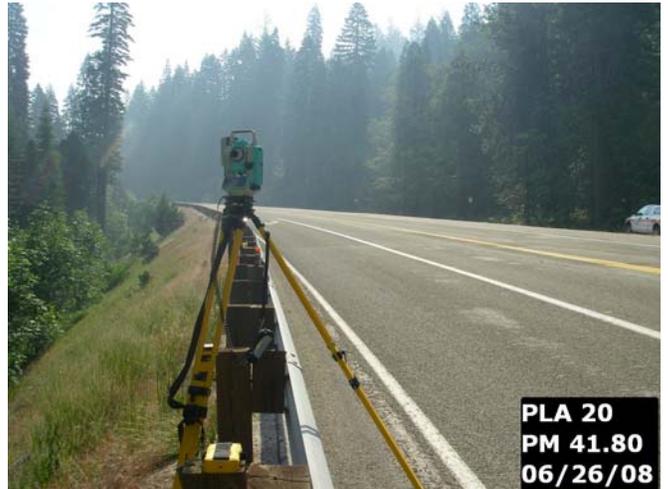
Outlet: steep embankment, rt. turn aux. lane

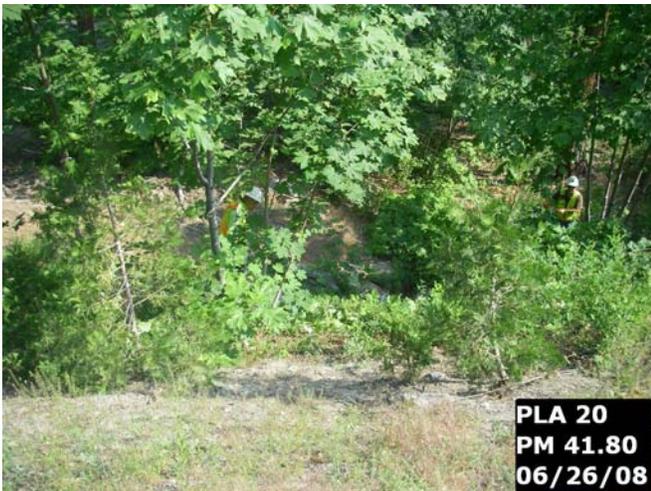
Outlet: looking @ outlet from roadway above

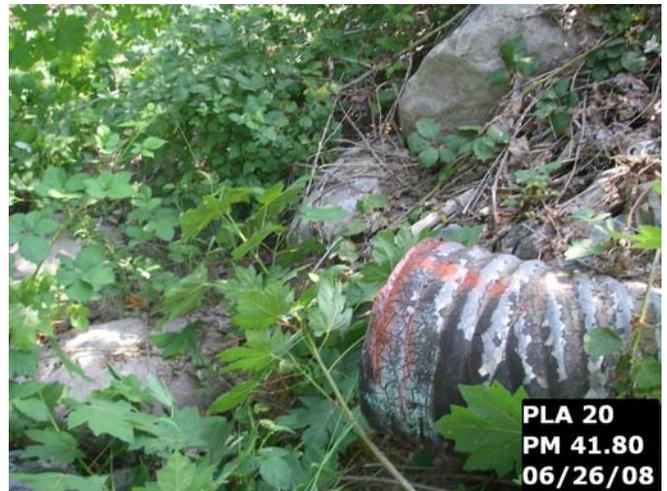
Outlet: 18" cmp

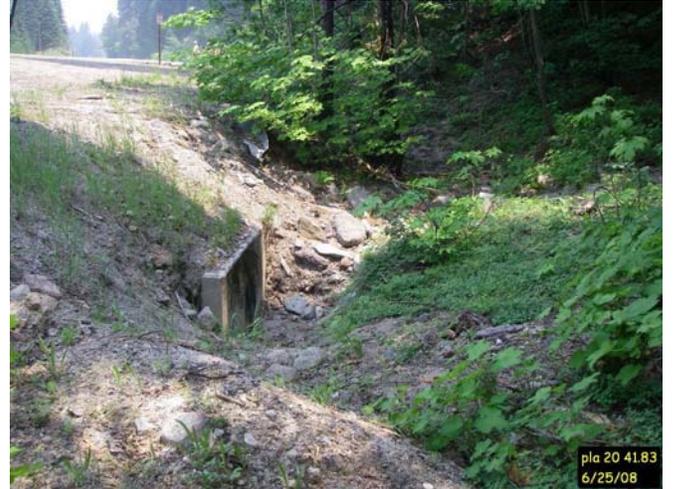
Inlet: pretty well defined drainage paths

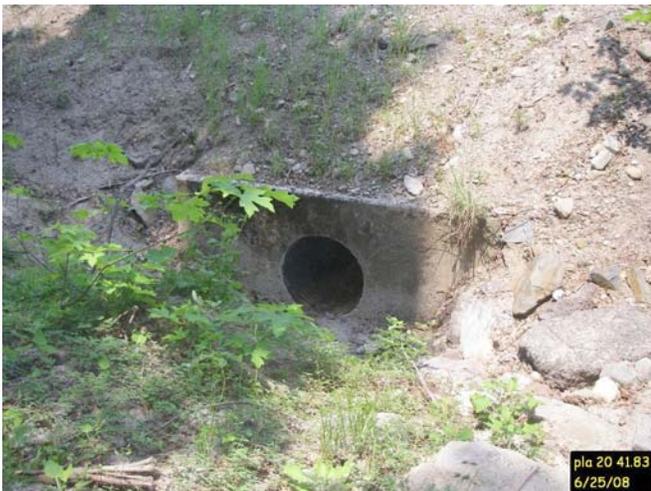
Inlet: 24" csp with headwall

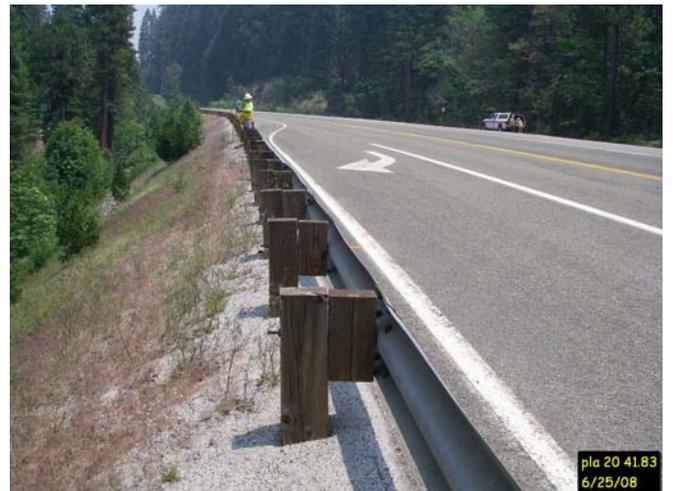
Outlet: steep embankment @ rt. turn lane

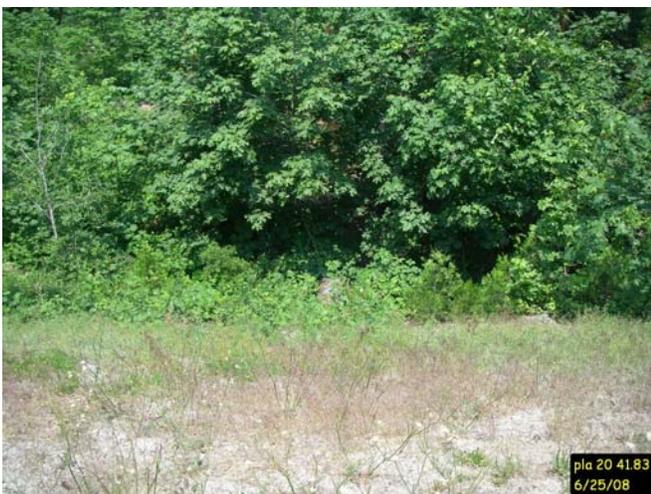
Outlet: from EP looking down to outfall

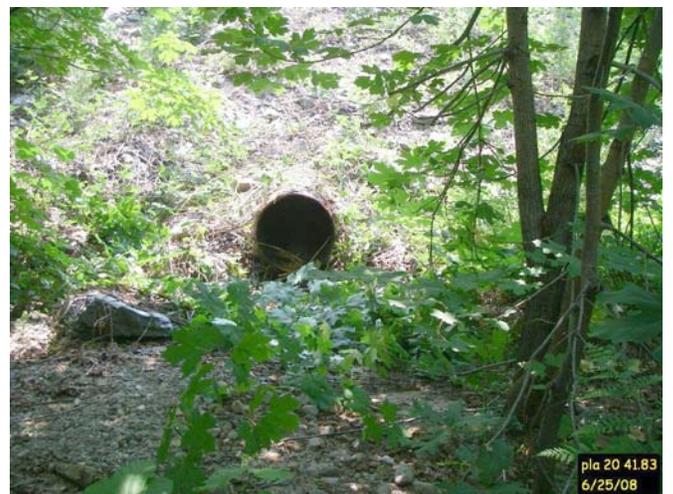
Outlet: 24" csp at toe of embankment

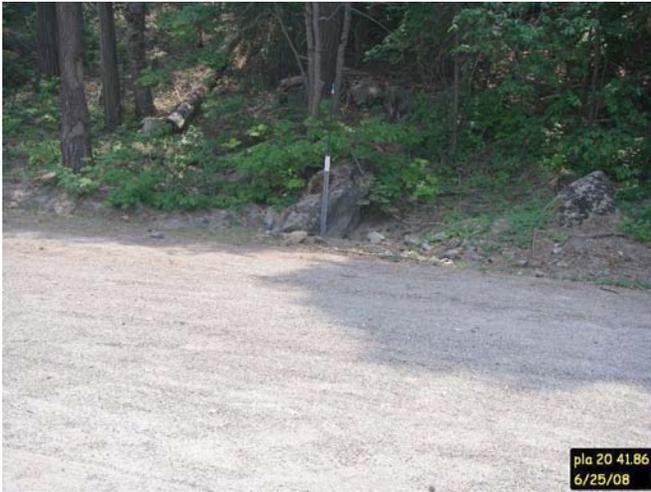
Inlet: looking towards inlet from EP

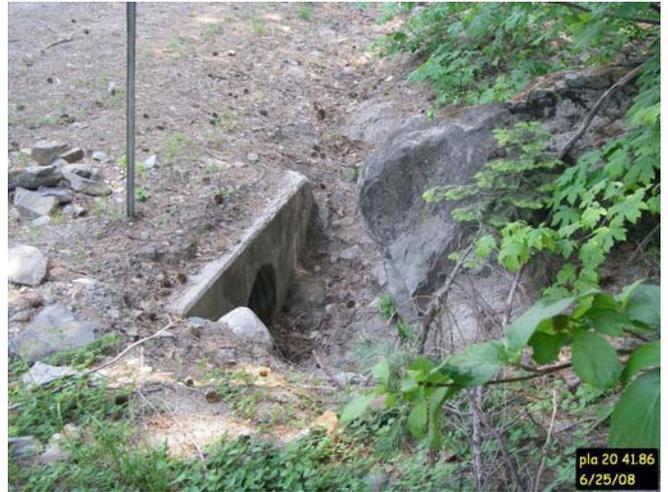
Inlet: 24" cmp with headwall

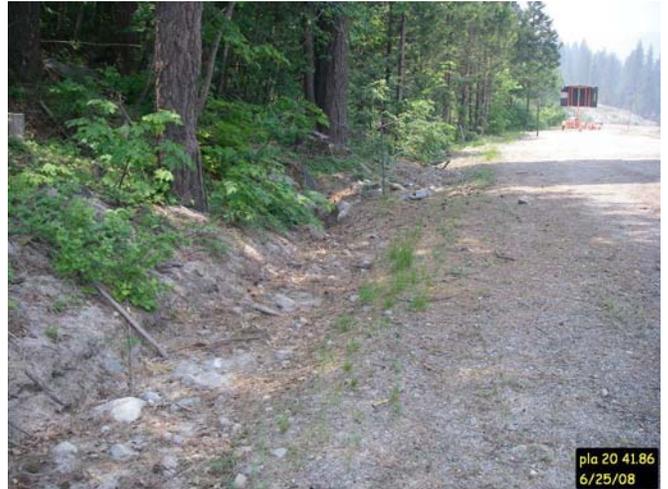
Inlet: looking west from inlet

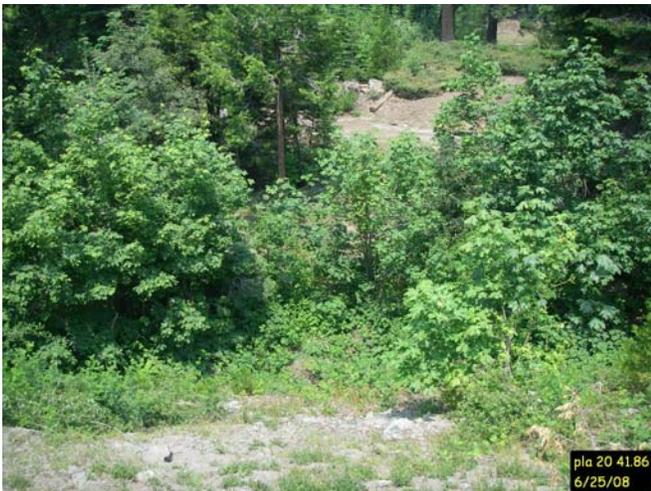
Outlet: view from EP towards outlet

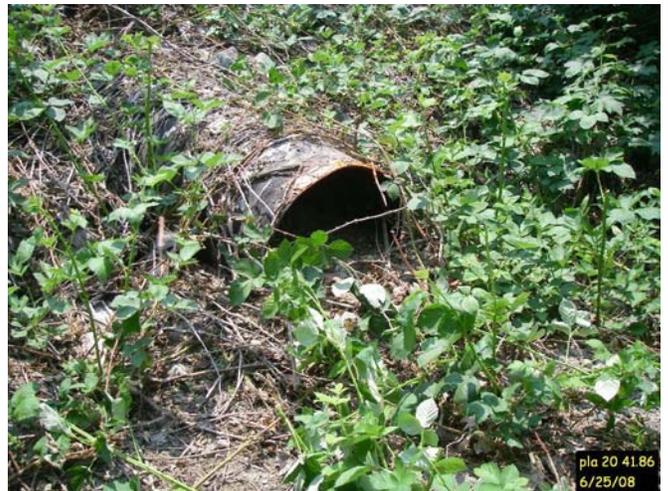
Outlet: partially buried

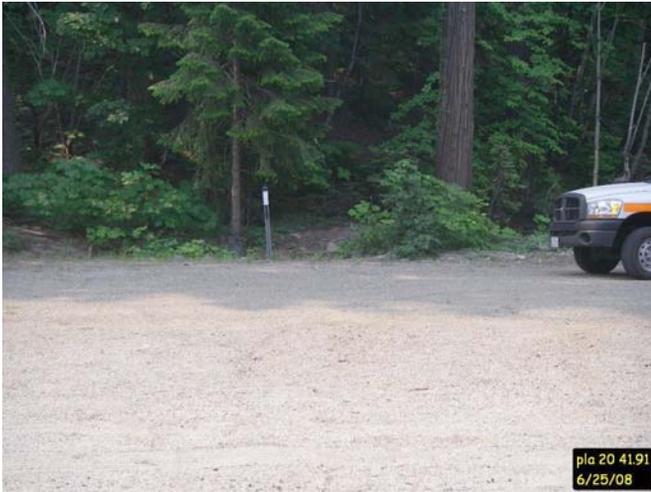
Inlet: from EP- notice large shoulder area

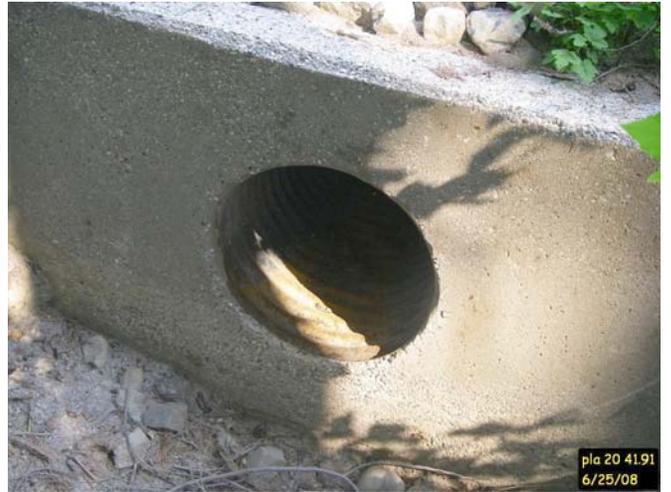
Inlet: 24" cmp with headwall

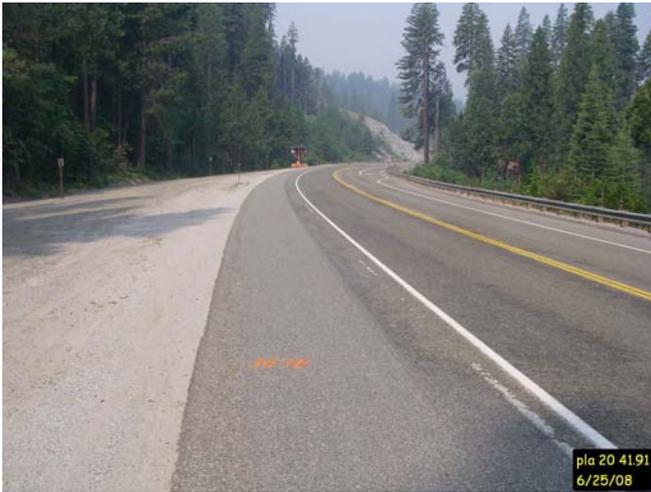
Inlet: looking west

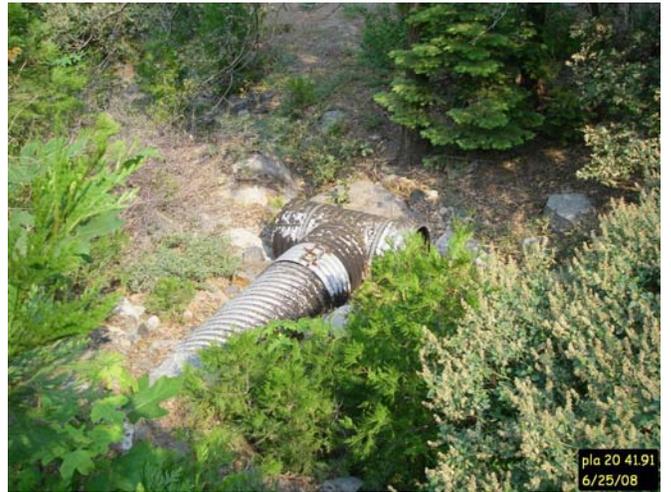
Outlet: culvert has T section at outfall

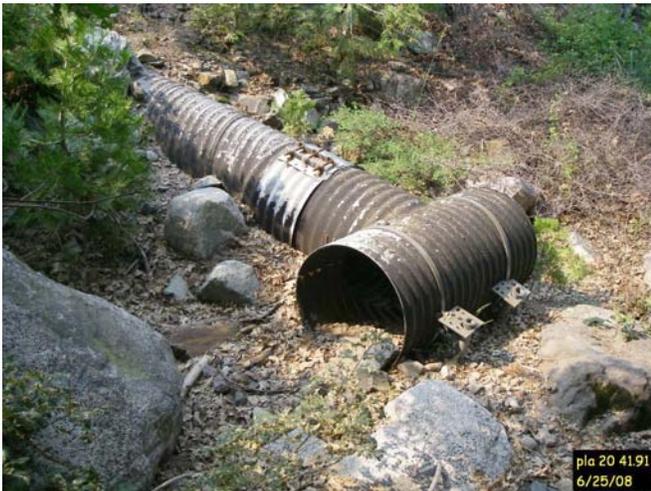
Outlet: another view of T section

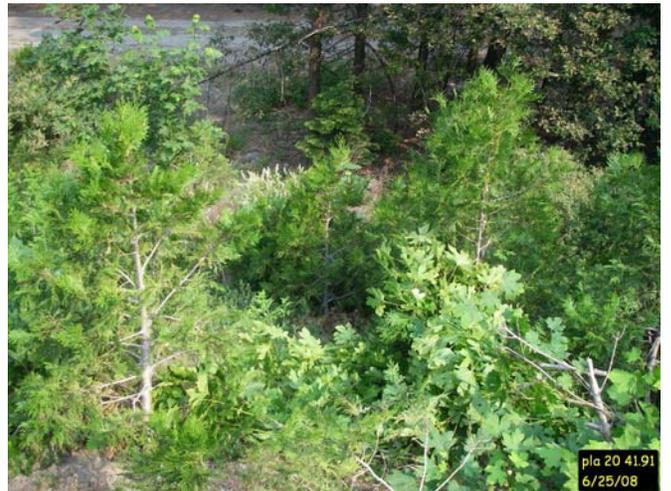
Outlet: looking towards outlet from EP

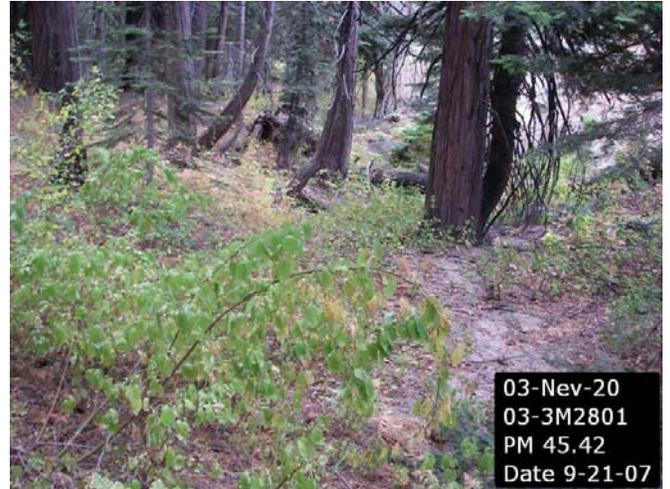
Inlet: area around inlet

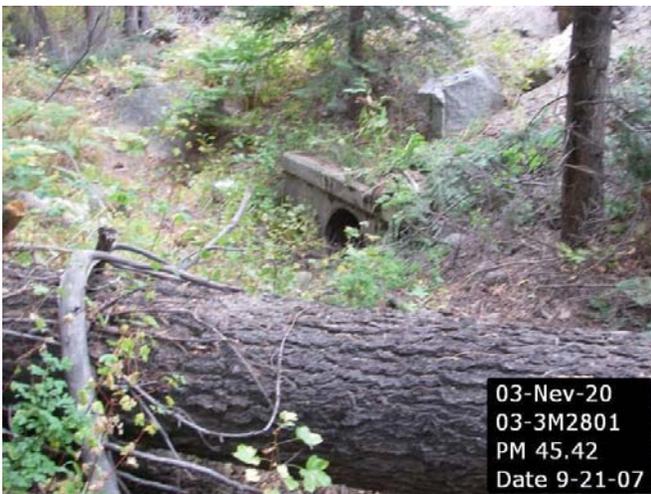
Inlet: note headwall

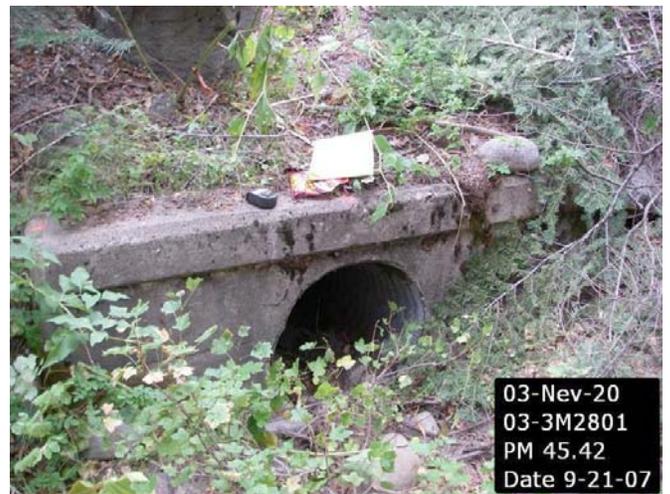
Inlet: 24" cmp with headwall

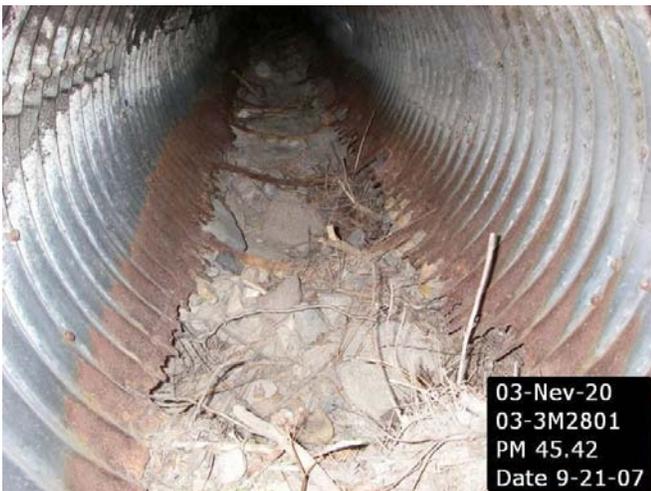
Inlet: invert badly deteriorated

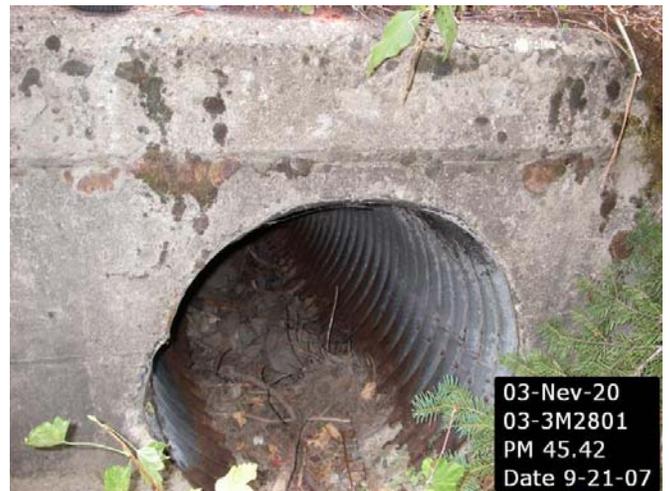
Inlet: headwall at toe of steep embankment

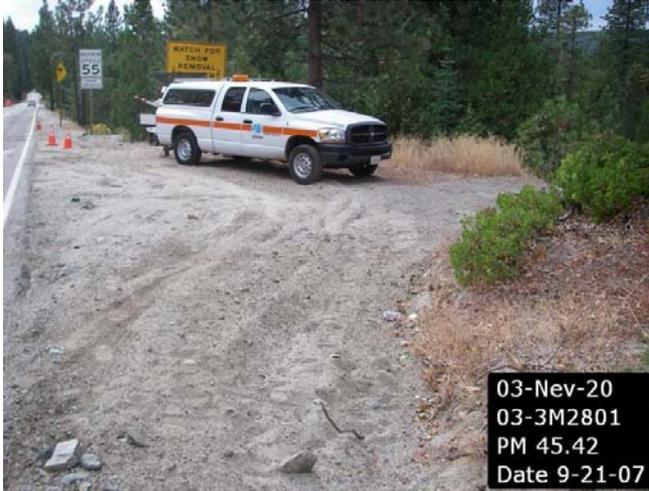
Outlet: access road starts in front of truck

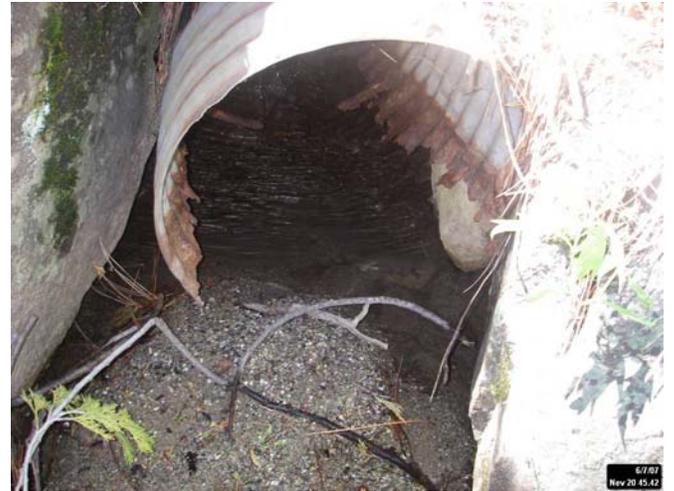
Outlet: invert is gone

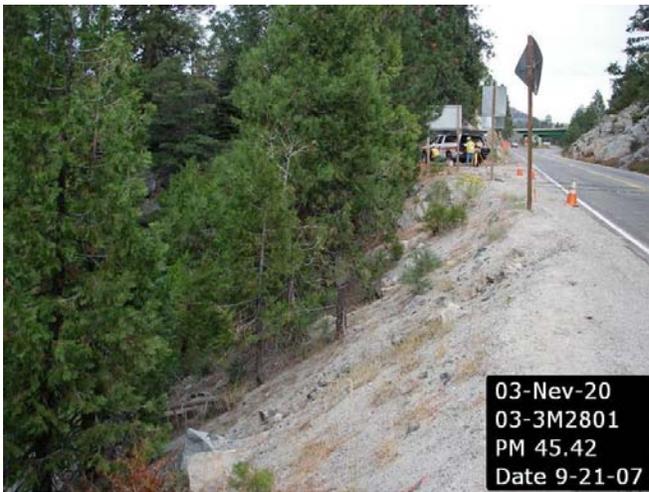
Outlet: high speed, minimal shoulder with turnout

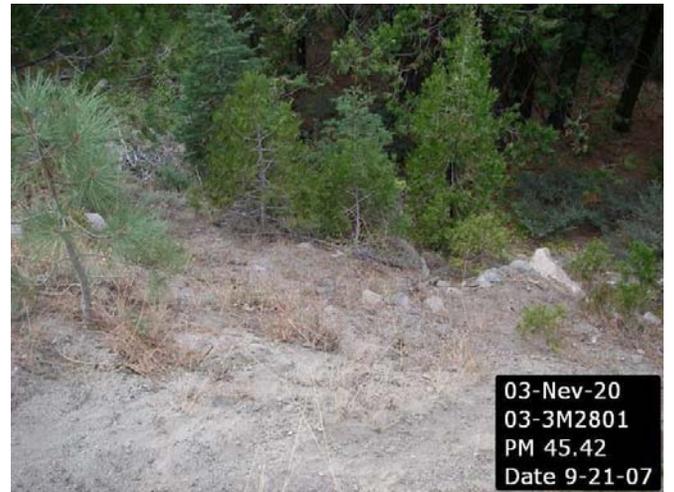
Outlet: looking down from EP

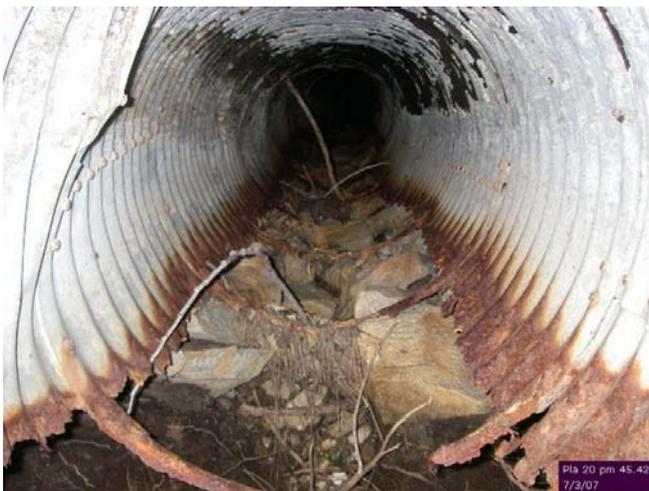
Outlet: fortunately native rocks below culvert remain
