**FOR CONTRACT NO. 030000598
03-3M7604**

INFORMATION HANDOUT

PHOTOGRAPHS

03-NEV, PLA-20-VAR

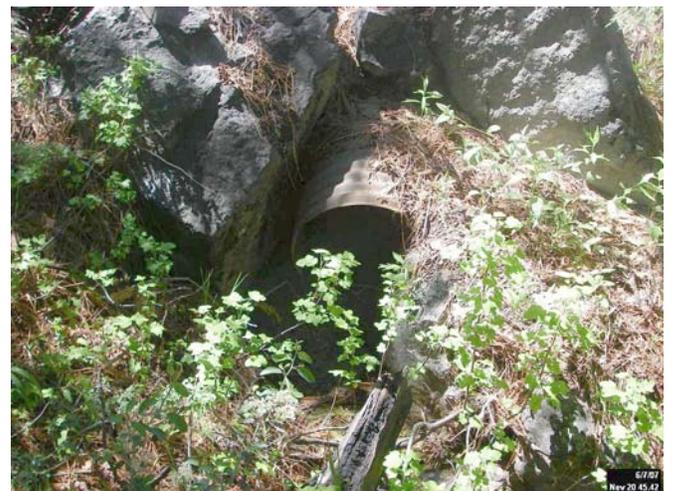
Outlet: hidden by boulders
