INFORMATION HANDOUT

Foundation Report for Bridge No. 10E0031, dated September 12, 2014

File: 01-MEN-253-PM 6.89
Soldier Pile Tieback Wall
EA: 01-0B570
EFIS No. 0112000139

Subject: Foundation Report

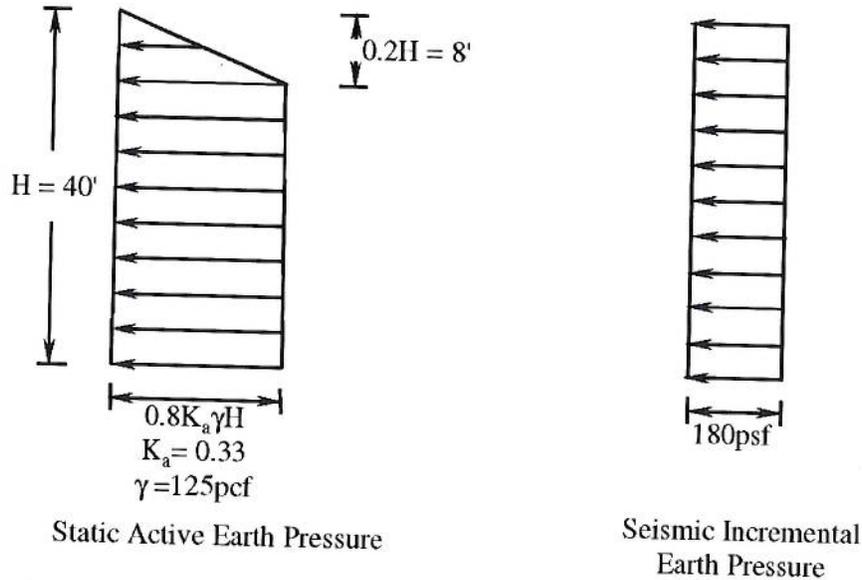
Active Earth Pressures Distributions (per linear foot) for Soldier Pile Tieback Wall

The recommended static active lateral earth pressure and seismic incremental earth pressure distribution diagrams are provided below. The recommendations are based on a wall height of 40 feet, multiple rows of tiebacks, Caltrans standard structural backfill material, and a horizontal seismic acceleration coefficient, k_h , of 0.18g.

The above recommended earth pressures are nominal values, therefore no factor (load factor or resistance factor) is included. As the wall is designed free drained, hydrostatic pressure needs not to be considered.

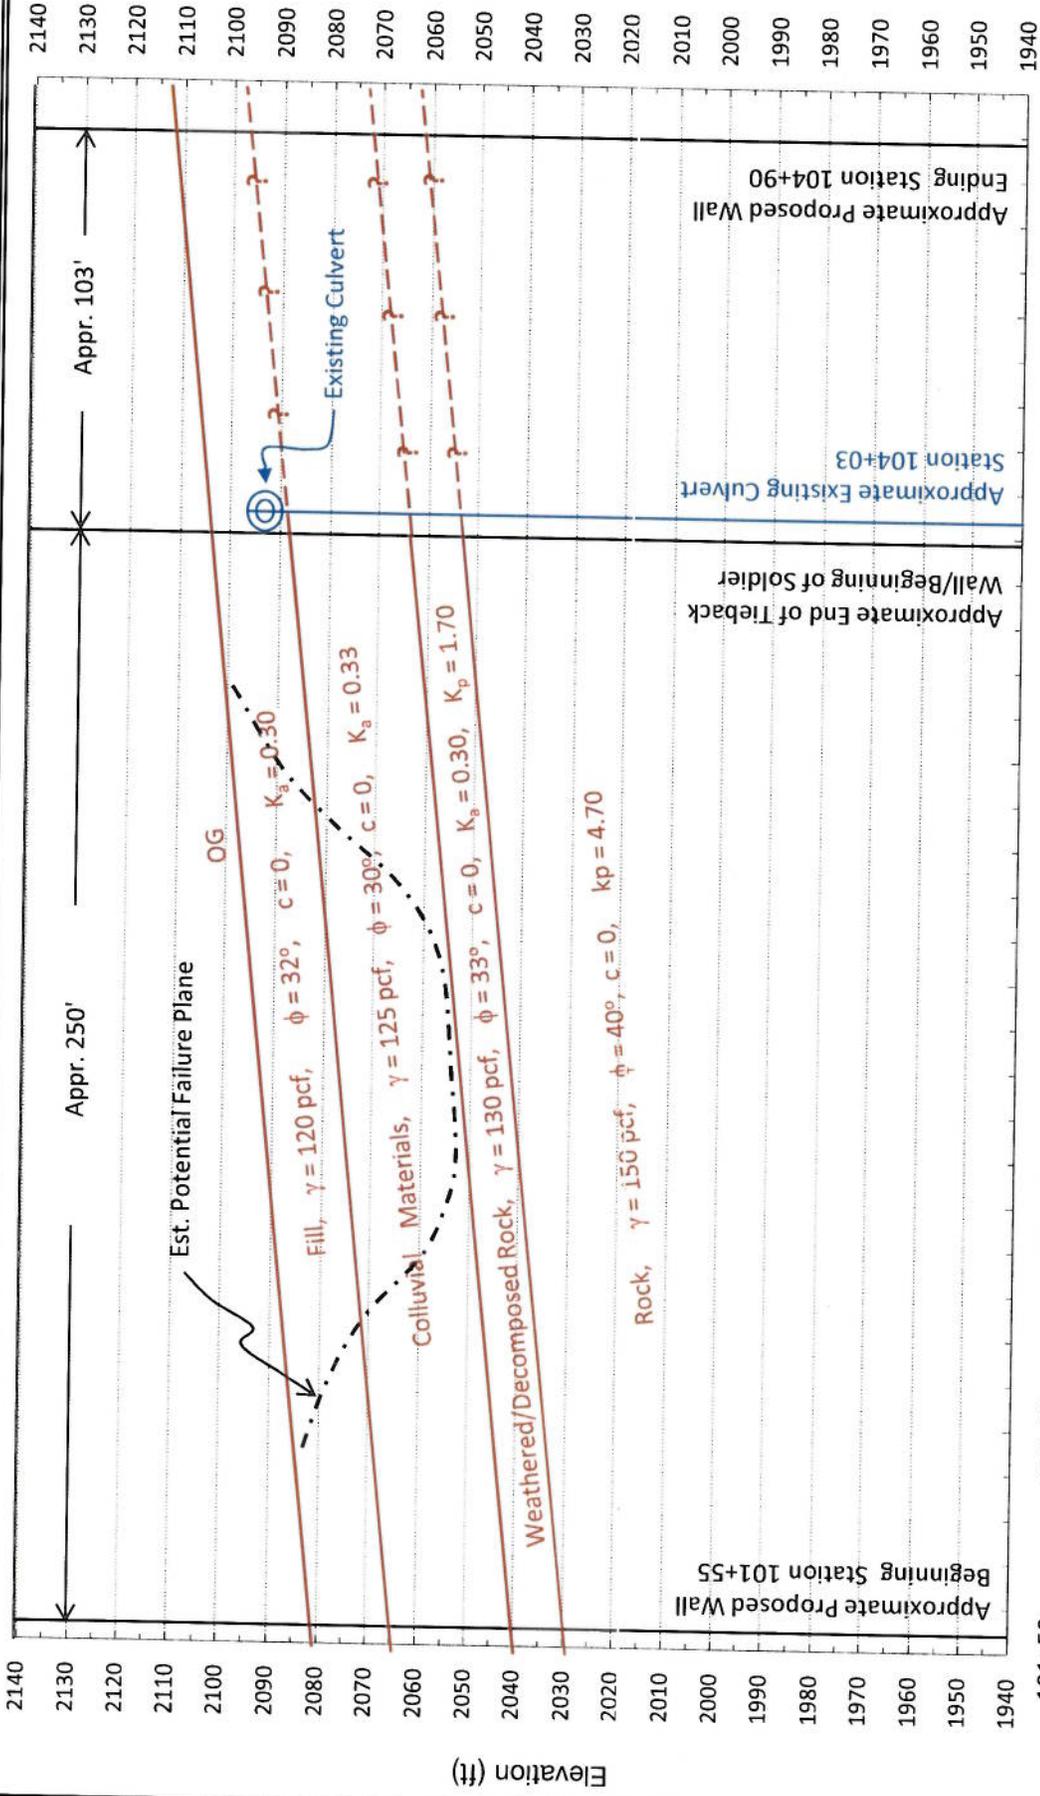
The subsurface materials encountered in the borings consisted of asphalt materials, fills, colluvium, and rock. Below the asphalt pavement section, about 10 to 15 feet of fill materials were encountered. The fills contained clays, sands and gravels. SPT blow counts recorded in the fills ranged from 5 to 9 blows per foot (bpf) indicating that the fills were soft/loose to medium stiff/dense. Below the fills, about 20 to 25 feet of colluviums were encountered. The colluviums consisted of a mixture of sands, gravels and isolated cobbles and boulders. The colluviums were medium dense to very dense with recorded SPT blow counts ranging from 20 to over 57 bpf. Below the colluviums, rock was encountered. The rock was primarily sedimentary rock consisting of sandstone and mudstone. About 10 feet of the upper rock was extensively weathered and was intensely fractured or decomposed. A Generalized Subsurface Profile is provided in Figure 4 in the Appendix.

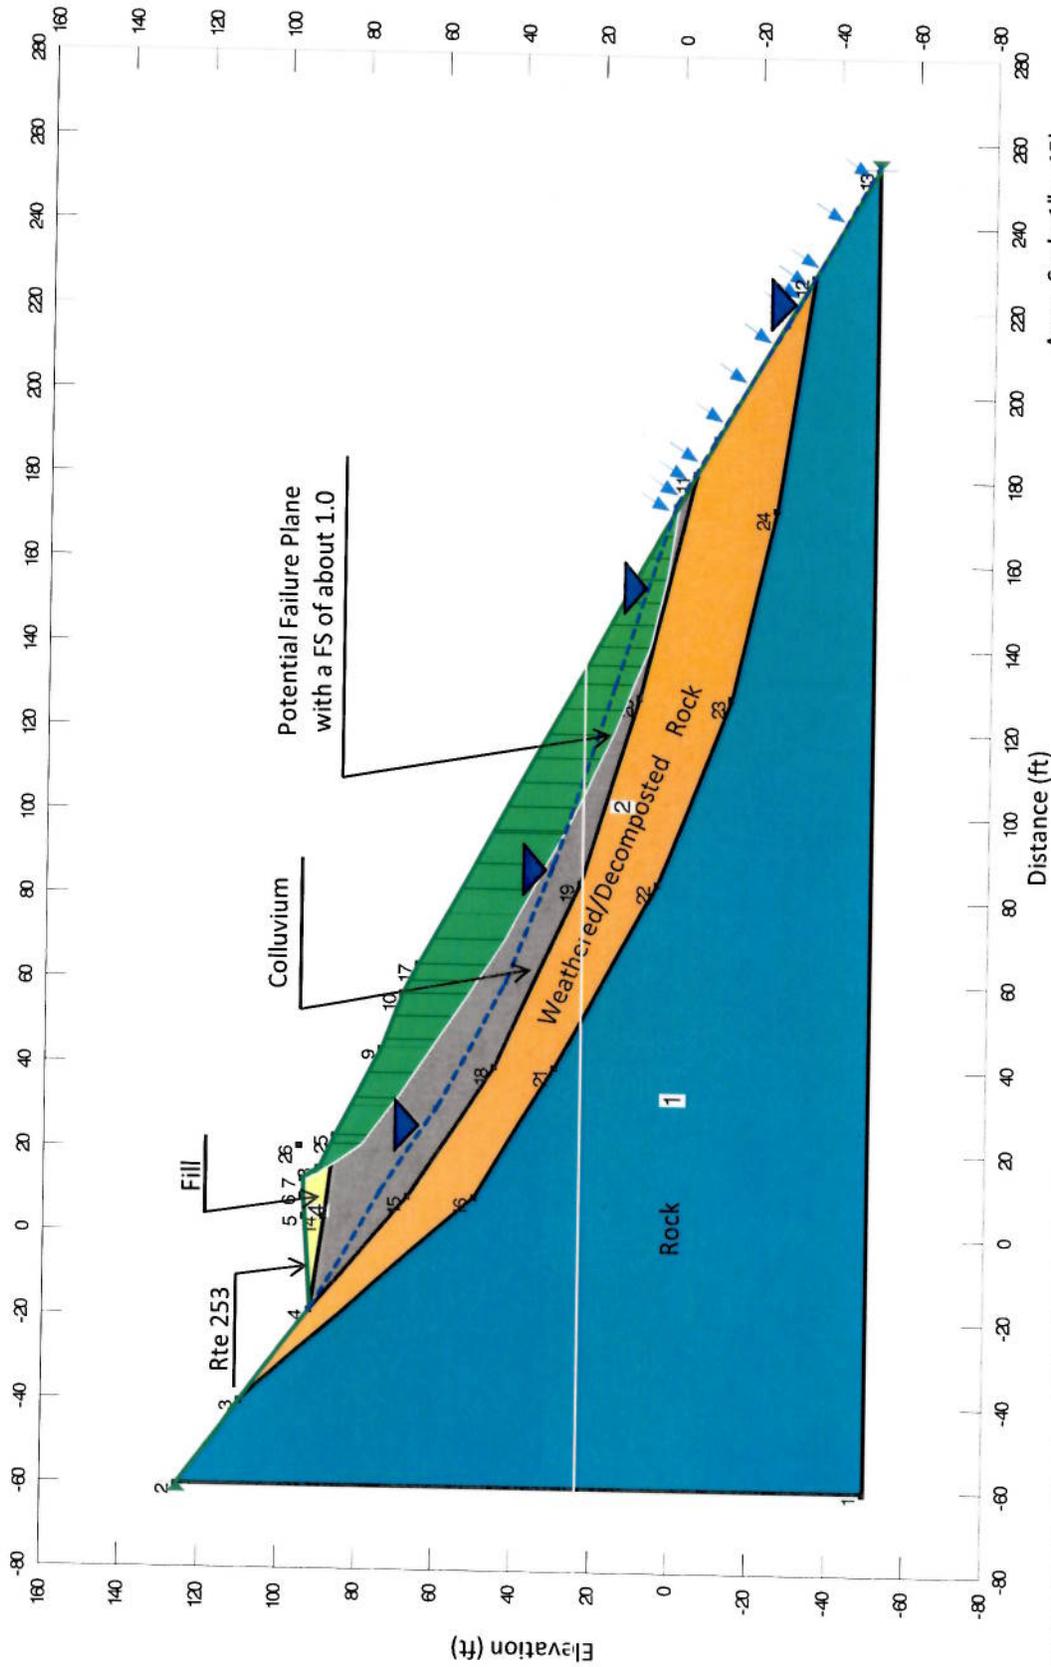
The “slide-out” was studied to back-analyze the insitu subsurface condition. No surcharge or seismic loading was considered to replicate the actual condition. Based on the study, the failure

plane took place primarily in the colluviums extending about 200 feet longitudinally and about 90 feet transversally between its head and toe. Estimated engineering parameters for the subsurface materials are summarized in Table 4 below. Figure 5 in the Appendix shows the potential failure plane on the two dimensional Slope/W model.

Based on the above study, without remediation, the colluviums may experience further downward movement resulting in additional “slide-out” with a trigger condition, such as a heavy storm similar to that occurred on March 2011. The proposed soldier pile tieback wall is suitable for use to remediate the current “slide-out” and to prevent future movement at the site.

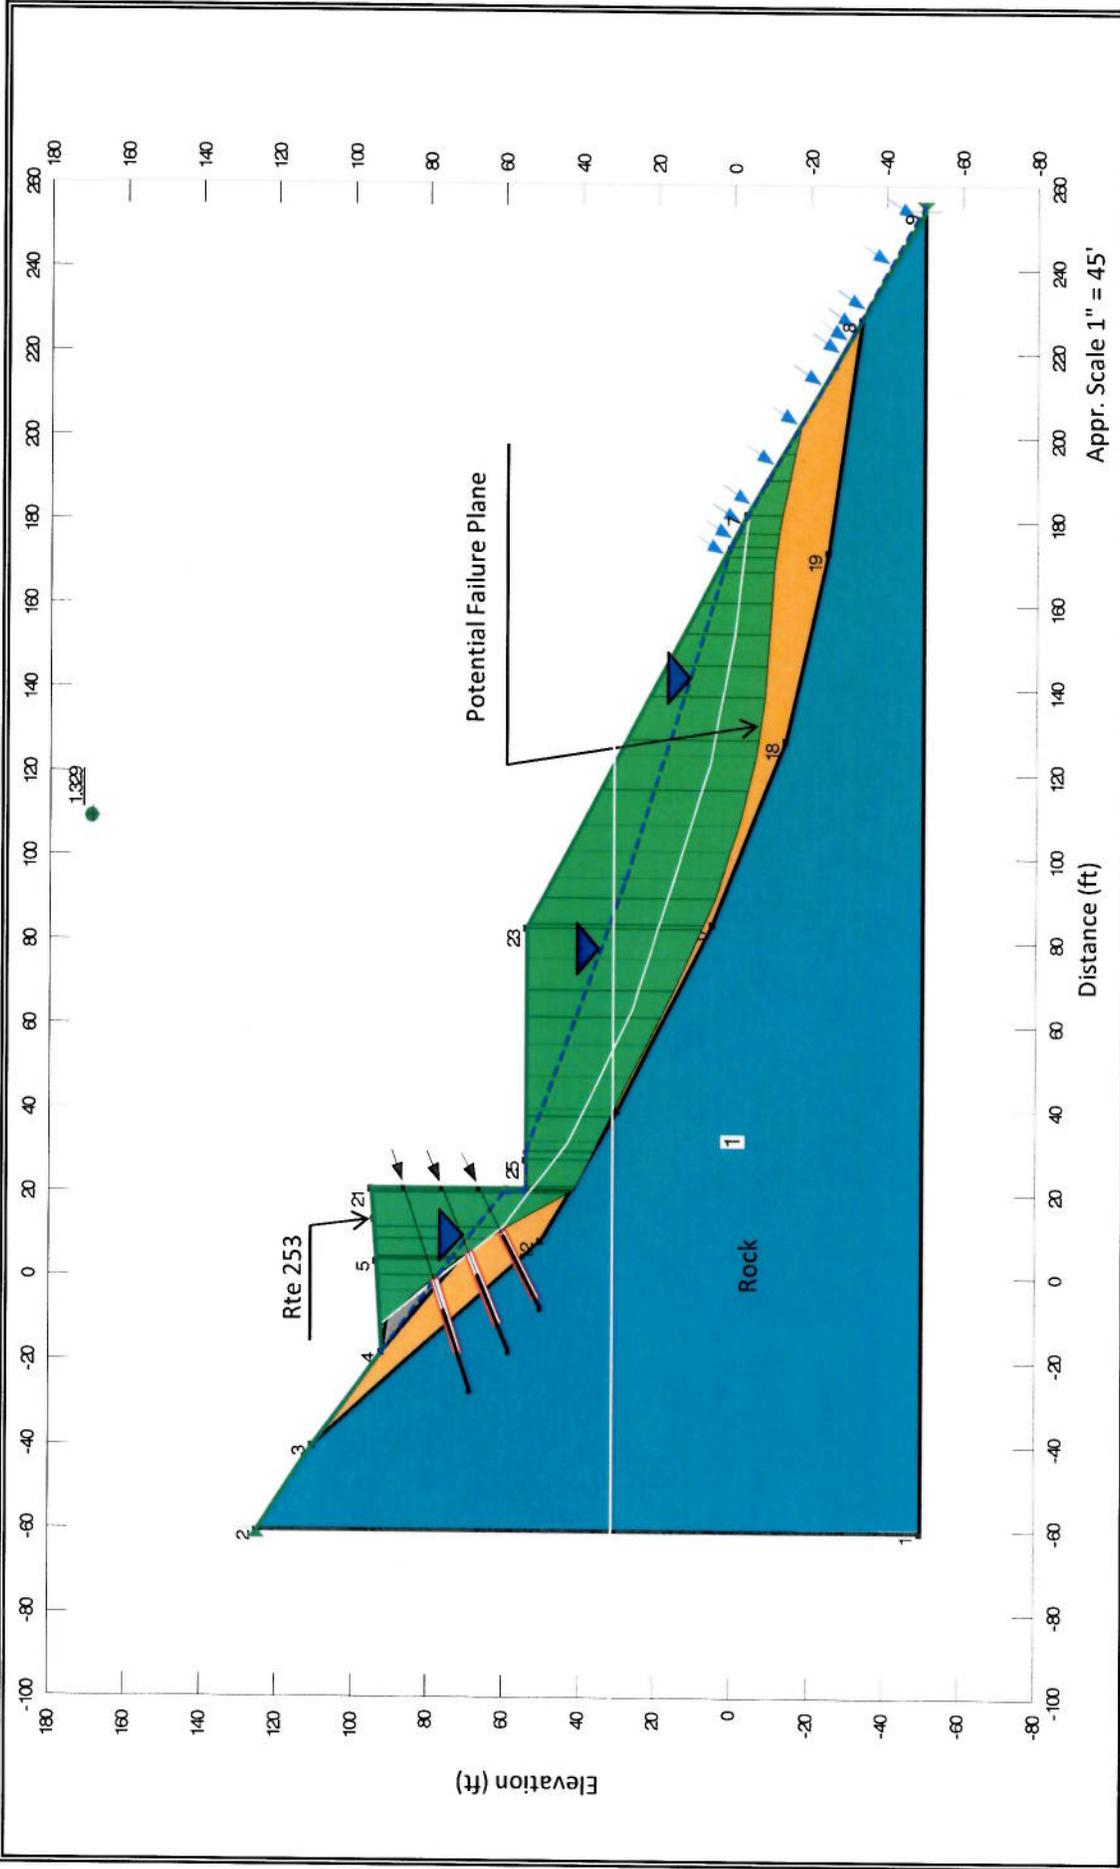
With the above engineering parameters, the proposed soldier pile and tieback wall system was analyzed with a static surcharge load of 240 pounds per square foot and a seismic load consisting of a horizontal acceleration coefficient, k_h , equaling to one third of the PGA. A design wall height of 40 feet was considered such that the wall would be extended below the bottom of the colluvium. Based on our conversation with your office, 3 rows of tiebacks were considered with vertical spacing of 10 and 12 feet. Based on the analysis, Table 5 below summarizes the minimum bond and unbond lengths required for the tiebacks to satisfy global stability. A plot of the soldier pile tieback wall with the minimum satisfying factor of safety for global stability is shown in Figure 6 in the Appendix.

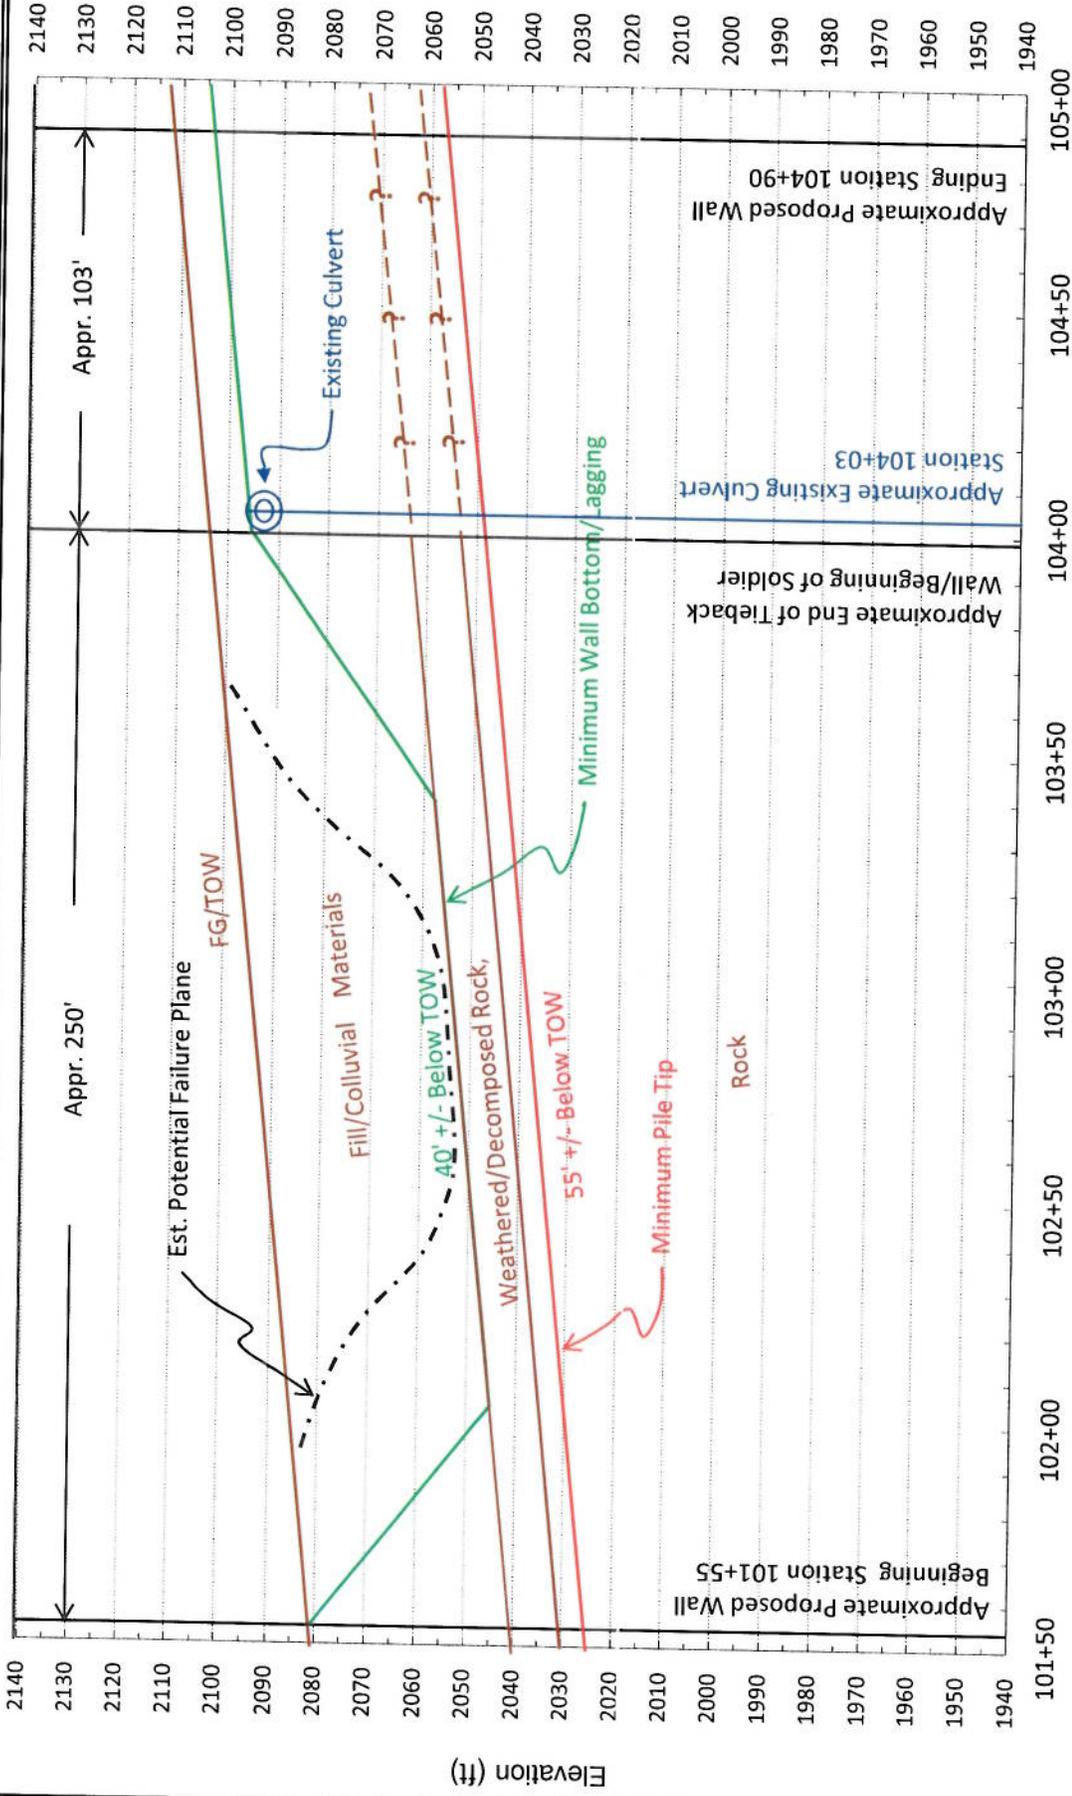
**Approximate Wall Profile
(Wall Bottom & Pile Tip)**

A design height of 40 feet from top of wall (TOW) to bottom of lagging is recommended for the soldier pile tieback wall such that the bottom of the lagging will be extended below the bottom of the colluvium. Based on the provided survey result and cross sections, the original ground in the area to receive the soldier pile wall is about 3 to 6 feet below the TOW. It is anticipated that minor excavation (less than 2 feet) will be required to remove the topsoil and loose surficial materials and to place the lagging. Therefore, for estimation purposes, the soldier pile wall may be considered as 8 feet high. At the ends of the walls, the bottoms of the walls maybe stepped to aid in construction. The recommended stepping ratio is 1.5:1 (H:V). In the area where the walls are joining together, the wall height will need to be transitioned from 40 feet (soldier pile tieback wall) to about 8 feet (soldier pile wall). A transitioning/stepping ratio of 1:1 may be used if 1.5:1 ratio cannot be realized due to site limitation. A plot showing the recommended design wall height and wall length is provided in Figure 7 in the Appendix.

Based on the provided survey result, the General Plan, and our field investigations, a design wall length of about 250 feet, approximately from Station 101+55 to Station 104+03 is considered suitable for the soldier pile tieback wall at the site. Based on the General Plan, the soldier pile wall is about 90 feet long, approximately from station 104+03 to Station 104+90.
