INFORMATION HANDOUT

For Contract No. 02-2E8004

At 02-Sis-5-R7.2

ASBESTOS AND LEAD-CONTAINING PAINT SURVEY REPORT

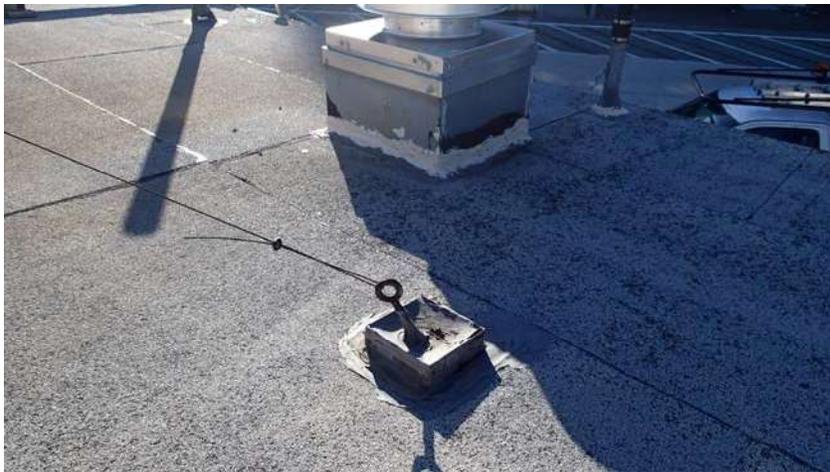
Photo 2 – Office roof and asbestos-containing roof mastic

We also recommend the notification of contractors (that will be conducting demolition, renovation, or related activities) of the presence of asbestos in their work areas (i.e., provide the contractor[s] with a copy of this report and a list of asbestos removed by contractor[s] during subsequent abatement activities). Personnel not trained for asbestos work should be instructed not to disturb asbestos.

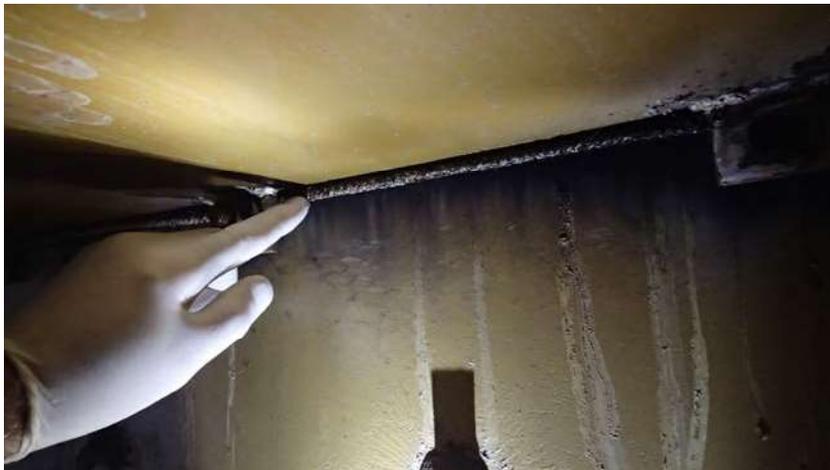
Photo 3 – Asbestos-containing boiler gasket material, boiler room

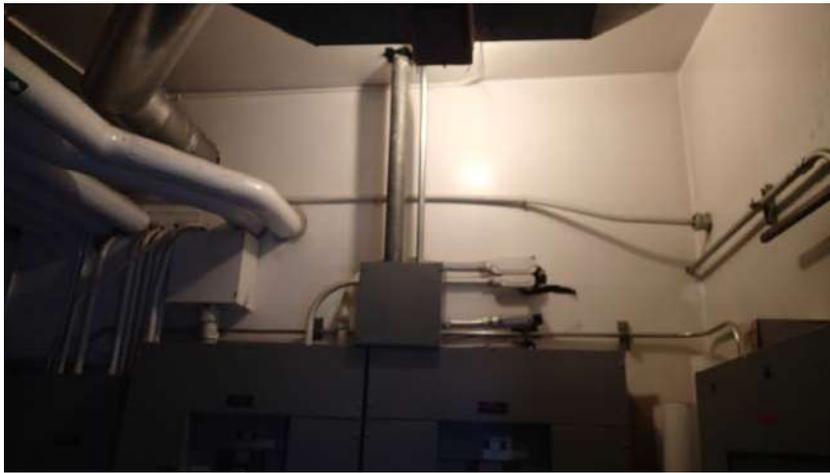
Photo 4 – Non-suspect yellow fiberglass thermal system insulation and asbestos-containing gypsum board wall system, boiler room

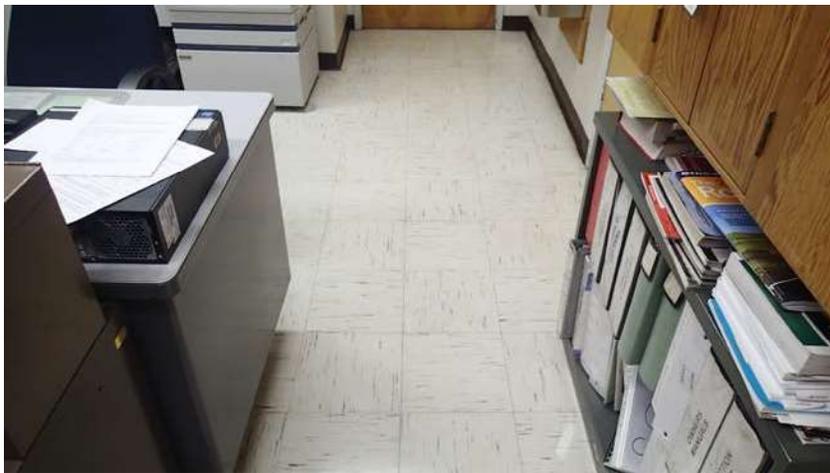
Photo 5 – White 12-inch by 12-inch resilient floor tile with asbestos-containing mastic, offices

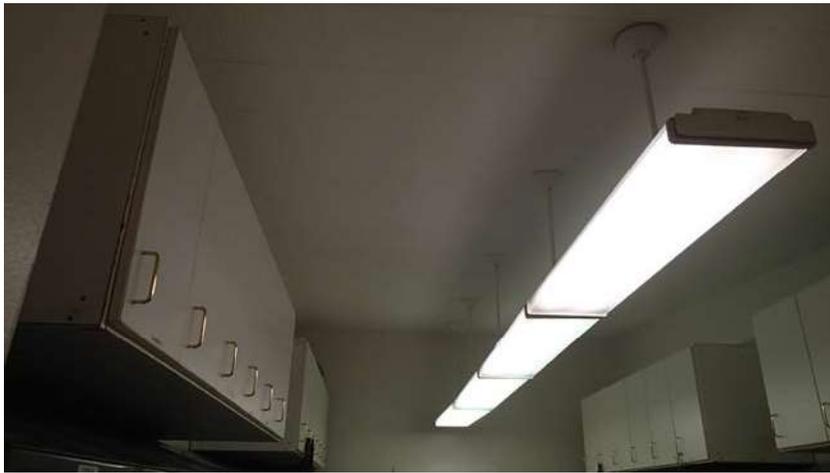
Photo 7 – 12-inch by 12-inch acoustical ceiling tiles and asbestos-containing gypsum board wall system, offices

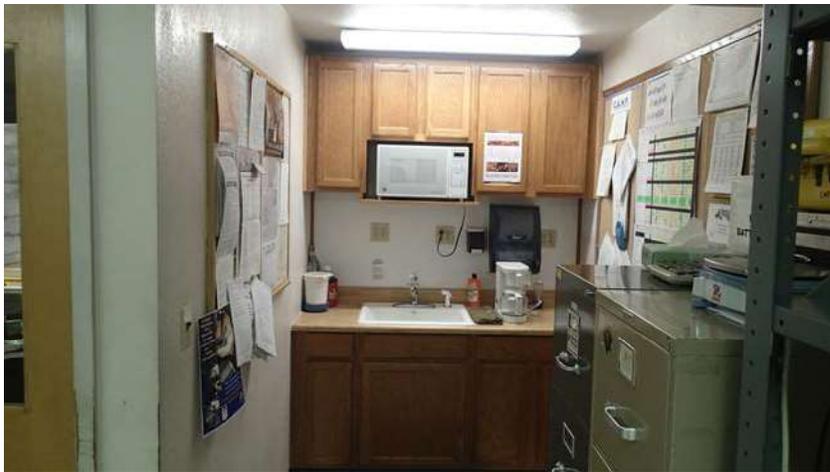
Photo 8 – Wall texture and asbestos-containing gypsum board wall system, offices

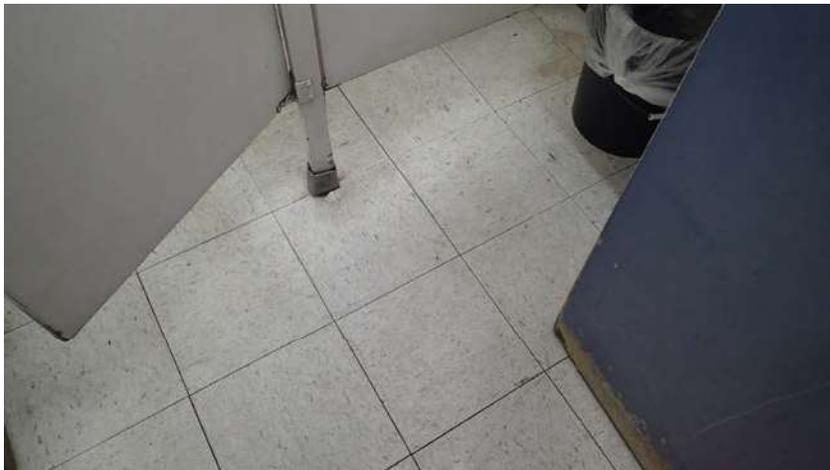
Photo 9 – White 12-inch by 12-inch resilient floor tiles with asbestos-containing mastic, exterior restrooms

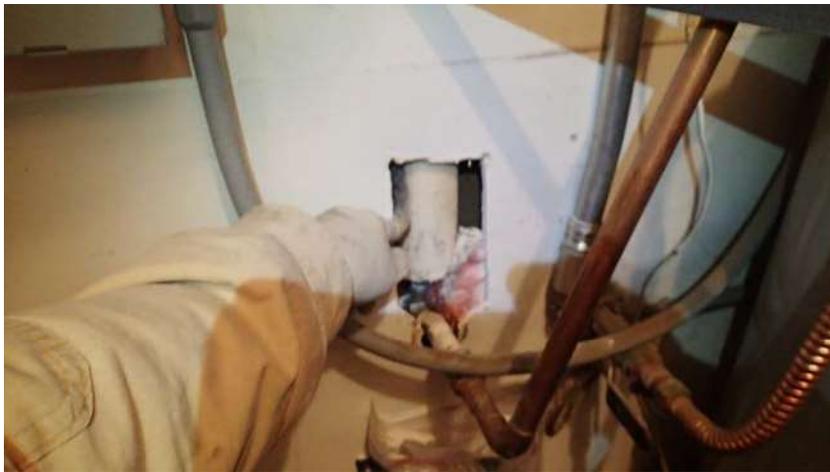
Photo 11 – Asbestos-containing thermal system insulation, boiler room and office wall and ceiling cavities

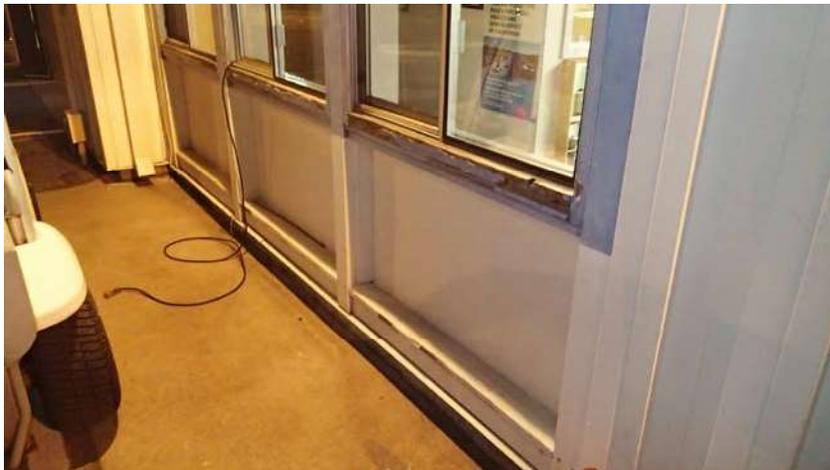
Sample P1 representing approximately 10 square feet of deteriorated dark gray trim exhibited a total lead concentration of 1,200 mg/kg and a TCLP lead concentration of 0.98 mg/l.

Deteriorated gray trim sampled during our survey would be classified as California hazardous based on lead content. As such, the deteriorated paint must be removed and disposed of prior to renovation, demolition, or other activities that would disturb the paint.

Photo 12 – Exterior wall and trim paint

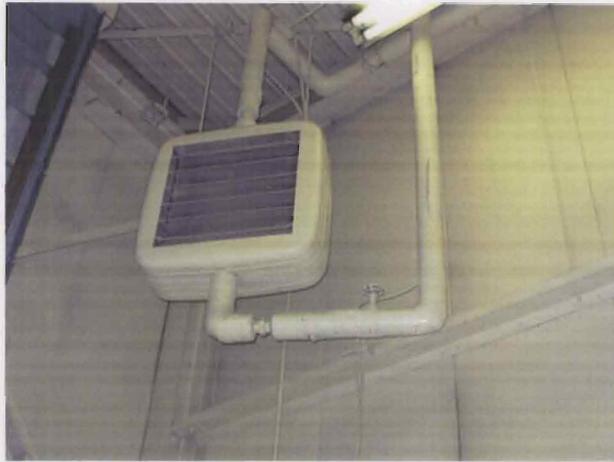
Photo 4 – Thermal system insulation (3.5-inch diameter)

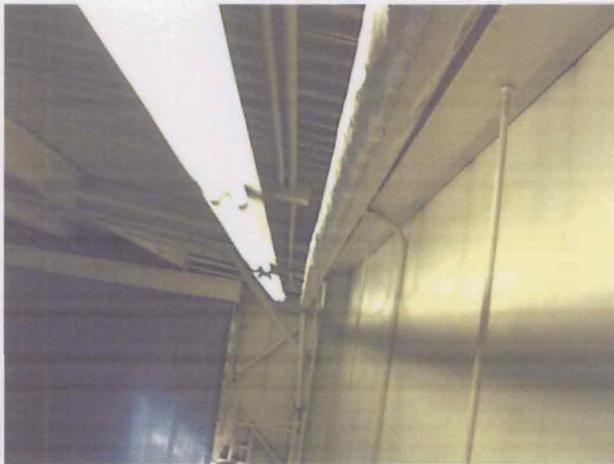
Photo 5 – Thermal system insulation (2-inch diameter)

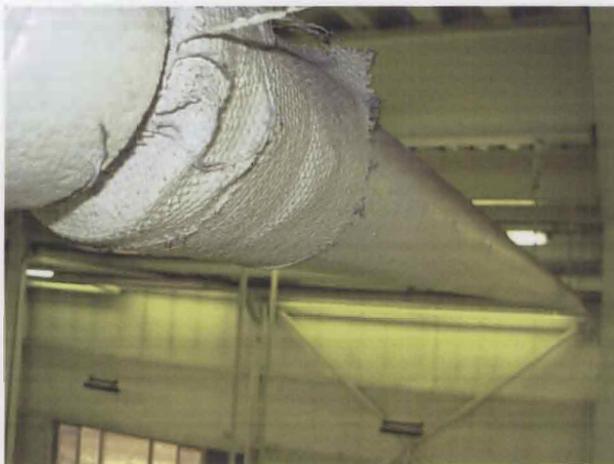
Photo 6 – Thermal system insulation (3.5-inch diameter)

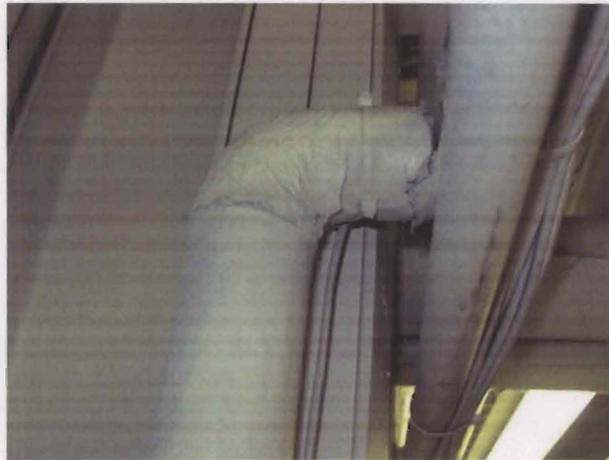
Photo 7 – Thermal system insulation (5-inch diameter)

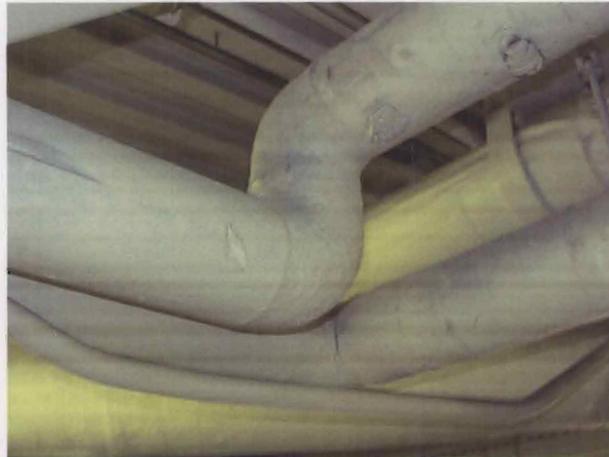
Photo 8 – Thermal system insulation (7-inch diameter)

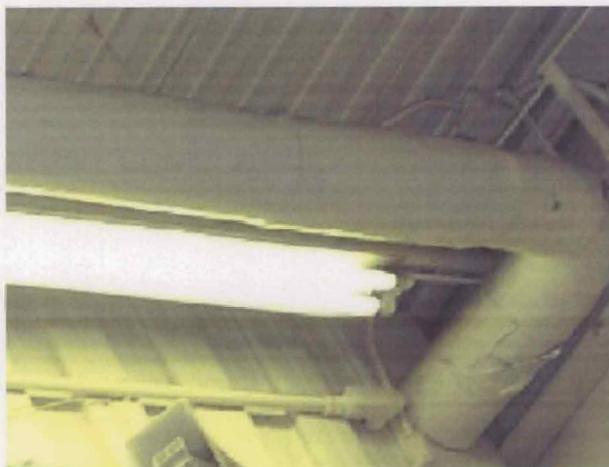
Photo 9 – Thermal system insulation (9-inch diameter)
