INFORMATION HANDOUT

**For Contract No. 03-1A8434
NEAR SOUTH LAKE TAHOE
FROM CASCADE ROAD TO UPPER EMERALD BAY ROAD**

**Identified by
Project ID 03000002244**

03-ED-89-PM 13.8/18.0
 Geotechnical Design Report

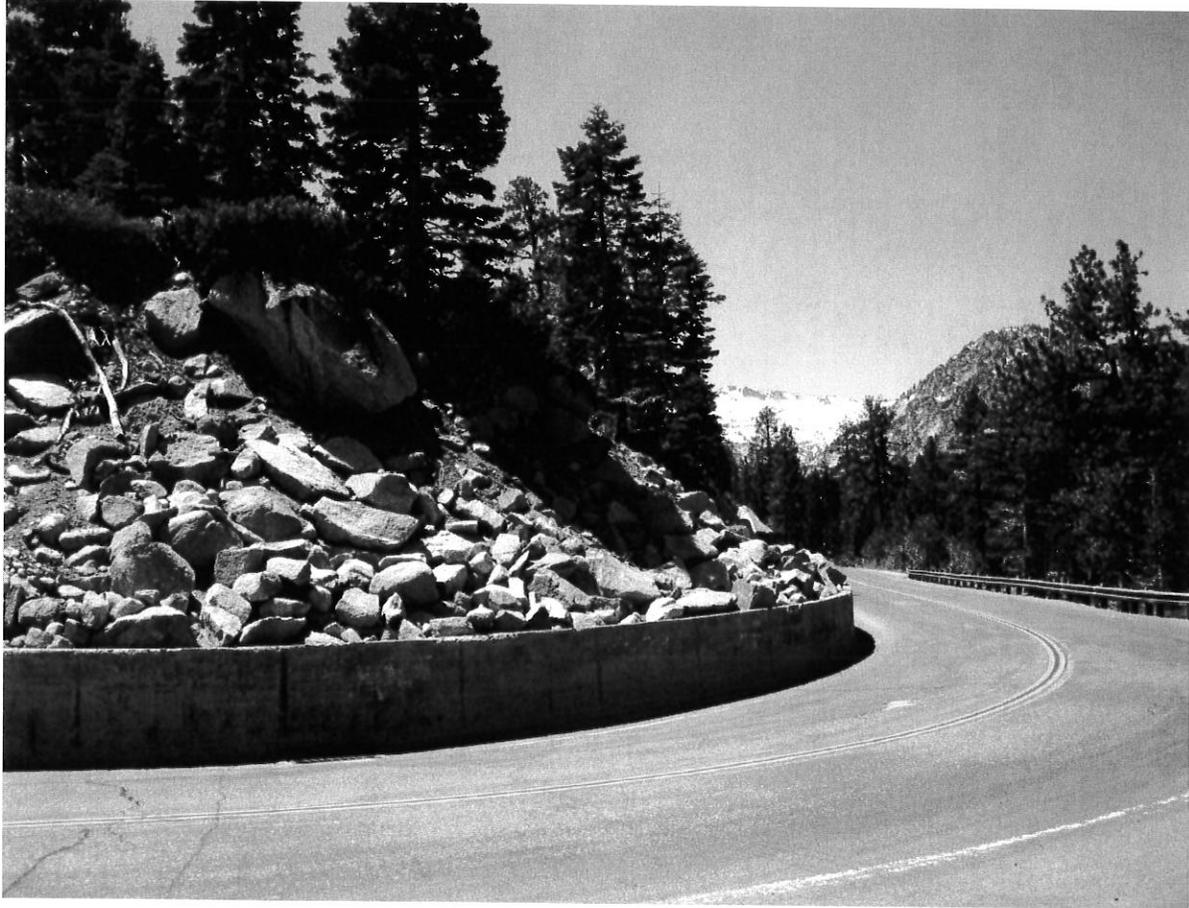
Plate No.
 2a

Within the project limits, Route 89 is roughly oriented north-to-south and is composed of an asphalt concrete-paved, two-lane roadway on the slope above Emerald Bay (see Plate No. 1). This section of Route 89 has variable shoulder width. Cut slopes varying between 1.5:1 H:V to 1:1 and extending up to a height of 90 ft in the glacial till and granite bedrock materials. Boulders were noted adjacent to the road way that ranged from 3 to 8 feet in diameter (see Plate No. 2a).

Looking north west at "A" Line approximately STA 205+50.

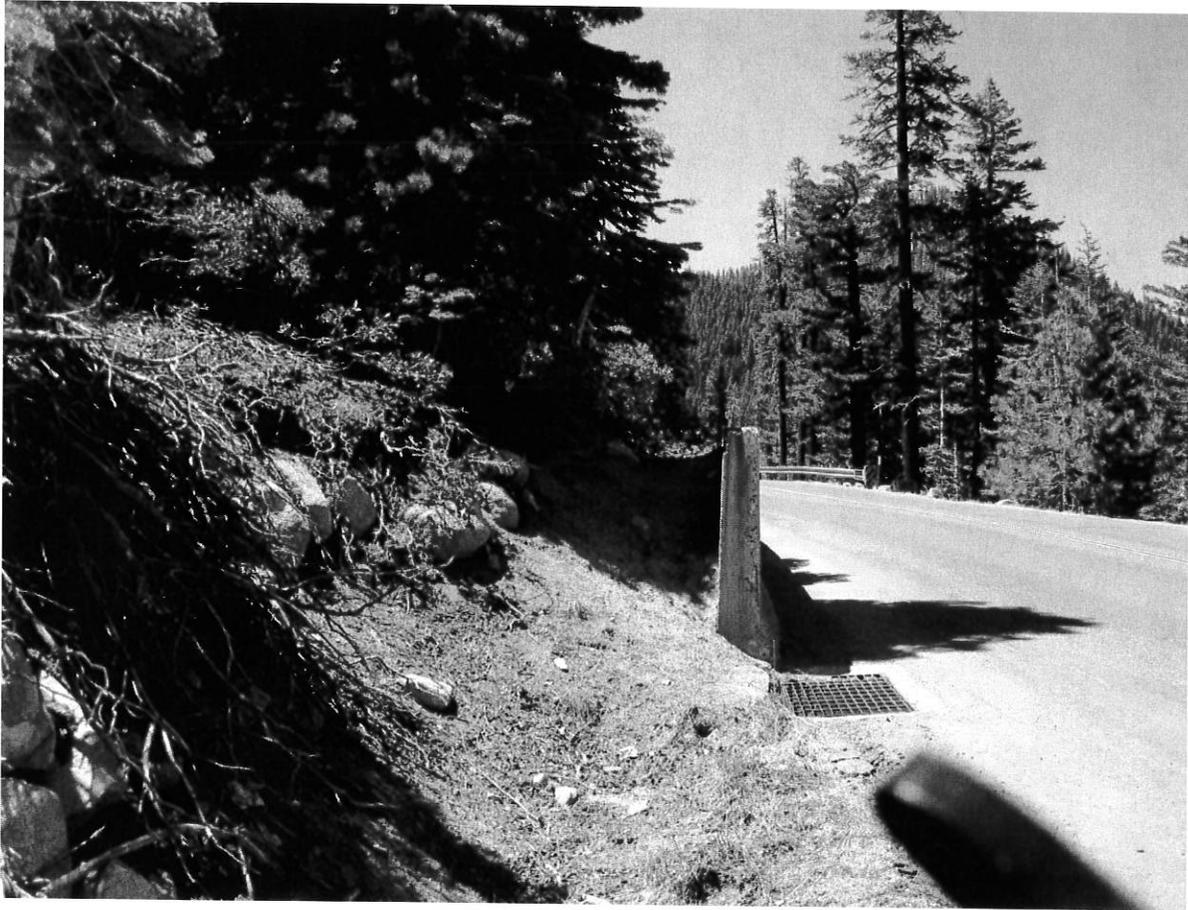
Plate No.
2b

A site reconnaissance was performed on May 16, 2012. No subsurface exploration, sampling, or testing was performed. During the site reconnaissance, most of the slopes appeared generally to be in good condition and repair. Soil loss appears to have occurred at the ends of retaining walls, most likely due to erosion (see Plate No. 2b).

Looking north at "A" Line approximately STA 291+00.

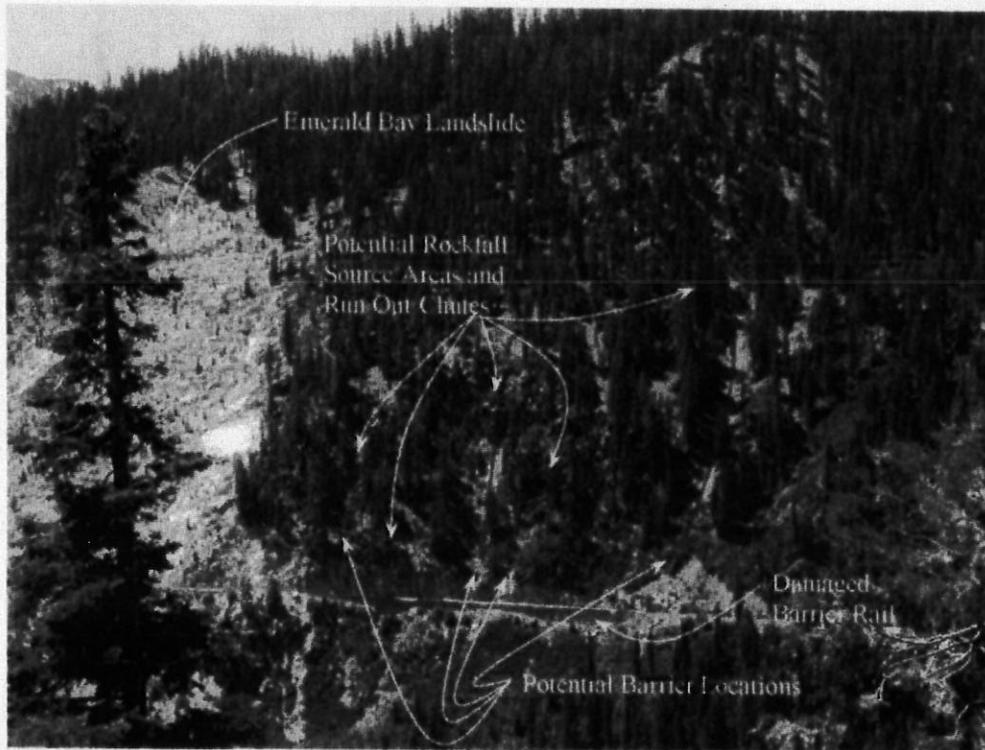
Greg Slocum, Structures Design, is preparing an Advanced Planning Study for the repair/replacement of a rock-type barrier rail along Highway 89 in El Dorado at Kilometer Post 26.6. The existing barrier has been severely damaged by rockfall. Mr. Slocum asked the Office of Geotechnical Design - North (OGDN) to recommend appropriate rockfall mitigation measures for this site. This section of the highway is located on the slope above the western end of Emerald Bay, Lake Tahoe. It is located next to the Emerald Bay landslide (see Photograph 1 below).

Photograph 1. A photograph taken looking southwest toward of the slope above the damaged barrier and the Emerald Bay landslide.
