GEOTECHNICAL DESIGN REPORT

ROUTE: 03-ED-193-23.4

Date: January 27, 2012
File: 03-ED-193-PM 23.3/23.5
03-1F6001
0300020566
Reconstruction of Embankment
Slope with Gabion Wall

Subject: Geotechnical Design Report

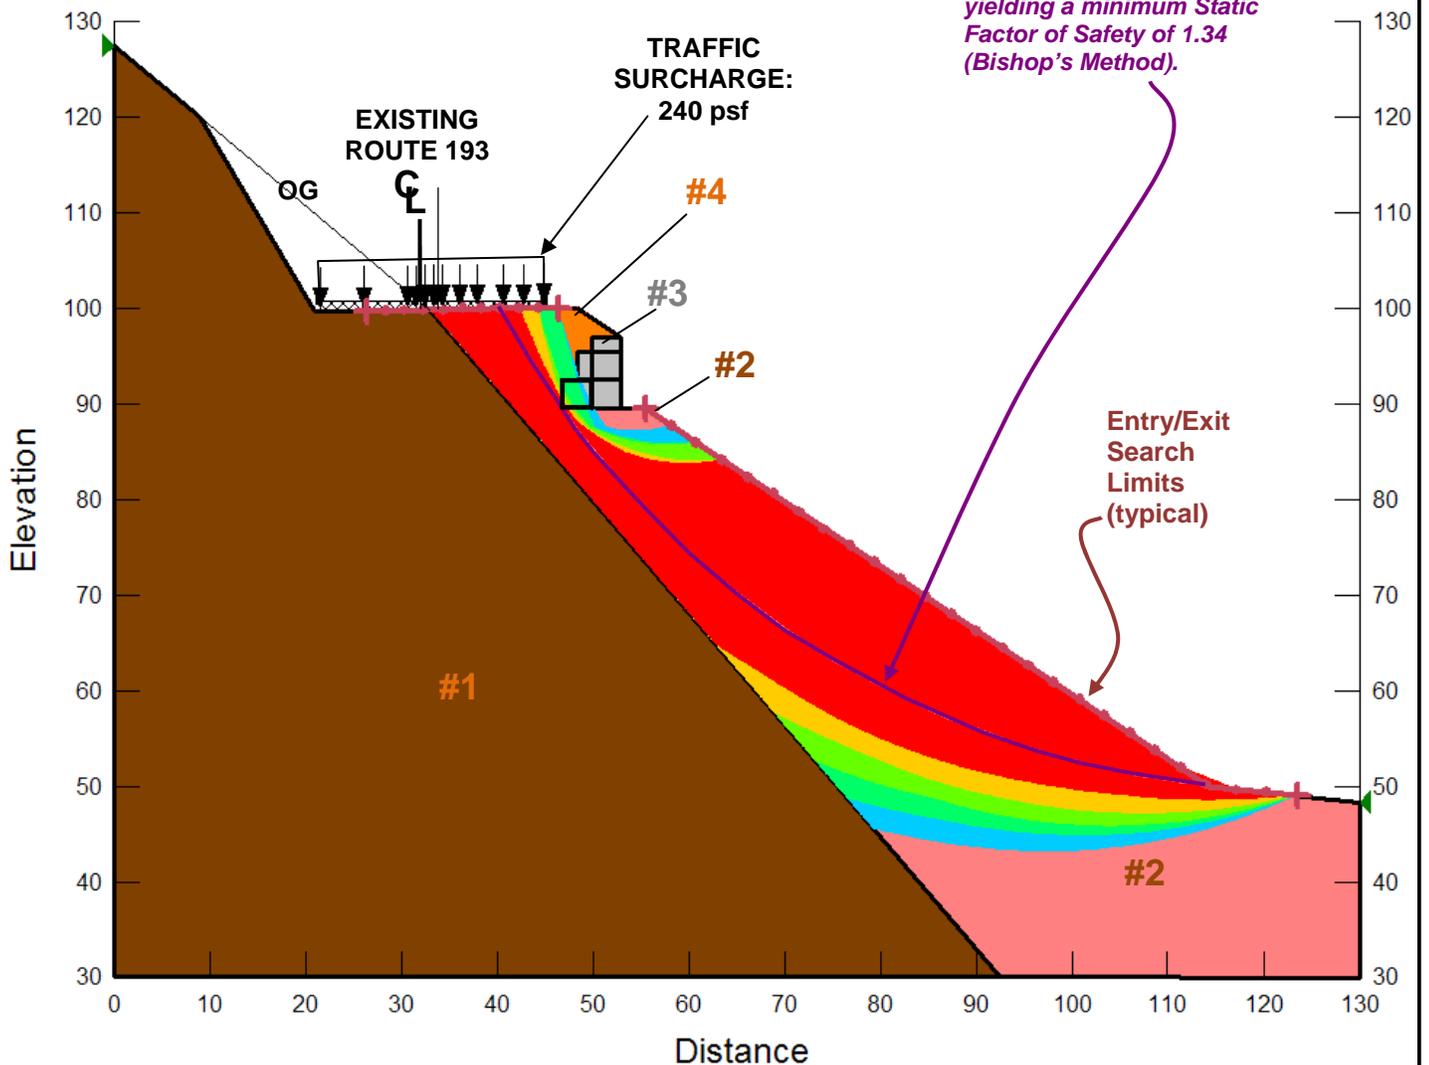
Plate
No. 2

The minimum live load surcharge for “vehicular loading” of 0.240 ksf (per Caltrans BDS Article 5.5.5.10.5) was applied in the travel way for all analyses performed. Caltrans Standard Specifications 2010, Article 72-16.02G indicates that rock-filled gabions must have a unit weight of at least 110 pcf. For a typical gabion fill porosity of 30%, this roughly corresponds to a gabion stone unit weight of 157 pcf. Initially, a slope stability limit equilibrium method (LEM) of analysis (per SlopeW software, Reference No. 11) was performed on the existing site conditions utilizing approximated, generalized strength parameters; the analysis yielded a minimum factor of safety (FS) of 1.34. Subsequently, a LEM analysis was performed for the highest proposed wall configuration and yielded a minimum FS of 1.34 for overall stability (see Plate No. 2). In accordance

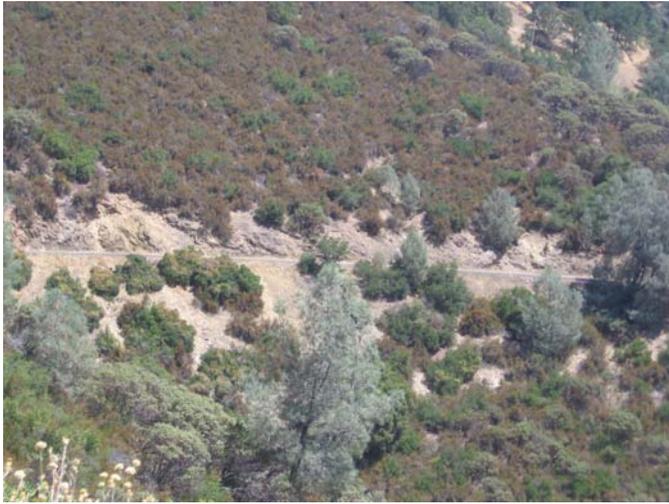
Photo No. 1. Project site vantage point view from easterly direction (photo taken on 8-25-11).

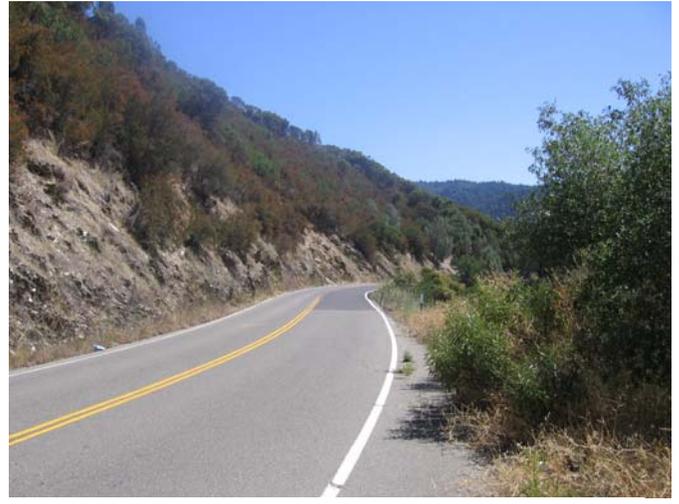
roadway was absent of any significant signs of distress. A bulk sample was obtained of the near-surface embankment materials, and was retrieved from select locations and composited for laboratory testing. Site description comments in this section were based on a site visit made on August 25, 2011.

Photo No. 2. Project site viewing from southeasterly direction; Note pavement patch (photo taken on 8-25-11).

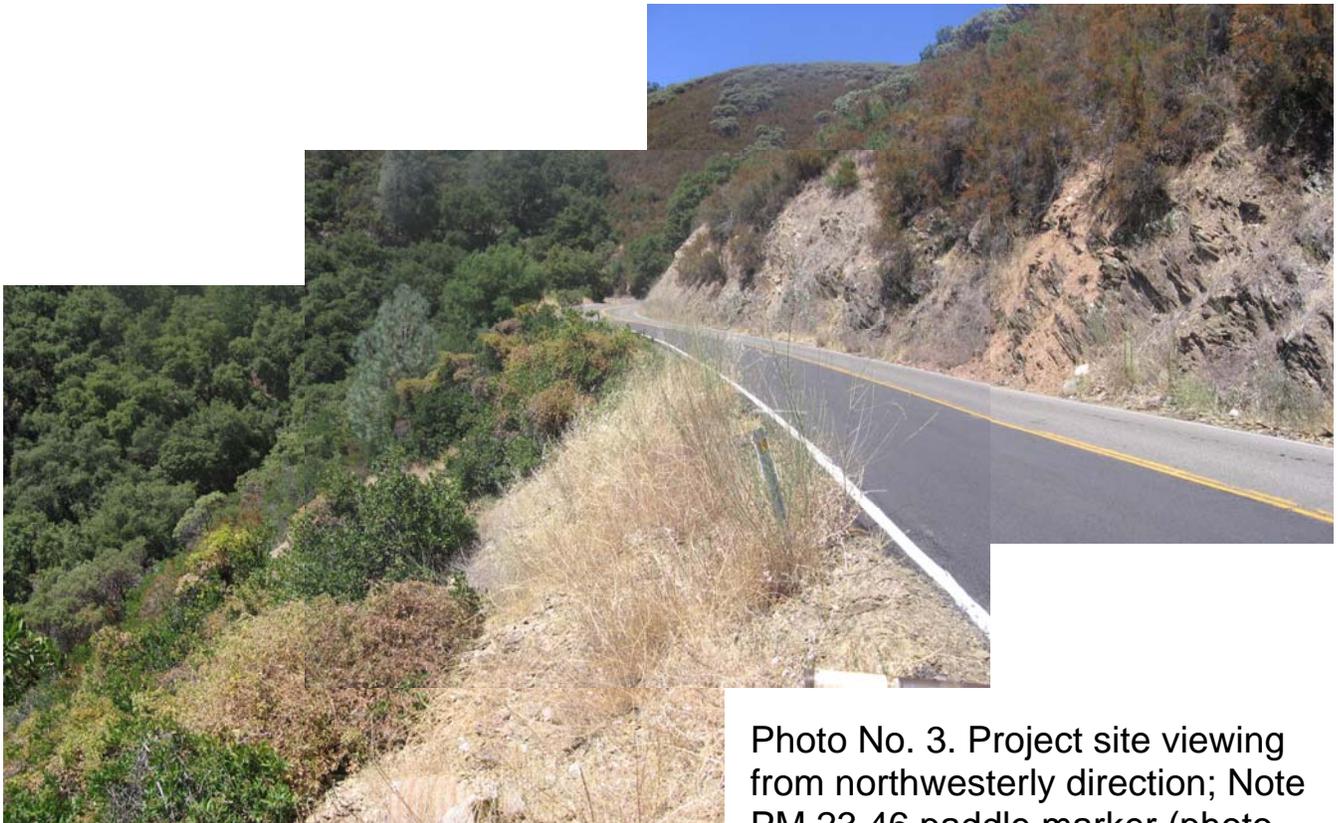
Photo No. 3. Project site viewing from northwesterly direction; Note PM 23.46 paddle marker (photo taken on 8-25-11).

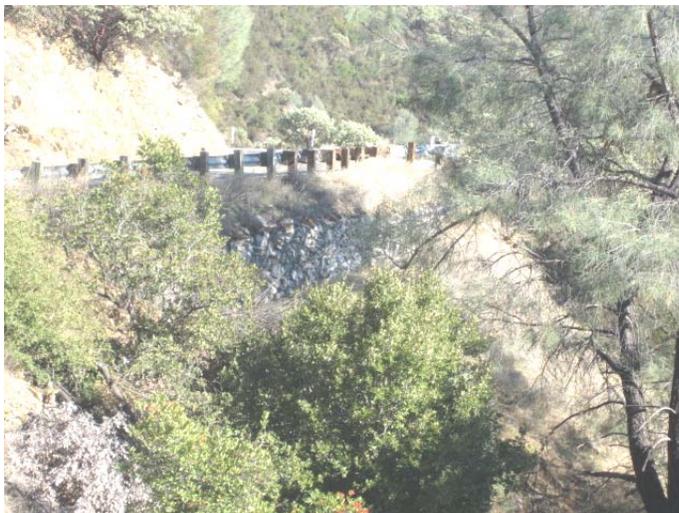
The existing gabion wall site appeared to have been constructed as indicated on the As Built project plans (see “Background” section). Embankment materials downhill, below the toe of the wall extended for about 30 feet vertically and were noted to be sloped at roughly 1.3H:1V (see photographs, Plate No. 4). The roadway pavement area behind the wall did not have any indications of post construction pavement patches. No significant distress was noted in the pavement; however, a minor (less than 3/16 inch width) longitudinal crack appears to have developed behind the heel of the wall.

Photo No. 4. Existing gabion wall (PM 23.2) site; vantage point view from southwesterly direction (photo taken on 8-25-11).

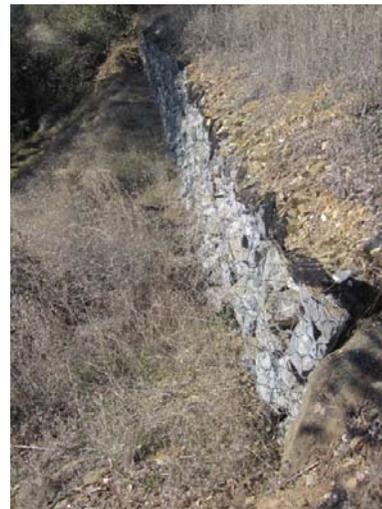
Photo No. 5. Existing gabion wall (PM 23.2) viewing from easterly direction (photo taken on 8-25-11).

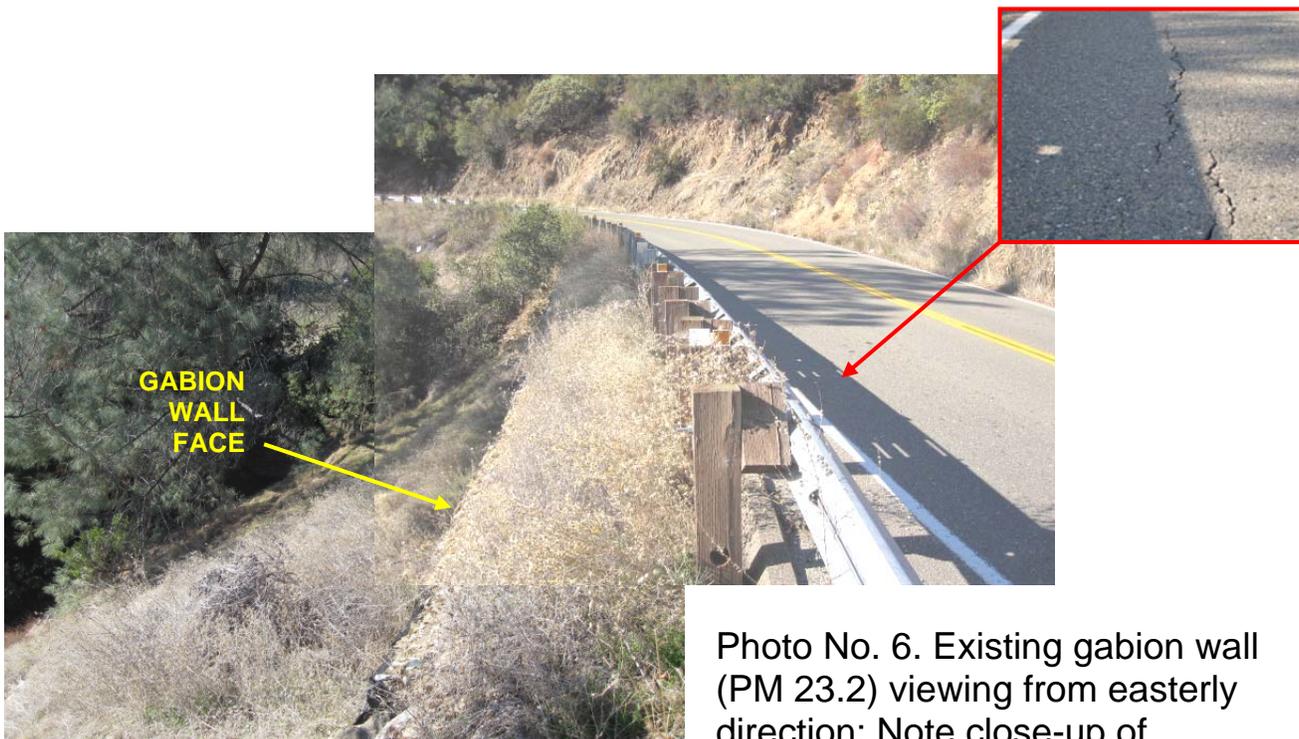
Photo No. 6. Existing gabion wall (PM 23.2) viewing from easterly direction; Note close-up of longitudinal pavement cracking (photo taken on 8-25-11).

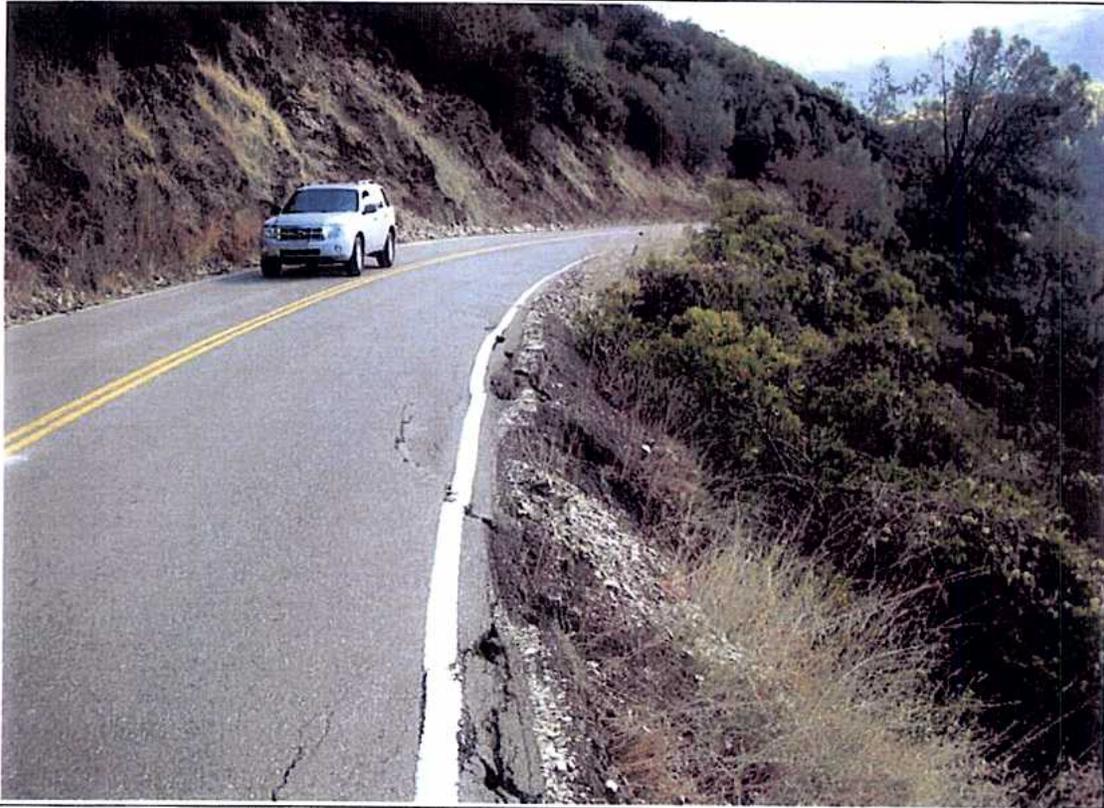
Location 1 (PM 23.45), This section of highway was previously identified as needing a retaining wall system due to slide movement. A Minor A Project is currently programmed to make permanent repairs in the 11/12 fiscal year. The recent storm has accelerated the earth movement and created uneven pavements in the travel lane. The eastbound lane currently exhibits pavement differentials of about 2" in elevation. The proposed removal and replacement of the existing asphalt concrete is only a temporary repair until the programmed permanent repairs can be constructed.

Location 1: Ed-193 PM 23.45. embankment settlement and pavement failure

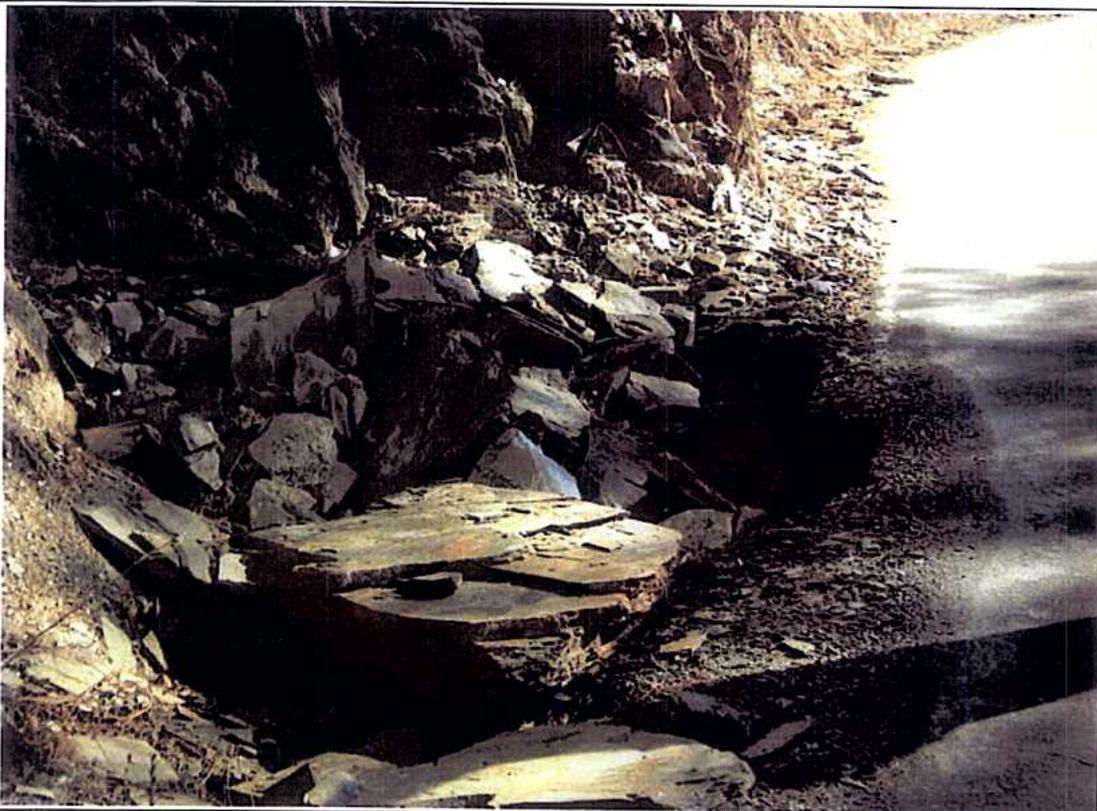
At Location 2 (PM 23.75), the cut slope has failed and plugged an existing cross culvert. The storm water traveled across highway and washed out the embankment and undercutting the pavement. On October 26, 2010, a Geotech field reviewed the site and recommended that a gabion wall be installed and pavement replaced.

Location 2: ED-193 PM 23.75 Plugged culvert from cut slope failure.

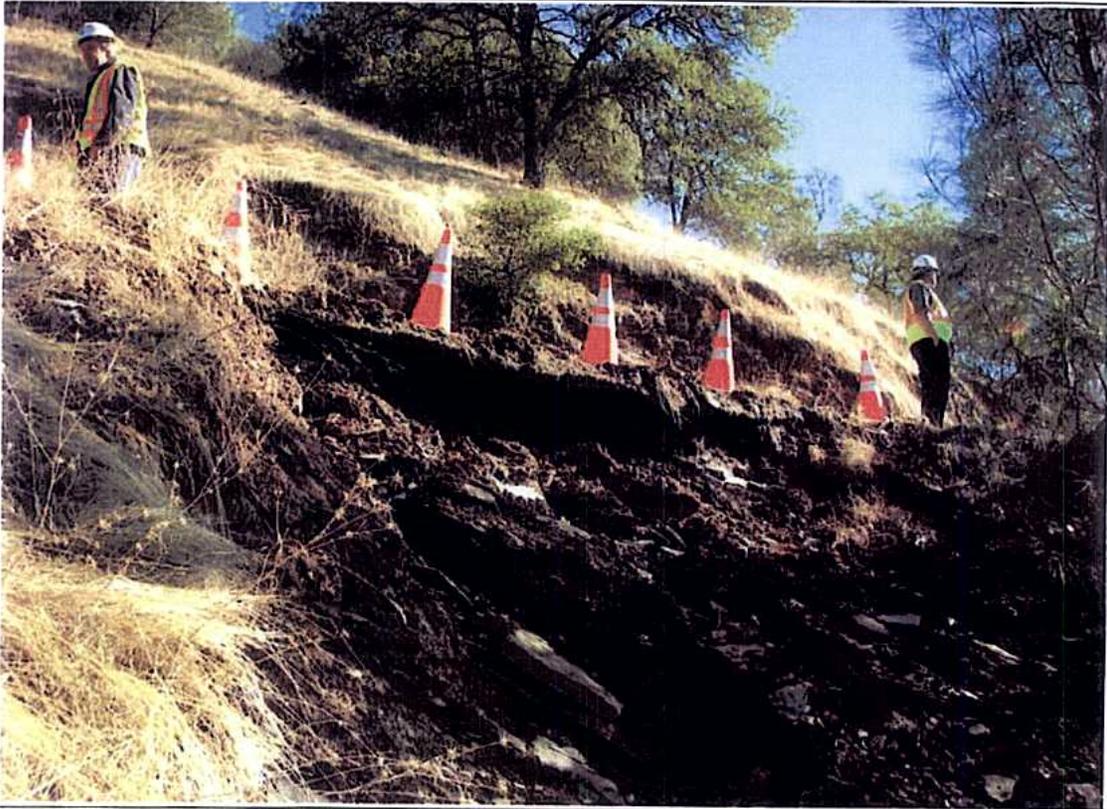
Location2: ED-193 PM 23.75 Plugged culvert results in pavement undermining

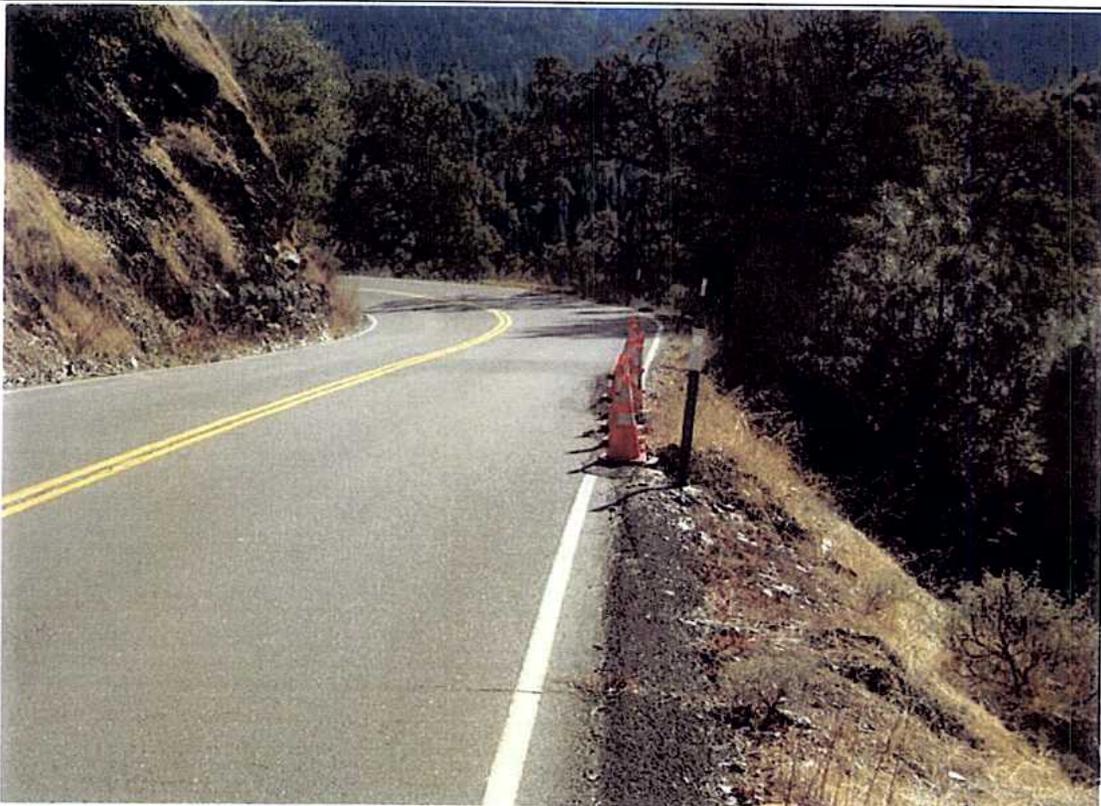
Location 2: ED-193 PM 23.75 Cones placed within travel way to let public know

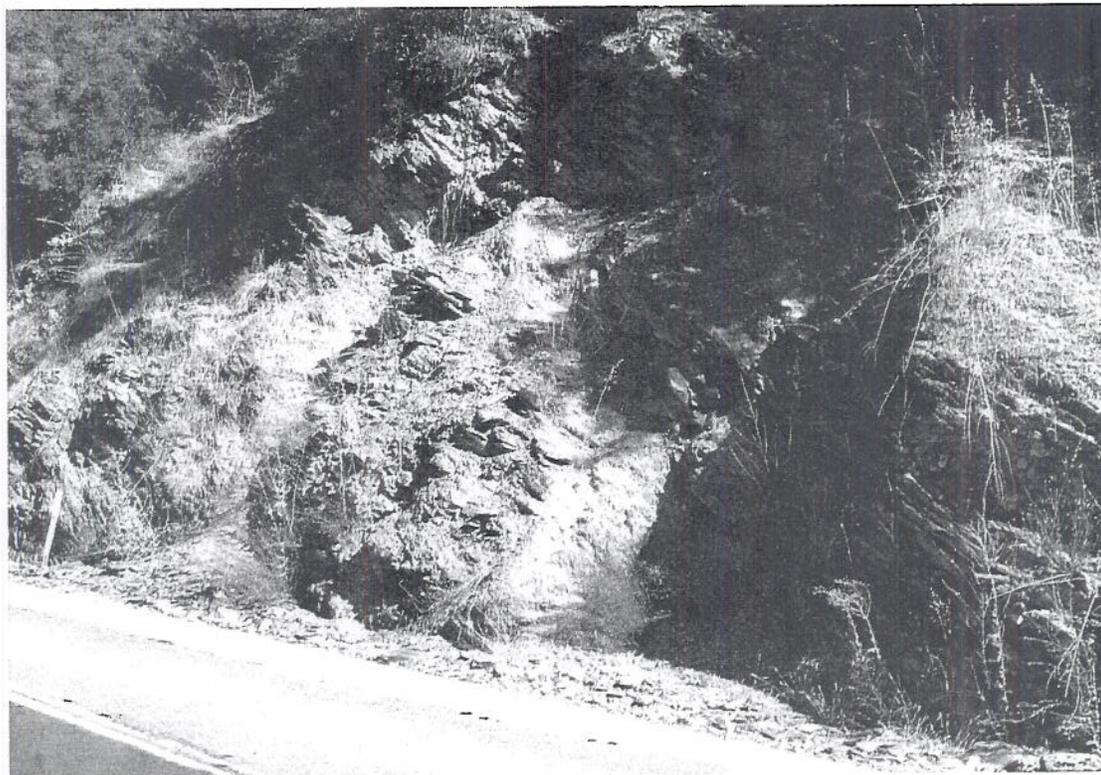
John Pfeiffer performed the geologic assessment of the outcrops visible on the site. The observed geology was generally consistent with that depicted on the referenced geologic map. The bedrock exposures observed in cut slopes on the site appeared to be comprised of highly to moderately weathered metasedimentary rock (slate). The fill material below the southbound lane was observed to consist of similar metasedimentary rock. The samples submitted for laboratory analysis consisted of a representative mix of weathered metasedimentary rock fragments and associated residual soil. Materials and features indicative of a geological environment conducive to the formation of NOA were not observed at the site. Photographs of the project area are presented in Photograph Nos. 1 through 4.

Photo No. 2 Typical exposure of weathered slate (Mariposa Formation) in the project area.

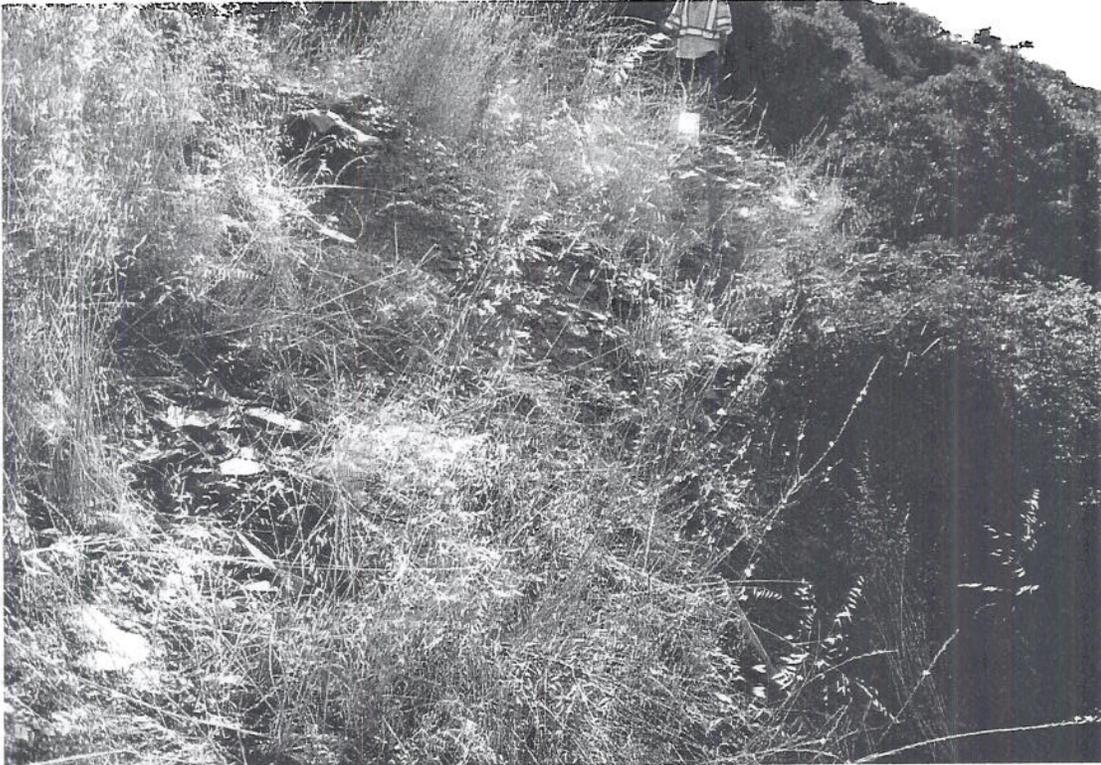
Photo No. 3 View of sample collection area downslope of southbound lane of SR-193.

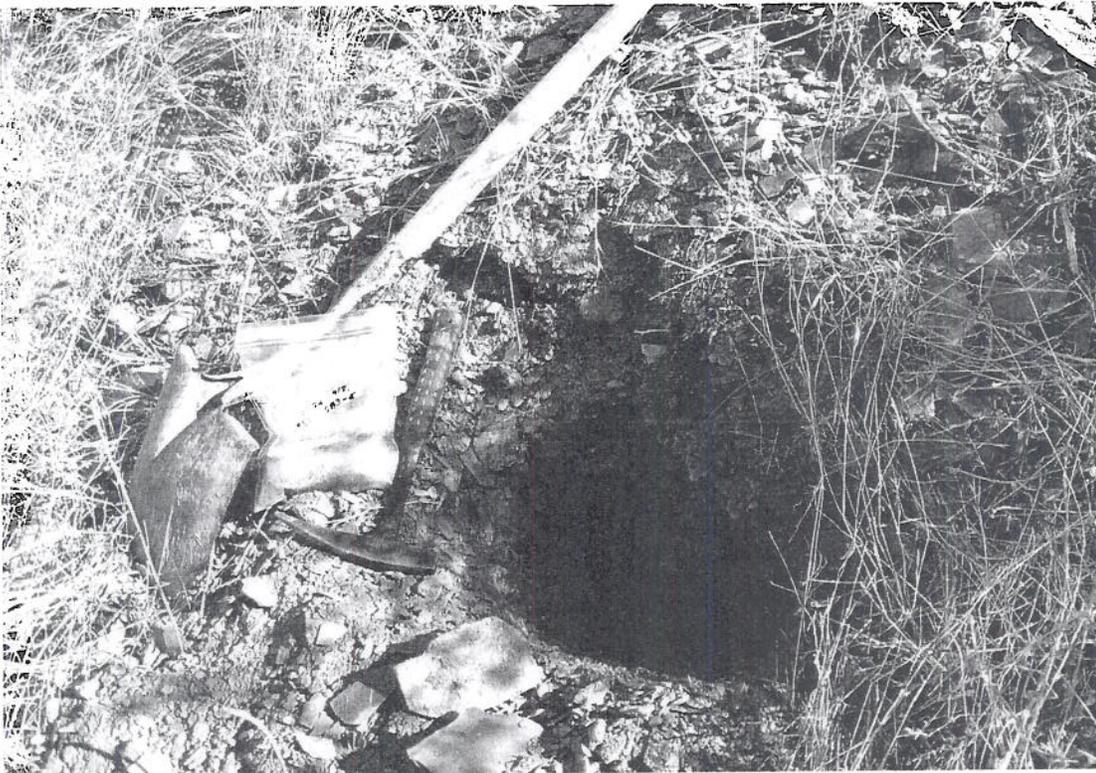
Photo No. 4 View of sample SB3-6 collection location, which is typical for the project.
