SOUTH ACCESS TO THE GOLDEN GATE BRIDGE
DOYLE DRIVE

**DRAFT
THIRD FINDING OF EFFECT
ADDENDUM**

San Francisco County, US101 KP 12.8-15.7 (PM 8.0-9.8) / SR1 KP10.9-11.4 (PM 6.8-7.1), EA 04-16370

March 2010

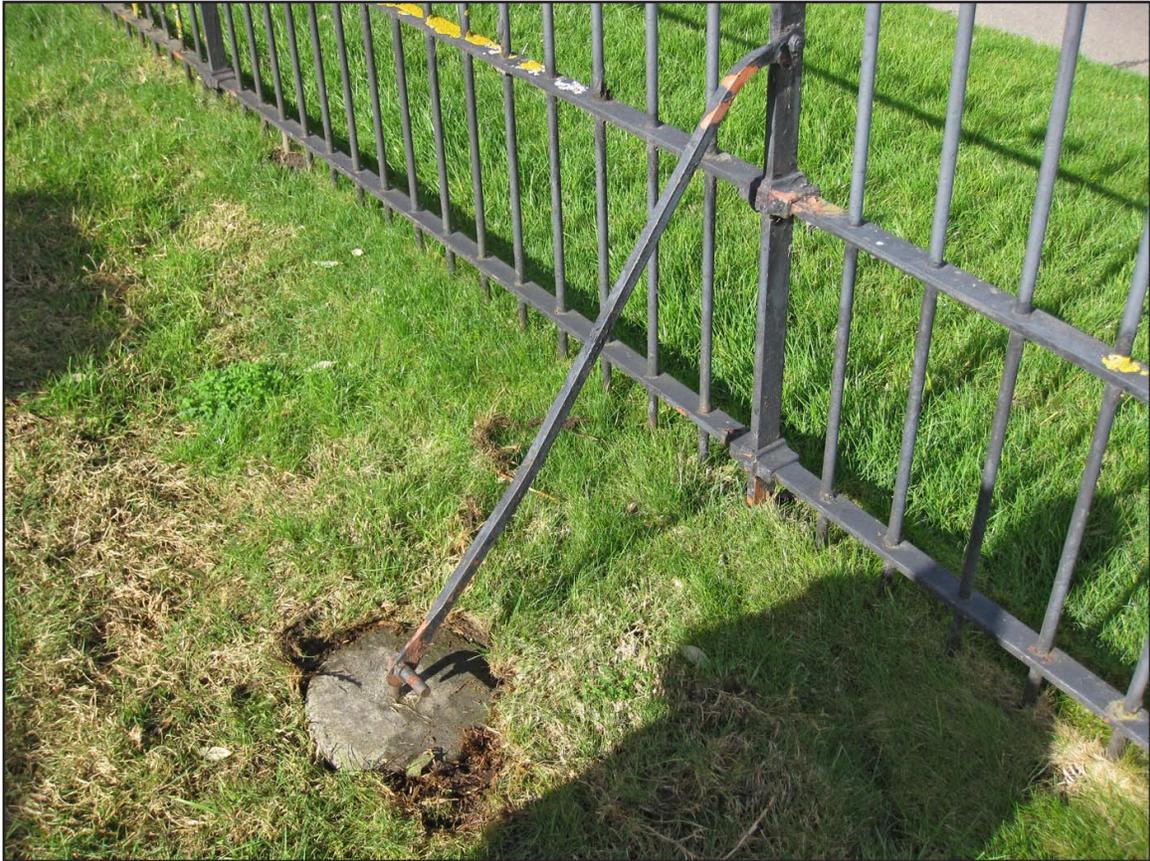
Every third segment is supported by an iron brace attached to a post and anchored in the ground with concrete to help keep the fence erect (Figures 9-2 and 9-3). The fence attaches to the western stone wall and the eastern main gate with pairs of iron brackets and bolts that secure each rail to the stone wall and masonry main gate post (Figures 9-4, 9-5, and 9-6). The general condition of the fence is poor. Numerous coats of cracked and peeling paint are visible along the fence. Areas of the fence where the iron is exposed display moderate to severe corrosion caused by water exposure and lichen and moss growth. A number of fence elements are bent, some connecting brackets are loose, and many finials are partially or completely broken off. Refer to Appendix B for a detailed description of fence conditions.

Photo 3. Brace arrangement for boundary fence along Lincoln Boulevard, facing northwest.

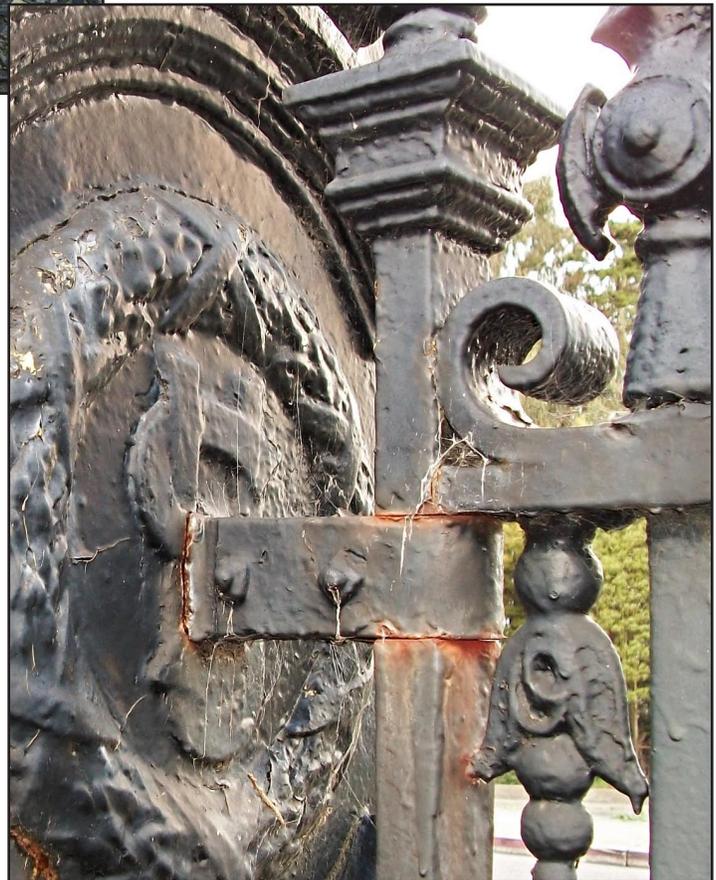
The vehicle gate possesses a lock assembly, and each pedestrian gate possesses a gate handle with lock assembly. The condition of the western gate is generally poor. Several layers of peeling and chipped paint are apparent, and exposed areas display moderate to severe corrosion. Additional poor conditions include failing hinges, corroded handles and locks, structural cracks in the gate posts, and broken or missing finials and fretwork (Figures 9-7 through 9-13). Refer to Appendix B for a detailed description of gate conditions.

Photo 9. Rusted gate hinge, facing northwest.

The iron gate and fence will be restored, with retention of as much of the original materials as possible, or with suitable substitute material, as appropriate. Paint will be removed, corroded and missing portions of the fence and gate will be replaced in kind, and the fence and gate will be repainted and re-installed in the same location and in the same order as they currently stand. The gate pillars will be restored *in situ*.

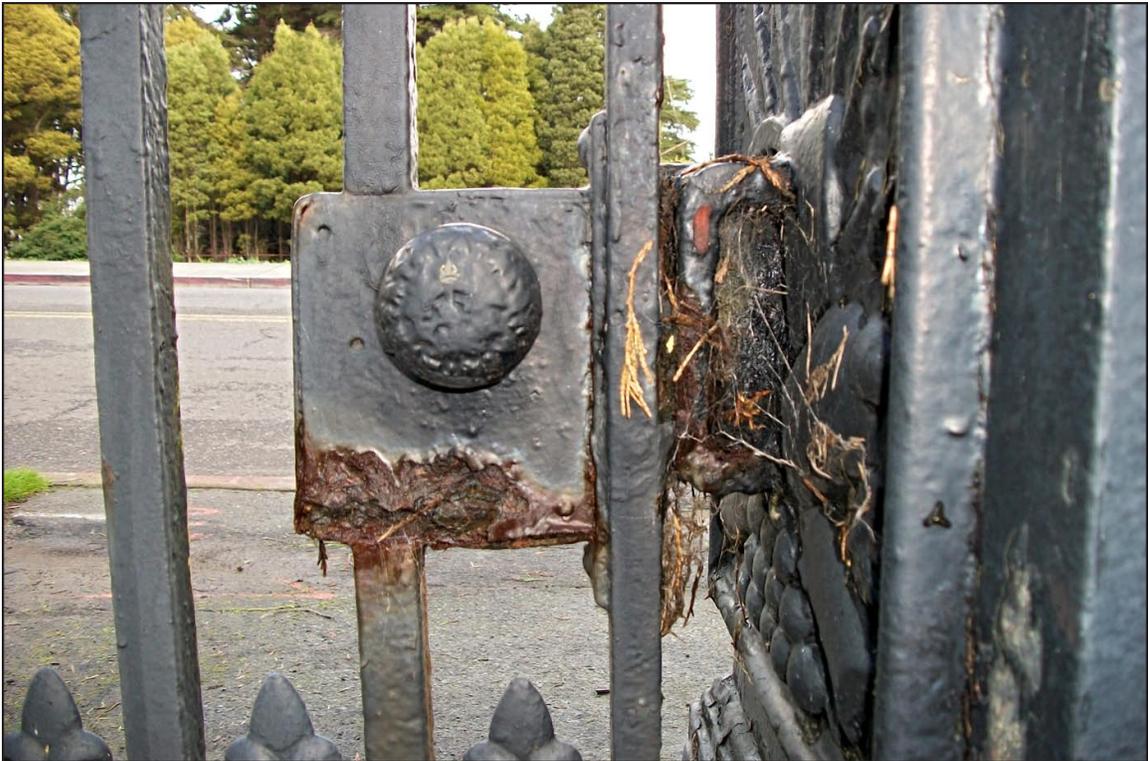
Photo 10. Iron corrosion on gate, facing north.

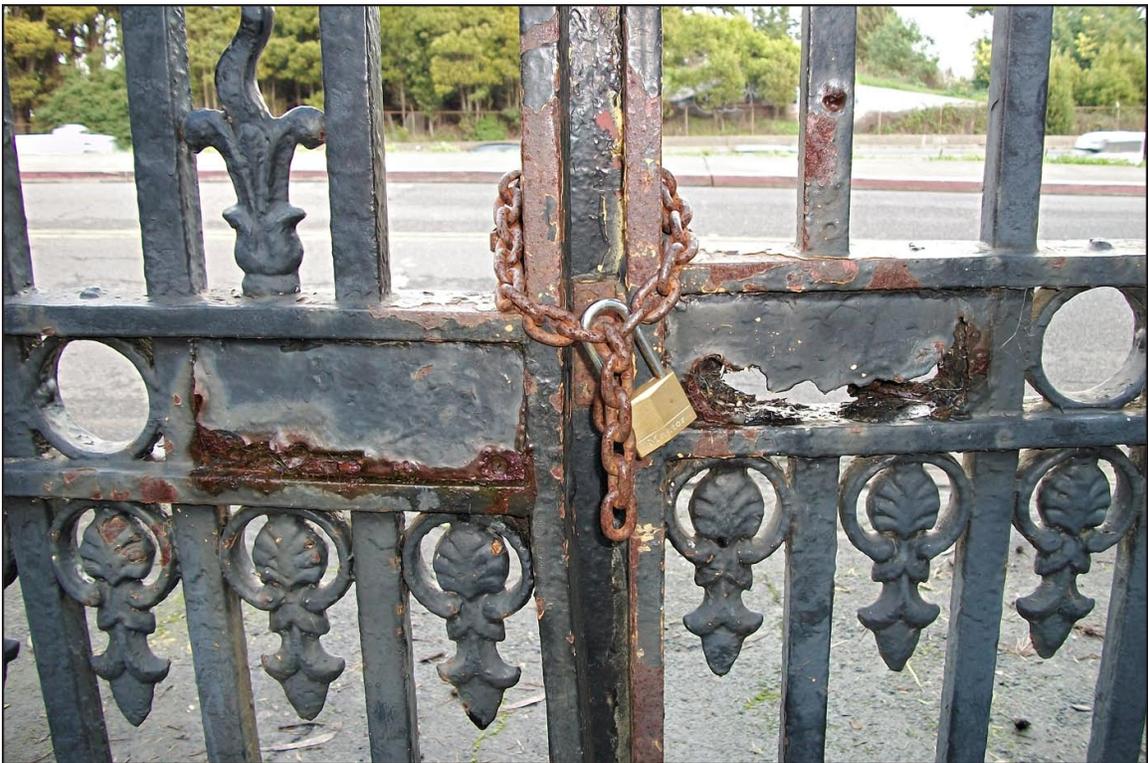
Photo 11. Severe corrosion at center of gate arrangement, facing north.

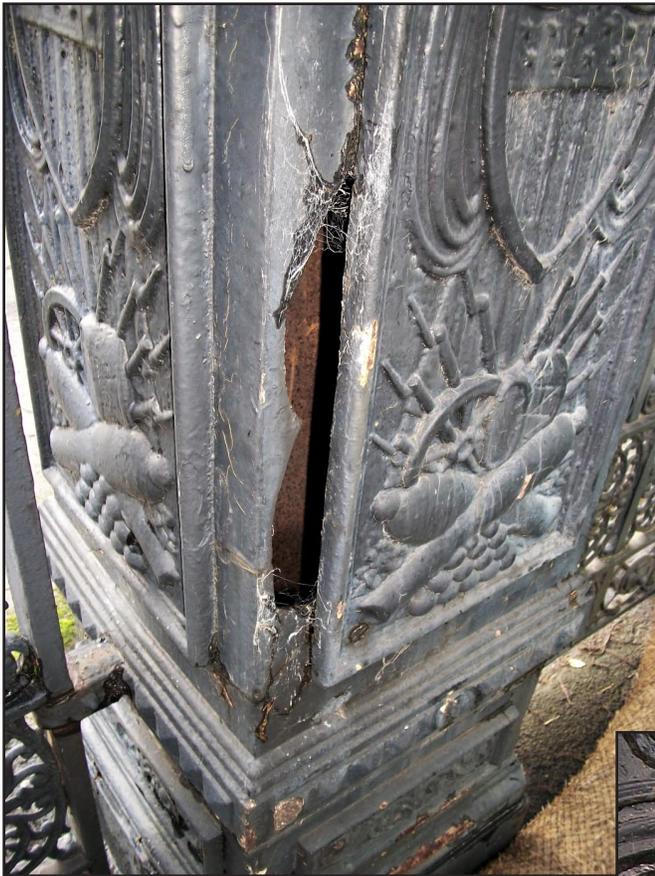
Photo 12. Severe corrosion at corner of gate post, facing northeast.

Eastern Vehicle Gate Post	Chipped	General	Large piece of post broken out on SW corner	No problems observed	Some corrosion	n/a	n/a
Eastern Pedestrian Gate	Chipped	General, severe in some areas	None observed	One missing finial on bottom row; one bent finial on middle row	Some corrosion	No problems observed	Missing
Eastern Pedestrian Gate Post	Chipped	General	None observed	No problems observed	Some corrosion	n/a	n/a

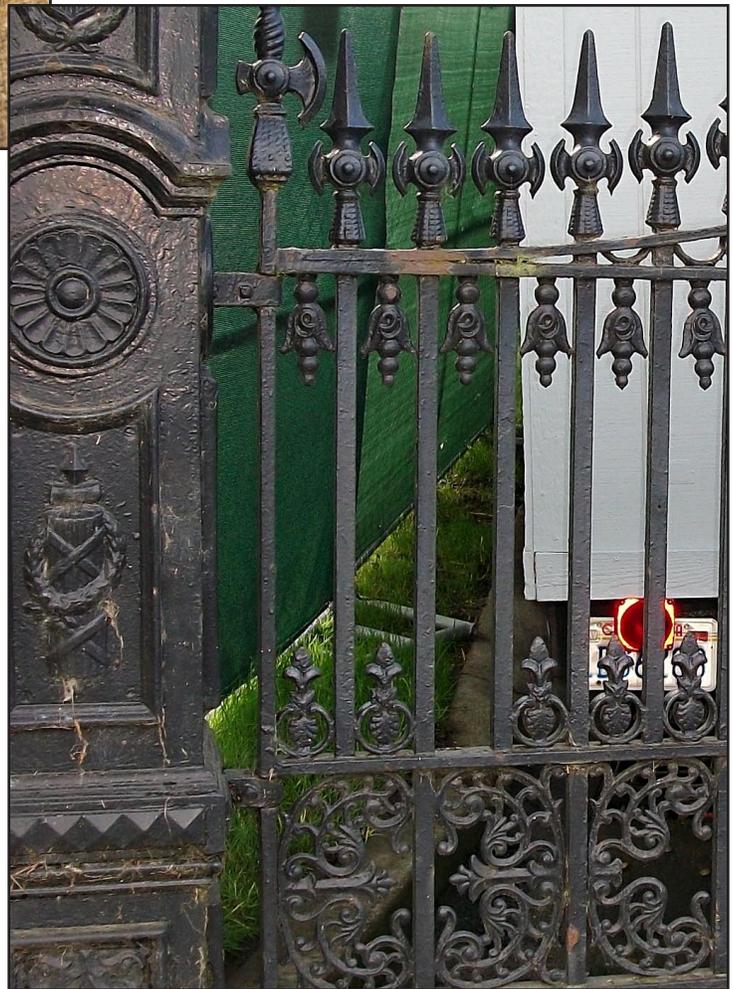
Photo 13. Rust and missing finial at pedestrian gate, facing south.

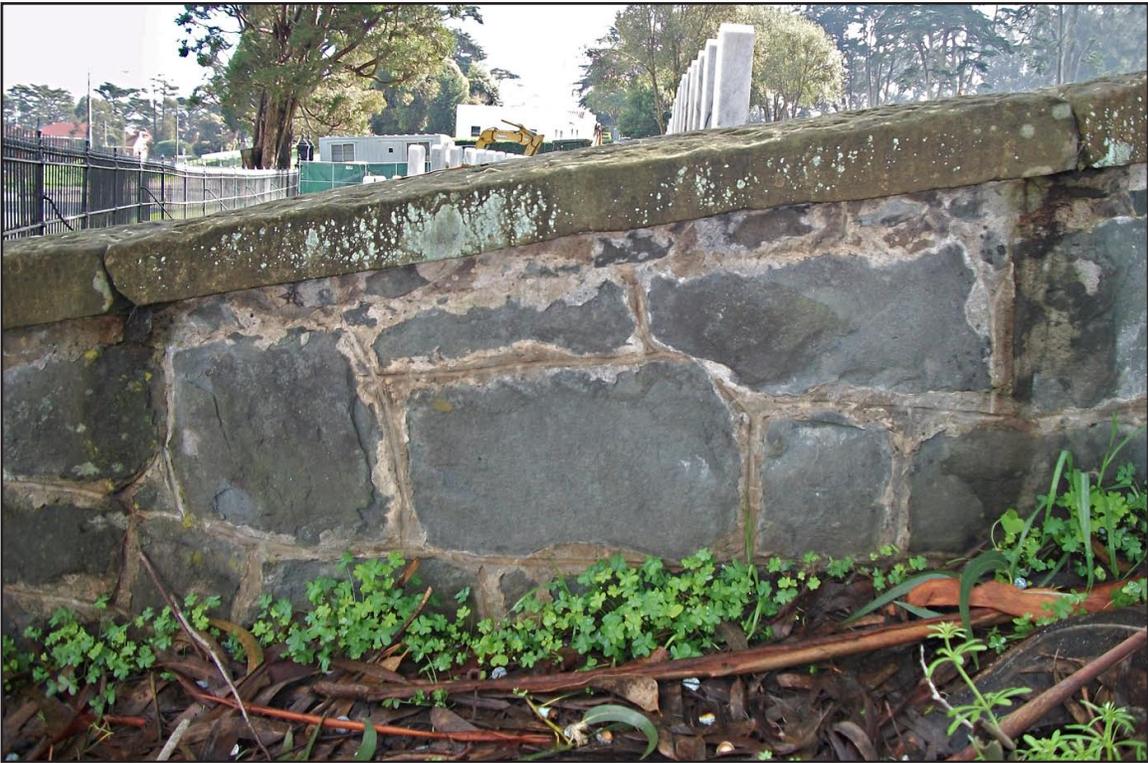
Photo 15. Lichen at northwest end of western boundary wall, facing east.

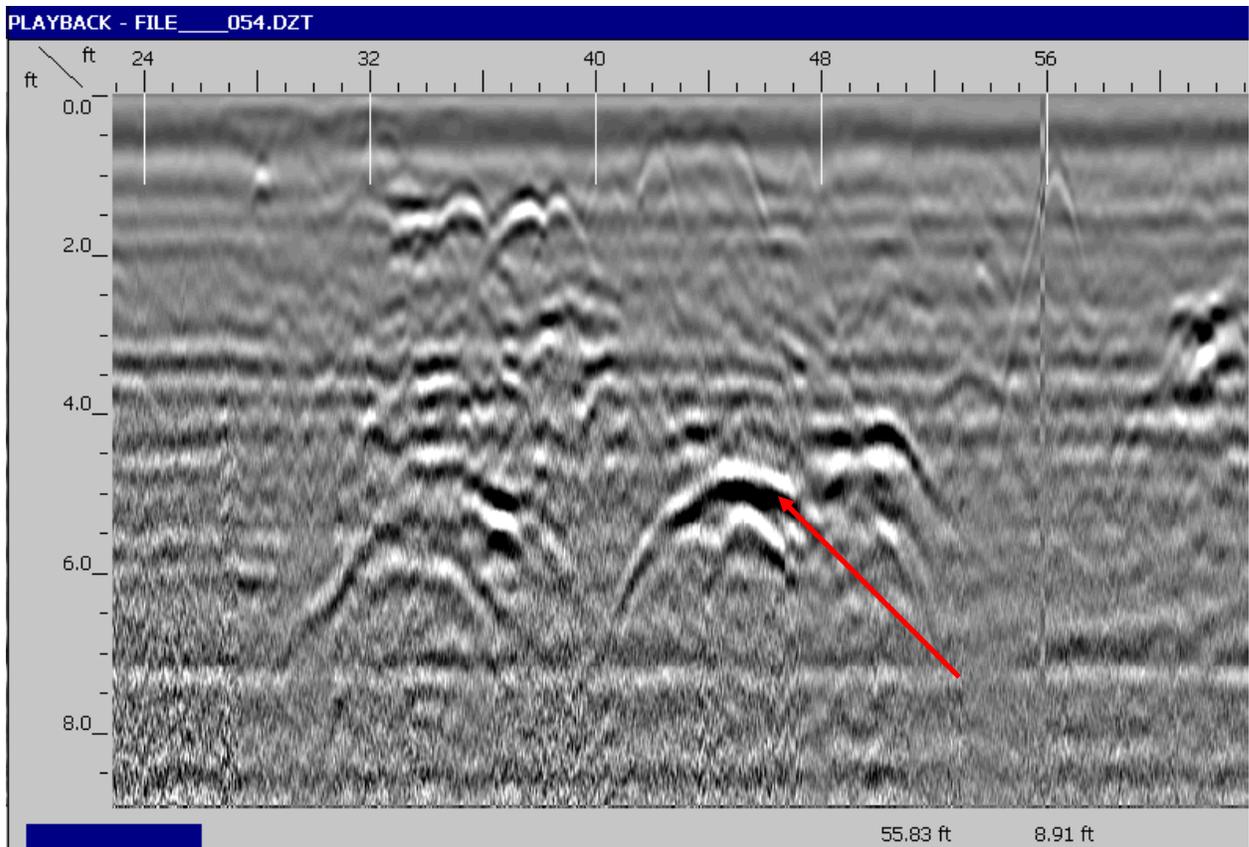
Here is an image from the ground penetrating radar system. In this image you can clearly see the location of a coffin. This image was taken from a scan over a known gravesite. I have added a red arrow indicate the location of the coffin.

Again, this image was taken from a known gravesite. I did not locate any images similar to this in the areas scanned near the fence.
