**ASBESTOS AND DETERIORATED LEAD PAINT SURVEY**

**Phillip S. Raine Safety Roadside Rest Area  
Tulare County, California**

**GEOCON PROJECT NO. S9200-06-61  
CONTRACT NO. 06A1141  
TASK ORDER NO. 61, EA 06-0A9701**

Subject: PHILLIP S. RAINE SAFETY ROADSIDE REST AREA  
HIGHWAY 99, TULARE COUNTY, CALIFORNIA  
CONTRACT NO. 06A1141  
TASK ORDER NO. 61, EA NO. 06-0A9701  
ASBESTOS AND DETERIORATED LEAD-CONTAINING PAINT  
SURVEY REPORT

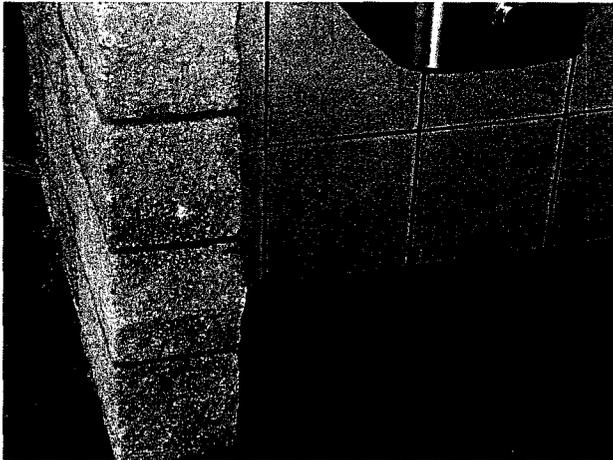
**Photo 6 – Typical exterior mortar and ceramic wall tile grout on SRRA restrooms**

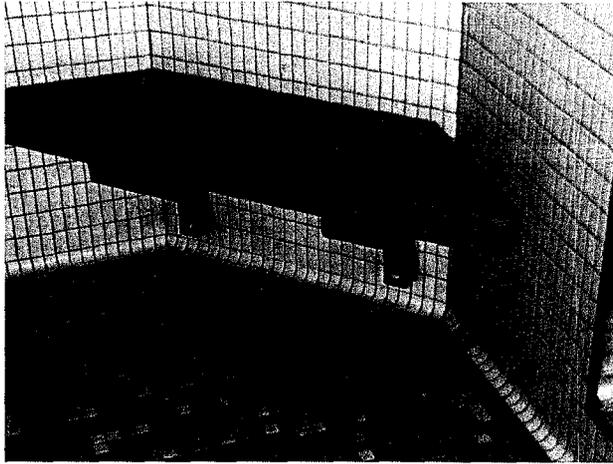
**Photo 7 – Typical interior ceramic wall and floor tile systems in SRRA restrooms**
