# MATERIALS INFORMATION HANDOUT

**Contract Number**  
**06-0M4404**

**06-Ker-33**  
**PM 34.3 / 40.3**

**Cold In-Place Recycling**  
**Hot Mix Asphalt**

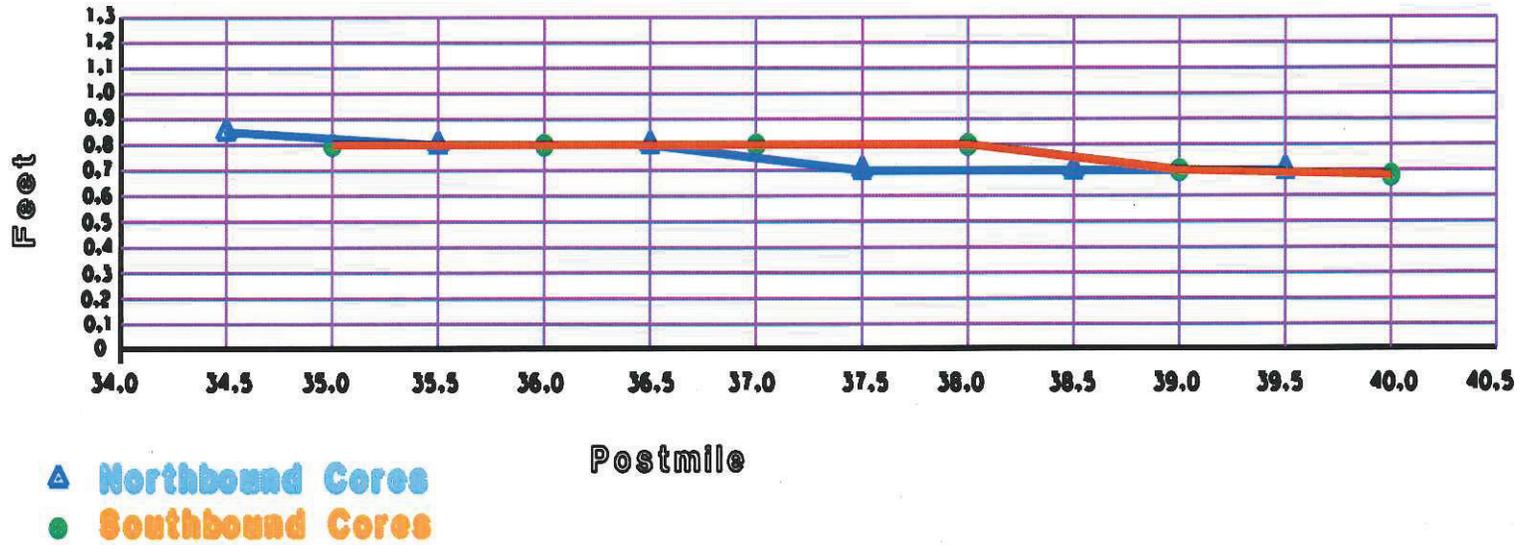
### Ker-33 AC Thickness

The general structural section is HMA over original ground. At some locations, the base material is native material or oil treated base. Cores indicated a depth of HMA that range from 0.68 foot to 0.85 foot. Core samples taken were not uniform in appearance. Some core samples show signs of failure at a depth of 0.45 foot, some are cracked vertically, while some crumbled at a depth of 0.30 foot from the pavement surface.
