# **INFORMATION HANDOUT**

**For Contract No. 06-0Q2404**

# MATERIALS INFORMATION HANDOUT

Cold In-Place Recycling  
Hot Mix Asphalt

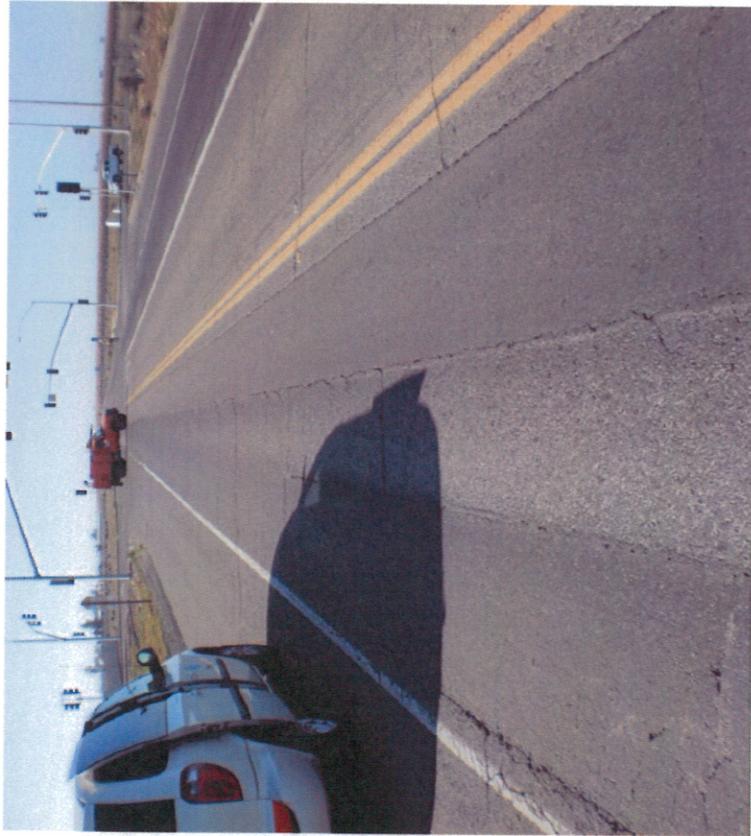
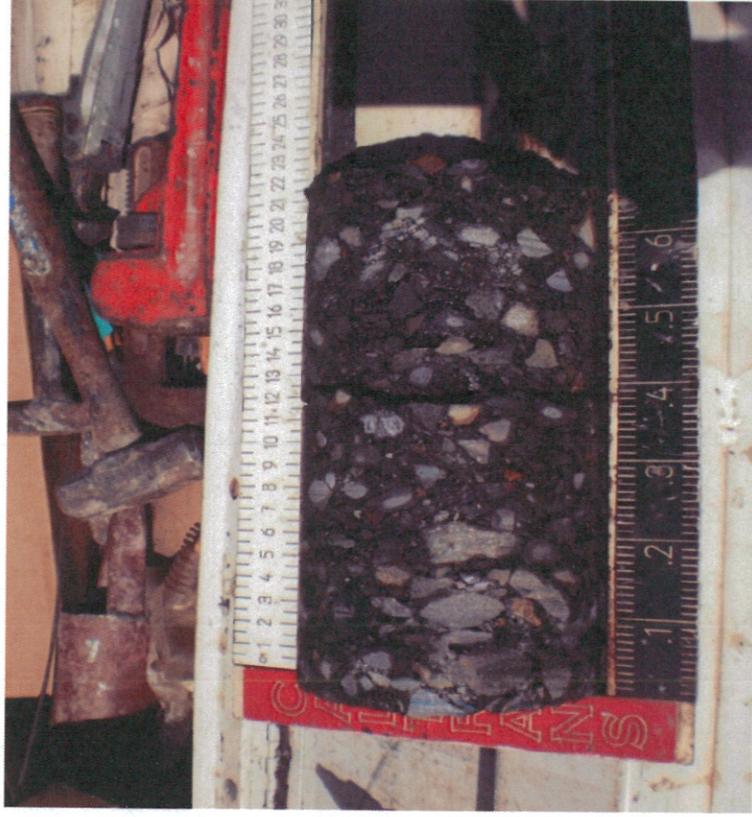
**Core -1 -NB Mainline -PM 6.10**

Test Section	Core Hole Location (PM, Lane No., Direction)	Layer 1 (Seal Coat?)	Layer 2 (Struct. Sect.)	Layer 3 (Struct. Sect.)	Layer 4 (Struct. Sect.)	Layer 5 (Base Matrl)	Total Core Thickness	Remarks
1	Fre-41 NORTHBOUND LANE 1 - PM M6.10	Chip Seal	0.67'-DGAC			Aggregate Base	0.67'	The Core was taken at PM M6.09 NORTHBOUND. The total core was 0.67' in thickness. The top layer was chip seal and the rest of the core was DGAC, core was intact. The base materials was Aggregate Base.
2	Fre-41 SOUTHBOUND LANE 1 - PM M 5.90	Chip Seal	0.56'-DGAC			Aggregate Base	0.56'	The Core was taken at PM M5.90 Southbound. The total core was 0.56' in thickness. The top layer was chip seal and the rest of the core was DGAC, core was Intact. The base materials was Aggregate Base.
3	Fre-41 NORTHBOUND LANE - PM M 5.65	Chip Seal	1.22'-DGAC			Aggregate Base	1.22'	The Core was taken at PM M 5.65 Northbound. The total core was 1.22' in thickness the top layer was chip seal core was Delaminated @ 0.65' and 0.98' from the top. The base materials was Original Ground.

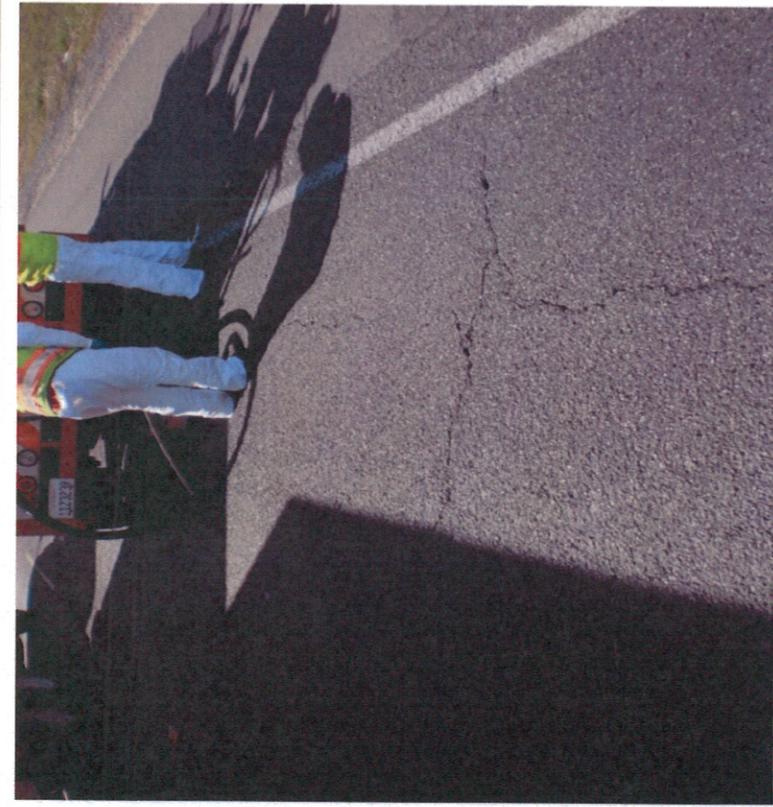
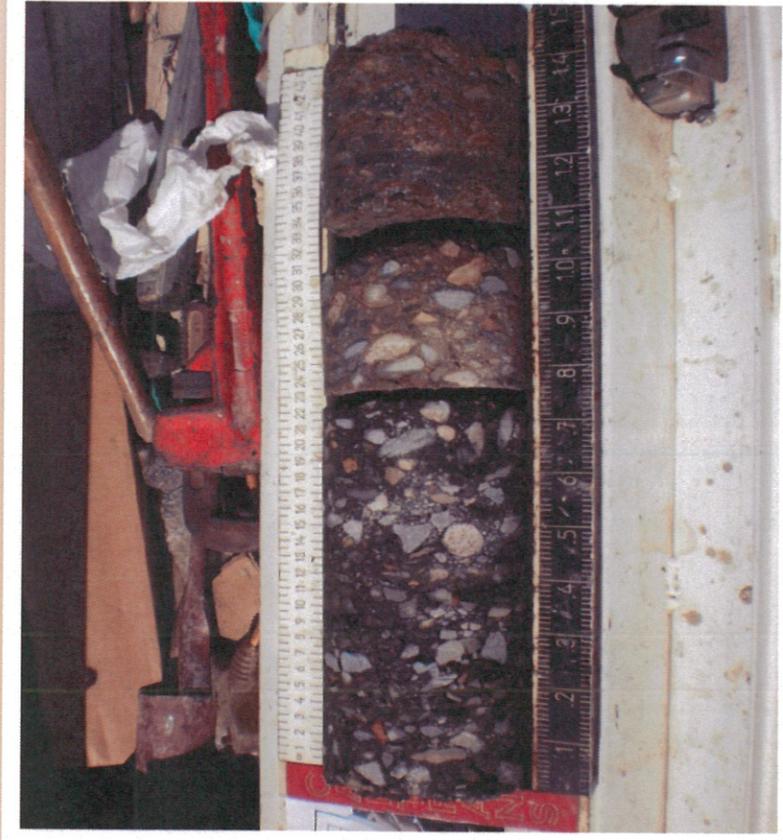
**Core -4-SB Mainline -PM 5.35**

4	Fre-41 SOUTHBOUND LANE 1 - PM M 5.35	Chip Seal	0.74'-DGAC		0.66'-CTB	Aggregate Base	1.40'	The Core was taken at PM M5.35 Southbound. The total core was 1.40' in thickness. The top layer was chip seal and 0.74' of the core was DGAC, remaining 0.66' was CTB. Core was Delaminated @ 0.74' and 1.04' from the top. The base materials was Aggregate Base.
5	Fre-41 NORTHBOUND LANE - PM R 5.10	Chip Seal	0.70'-DGAC			Aggregate Base	0.70'	The Core was taken at PM R 5.10 northbound. The total core was 0.70' in thickness. The top layer was chip seal and the rest of the core was DGAC, core was Intact. The base materials was Aggregate Base.
6	Fre-41 SOUTHBOUND LANE 1 - PM R 4.85	Chip Seal	0.72'-DGAC			Aggregate Base	0.72'	The Core was taken at PM R4.85 Southbound. The total core was 0.72' in thickness. The top layer was chip seal the rest was DGAC, and intact. The base materials was Aggregate Base.
7	Fre-41 NORTHBOUND LANE - PM R4.60	Chip Seal	0.78'-DGAC			Aggregate Base	0.78'	The Core was taken at PM R4.60 Northbound. The total core was 0.78' in thickness. The top layer was chip seal and the rest of the core was DGAC, core was Intact. The base materials was Aggregate Base.

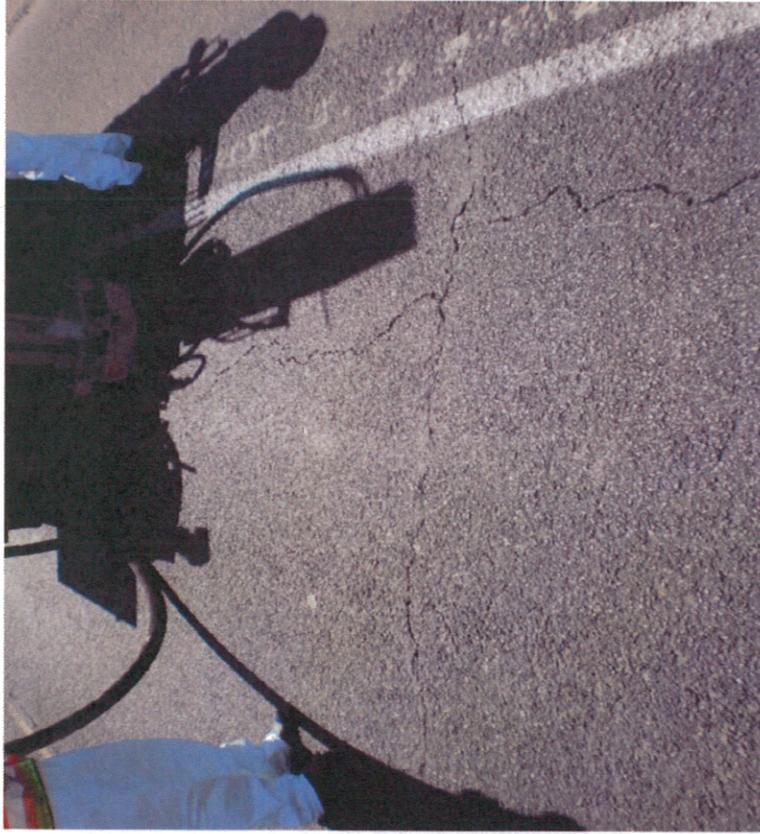
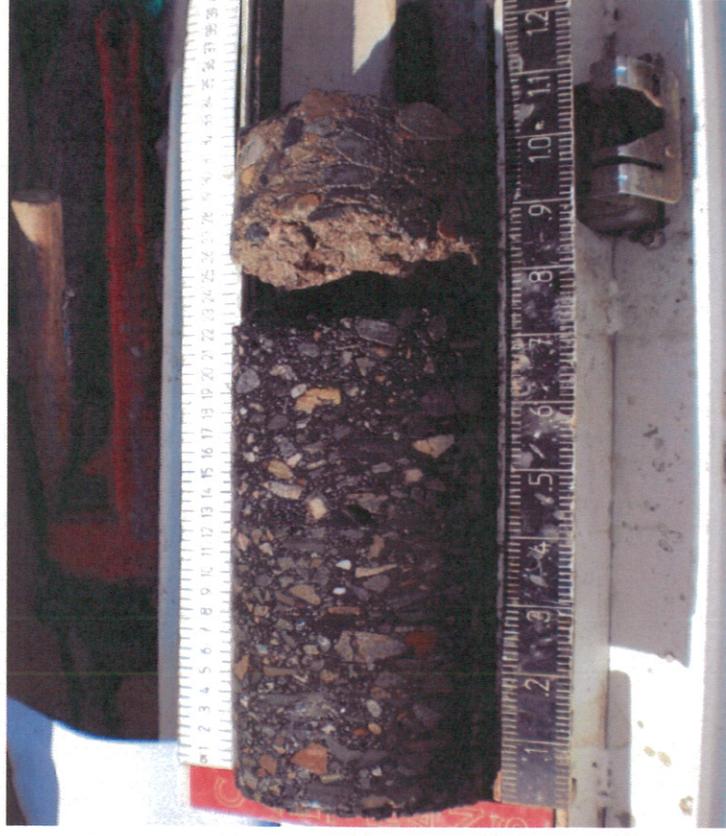
**Core -8-SB Mainline -PM 4.35**

8	Fre-41 SOUTHBOUND LANE 1 - PM R4.35	Chip Seal	0.75'-DGAC		0.25'-CTB	Aggregate Base	1.0'	The Core was taken at PM R 4.35 Southbound. The total core was 1.0' in thickness. The top layer was chip seal and 0.75' of the core was DGAC, remaining 0.25' was CTB. Core was Delaminated @ 0.75' from the top. The base materials was Aggregate Base.
9	Fre-41 NORTHBOUND LANE - PM R 4.10	Chip Seal	0.70'-DGAC		0.25'-CTB	Aggregate Base	0.95'	The Core was taken at PM R 4.10 Northbound. The total core was 0.95' in thickness. The top layer was chip seal and 0.70' of the core was DGAC, remaining 0.25' was CTB. Core was Delaminated @ 0.75' from the top. The base materials was Aggregate Base.
10	Fre-41 SOUTHBOUND LANE 1 - PM R 3.85	Chip Seal	0.65'-DGAC		0.30'-CTB	Aggregate Base	0.95'	The Core was taken at PM R 4.10 Northbound. The total core was 0.95' in thickness. The top layer was chip seal and 0.65' of the core was DGAC, remaining 0.30' was CTB. Core was Delaminated @ 0.38' from the top. The base materials was Aggregate Base.

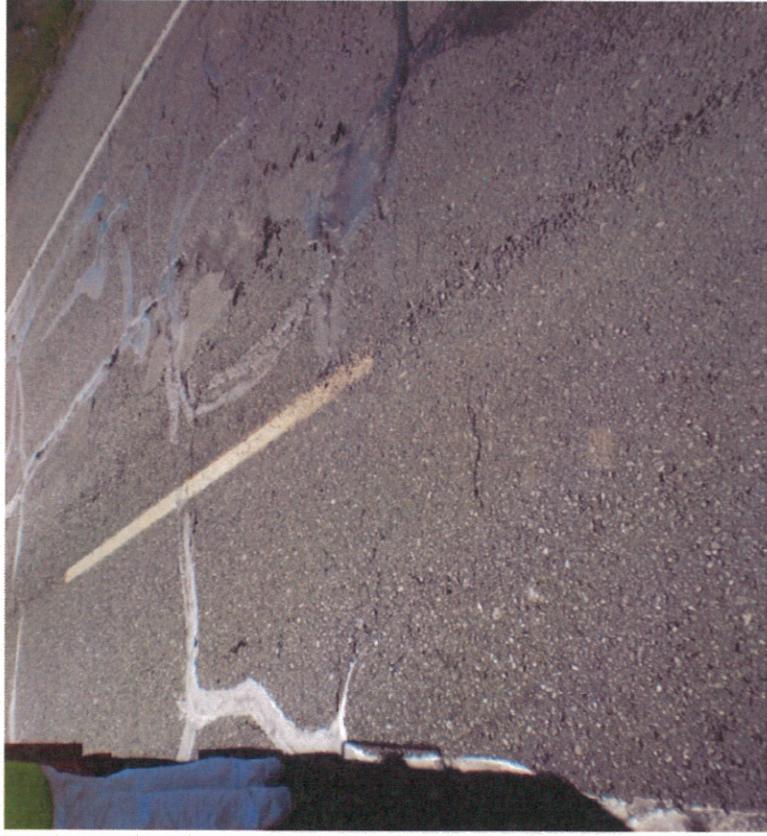
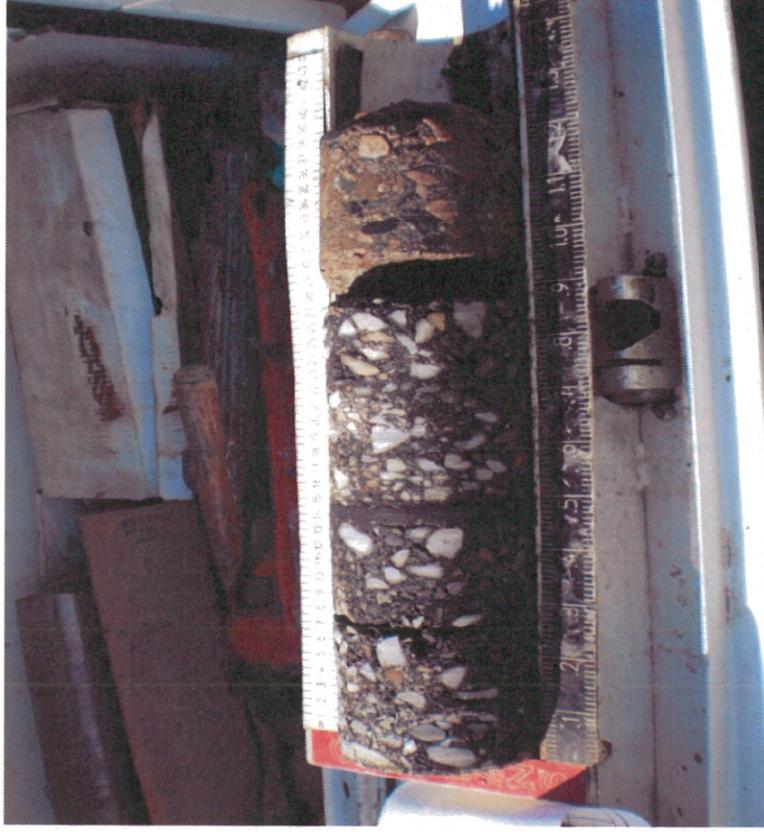
**Core -11-NB Mainline -PM 3.60**

11	Fre-41 NORTHBOUND LANE - PM R 3.60	Chip Seal	0.90'-DGAC		0.30'-CTB	Aggregate Base	1.20'	The Core was taken at PM R 3.60 Northbound. The total core was 1.20' in thickness. The top layer was chip seal and 0.90' of the core was DGAC, remaining 0.30' was CTB. Core was Delaminated @ 0.26' and 0.90' from the top. The base materials was Aggregate Base.
12	Fre-41 SOUTHBOUND LANE 1 - PM R 3.35	Chip Seal	0.80'-DGAC		0.38'-CTB	Aggregate Base	1.18'	The Core was taken at PM R 3.35 Southbound. The total core was 1.18' in thickness. The top layer was chip seal and 0.80' of the core was DGAC, remaining 0.38' was CTB. Core was Delaminated @ 0.24' and 0.80' from the top. The base materials was Aggregate Base.
13	Fre-41 NORTHBOUND LANE - PM R 3.10	Chip Seal	0.64'-DGAC		0.30'-CTB	Aggregate Base	0.94'	The Core was taken at PM R 3.10 Northbound. The total core was 0.94' in thickness. The top layer was chip seal and 0.64' of the core was DGAC, remaining 0.30' was CTB. Core was Delaminated @ 0.32' and 0.65' from the top. The base materials was Aggregate Base.
