INFORMATION HANDOUT

For Contract No. 07-288504

At 07-LA-405-10.5/12.6

MATERIALS INFORMATION

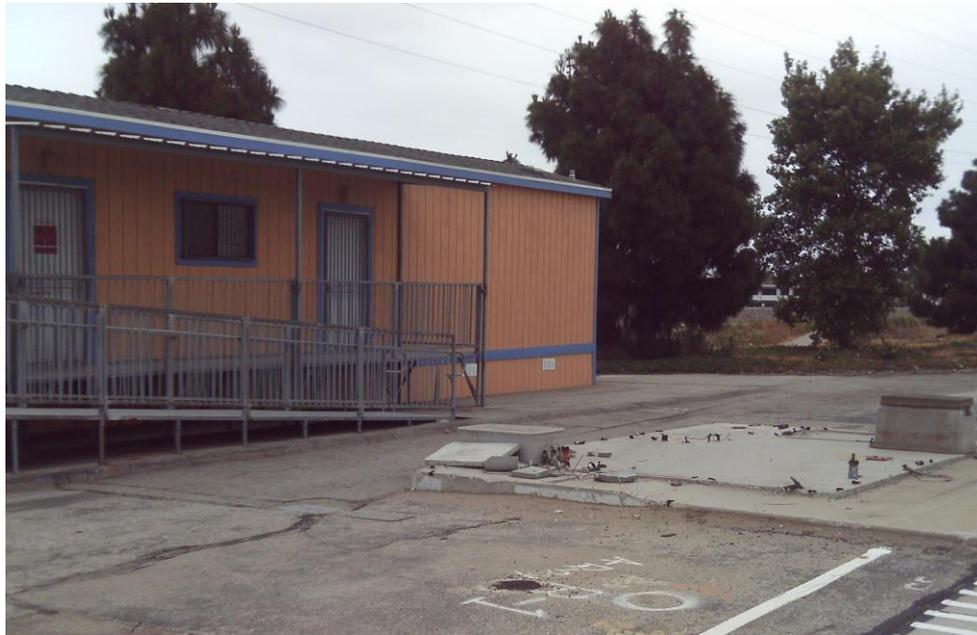
Photograph No. 1

VIEW OF CVEF MOBILE STRUCTURE, FACING NORTHEAST. ALL PAINTED SURFACES APPEARED IN GOOD CONDITION WITH NO EVIDENCE OF DETERIORATING PAINT.

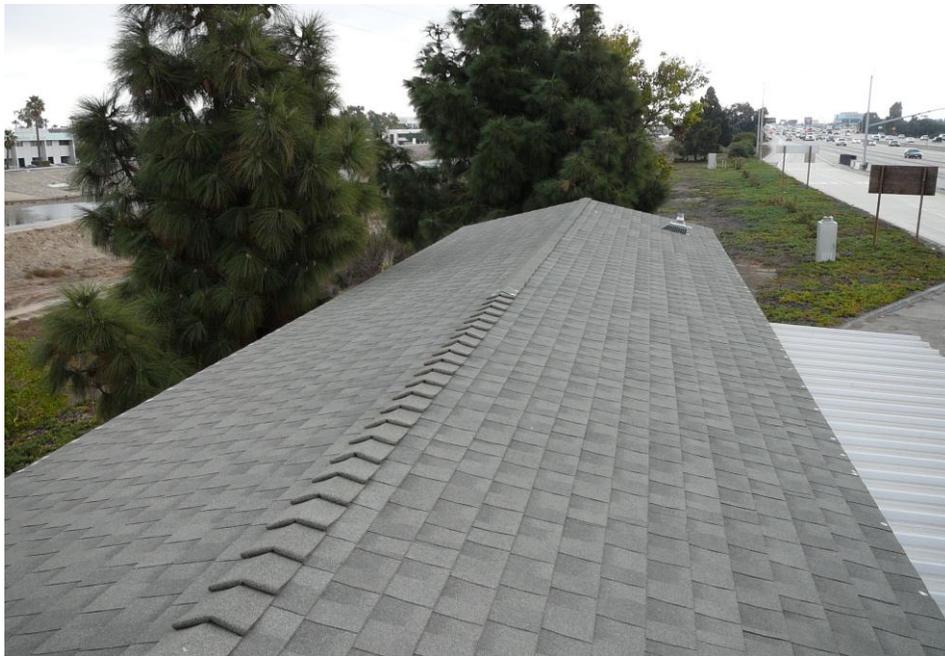
Photograph No. 2

VIEW OF ROOFING MATERIALS, FACING SOUTHEAST. NO ASBESTOS DETECTED.

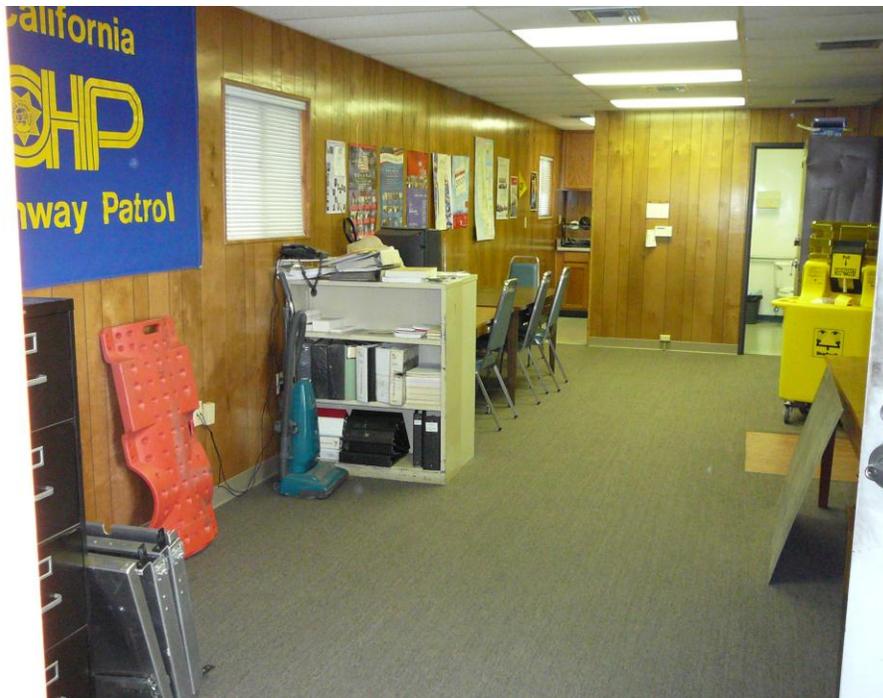
Photograph No. 3

VIEW OF INTERIOR PORTION OF THE CVEF MOBILE STRUCTURE FROM ROOM 3 FACING TOWARD ROOMS 4 AND 5.

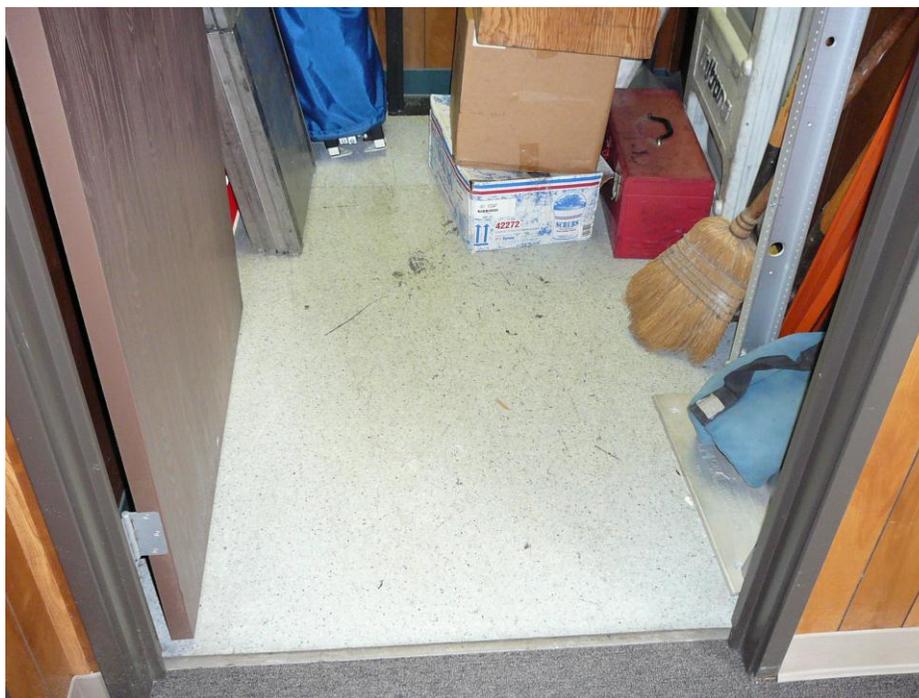
Photograph No. 4

VIEW OF SHEET VINYL FLOORING. NO ASBESTOS DETECTED.

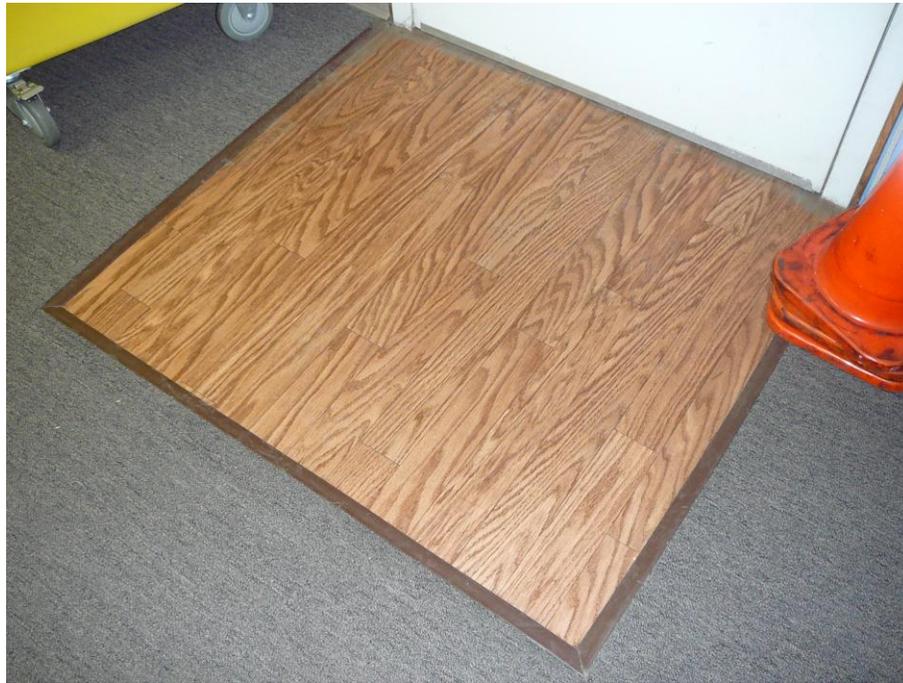
Photograph No. 5

FAUX WOOD SHEET VINYL FLOORING AND BOTH ENTRY DOORS. NO ASBESTOS DETECTED.

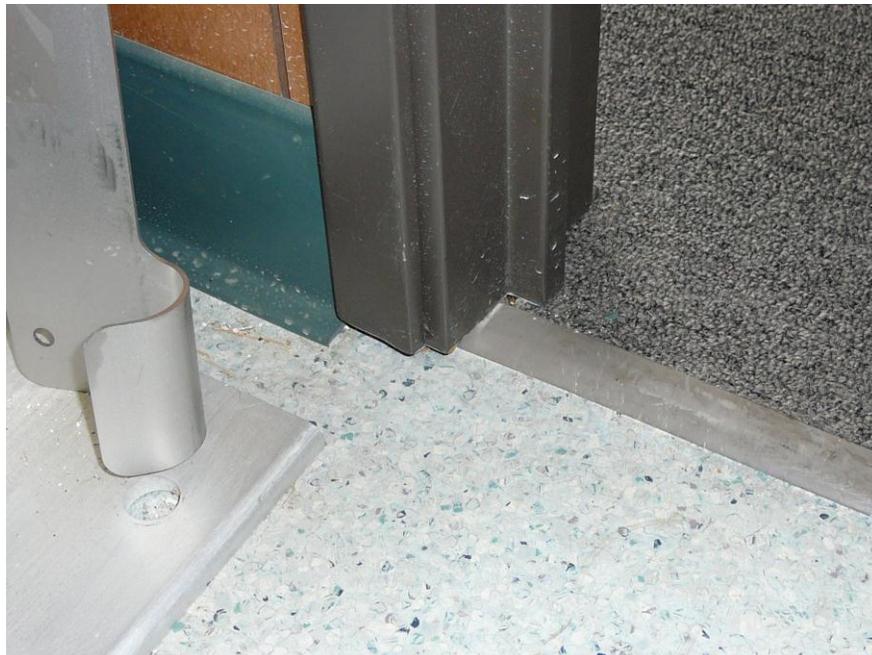
Photograph No. 6

GREEN BASEBOARD WITH MASTIC. NO ASBESTOS DETECTED.

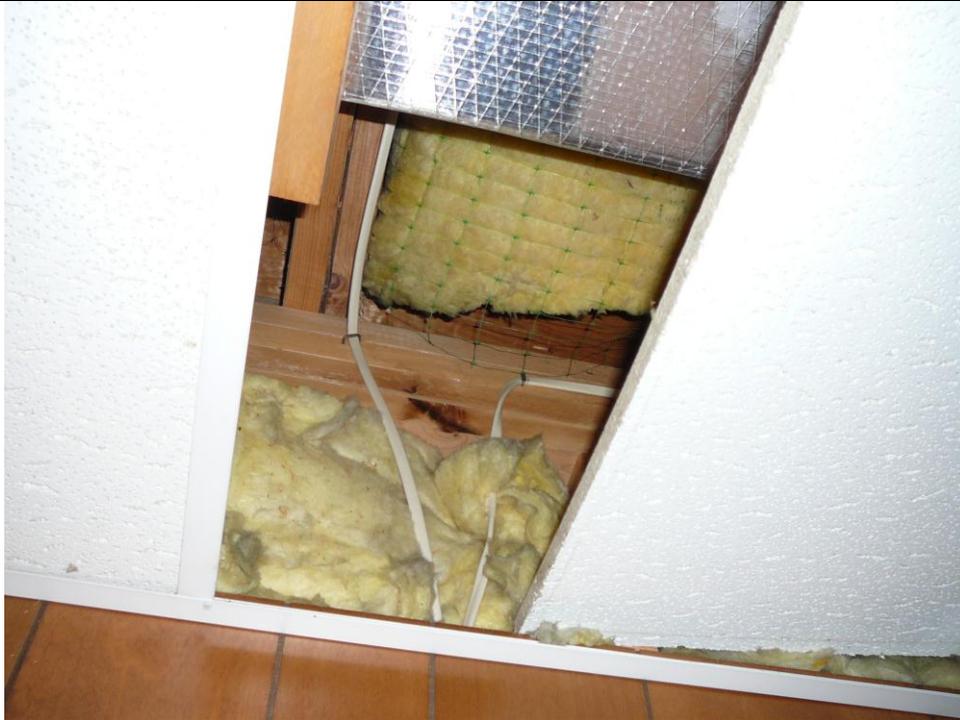
Photograph No. 7

CEILING PANEL AND INSULATION ABOVE THE FALSE CEILING. NO ASBESTOS DETECTED.

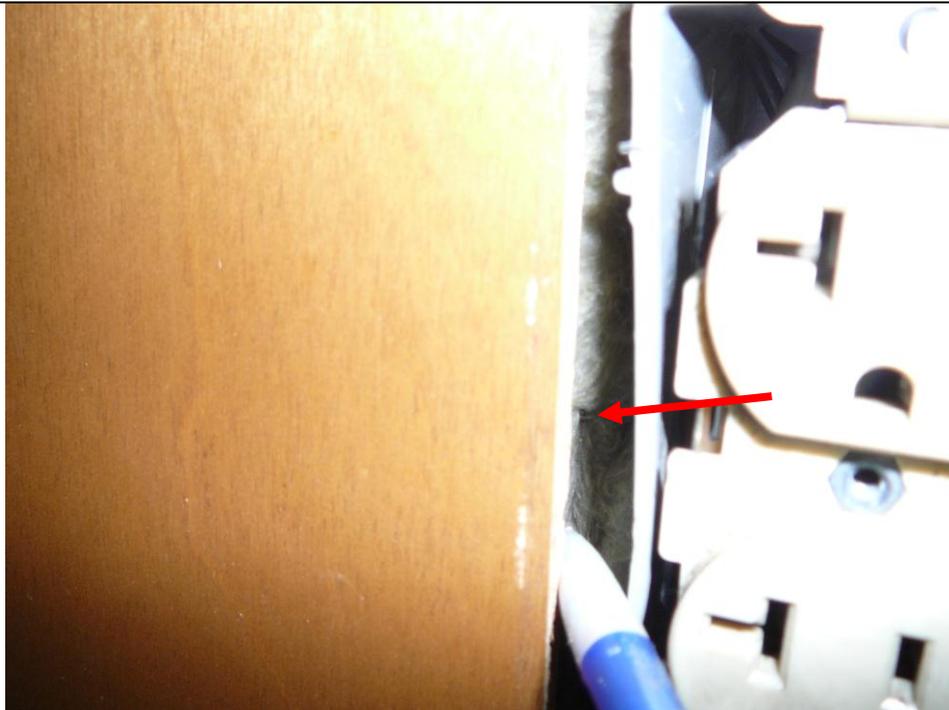
Photograph No. 8

VIEW BEHIND THE WALL PANELING. NO DRYWALL OBSERVED BEHIND THE PANELING IN ROOMS 1 THROUGH 4. DRYWALL FOUND BEHIND FIBER REINFORCED PLASTIC PANELS OF ROOM 5 (RESTROOM) BUT NO ASBESTOS WAS DETECTED IN THE SAMPLES.
