INFORMATION HANDOUT

For Contract No. [10-0Y2604](#)

MATERIALS INFORMATION

Summary of Investigations

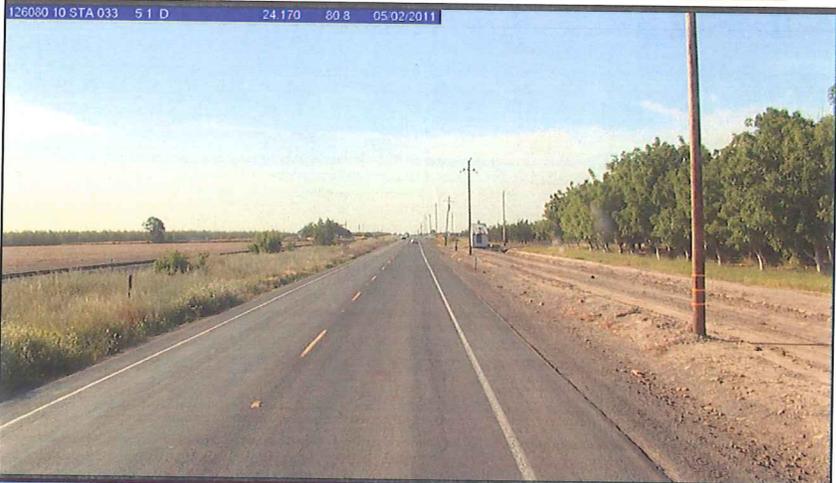
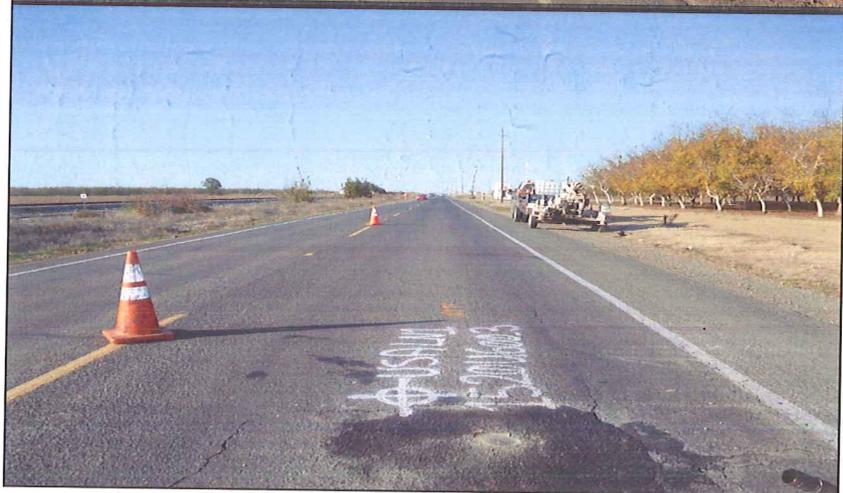
1520U600_3

Layer Type	Layer Characteristic	Layer Thickness				
		1	2	3	4	Avg
HMA	1/2" max coarse	160	160	160	160	160
HMA	1/2" max coarse [BROKEN]	47	47	47	47	47
PCC	1-1/4" max	113	113	113	113	113
AB	Granular base, 1" max	110				110
SG	(SM) dark brown					0
Sum		430	320	320	320	430
