**LIMITED ASBESTOS AND LEAD-BASED
PAINT SURVEY REPORT
RAINBOW TRUCK INSPECTION FACILITIES
FALLBROOK, CALIFORNIA**

**CALTRANS DISTRICT 11 EA 275600
CONTRACT NO. 11A1638
TASK ORDER NO. 6**

March 30, 2009

Kleinfelder Project No. 101854

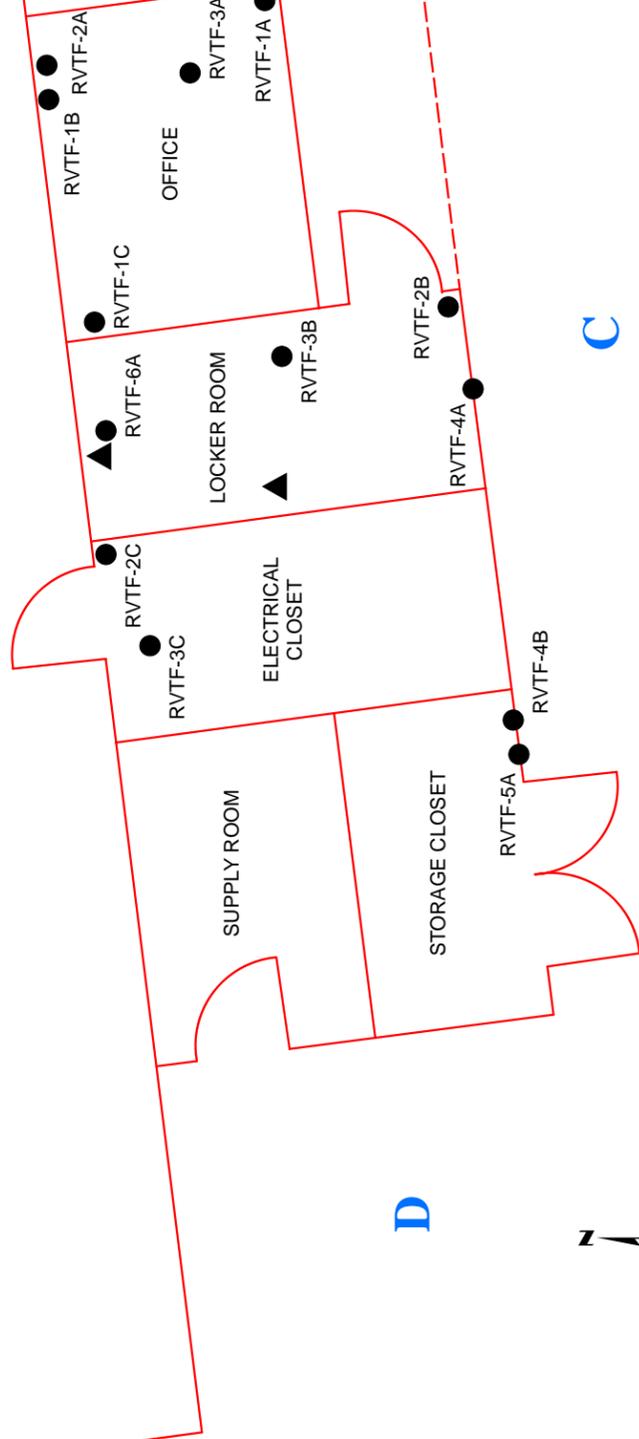
PROJECT NO. 101854	SAMPLE LOCATION MAP	PLATE 2
DRAWN: 2/19/09		
DRAWN BY: JP	ASBESTOS AND LEAD-BASED PAINT SURVEY REPORT RAINBOW TRUCK INSPECTION FACILITY FALLBROOK, CALIFORNIA	
CHECKED BY: RS		
FILE NAME: 101854site.MXD

Table 2, provided in Appendix A, provides a summary of these building materials that were identified as containing asbestos. Plate 2 shows the approximate locations of these materials.

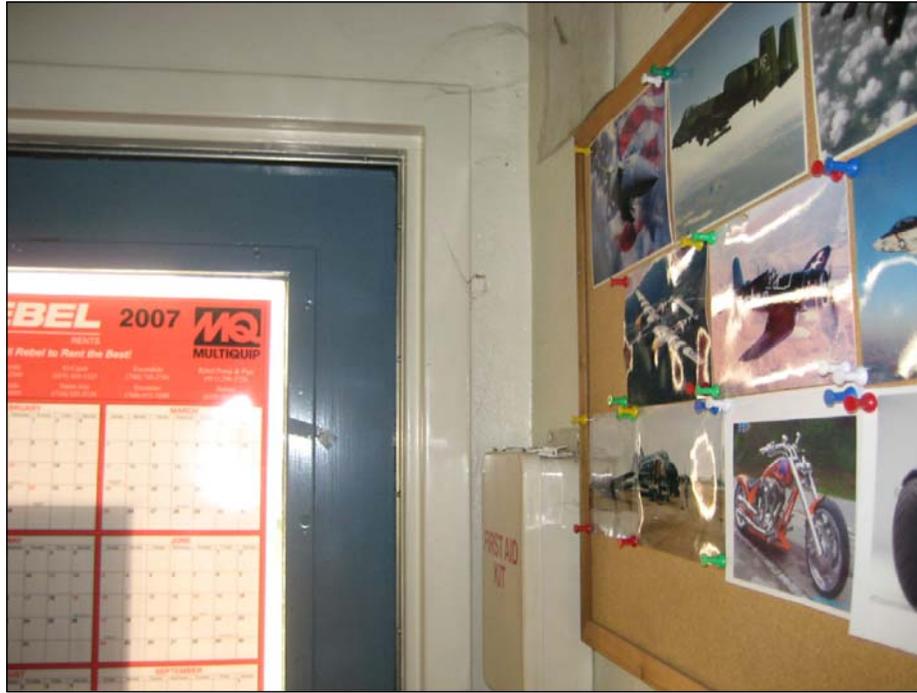
RVTF-1A SAMPLE LOCATION-OFFICE WALL.

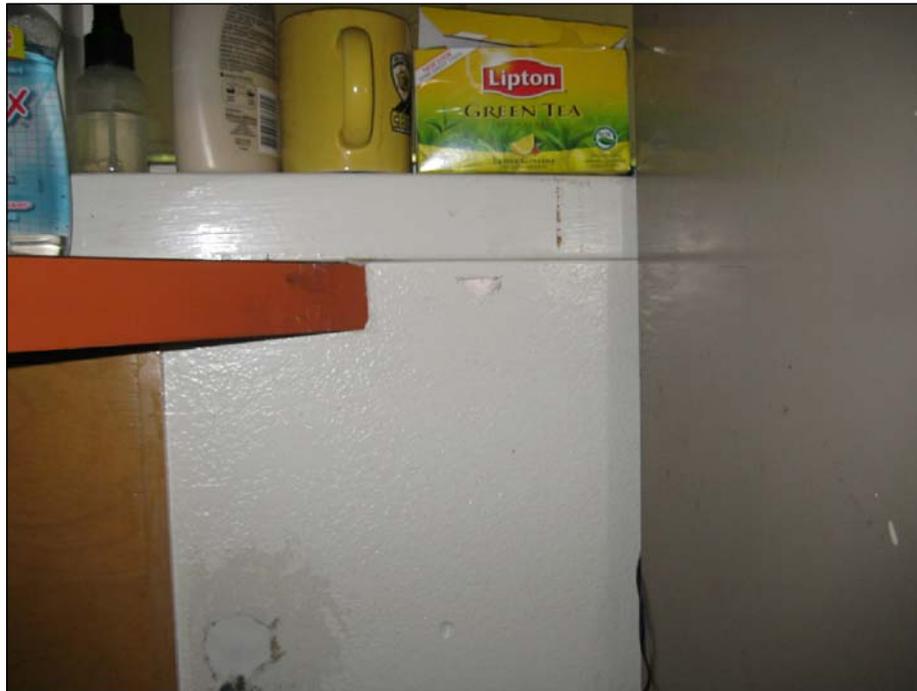
RVTF-1B SAMPLE LOCATION-OFFICE WALL

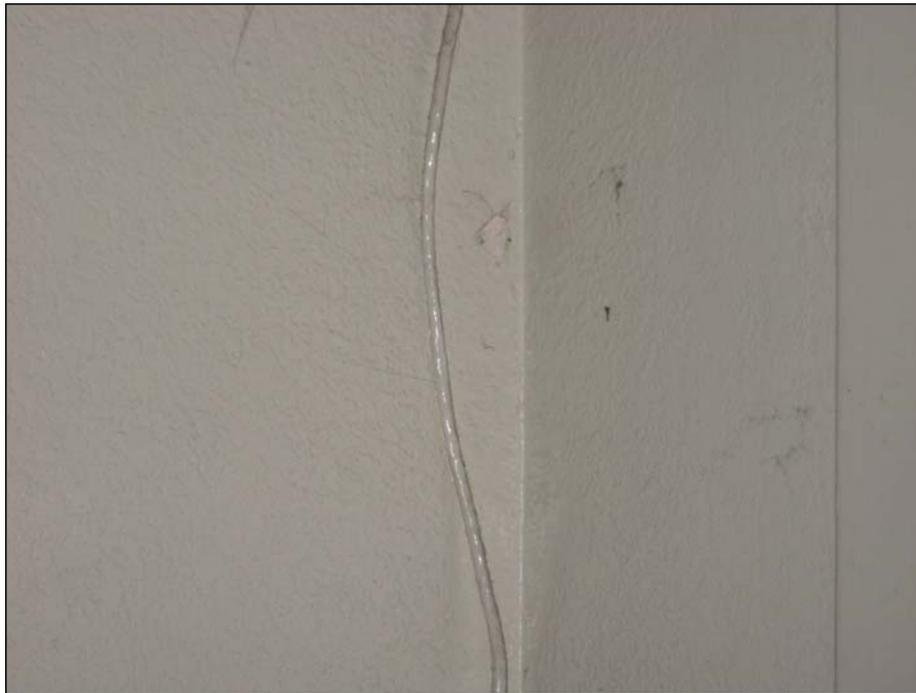
RVTF-1C SAMPLE LOCATION-OFFICE WALL.

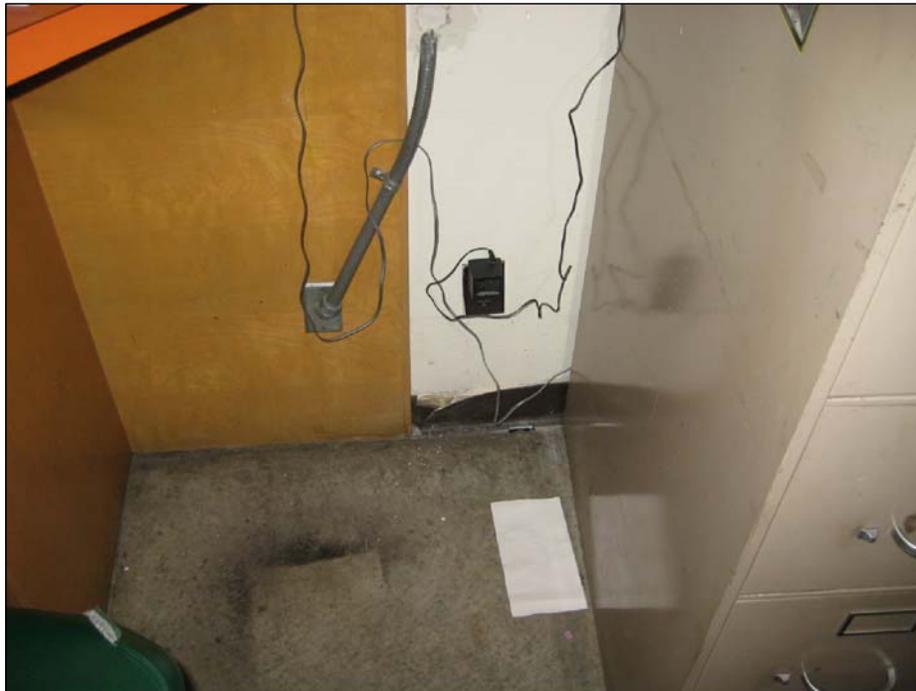
RVTF-2A SAMPLE LOCATION-BASE COVE AND MASTIC IN OFFICE.

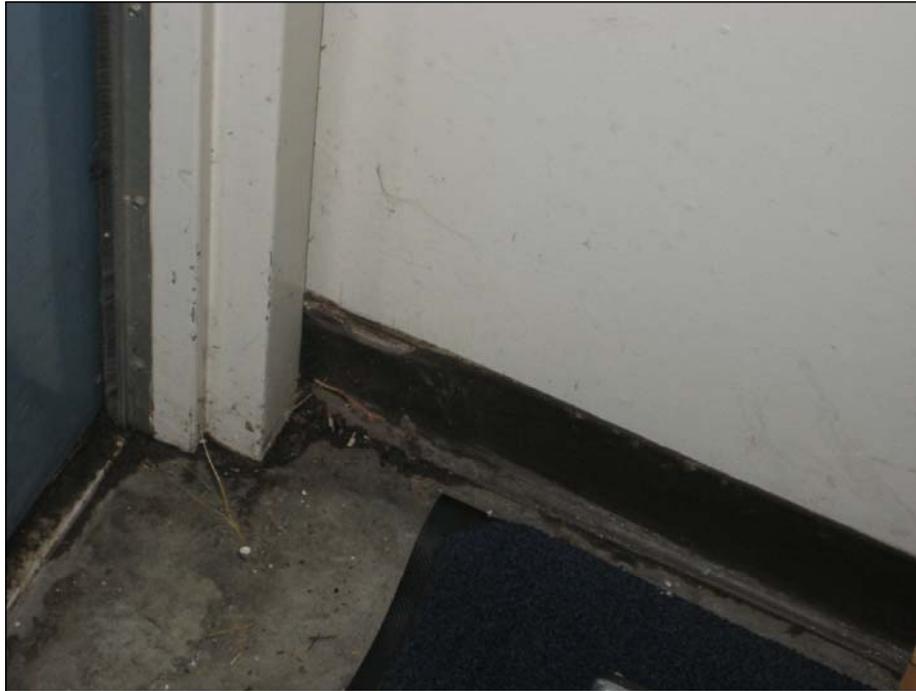
RVTF-2B SAMPLE LOCATION-BASE COVE AND MASTIC IN LOCKER ROOM.

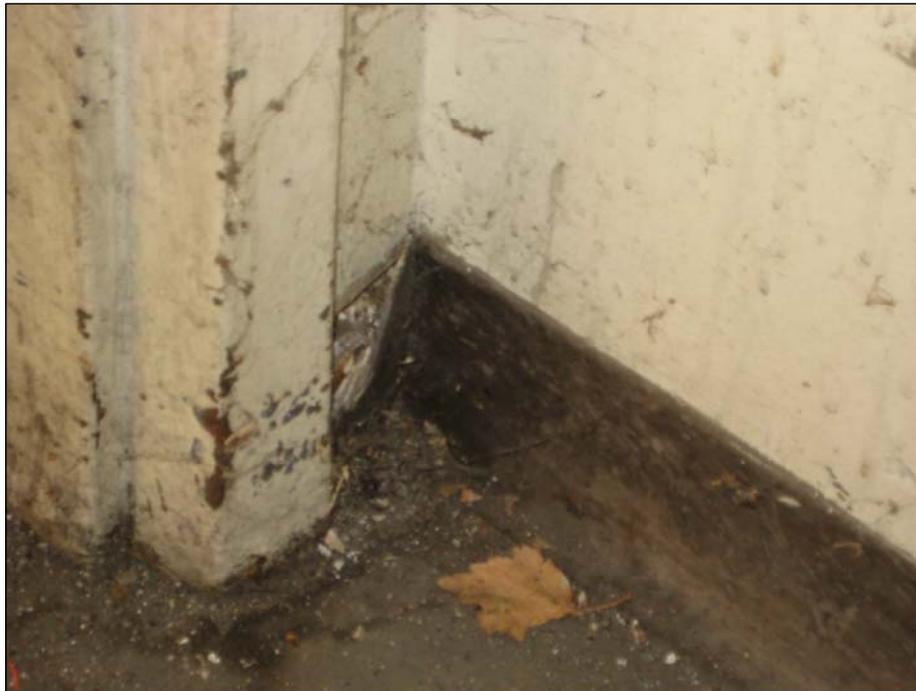
RVTF-2C SAMPLE LOCATION-BASE COVE AND MASTIC IN ELECTRICAL CLOSET.

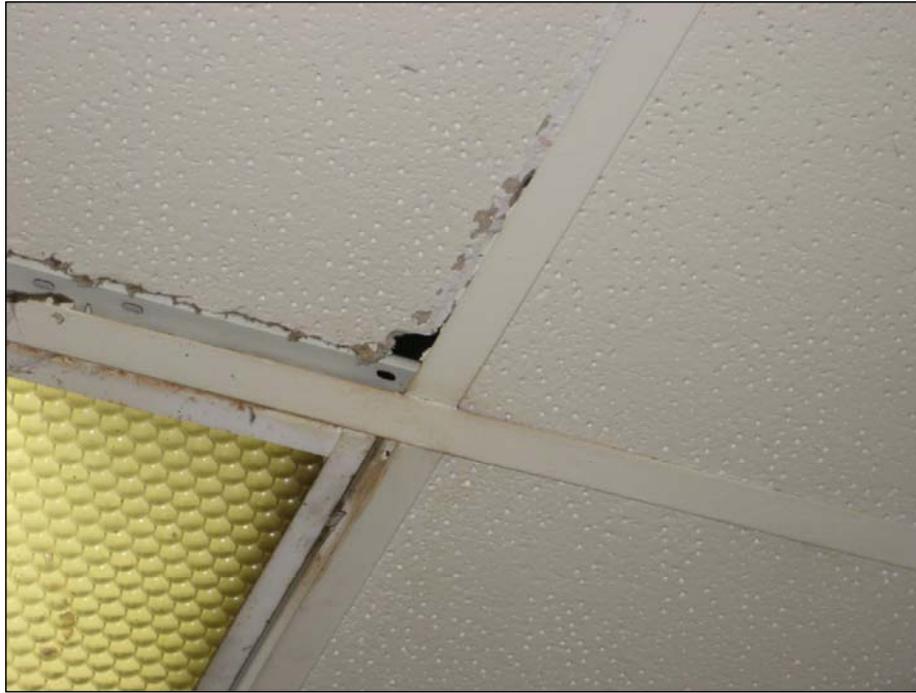
RVTF-3A SAMPLE LOCATION-CEILING TILE IN OFFICE.

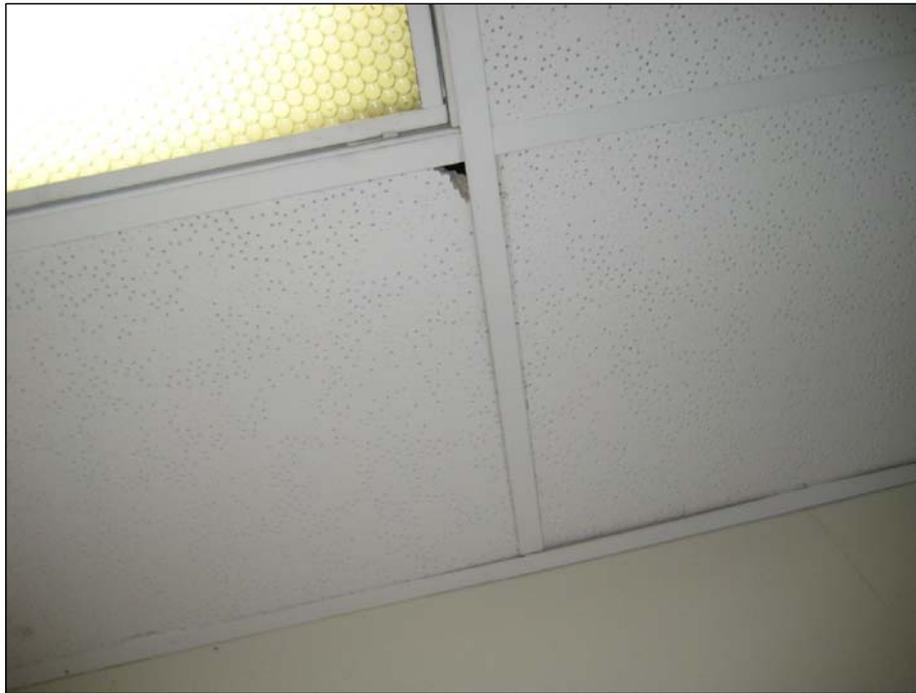
RVTF-3B SAMPLE LOCATION-CEILING TILE IN LOCKER ROOM.

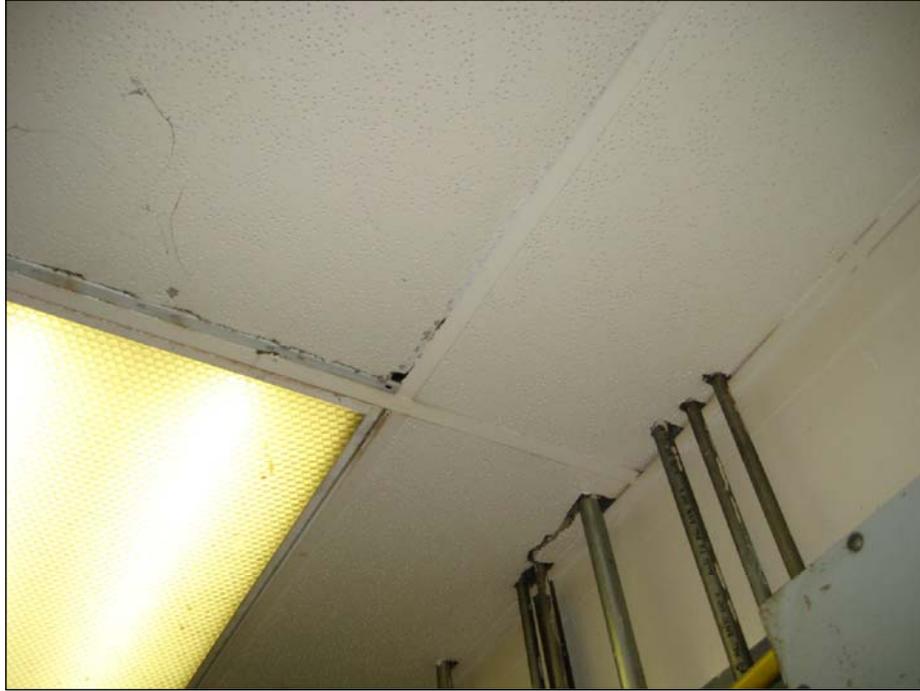
RVTF-3C SAMPLE LOCATION-CEILING TILE IN ELECTRICAL CLOSET.

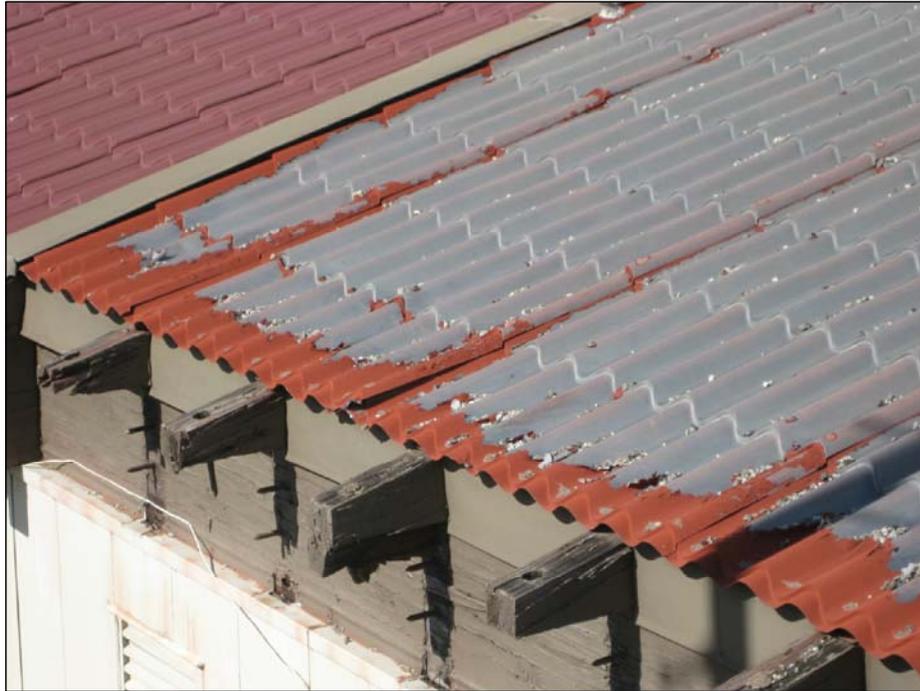
RVTF-4A SAMPLE LOCATION-ROOF.

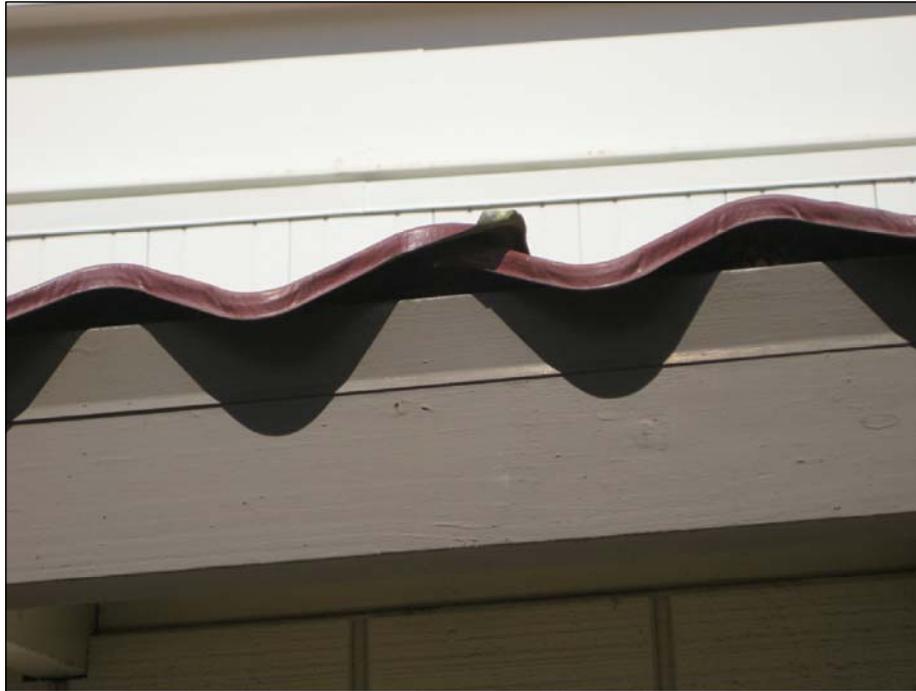
RVTF-4B AND 5A SAMPLE LOCATIONS-ROOF AND ROOF INSULATION.

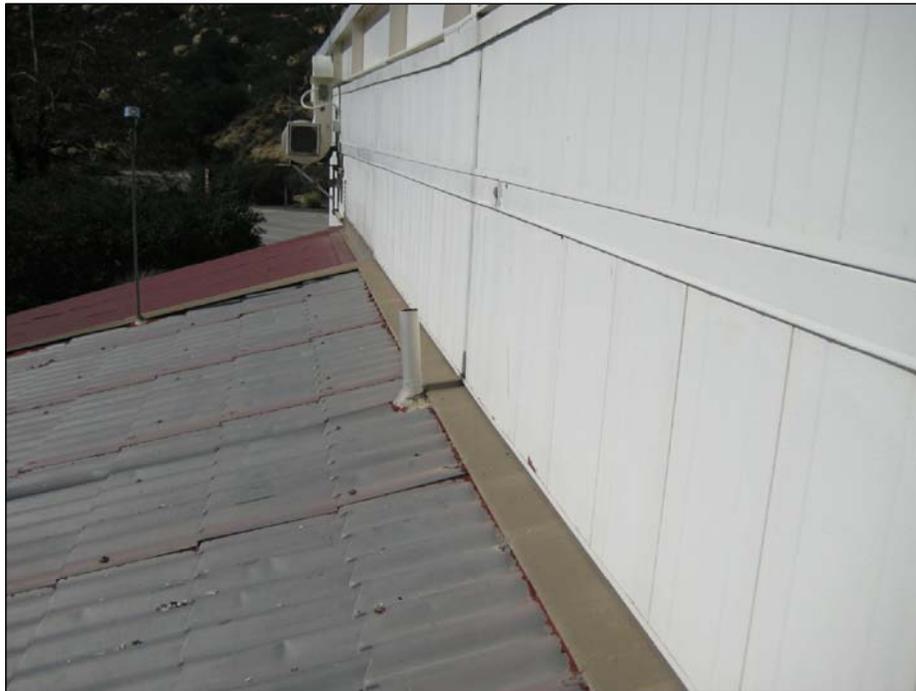
- Beige roof penetration mastic noted on the roof penetrations of the lean-to structure east roof (Sample Nos. RVTF-6A) contains 5 percent chrysotile asbestos. This material appeared to be in good condition and is estimated to encompass approximately 2 square feet. This material is classified as Category I non-friable ACM.

RVTF-6A	Beige Roof Penetration Mastic/Paint	East Roof, north side	5%/ND	Good/NF	2 SF

Asbestos Containing Material	Material Location	Asbestos Content	Condition/Friability/Category	Estimated Quantity
Beige Roof Penetration Mastic	Roof penetrations on east roof	5%	Good/NF/Category I	2 SF

RVTF-6A SAMPLE LOCATION-ROOF PENETRATION MASTIC.

- The owner should provide notification to employees, contractors, and subcontractors as to the presence and location of ACMs at the lean-to structure portion of the site. Notification should be provided to those workers performing duties in areas where these materials may be reasonably accessed and disturbed. At this time, and in their current physical state, the identified ACMs do not pose a significant health risk as long as they are not disturbed.

- Prior to building demolition or renovations, the property owner should retain a State of California-licensed asbestos abatement contractor to perform the abatement of the ACMs at the lean-to structure portion of the site. The general contractor for the demolition project may be a source for local licensed abatement contractors. Kleinfelder can also provide names of licensed and qualified abatement contractors in the area upon request. ACMs should be removed and disposed of only by properly licensed asbestos abatement contractors in compliance with applicable Federal, State, and local regulations.
