**ASBESTOS AND LEAD PAINT SURVEY REPORTS
CARQUINEZ MAIN BRIDGE AND NORTH APPROACH IMPROVEMENTS
SOLANO COUNTY, CALIFORNIA**

RE: **Asbestos Survey:** **Carquinez Bridge Cal-Trans buildings**
Vallejo, CA

RE: Lead-based Paint Inspection results for:

**Carquinez Bridge
CAL-TRANS Buildings
Vallejo, CA**

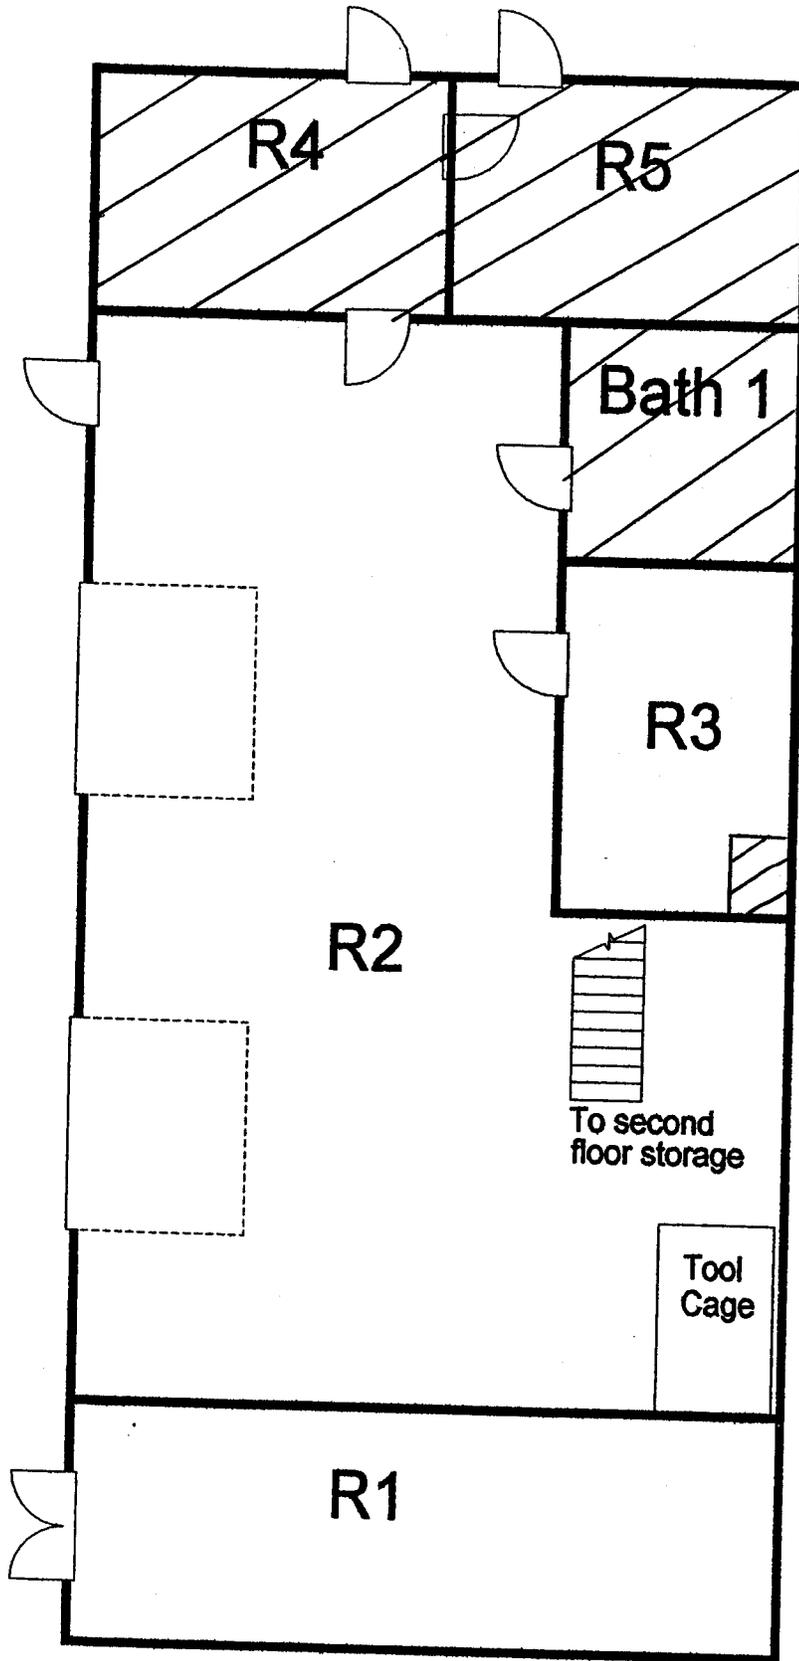
Maintenance Building

Sample 26-B					
Tan 9"x9" floor tile and black mastic	Maintenance building, SouthWest office and NorthWest office	Floor tile: >1% Chrysotile Mastic: 10% Chrysotile	Good, Non-friable / Category I	288 square feet	
Sample 30-B					
Brown-Tan linoleum and backing	Maintenance building, NorthEast corner of breakroom	20% Chrysotile	Good, Non-friable / RACM	30 square feet	This material will become Friable if the outer wear layer is separated from the backing
Samples 35-B and 36-B					
Corrugated Transite Siding	East Storage shed, West side and East side	25% Chrysotile	Fair, Non-Friable / Category II	875 square feet

Prior to any planned demolition that may disturb these materials, they must first be properly removed and disposed of by a licensed and certified Asbestos Abatement Contractor. Upon your request, HB&T Environmental, Inc. can provide Project Management Services that would monitor for the removal and disposal of these ACBMs.

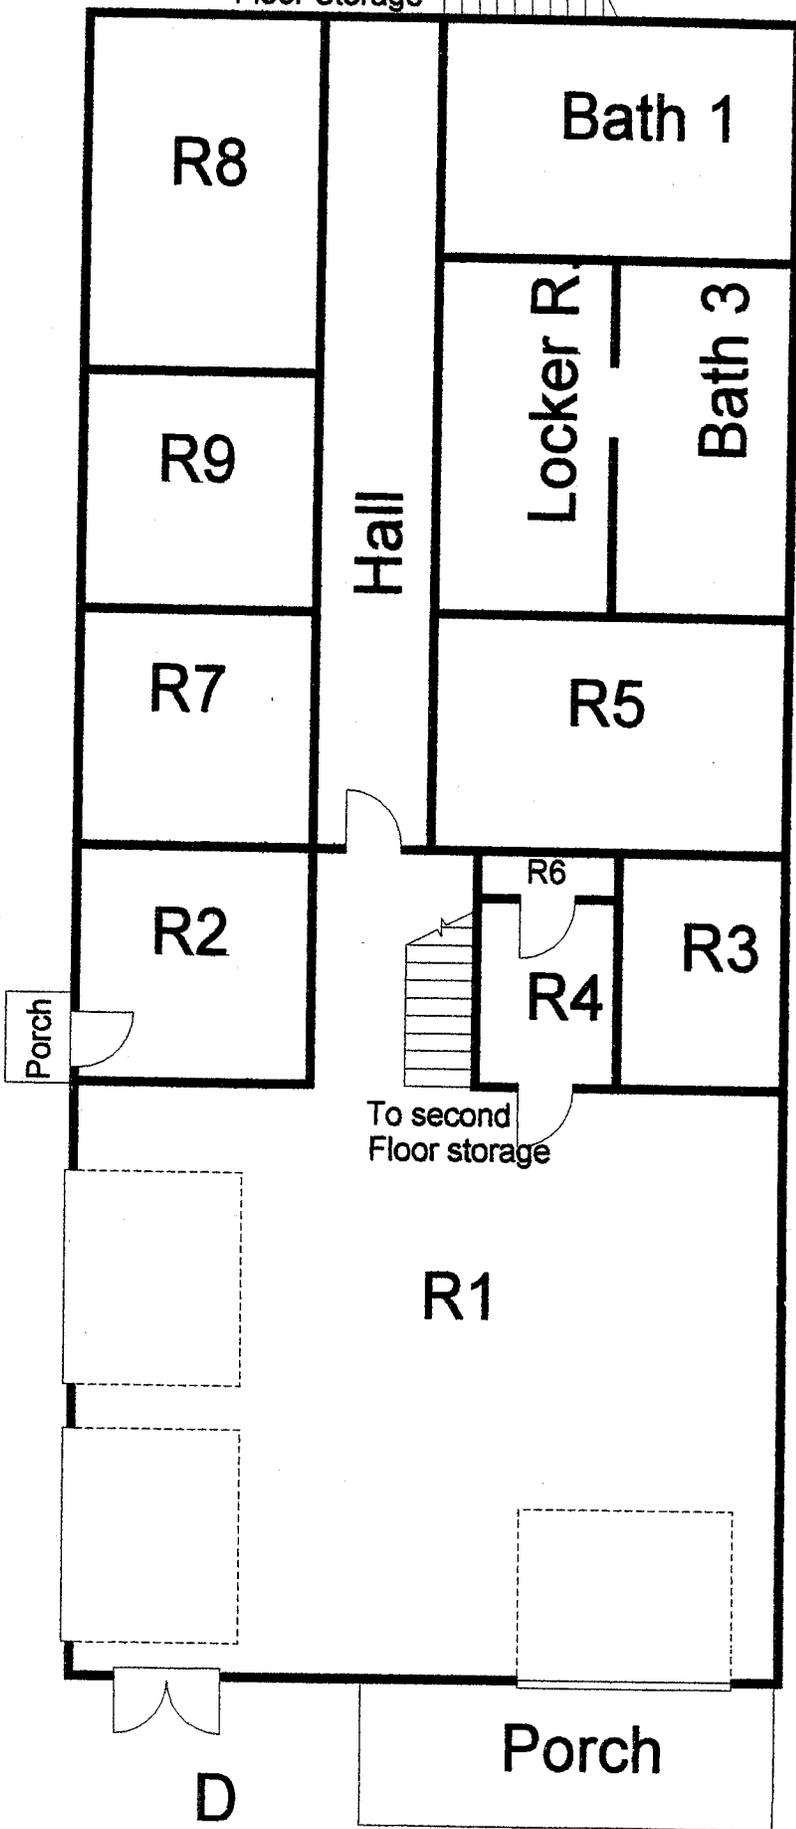
Paint Warehouse

A floor plan of the building is included, so you can identify the locations of high Lead levels on the report. All of the walls that are parallel to side A on the drawing are wall A on the report. The walls that are parallel to side B are wall B on the report etc. Similar building components are numbered from left to right as you face the wall where they

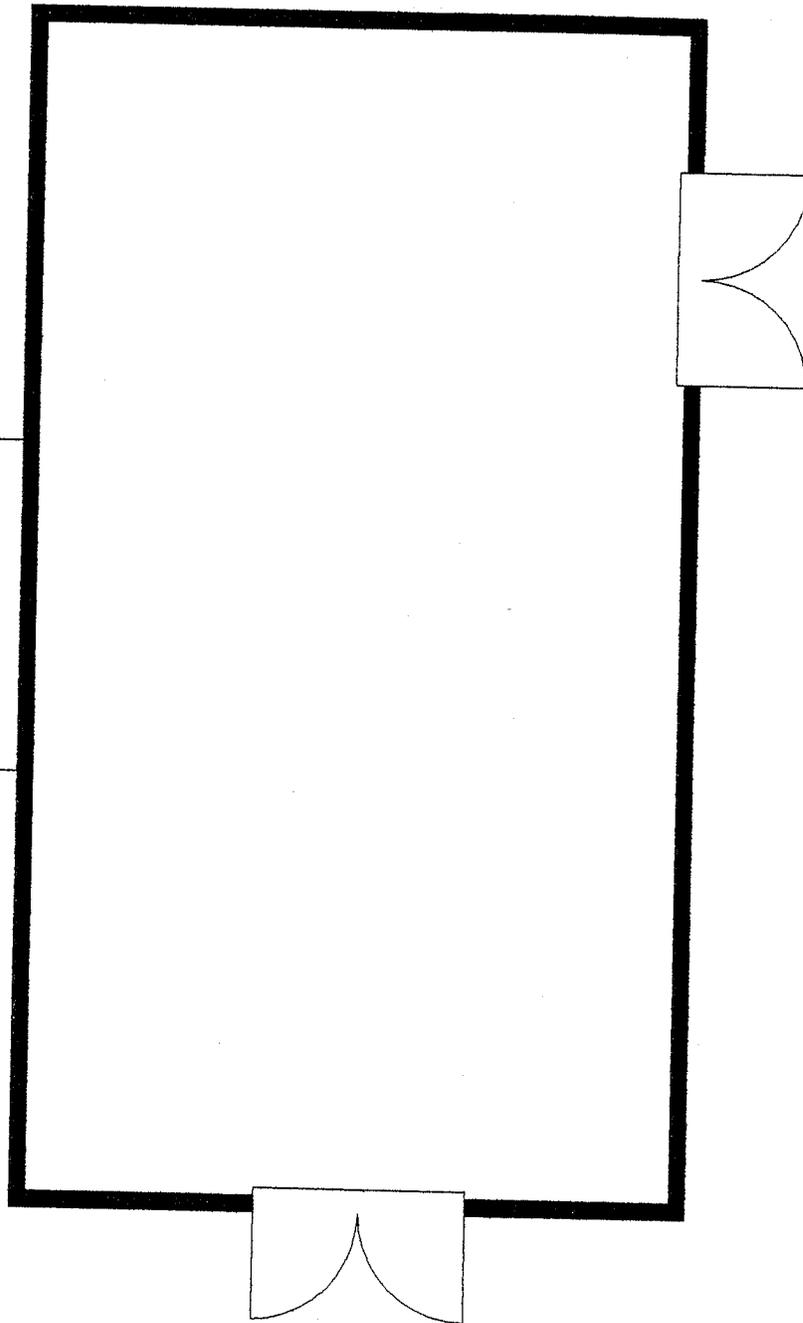
Compressor Bld.

Sand Tank Footings
See reading #227
