SAN FRANCISCO-OAKLAND BAY BRIDGE
EAST SPAN SEISMIC SAFETY PROJECT

PILE INSTALLATION DEMONSTRATION PROJECT
(PIDP) CONSTRUCTION REPORT

CONTRACT 04-012084
04-A1a-80-0.0/0.5

APRIL 2001

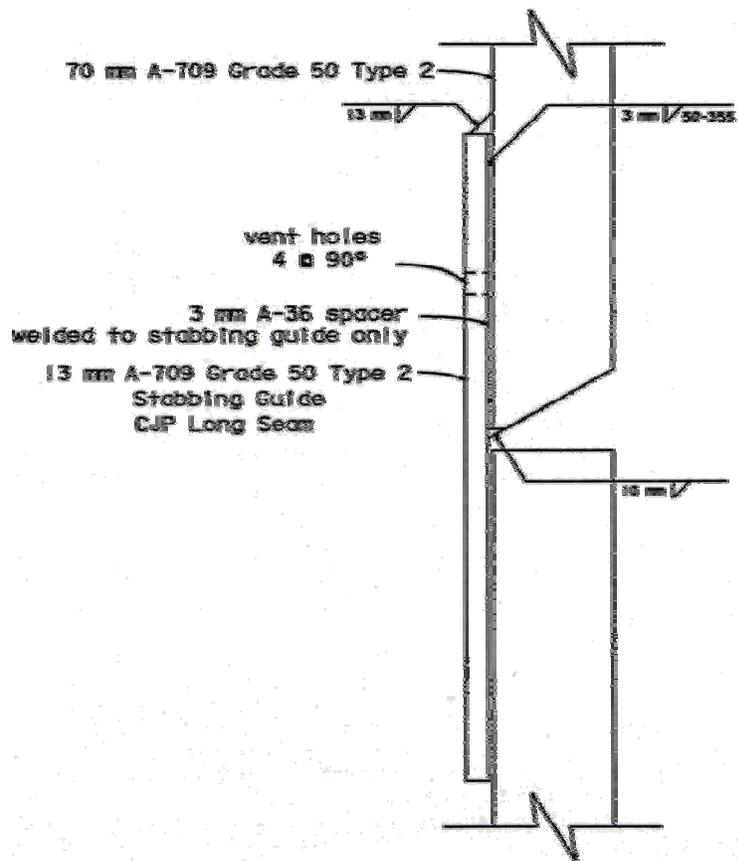
Figure 12 - Weld Detail with Spacer Plate

Based upon their experience, the welding consultant proposed a non-standard joint detail to perform the complete joint penetration girth weld (Fig. 12). This detail was intended to improve the ease of connecting (stabbing) two sections of the pile together in the field. This detail included a 3 mm spacer between the 13 mm backing plate and the pile plate. The welding consultant proposed to use a T-12 wire.

When the consultant attempted to assemble the two full-sized mock up pieces (2.4 m dia., 600 mm long, 70 mm thick), they found that the backing plate/stabbing guide created as many problems as it solved. While the stabbing effort was simplified, the gap between the backing plate and the lower pile section increased when the joint was preheated to the required temperature resulting in a failure to achieve the proper joint geometry. In some locations the gap exceeded 6 mm when preheating was complete. This fit-up difficulty was attributable to the additional hoop restraint on the pipe pile by the stabbing guide/backing bar related to the lack of provision for thermal expansion of the upper pipe. The Contractor requested permission to proceed with the PQRs with this geometry and the State granted this request.

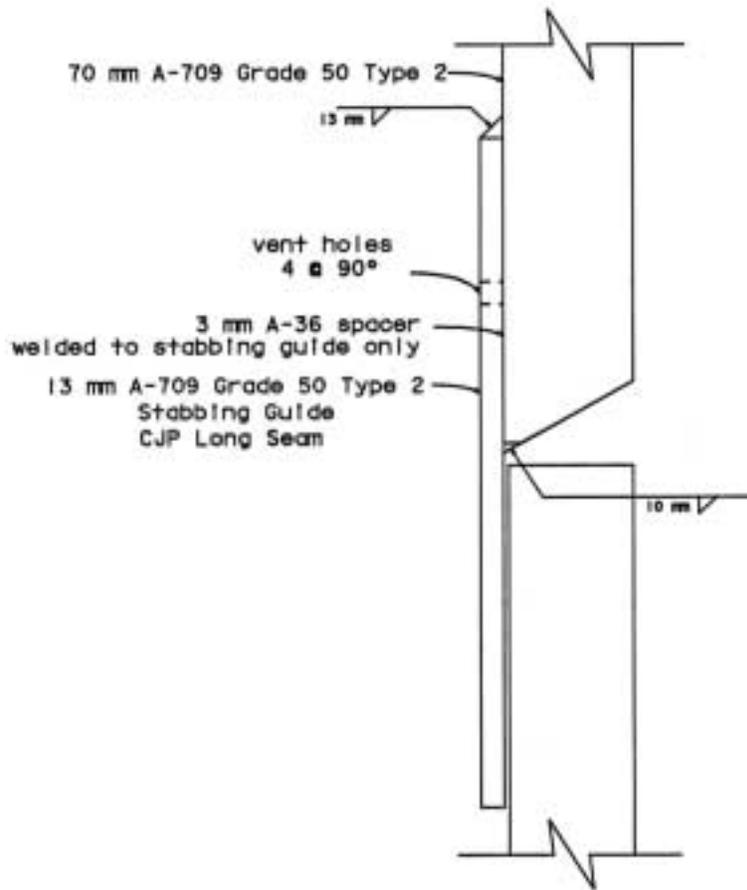
Figure 13 - Weld Detail As Built

The consultant attempted several Procedure Qualification Records (PQRs) using this detail. The consultant chose to prepare PQRs and Welding Procedure Specifications (WPSs) for procedures using two different wire types, as well as a Shielded Metal Arc Welding (SMAW) procedure for use in repairs. In order to complete the root of the weld, the Contractor chose to use a welding procedure which called for the first several passes to be welded using a SMAW process and then continue the filler passes and cap passes using the FCAW_G procedure. All of these PQRs and the qualification of some welders were attempted at the same time on this set of mock-up pipe sections. This endeavor took more than two days, working 24 hours per day, to perform. After completion of the Radiographic testing of this joint, the Contractor informed the Resident Engineer that this PQR showed numerous rejectable indications. The welding consultant decided against further use of the 3 mm spacer plate (Fig. 13).

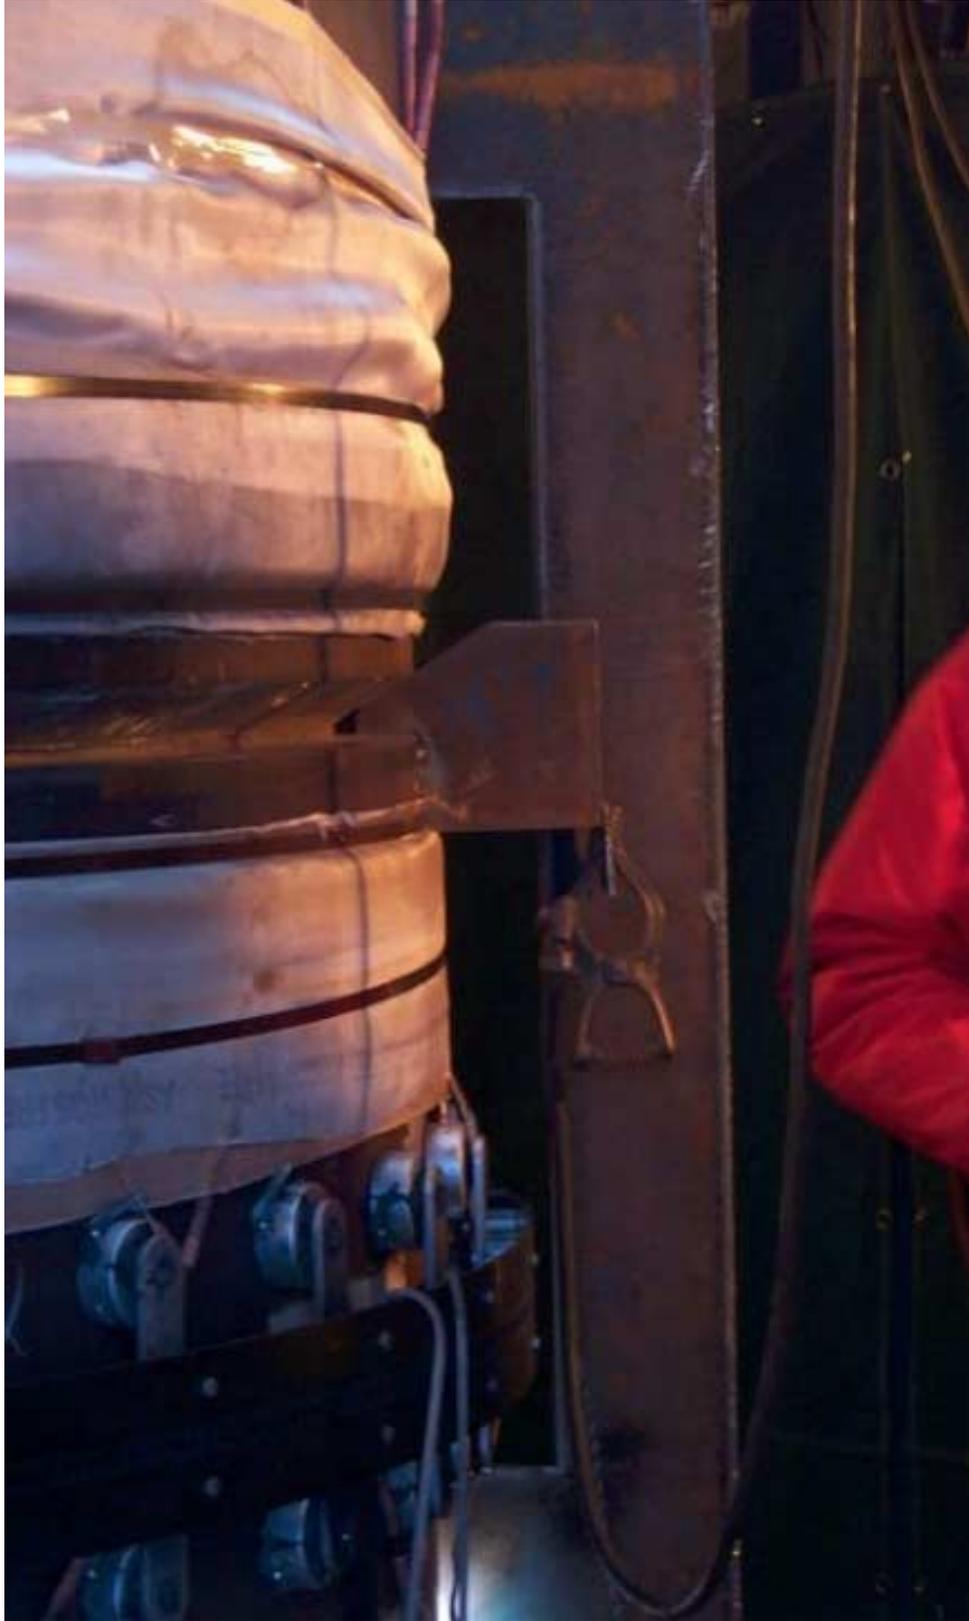
Figure 16 - Pile fit-up

In order to secure the pile segments upon stabbing and maintain the weld geometry, a set of wedges and strongbacks were temporarily welded to the face of the pile (Fig. 16). The Contractor took care to provide that these components would secure the pile and keep the stresses applied to the root passes of the weld by the movement of the DB-24 on the waves from cracking the initial passes of the weld. These wedges and strongbacks were removed entirely after the root passes were completed and the upper pile segment was adequately secured to the lower segment.

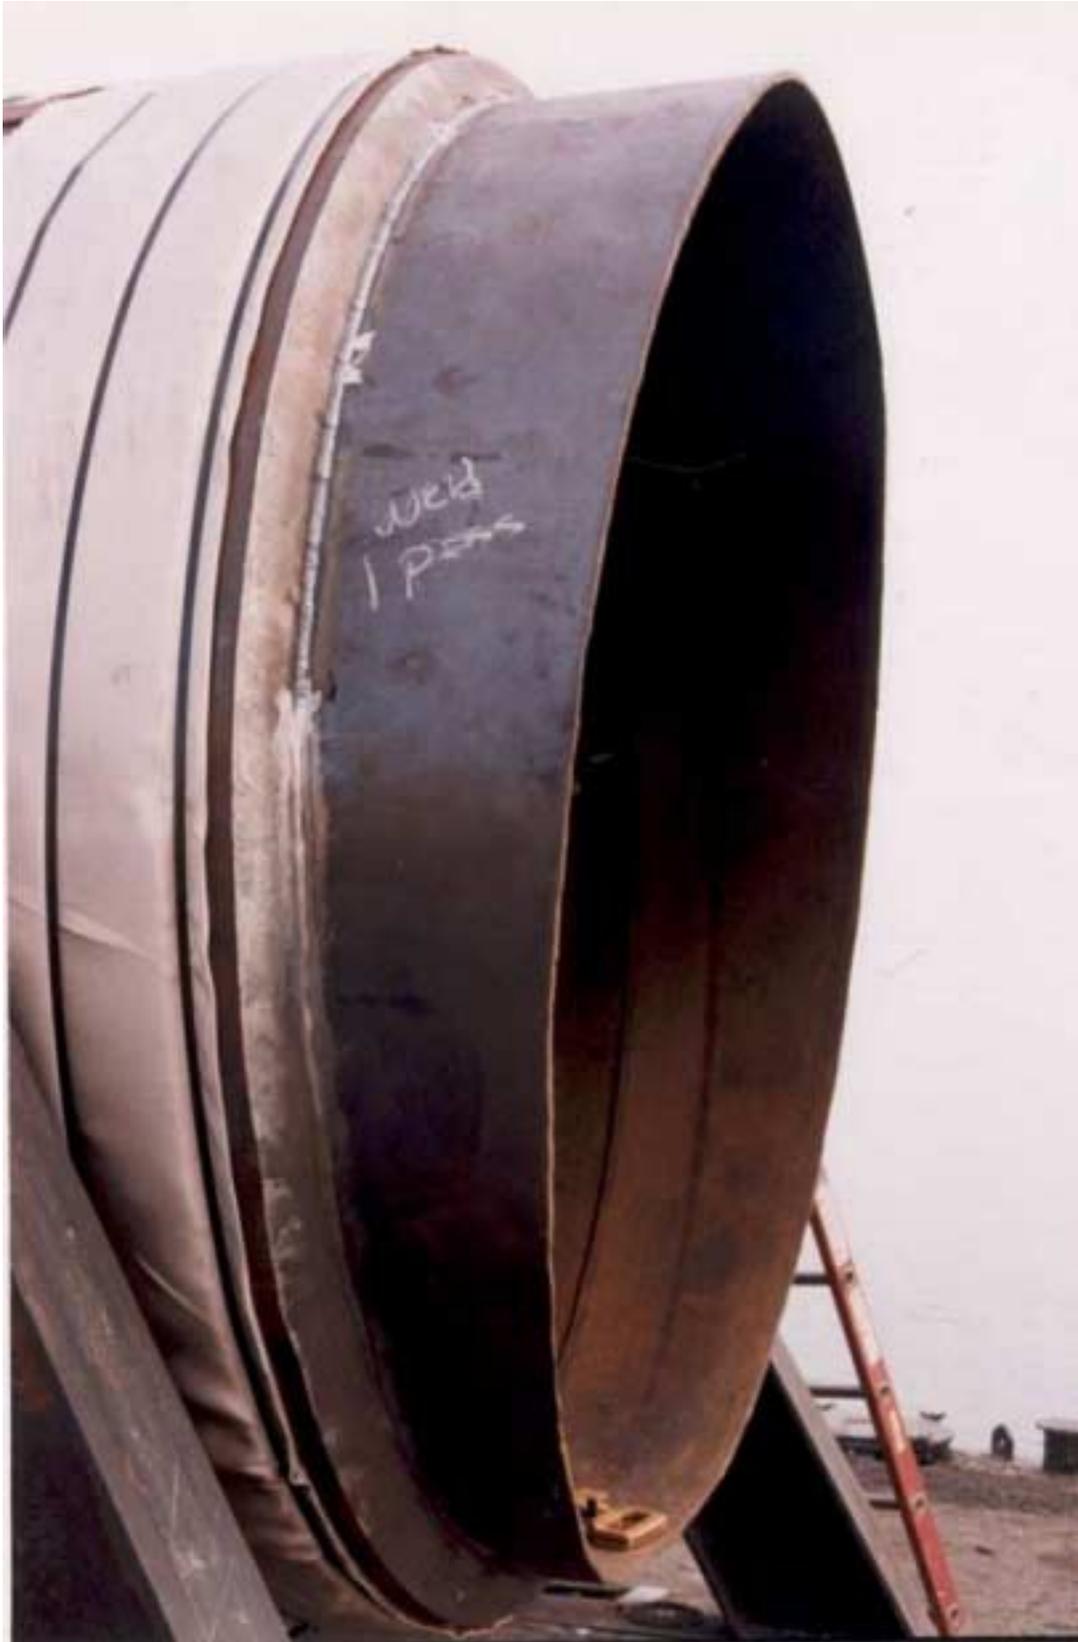
Figure 17 - Stabbing Guide

additional restraint caused the forces applied to the second weld by the weld shrinkage to crack the base metal of the backing plate adjacent to the weld.

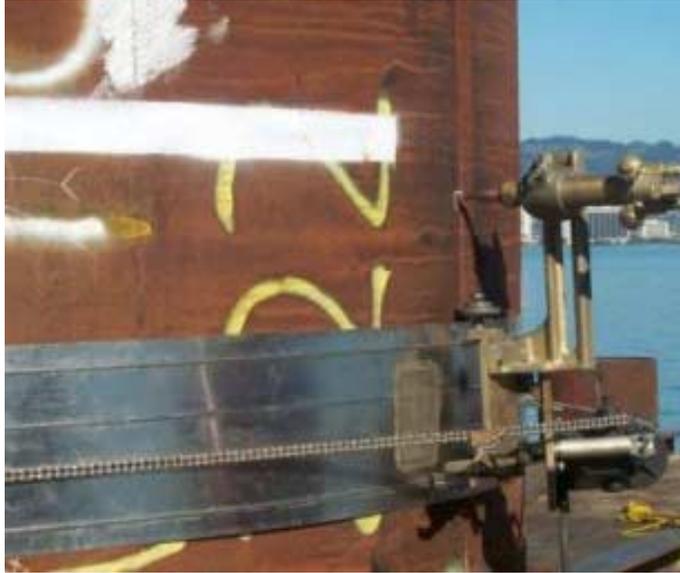
Figure 18 - Pile Cut-off

Upon completion of the driving of each of the lower three sections of pile, 1.5 m was cut off to fresh head the piles before the splice weld was made. These cuts all met the straight edge requirements of API 2B. Pile section 1D was cut off in the field to provide additional mock-up sections. This cut was made somewhat unevenly, which caused some irregularities in the pile stresses as determined by Fugro using their Pile Dynamic Analyzer (PDA).

- The pile batter did not appear to significantly reduce the drivability of the piles.
- Care must be taken to assure that the pile heads are cut off evenly and square to assure that the stresses applied by the pile hammer are distributed evenly to the piles.
- The waterborne sound attenuation efforts were both effective in reducing the SPLs to a point where the damage to fishes was noticeably reduced.
- MMM showed that there was a minimal effect of the pile driving upon the pinniped population in this part of the bay.

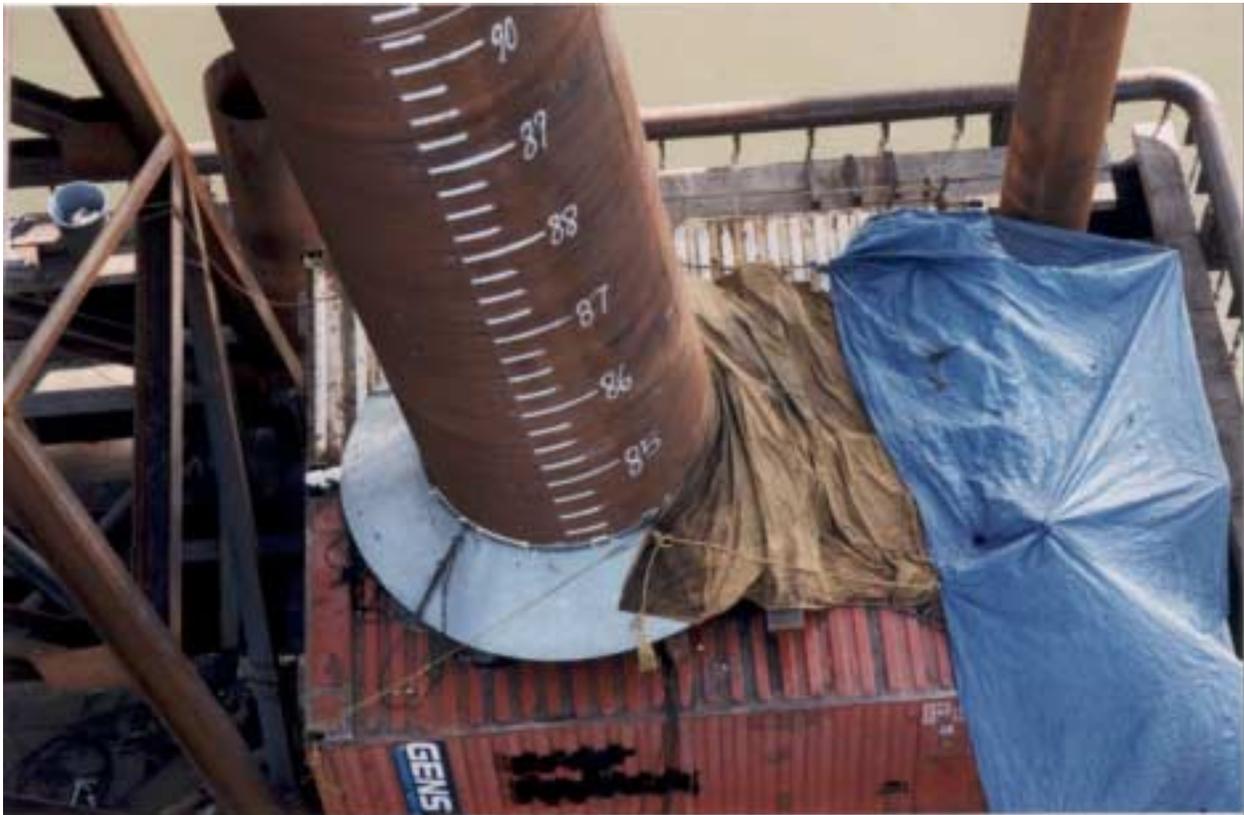
Figure 19 - Welding enclosure at pile 3

Flash burns from radiation that was reflected off the enclosure walls were one difficulty that was encountered. Fireproof shielding that minimized the reflections was found to be necessary. The personnel that regularly worked in the enclosure also found it necessary to apply heavy sun-screen to exposed skin and then wore clothing on the back of their heads in addition to using the hoods and eye protection devices that are standard in this industry. With multiple welding units working in this confined space the placement of the lights, machines, power chords, leads and support and QC/QA personnel all created additional logistic problems that had to be dealt with.
