*California Department of Transportation
Division of Maintenance*

Bridge Number : 42 0323R
Facility Carried: SR 180 EB
Location : 06-FRE-180-R59-FRE
City : FRESNO
Inspection Date : 01/26/2010

Bridge Inspection Report

STRUCTURE NAME: FIRST STREET UC

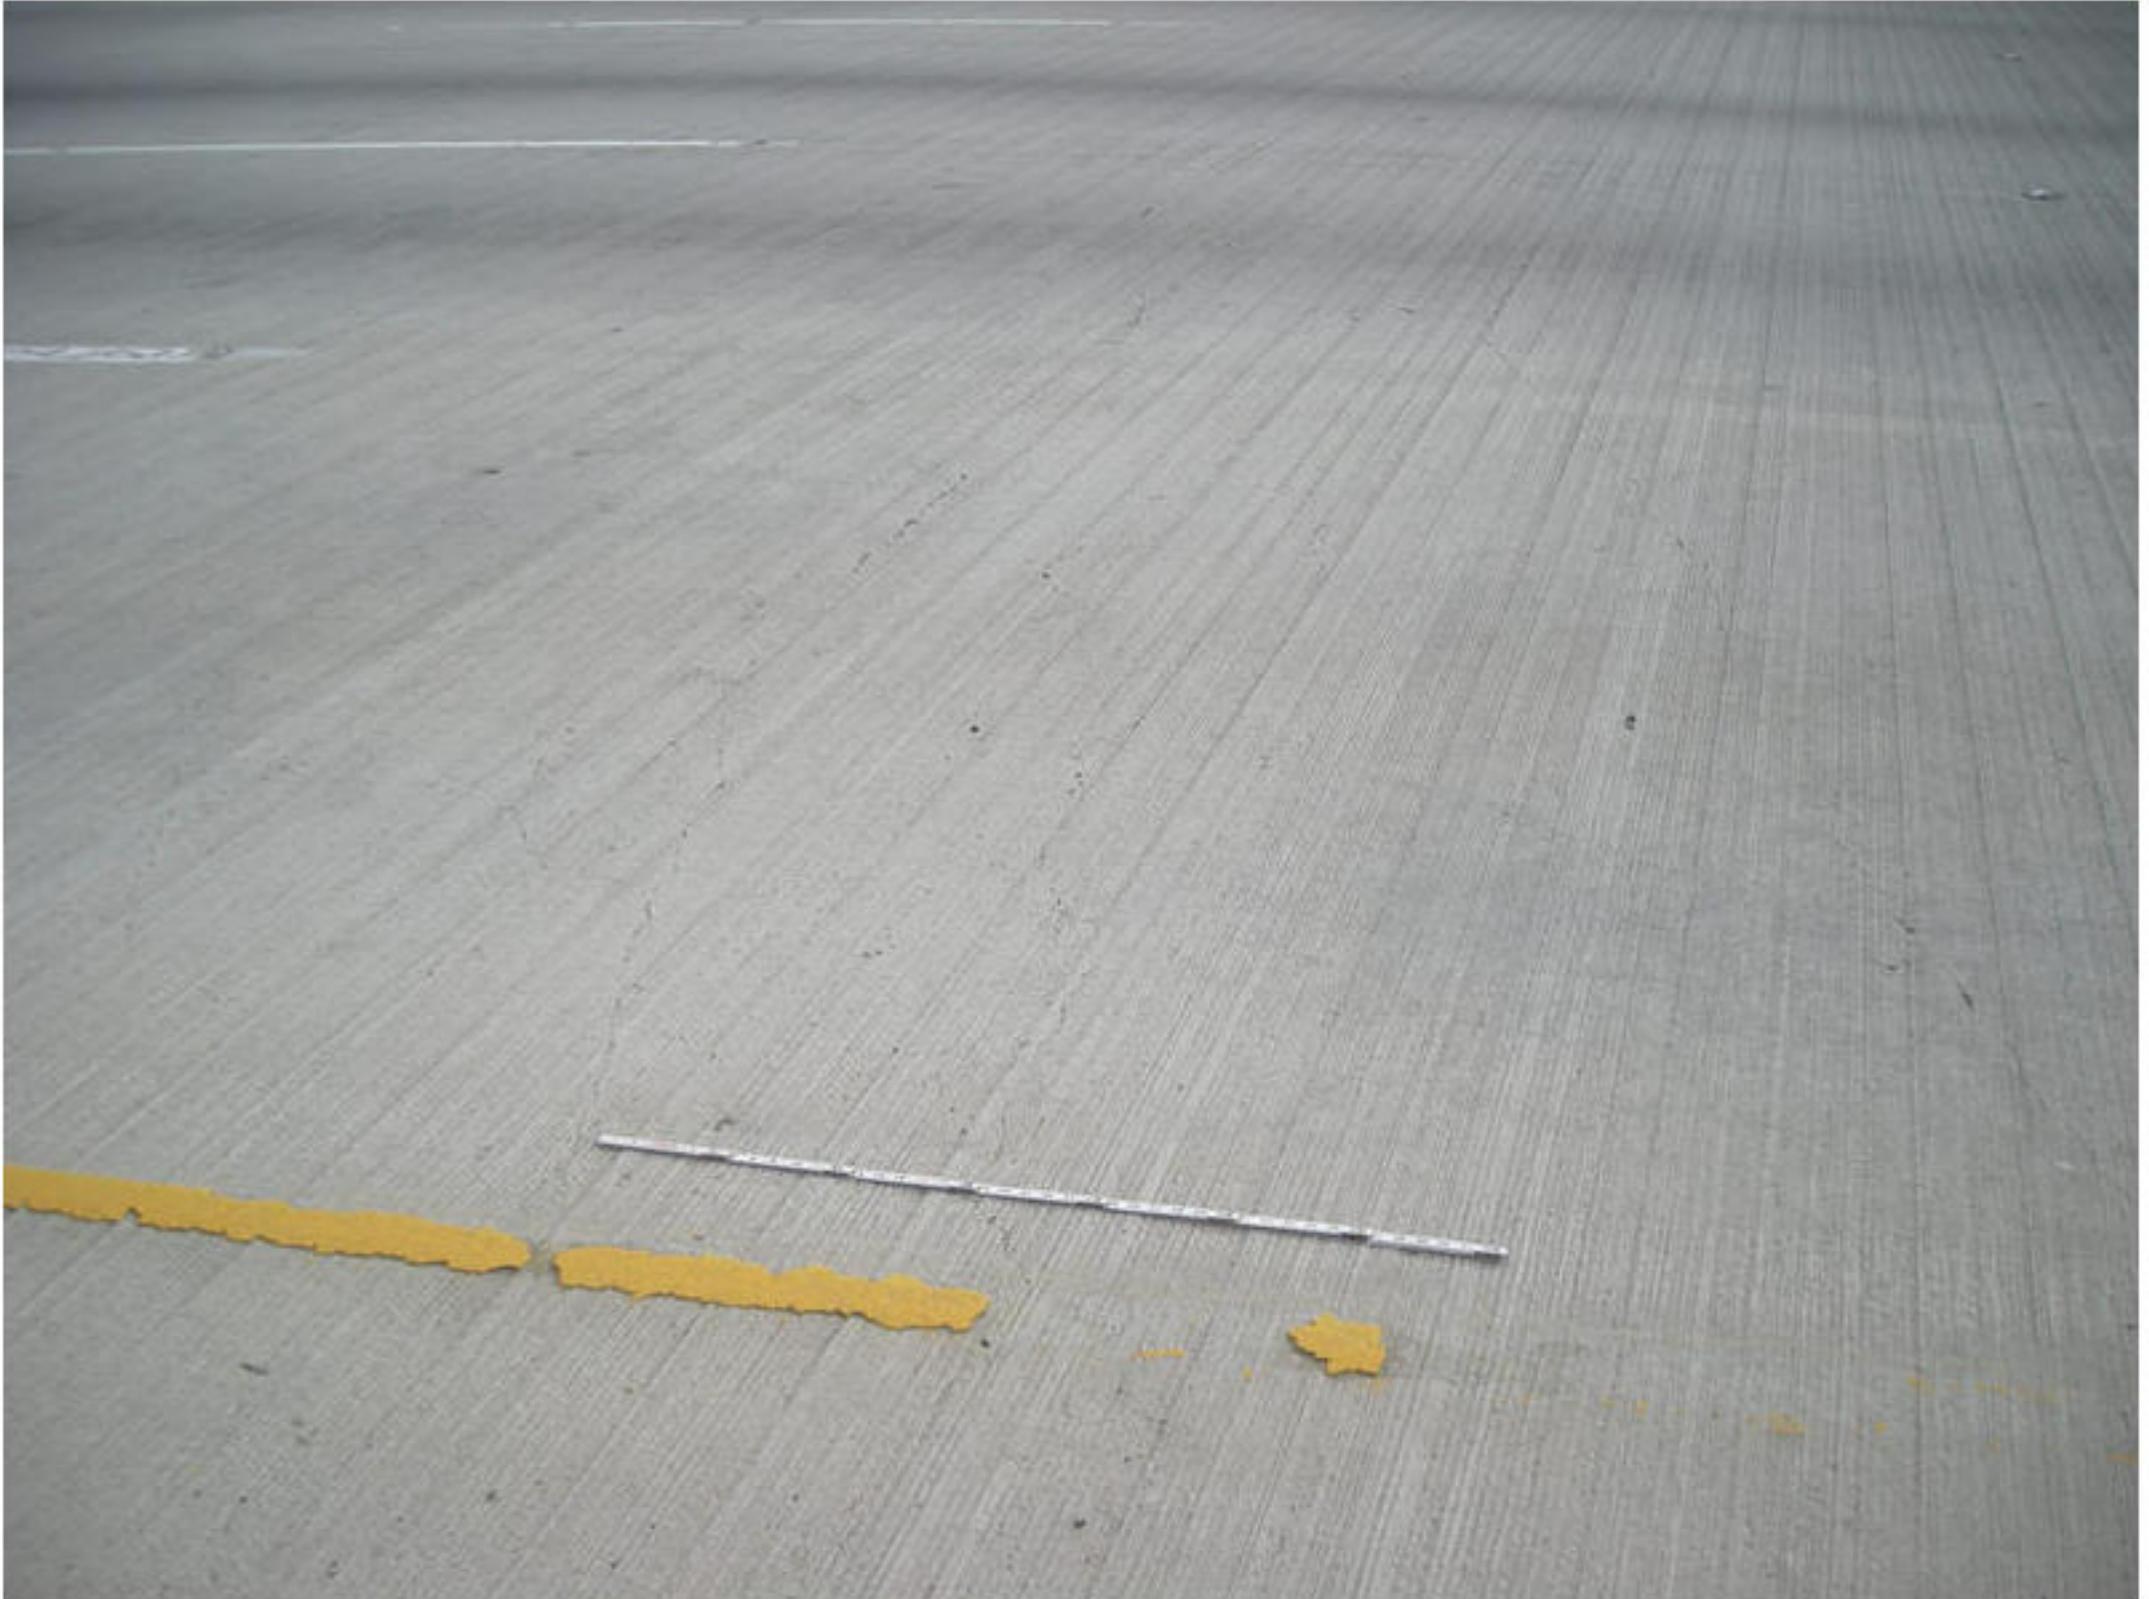
Element #358, Deck Cracking Smart Flag, was downgraded to condition state 3 due to the diagonal and transverse cracks on the deck.

There are diagonal and transverse cracks on the deck. The diagonal cracks are located at Abutment 1 and 3, are 1/64" to 1/32" in width and 3 to 4 feet on centers, while the transverse cracks are 1/64" to 1/32" in width and 16" on centers (photos 3 to 5). Cracks are common for concrete structures and most of the time they do not effect the ultimate capacity of the bridge. However, cracks in concrete can affect the service life of a structure by providing a pathway for moisture to access the deck reinforcing steel and accelerate corrosion. Due to the deck cracks, the deck should be treated with methacrylate to prevent water from corroding the deck reinforcing.

Photo No. 3
Deck cracking over the bent

of the time they do not effect the ultimate capacity of the bridge. However, cracks in concrete can affect the service life of a structure by providing a pathway for moisture to access the deck reinforcing steel and accelerate corrosion. Due to the deck cracks, the deck should be treated with methacrylate to prevent water from corroding the deck reinforcing.

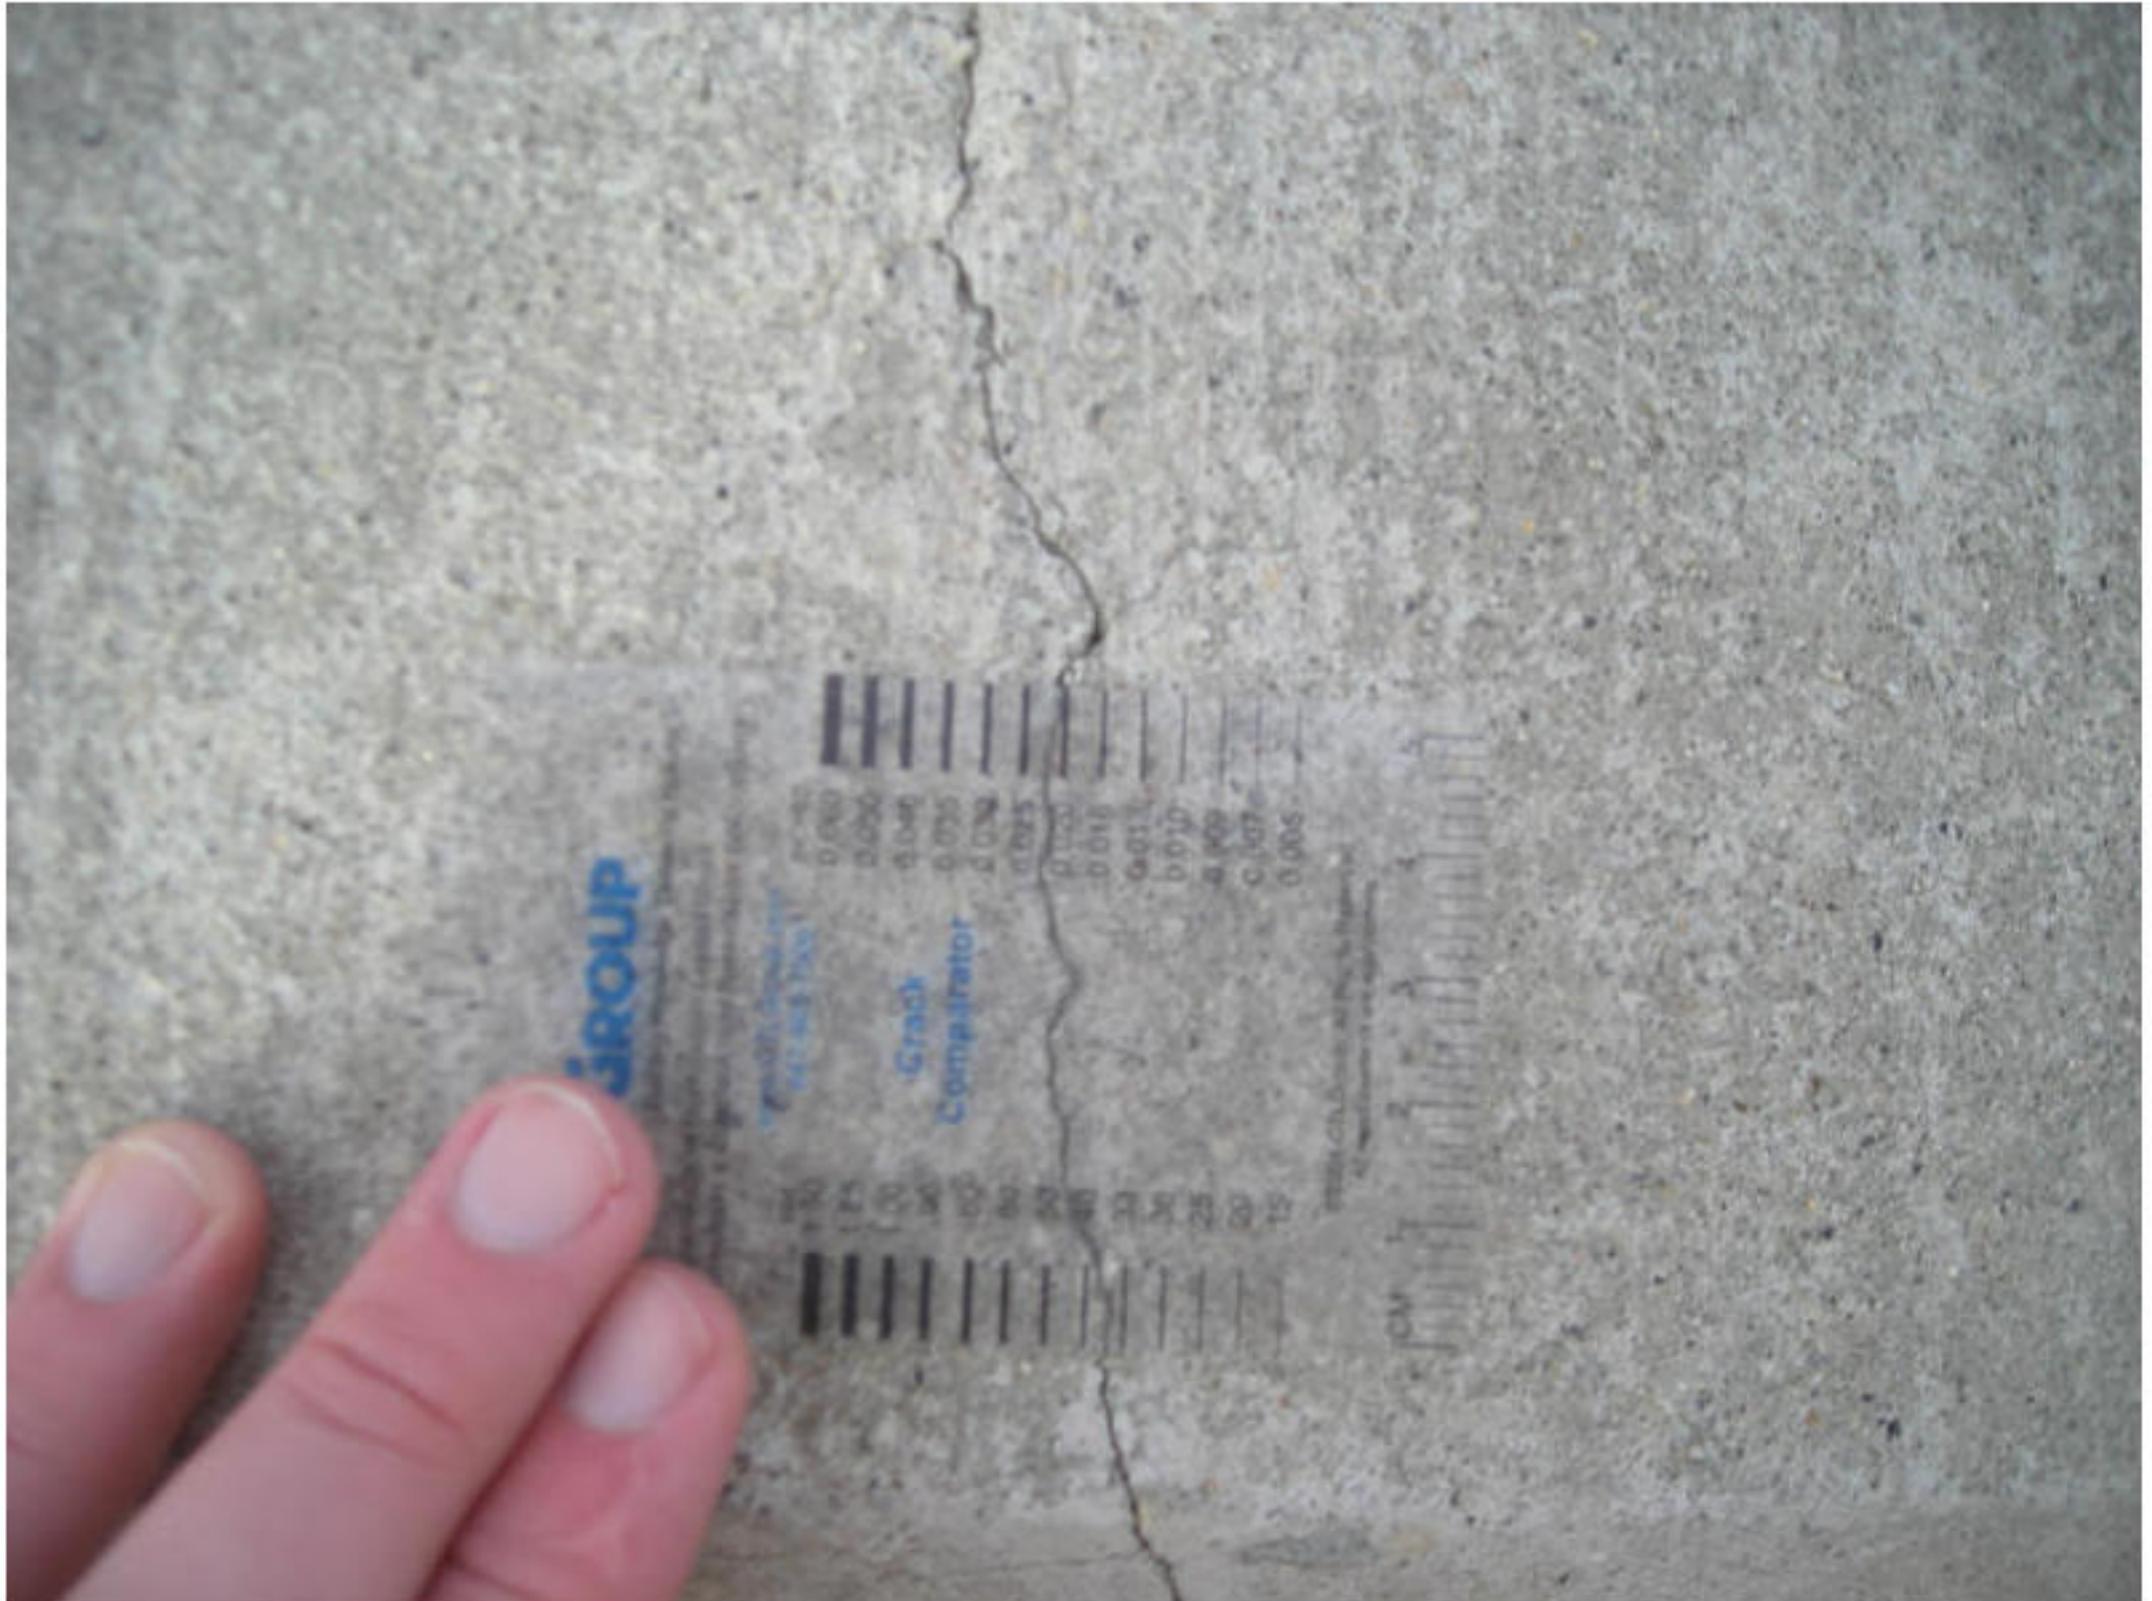
Photo No. 4
Close up of deck cracking over the bent

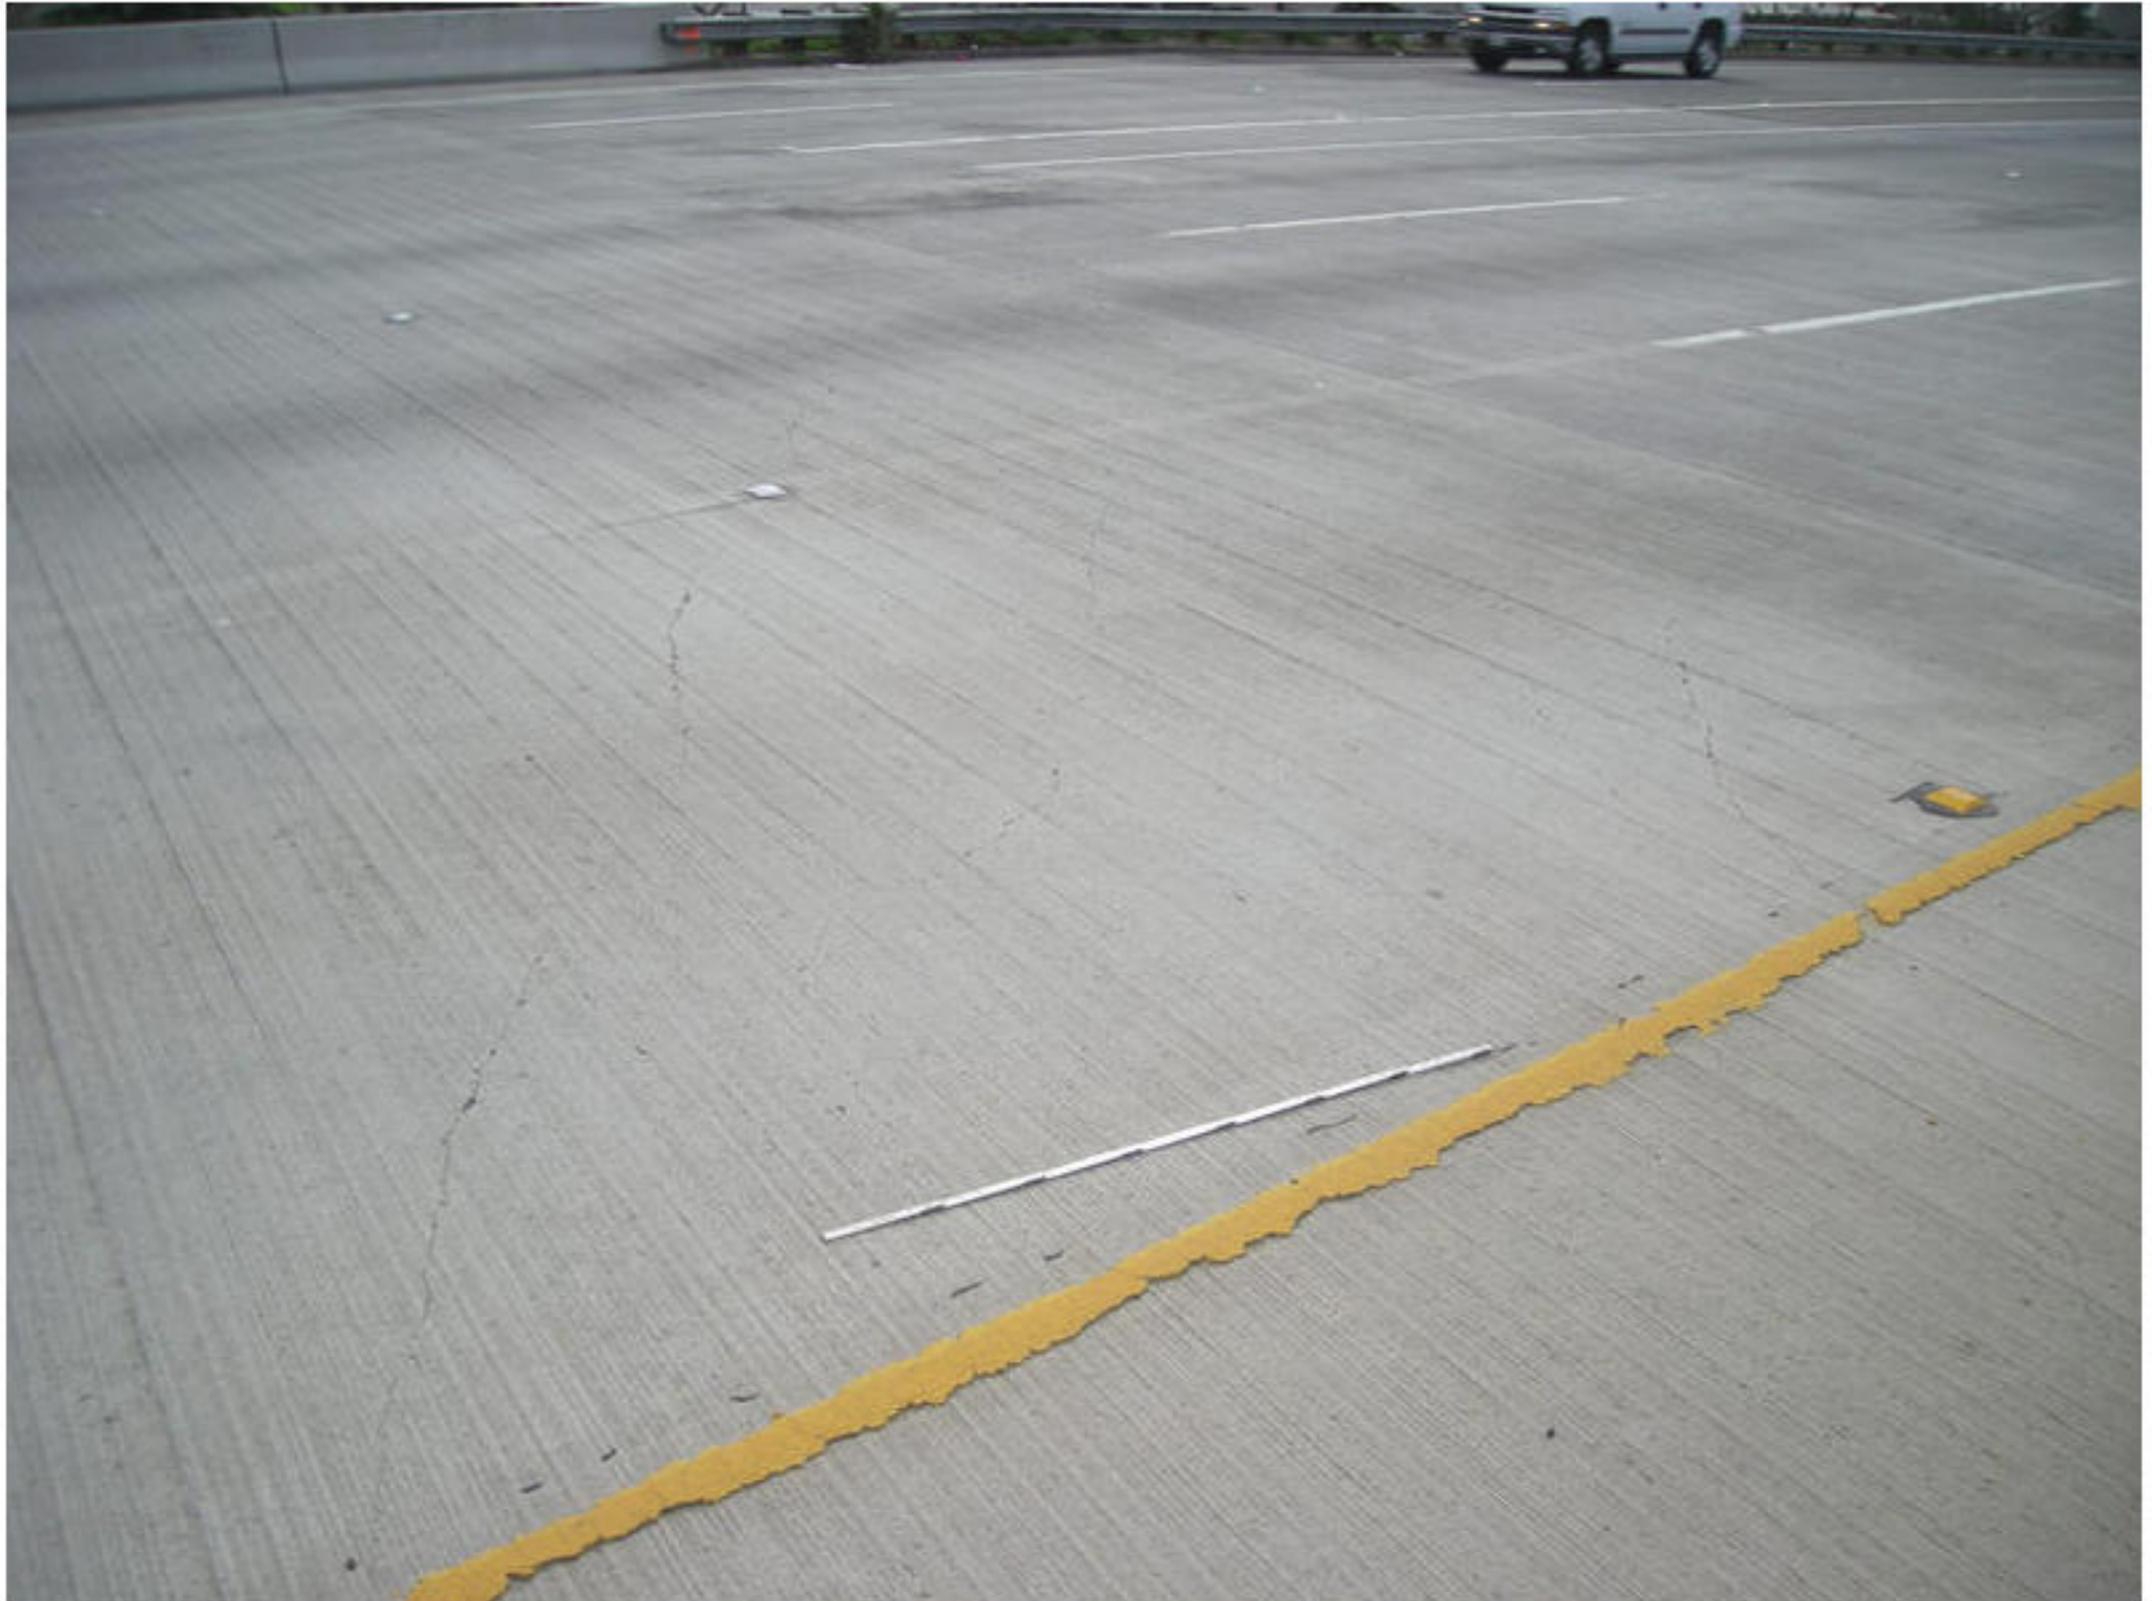
Photo No. 5
Deck cracking near the abutment

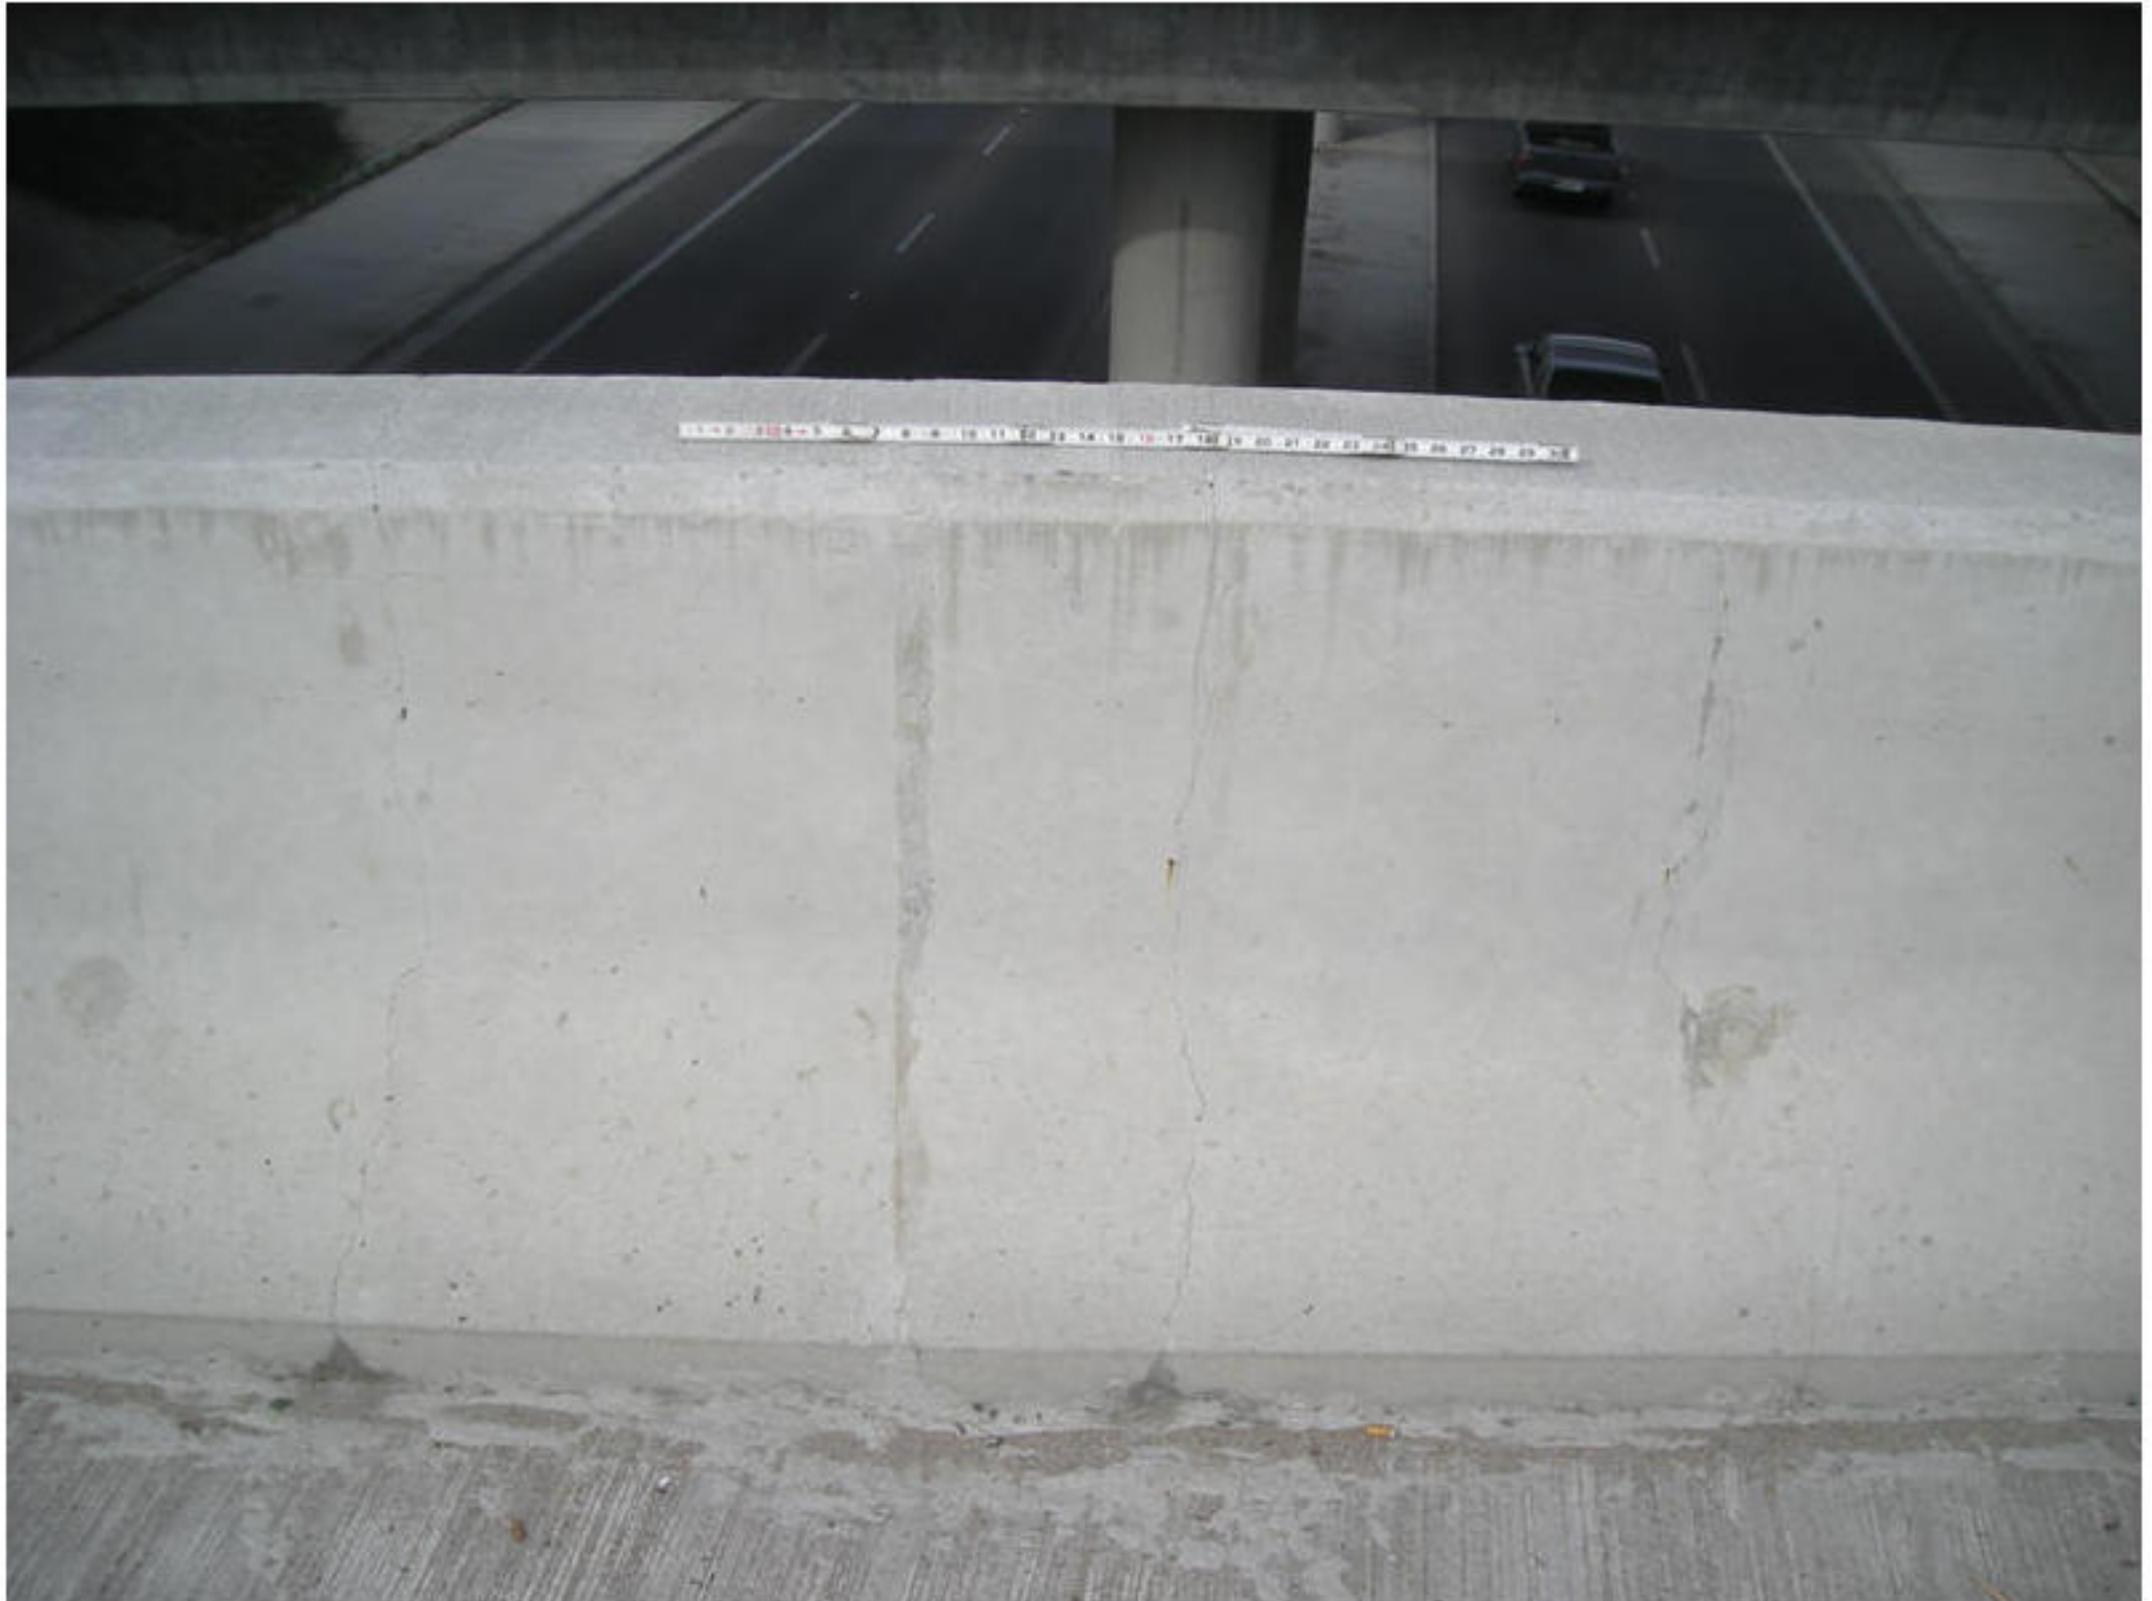
Vertical cracks are present on the left concrete rail over Bent 2 (photo 6). This condition is common in the negative moment regions and is noted for future reference.

Photo No. 6
Vertical cracks on the rail over the bent

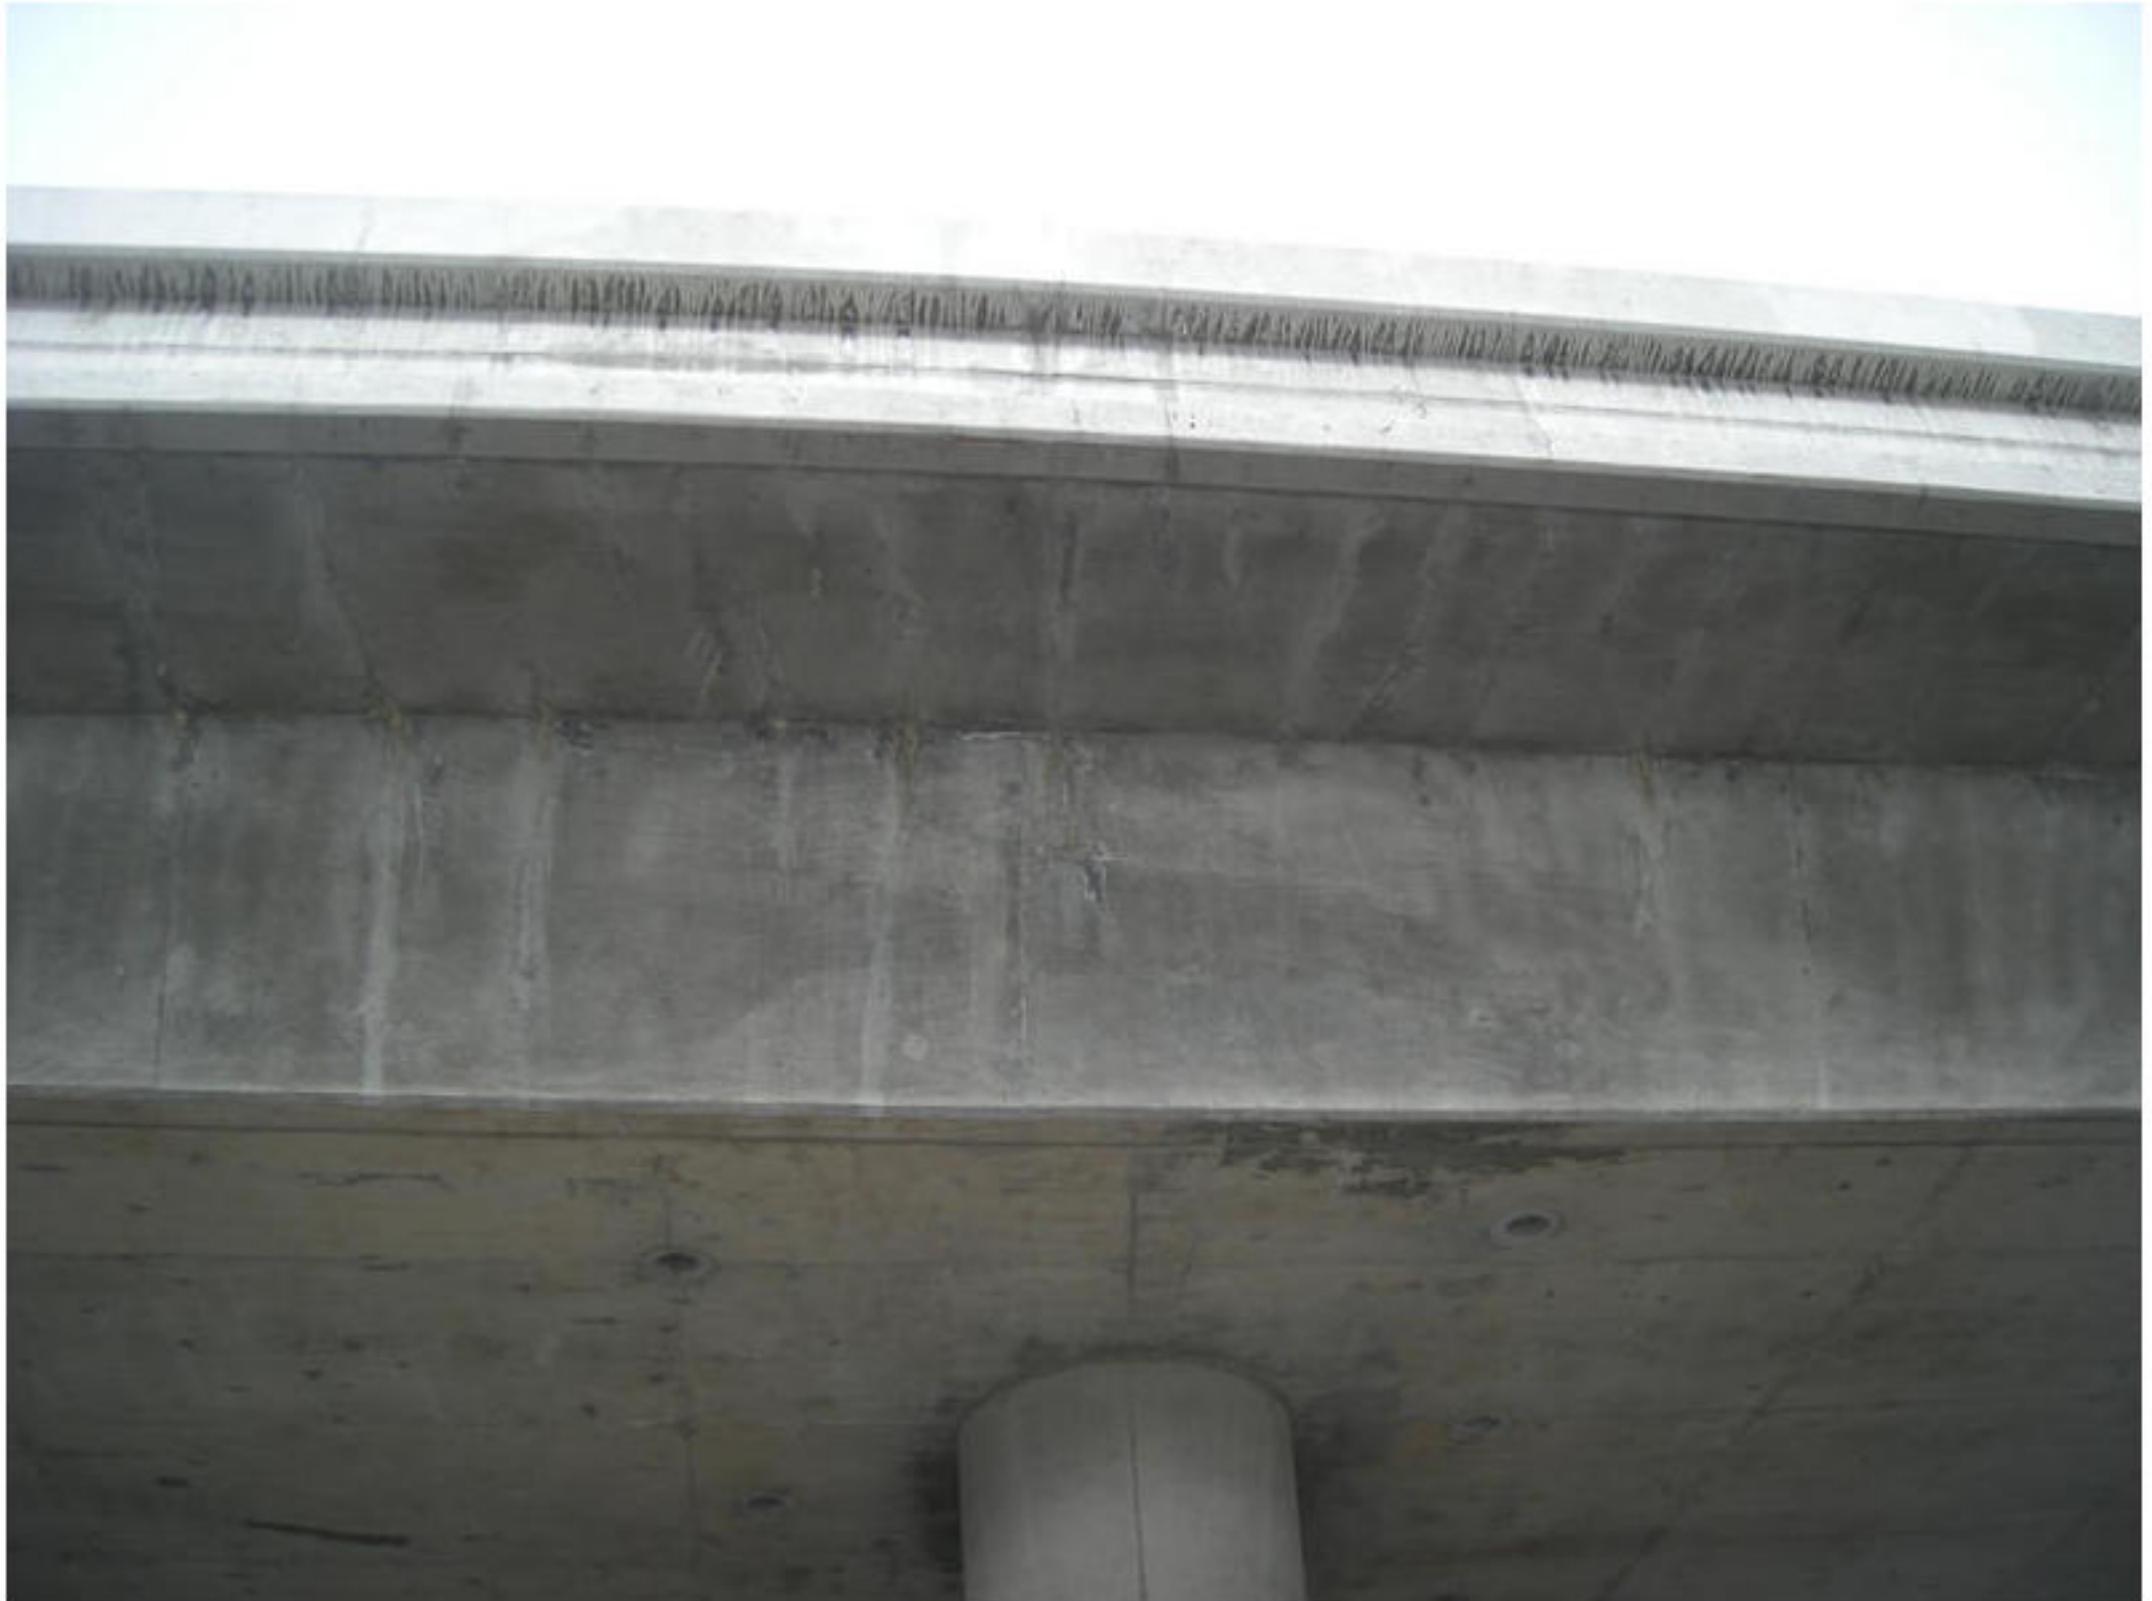
There are transverse cracks with light efflorescence on the undersurface of the overhangs at Bent 2 (photo 7). Again, cracking in the negative moment regions of concrete structures is common and this condition is no a concern and noted for future reference.

Photo No. 7
Transverse cracks on the overhang at Bent 2
