A Report on Observation of Underdrain Rehabilitation on I-Men-1-D,E Between 4.1 Miles North of Forsythe Creek and Ridgewood Summit

October 1957

State of California
Department of Public Works
Division of Highways
Materials and Research Department

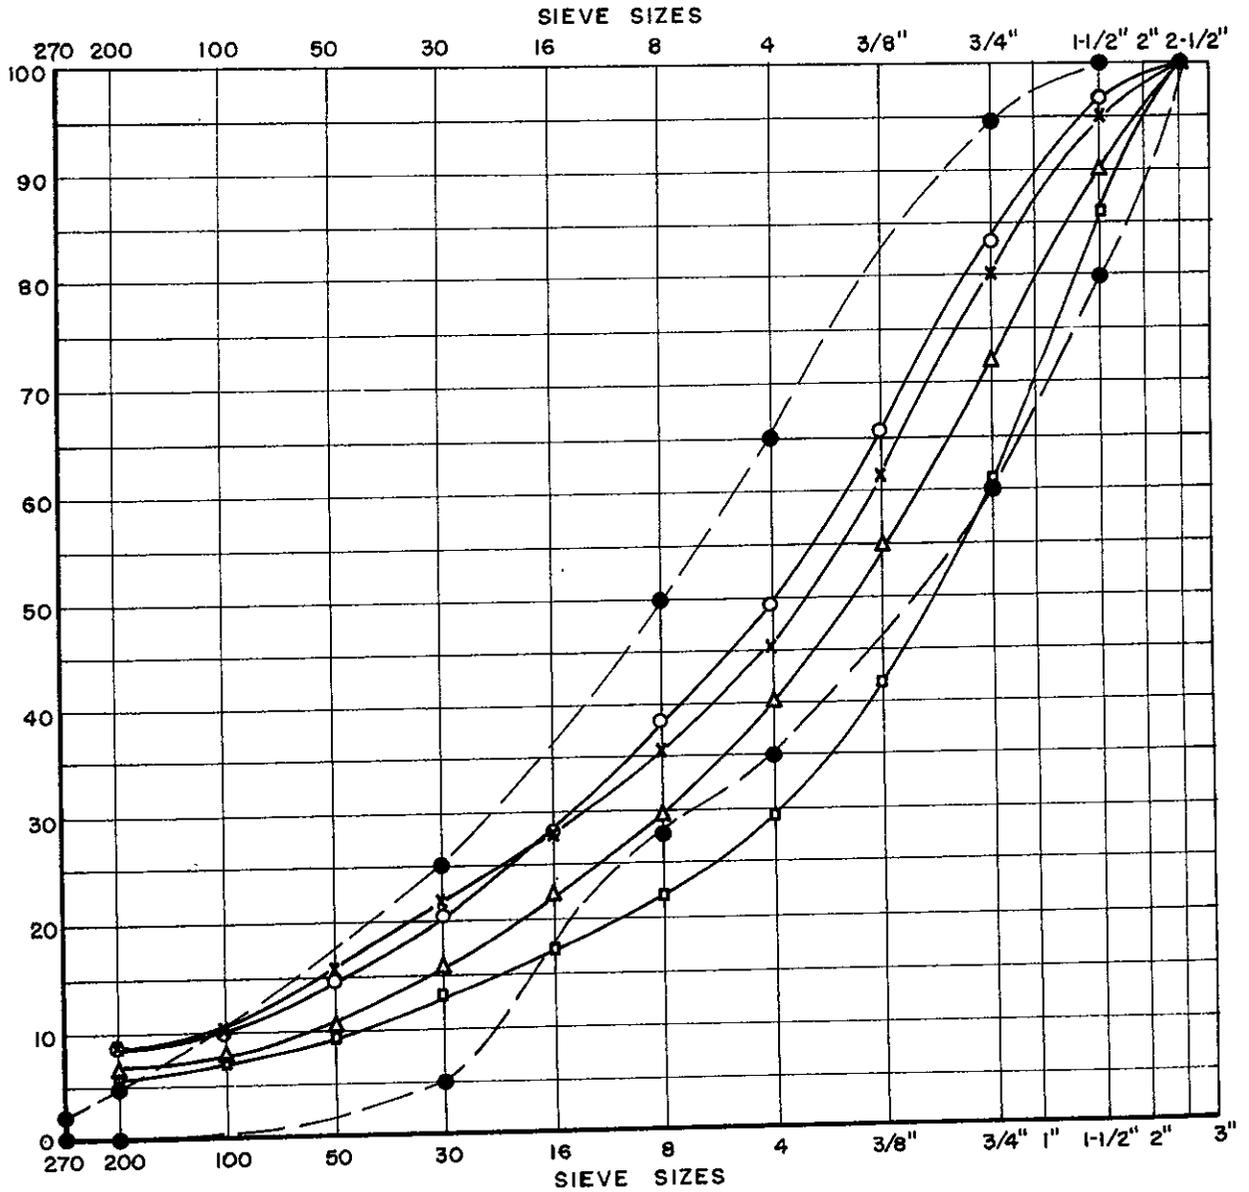
Chart 1.

The filter material that was used in the underdrains in Contract No. 53-1TC12-F was a river-run sand and gravel. The material was quite dense at the time of the rehabilitation operations and grading tests on four samples of the old filter material taken from the trenches showed 6% to 8% passing the No. 200 sieve. The Special Provisions called for 0 - 5% passing the No. 200 sieve, Chart No. 1. Grading tests which were performed at the time of the contract on material sampled from various gravel bars, stockpiles, test pits, stabilization trenches, etc., showed quite a range of passing #200, 1% - 7%, with an average of about 3%. Water flowed through this in-place filter material rather slowly and had a tendency to puddle, which might be an indication of non-uniformity in the grading. Laboratory permeability tests on the four samples of the old filter material gave permeability values of 0.1 to 3.0 feet per day. At times of high flow (rainy season, etc.) materials

3. The in-place filter material contained too much material passing the No. 200 sieve. When compacted, it has a low permeability and during periods of high flow water could not percolate through it fast enough to maintain a relatively dry roadbed.

Further studies and observations should be made in order to improve the specifications for filter material. The Materials and Research Department will continue studies on the specifications. In the meantime the special provisions should specify slightly less fines than the present standard specifications permit and should contain some provision regarding the durability of the filter material.

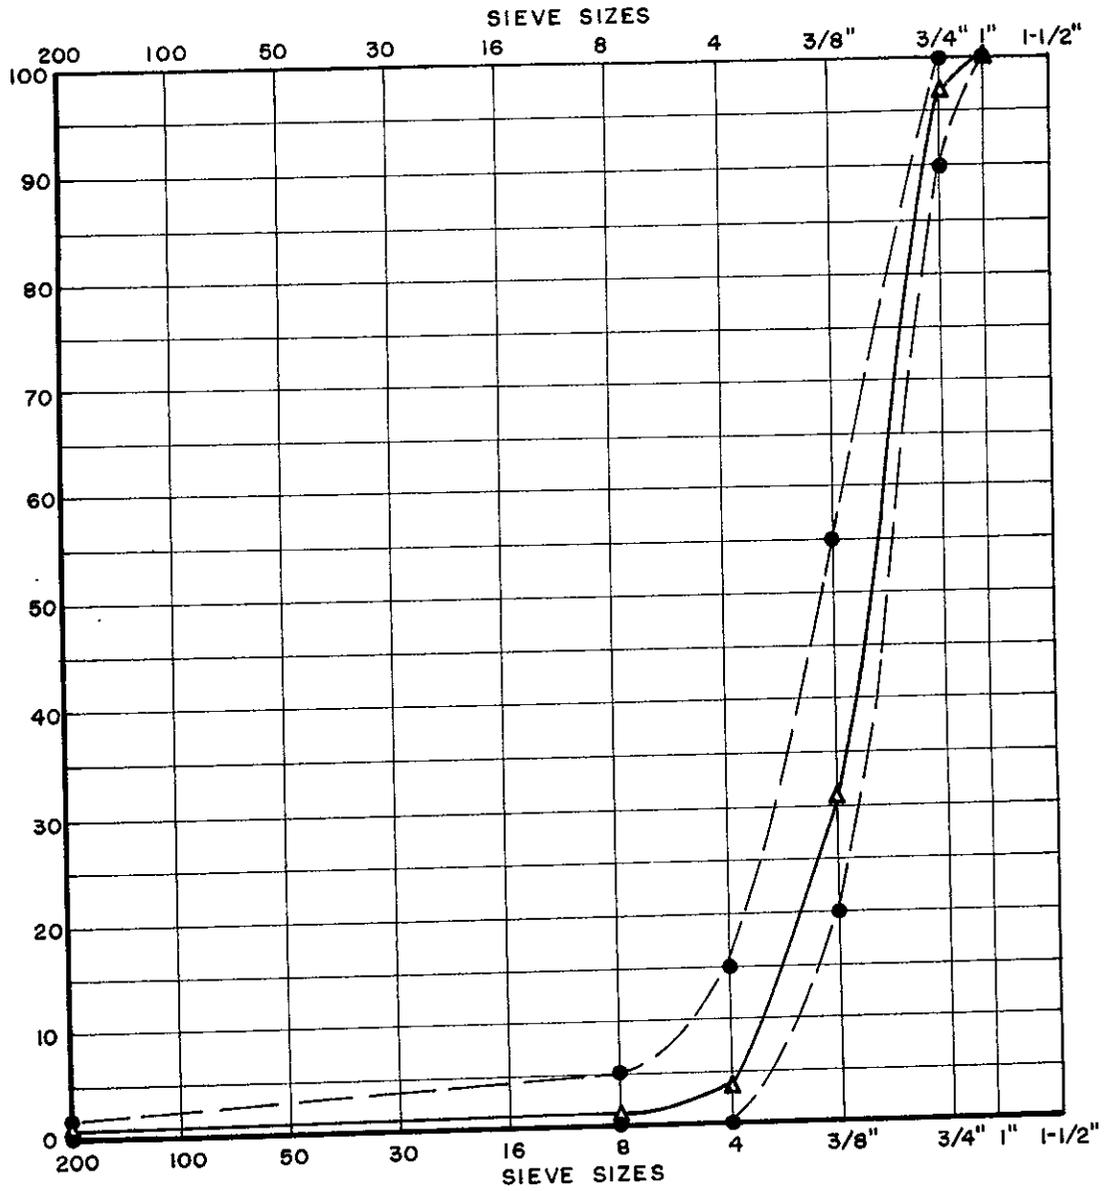
Chart 2.

The gradings of several samples obtained from trenches and trucks showed that the material met these specifications. The grading of one sample obtained from the trench is shown on Chart No. 2 and permeability tests indicate values of 200 - 300 feet per day. With the perforated metal pipe exposed to this material at 25 foot intervals, any water entering the underdrains should be carried to the pipe.

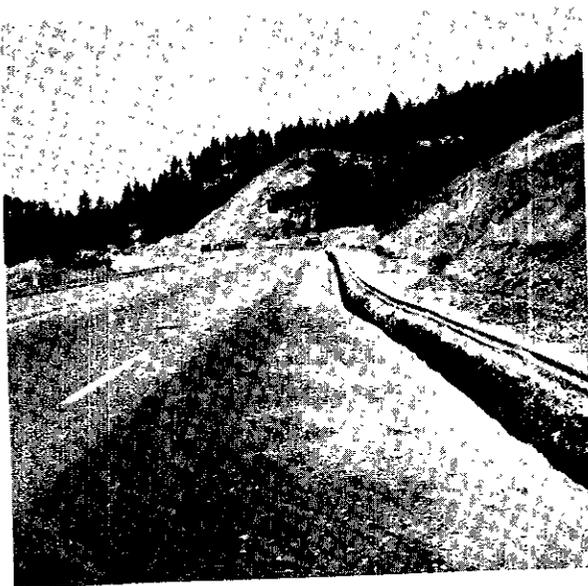
Photo No. 3 7-15-57
Sta. "D" 345+50 to 347+50. Under-drain in outer wheel track of outer northbound lane.

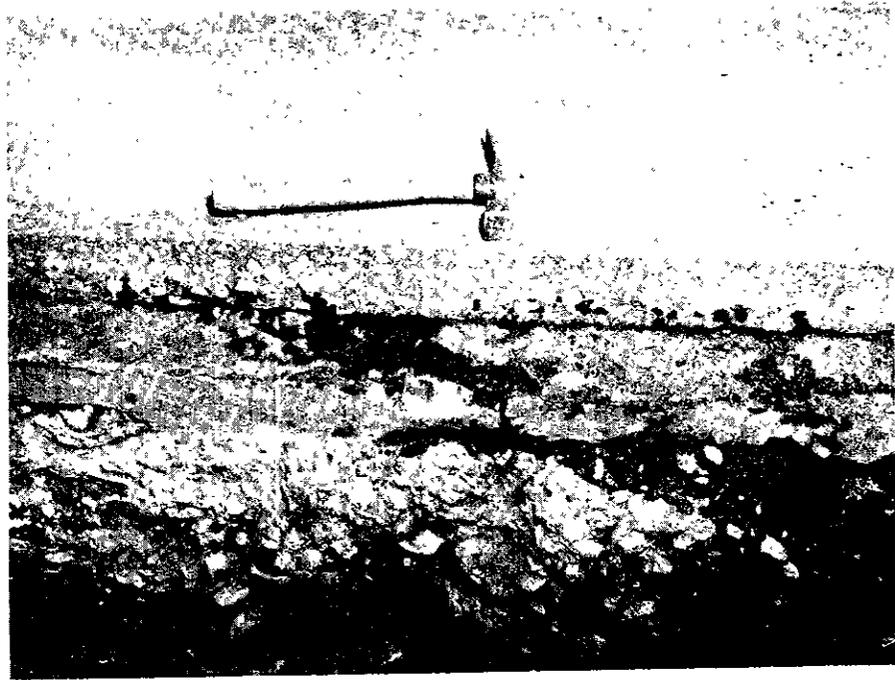
Photo No. 5 8-1-57
Sta. 347+50. Water between PMS and CTB. Considerable water in the CTB and below it.

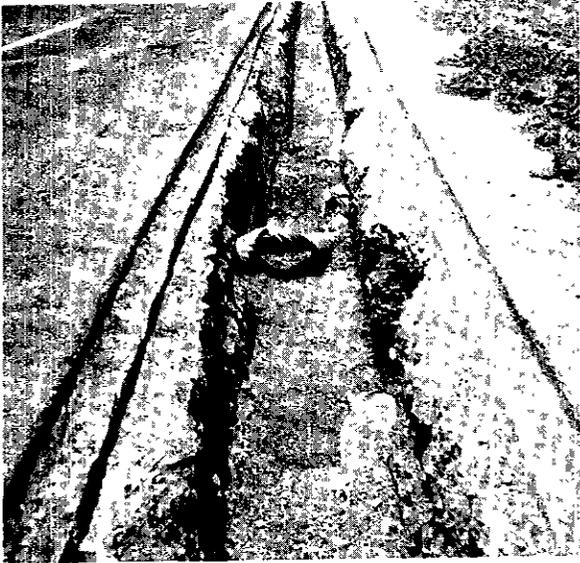
Photo No. 7
Sta. "D" 269+30 7-8-57

<u>Station</u>	<u>Deficiency</u>
"D" 218± to 219+60	Approx. 160' of PMP not placed
"D" 269+30 to 269+40	Approx. 10' of PMP missing. Trench filled with clay to top of underdrain. See Photo No. 7.
"D" 269+50 to 271+28	Clay seal around top of pipe. Effective depth of underdrain about 1 ft. (Thickness of filter material)
"D" 280+00 to 280+30	Perforations on side of pipe. Clay seal around pipe. See Photo No. 8.
"D" 280+90 to 281±	Approx. 10' of PMP missing.
"D" 304+65	Approx. 6' of PMP flattened. See Photo No. 9.
"D" 331+20 to 332+40	Clay seal around top portion of PMP. Effective depth of under- drain is about 1-1/2 ft.
"D" 333+10	No band coupling. PMP's separated 2" to 3". Clay in PMP from earth seal.
"E" 409+70	Ditto. See Photo No. 10.
"D" 352+71*	Approx. 10' of PMP missing. Underdrain full of clay.
"E" 396 to 398+25	Clay seal around top of PMP. Effective depth of underdrain is about 1 ft. See Photo No. 11.

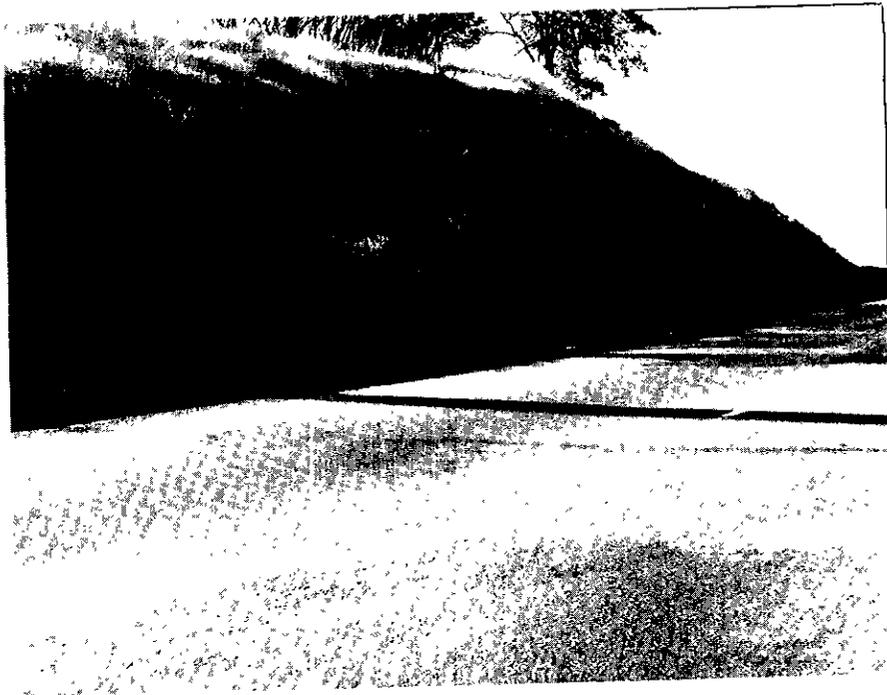
It was also noted that seepage from underground springs is showing on six cut faces, on the right at the following locations: "D" 208+80, "D" 222+00, "D" 239+00, "D" 365+50, "E" 381+00 and "E" 383+00. See Photos Nos. 13 and 14. Pumping has been observed in these areas during the past few years and no underdrains had been installed in these areas.

Photo No. 13
Right of Sta. "E" 383±. Spring area no under-
drains installed on Contract 53-1TC12-F. 8-1-57

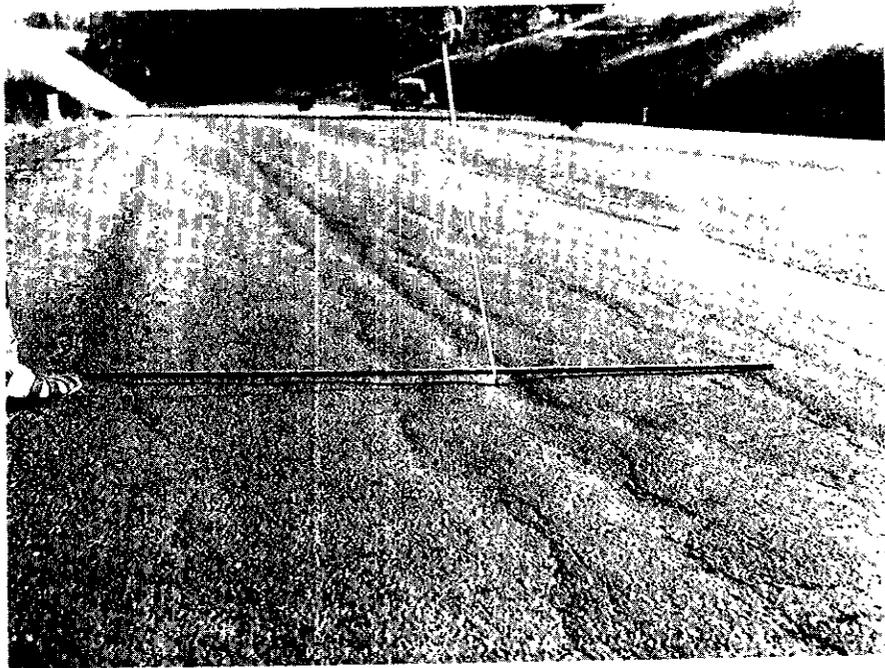
Photo No. 14 8-1-57
Sta. "E" 383±. Depressed outer wheel track,
southbound lanes.

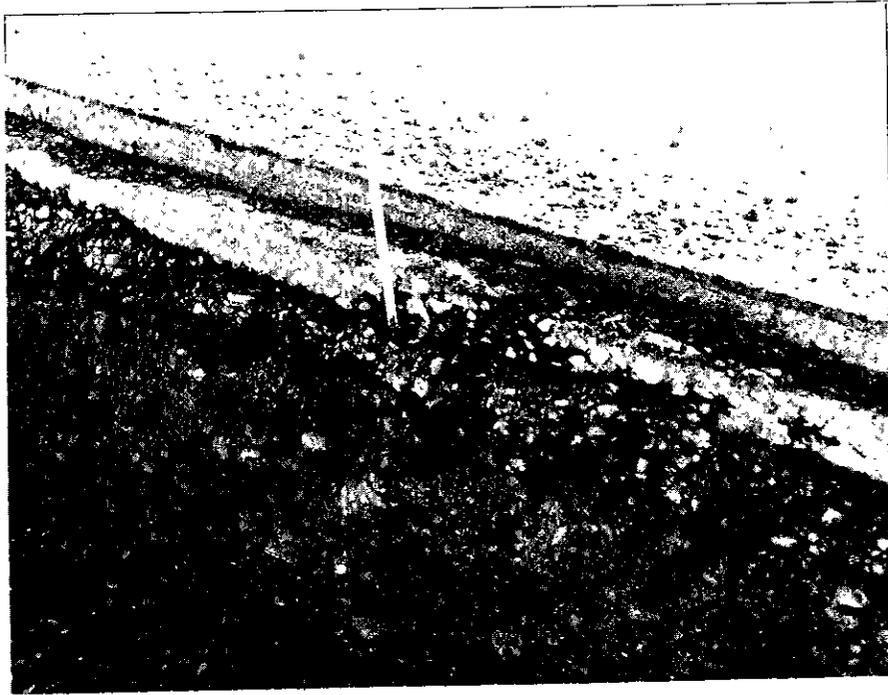
Photo No. 16 8-1-57
 Water cavity on right side of E. Sta. "E" 381+50.

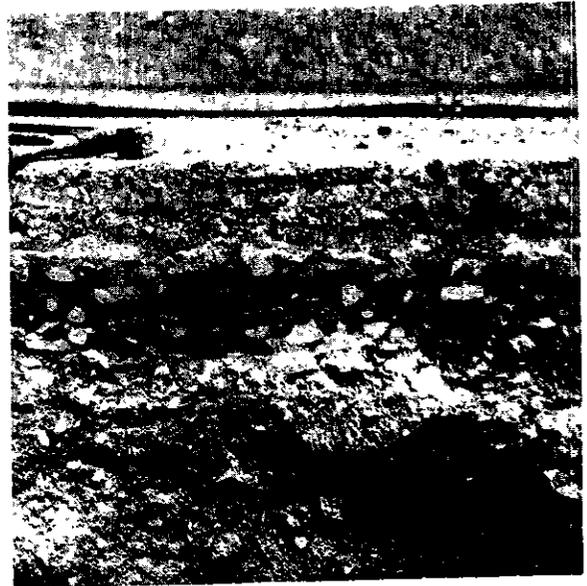
Photo No. 20
Approx. Sta. "E" 381. Pervious
CTB, large voids.
