A Report on an Investigation of the Corrosion of Reinforcing Steel in the Oten Wash Bridge No. 58-277 on Road XI-Imp -187-G

September 1959

R.F. Stratfull

State of California
Department of Public Works
Division of Highways
Materials and Research Department

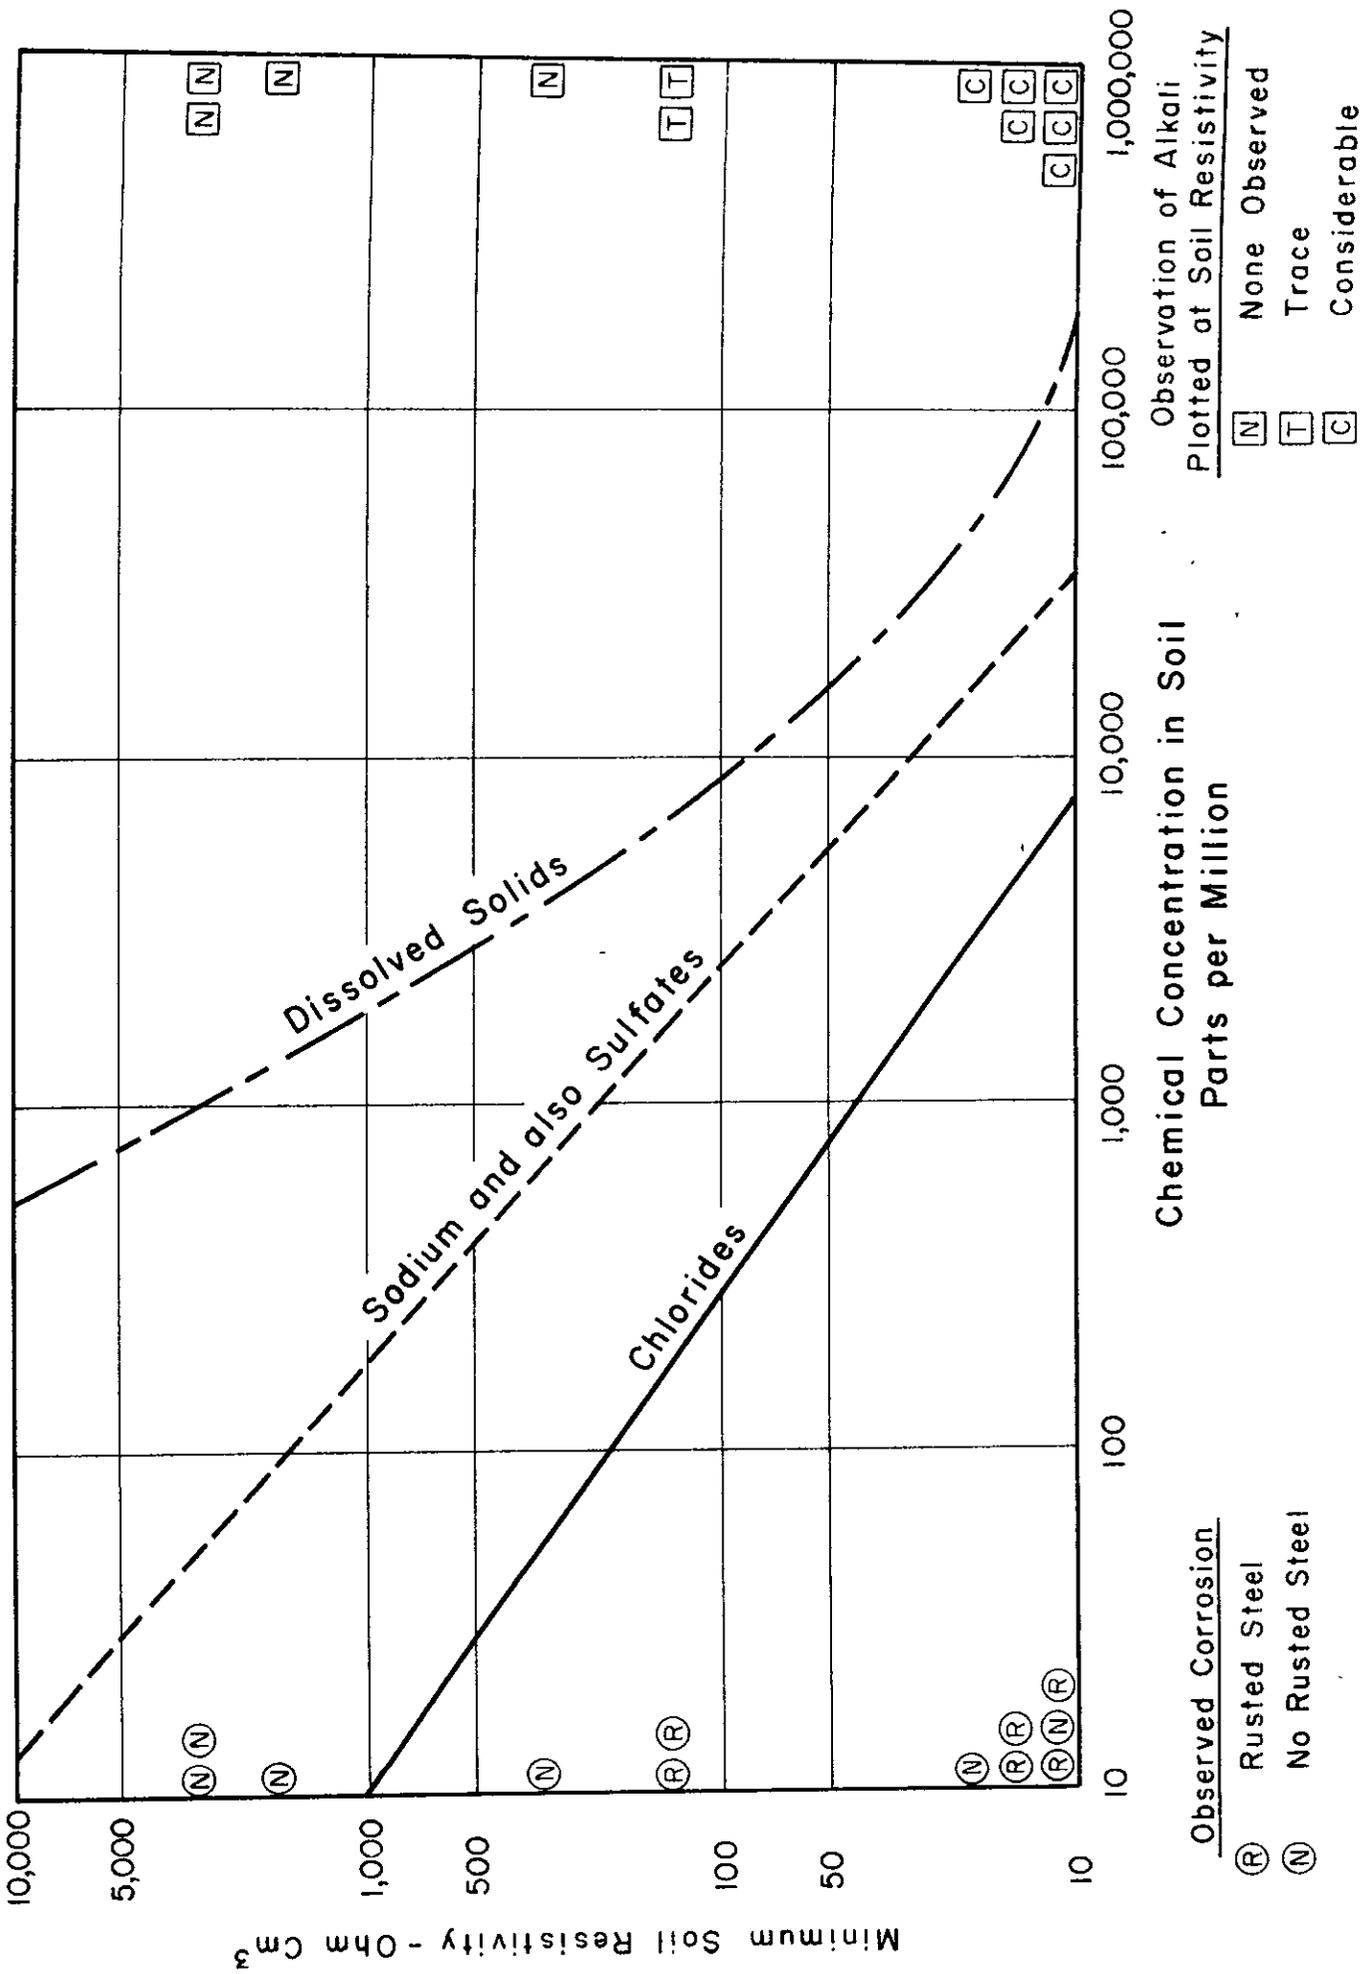
EXHIBIT 4

As will be noted on Exhibit IV and Table II, there appears to be a definite relationship between the minimum soil resistivity and the concentrations of Chlorides, sodium, sulfates and dissolved solids. Because of the few samples, it cannot be assumed that this apparent correlation is necessarily true for soils in other areas of the State.

Also included on Exhibit IV, is the observation of alkali deposits on the channel plotted at the measured minimum soil resistivity. From this exhibit, it could be inferred that when a trace of either white or black alkali is observed on the soil, that the minimum soil resistivity will be in the neighborhood of 200 ohm cm. As a point of reference for these values, the resistivity of sea water is in the range of 50 to 100 ohm cm.

Also included on Exhibit IV are notations indicating whether the reinforcing steel was rusted at the locations where the soil samples were obtained. Perhaps by chance, the indicated soil resistivity of 200 ohm cm again appears to be the limit where corrosion of reinforcing steel was observed. It would be no more than conjecture to state that 200 ohm cm may be the limit of anything, as there is no comparison based on time for any of these observations; and there is a possibility that corrosion may occur at a later date.

CHEMICAL ANALYSIS OF SOILS PLOTTED AGAINST
MINIMUM SOIL RESISTIVITY
