Progress Report on Studies on the Causes and Prevention of Erratic Cracking in Concrete Pavements

November 1961

State of California
Department of Public Works
Division of Highways
Materials and Research Department

Progress Report

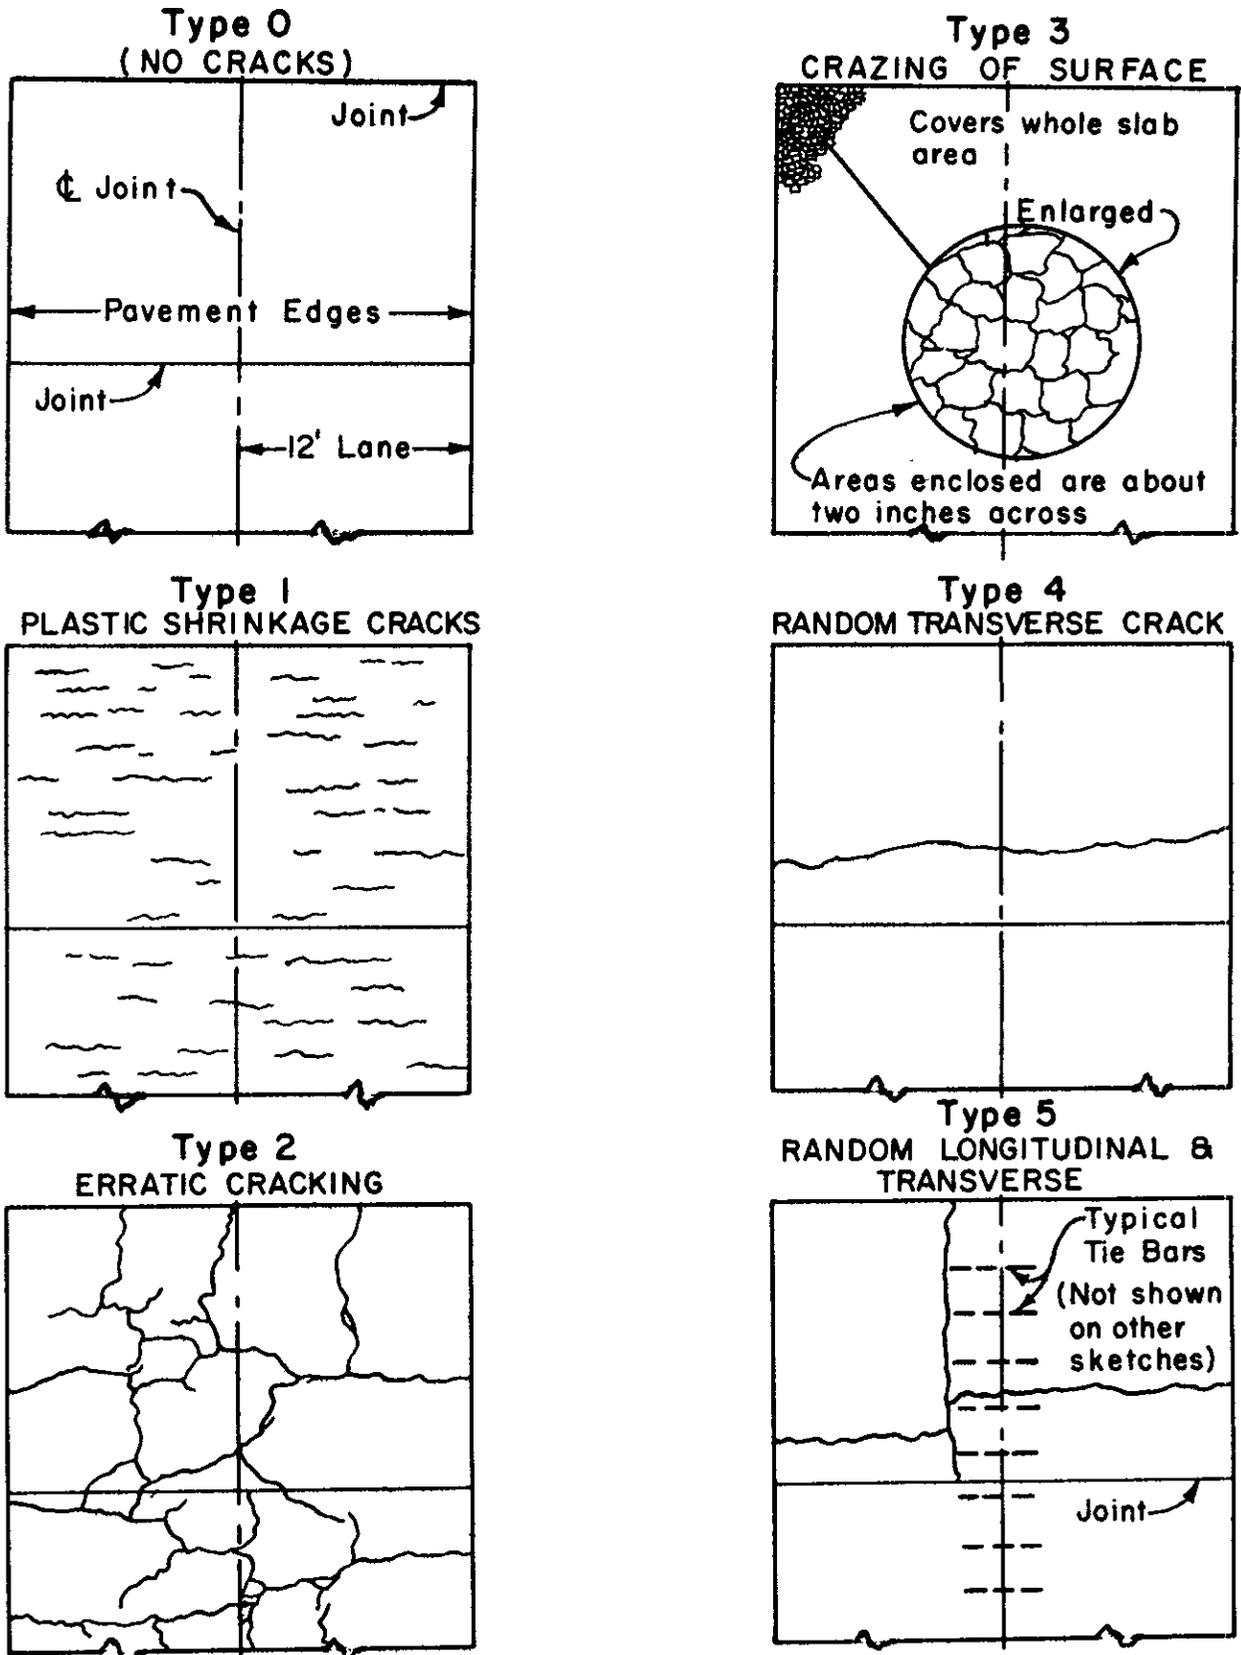
Figure 1

This investigation is being conducted in accordance with verbal instructions from Mr. J. W. Trask, Assistant State Highway Engineer, Operations, in August, 1959. The investigation is financed in part with Federal funds. For the purpose of this study, "erratic" cracking is defined as deep seated cracking having no pronounced orientation with respect to the margins of the pavement. The areas enclosed by the cracks, and/or the pavement margin usually being from about 10 to 75 square feet. For convenience in discussion, erratic cracking is designated as Type 2. See Figure 1.

Most of the pavements contain cracking of some type. The different types are broadly classified and illustrated in Figure 1, and the occurrence of the type of cracking found in each pavement is shown in Table 1.

GENERAL CLASSIFICATION OF CRACKING IN PCC PAVEMENTS
