Sandstorm Investigation in Coachella Valley Between Garnet and Thousand Palms on Road VIII-RIV-26-D Station 720+- to Station 810+-

August 1963

D.R. Whetsel

State of California
Department of Public Works
Division of Highways
Materials and Research Department

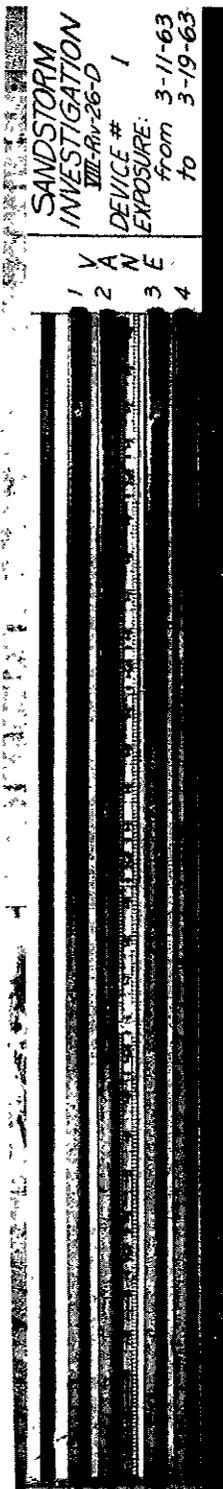
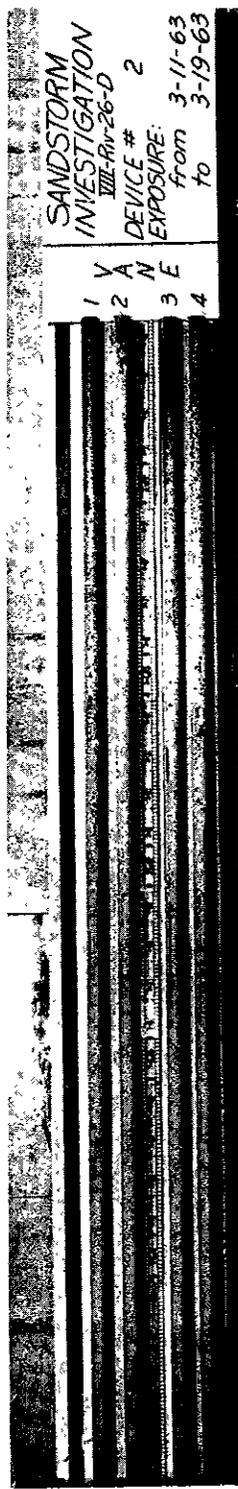
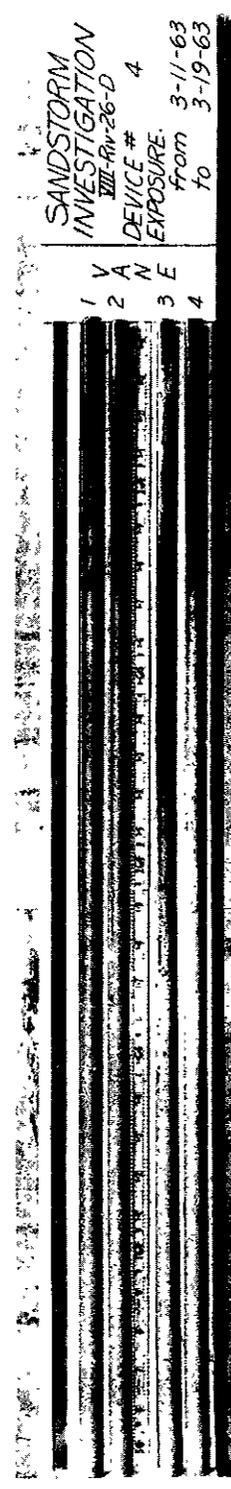
Exposure Period 2

SANDSTORM
INVESTIGATION
VIII-Riv-26-D
DEVICE # 1
EXPOSURE:
from 3-11-63
to 3-19-63

SANDSTORM
INVESTIGATION
VIII-Riv-26-D
DEVICE # 2
EXPOSURE:
from 3-11-63
to 3-19-63

SANDSTORM
INVESTIGATION
VIII-Riv-26-D
DEVICE # 4
EXPOSURE:
from 3-11-63
to 3-19-63

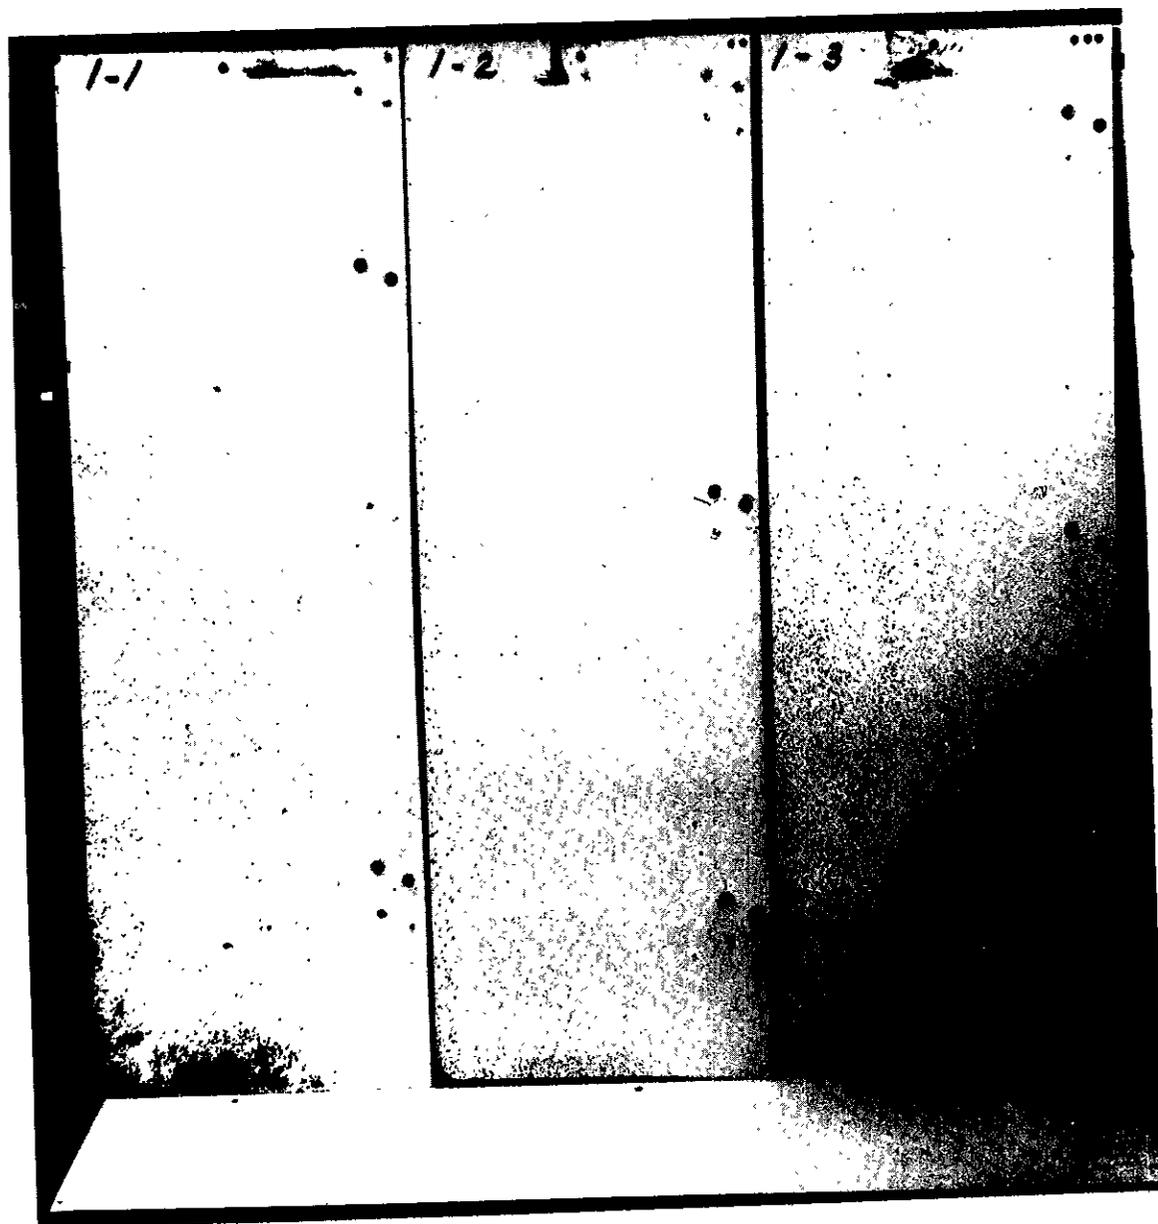
Vehicle Mounted Panels Test Run 1

In test run No. 1, Panel 1-1 was exposed easterly or downwind of the dike, Panel 1-2 was exposed through the area where the dike presumably affords the maximum protection, and Panel 1-3 was exposed westerly or upwind of the dike. The vehicle was driven at a speed of 50 mph for this test run. The damage to the three panels was insufficient after one pass to properly evaluate the damage. Two additional passes were made with the same three panels, exposing them in the same sequence as above and at the same speed. A photograph of the panels from test run No. 1 is shown on Fig. No. 20.

The damage to the vehicle mounted panels was greatest for those panels (1-3 and 2-3) exposed westerly and upwind of the dike. The least damage occurred to those panels (1-2 and 2-2) exposed in the protection area of the dike. These results are consistent with the data from the rotary sandstorm devices.

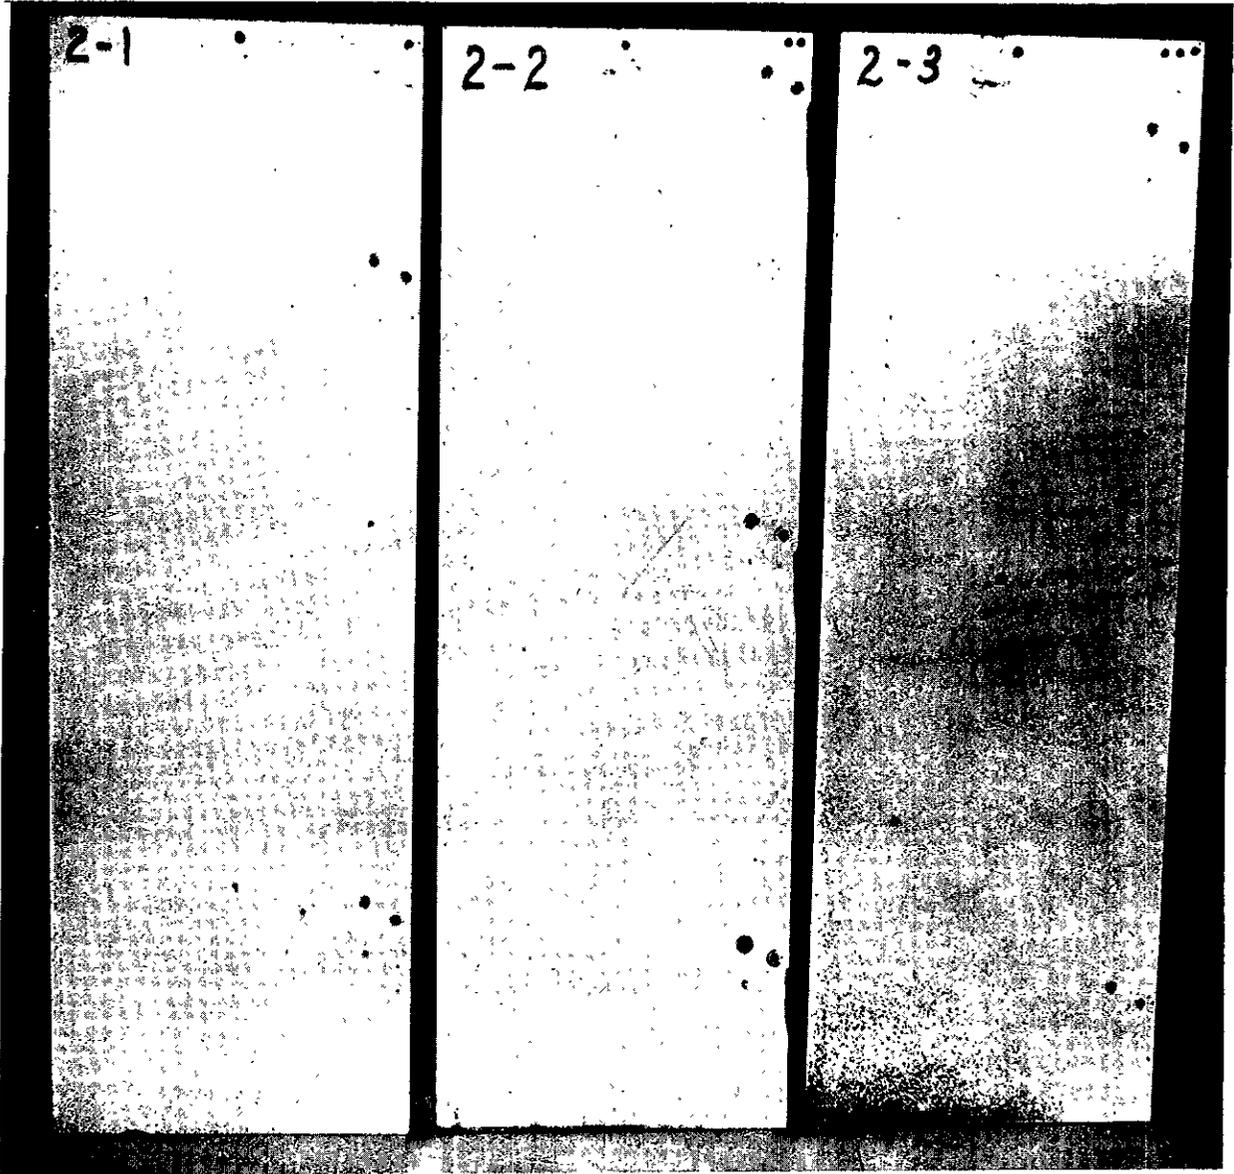
Vehicle Mounted Panels Test Run 2

Test Run No. 2, exposing Panels 2-1, 2-2, and 2-3, was made in the identical manner of test run No. 1 except that the vehicle was driven at a speed of 55 mph. A photograph of the panels from test run No. 2 is shown on Fig. No. 21. It should be noted that the distance that each panel was exposed is only about one-sixth the distance that a vehicle would be exposed in the sandstorm area. Hence in a comparable sandstorm a vehicle would be much more severely damaged than the panels were.
