Investigation of the Use of Lime For Treating Clay Basement Soil For Use As A Base Under Asphalt Concrete Surfacing

June 1967

E. Zube, C. Gates and M. Hatano

State of California
Department of Public Works
Division of Highways
Materials and Research Department

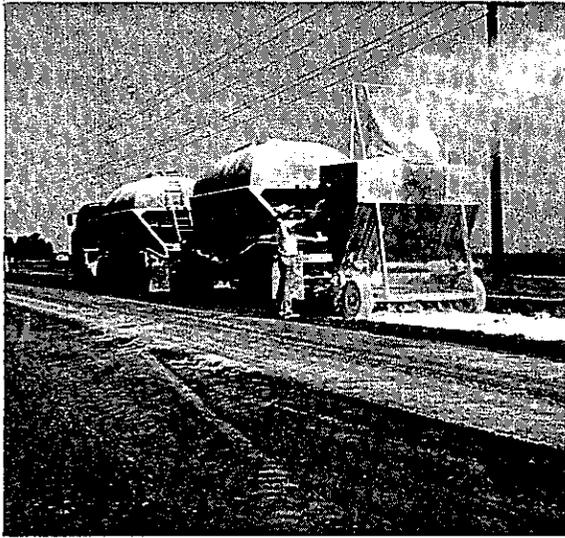
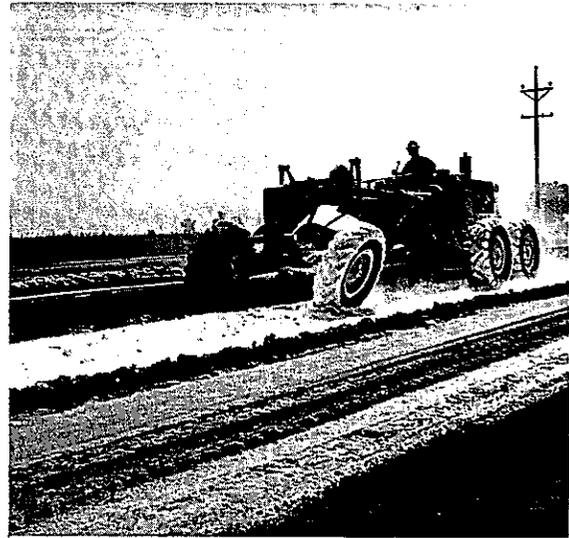
- 1) Rippers on motor grader initially scarified clay soil and then above photo shows lime being spread. 2) Motor grader covering lime and forming windrow for Woods Mixer.

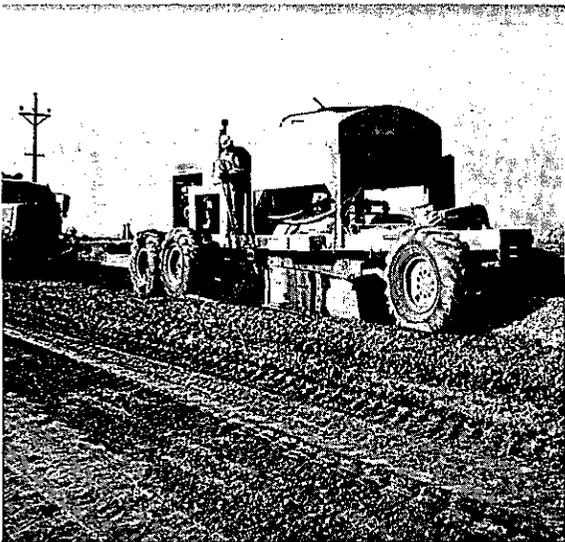
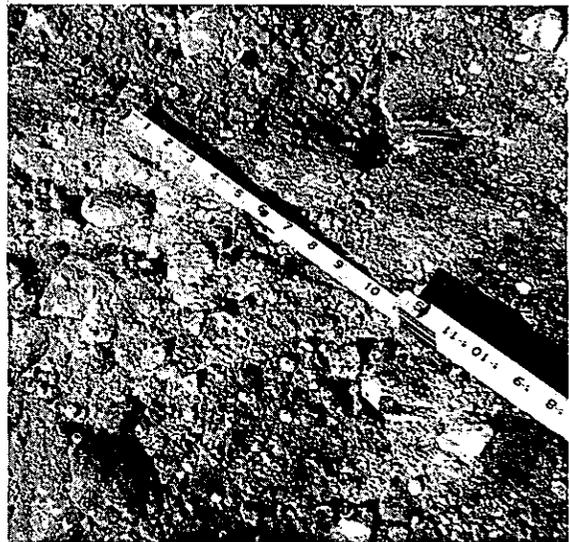
- 3) Woods Mixer mixing lime treated material. 4) Close-up showing lime treated material in windrow after one pass of Woods Mixer.

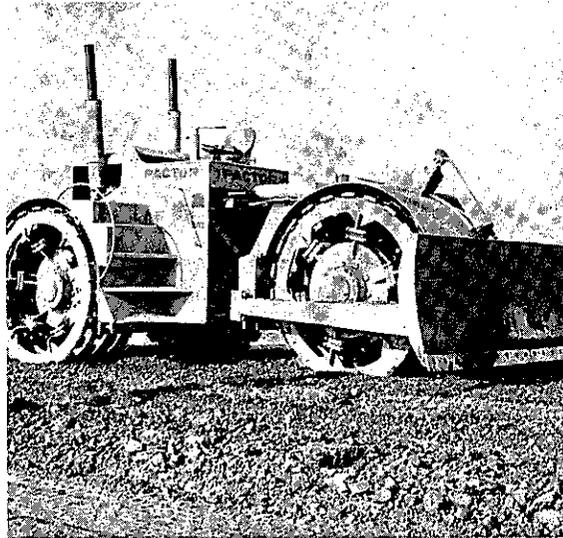
(5) Segmented 20,000 pound roller compacting lime treated material

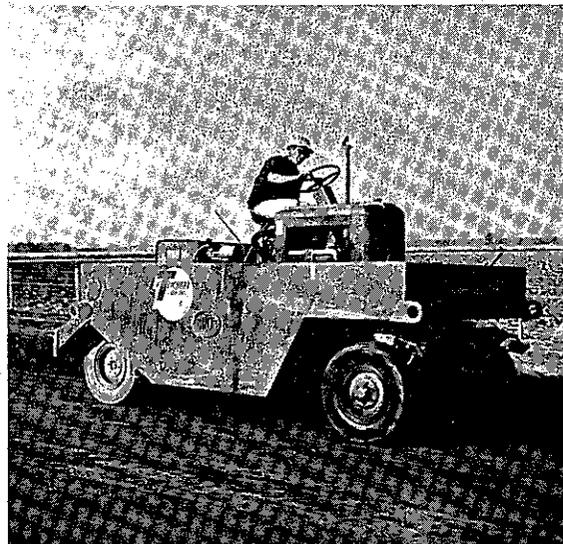
(6) Finish rolling with rubber tired compactor

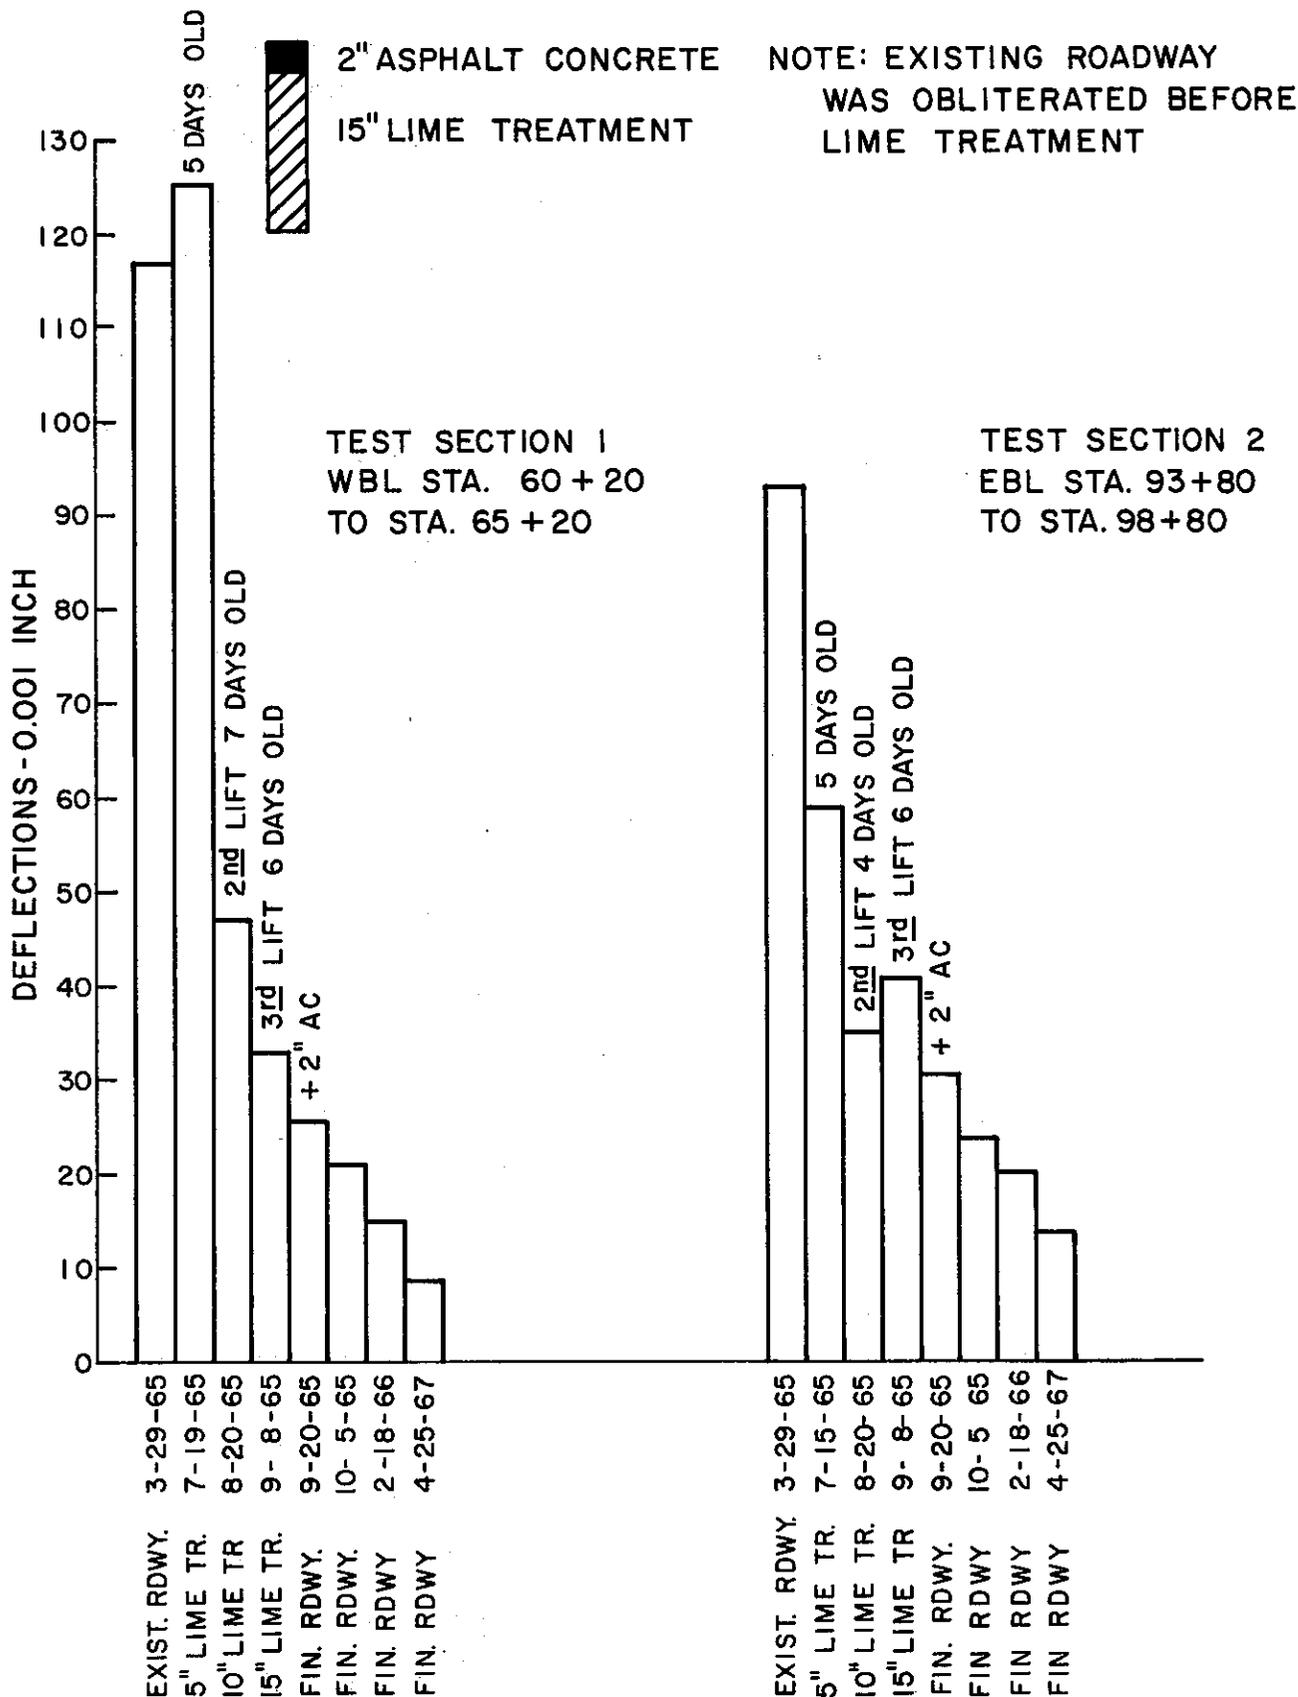
Figure 5

Average deflection measurements on the inner and outer wheel tracks are shown for the LTB test sections 1, 2, 3, and 4 (Figures 5, 5A, 6, and 6A). Deflection measurements were made on the existing roadway to give an indication of the level of deflection before construction. The average deflections of the test sections before lime treatment ranged from 0.018" to 0.117". The existing roadway was obliterated before construction of the new structural section.

After placing and compacting the first 5-inch layer of lime treated material, average deflections of the test sections ranged from 0.015" to 0.125". After the second layer was placed, the average deflections ranged from 0.015" to 0.047". Upon completion of the third layer, the average deflections ranged from 0.016" to 0.041".

Deflections on the finished roadway shortly after construction averaged 0.015" to 0.031". The tolerable deflection for this type of road is estimated to be around 0.032"2.

The deflections taken about 4 months after completion of construction were slightly lower (average ranged from 0.013" to 0.026"). About 10 inches of rain had fallen during this period.

About 1½ years after completion of construction, the average deflections ranged from 0.009" to 0.015".
