California Pavement Faulting Study

Interim Report

HIGHWAY RESEARCH REPORT

MATERIALS AND RESEARCH DEPARTMENT
RESEARCH REPORT
NO. M & R 635167-1

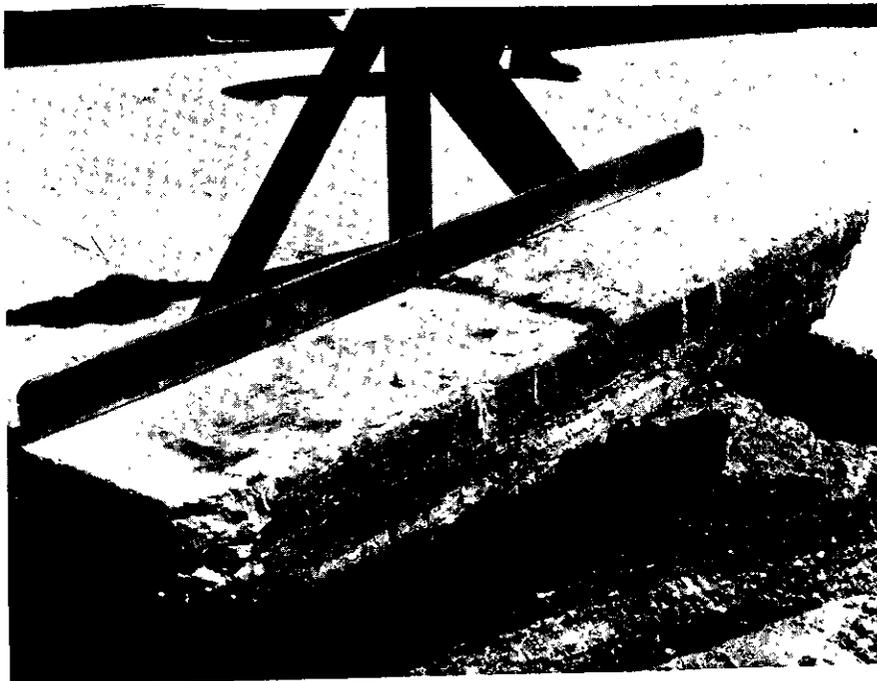
Figure 1

Since this was a new pavement, no significant findings were expected, nor were any found. However, it did serve the valuable purpose of familiarizing field personnel with the techniques of testing and slab removal before moving to locations under traffic. It was noted that there was no evident bond between the CTB and PCC (see Figure 1) and no cracks were found in the CTB. This site may be re-examined in the future, in which case, conditions before and after traffic can be compared.

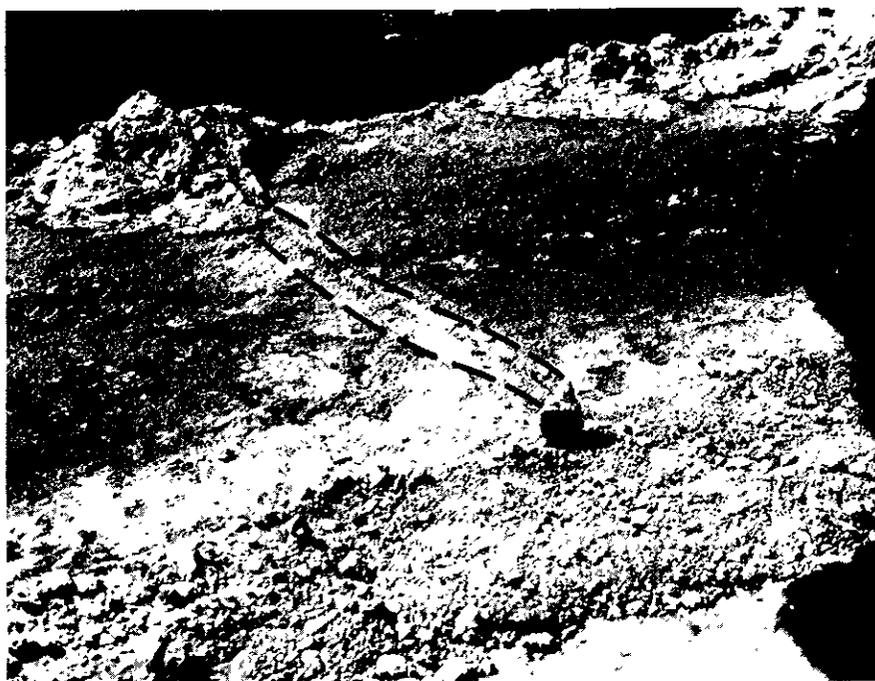
This site was on the inside, or No. 1 lane, and at the same joint as 2A. Pavement thickness in this lane is 0.67-ft. The purpose of the opening was to compare the unfaulted portion of the joint with the faulted. Figure 5 shows the condition of the CTB under the slab. A ridge of concrete and sandy particles was found under the joint, but there was no other sign of any buildup or movement of material. A tight crack was found in the CTB near the joint in this lane also.

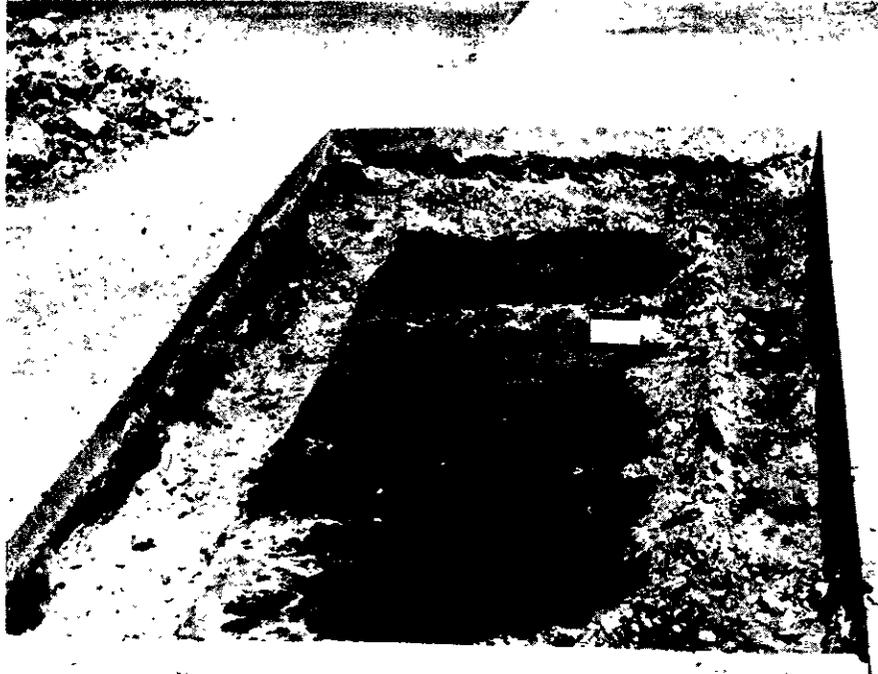
Figure 10

The layer of granular buildup was quite thick and again extended under both slabs. Petrographic tests on the samples identified the material as having approximately the same composition as the base and shoulders. Some iron fragments and glass beads were found and can reasonably be assumed to

have entered through the joint. (Glass beads are used in traffic striping paint.) Tests indicated the cement content of the loose material to be between 5% and 7%, and that of the CTB as about 3%. There was sufficient strength of the CTB (220 psi) to obtain cores, however.
