Evaluation Of Grooved Traffic Stripes On Portland Cement Concrete Highways

EVALUATION OF GROOVED TRAFFIC STRIPES ON PORTLAND CEMENT CONCRETE HIGHWAYS

CA-HY-MR-5193-1-72-31

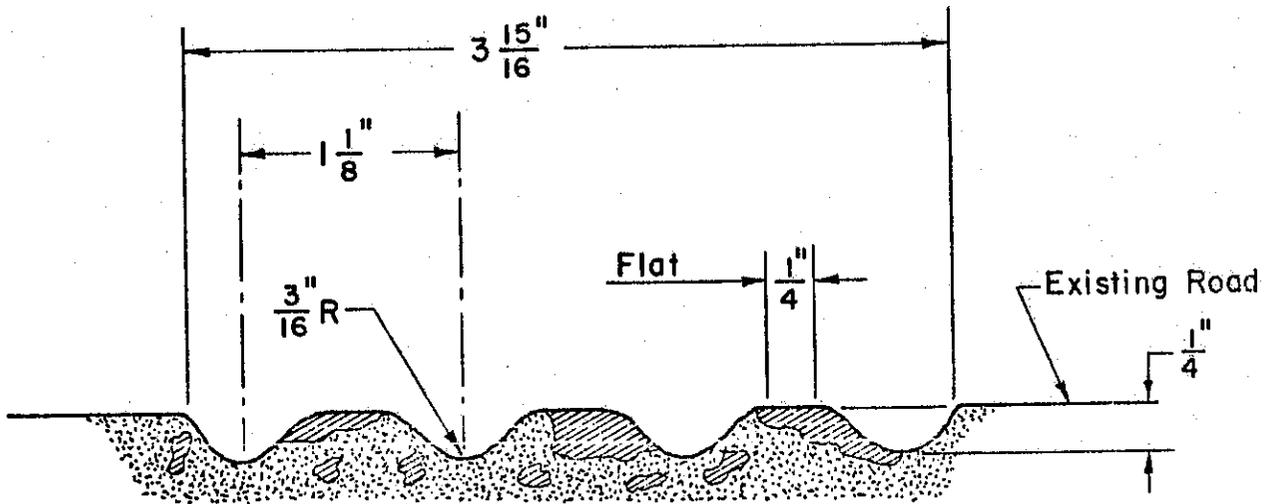
Figure 1

In a normal depth groove this dimension is $0 - \frac{1}{32}$ inch.
 For a deep grooved line, this dimension is $\frac{1}{16}$ inch minimum.

Grooved Traffic Line Cross Section

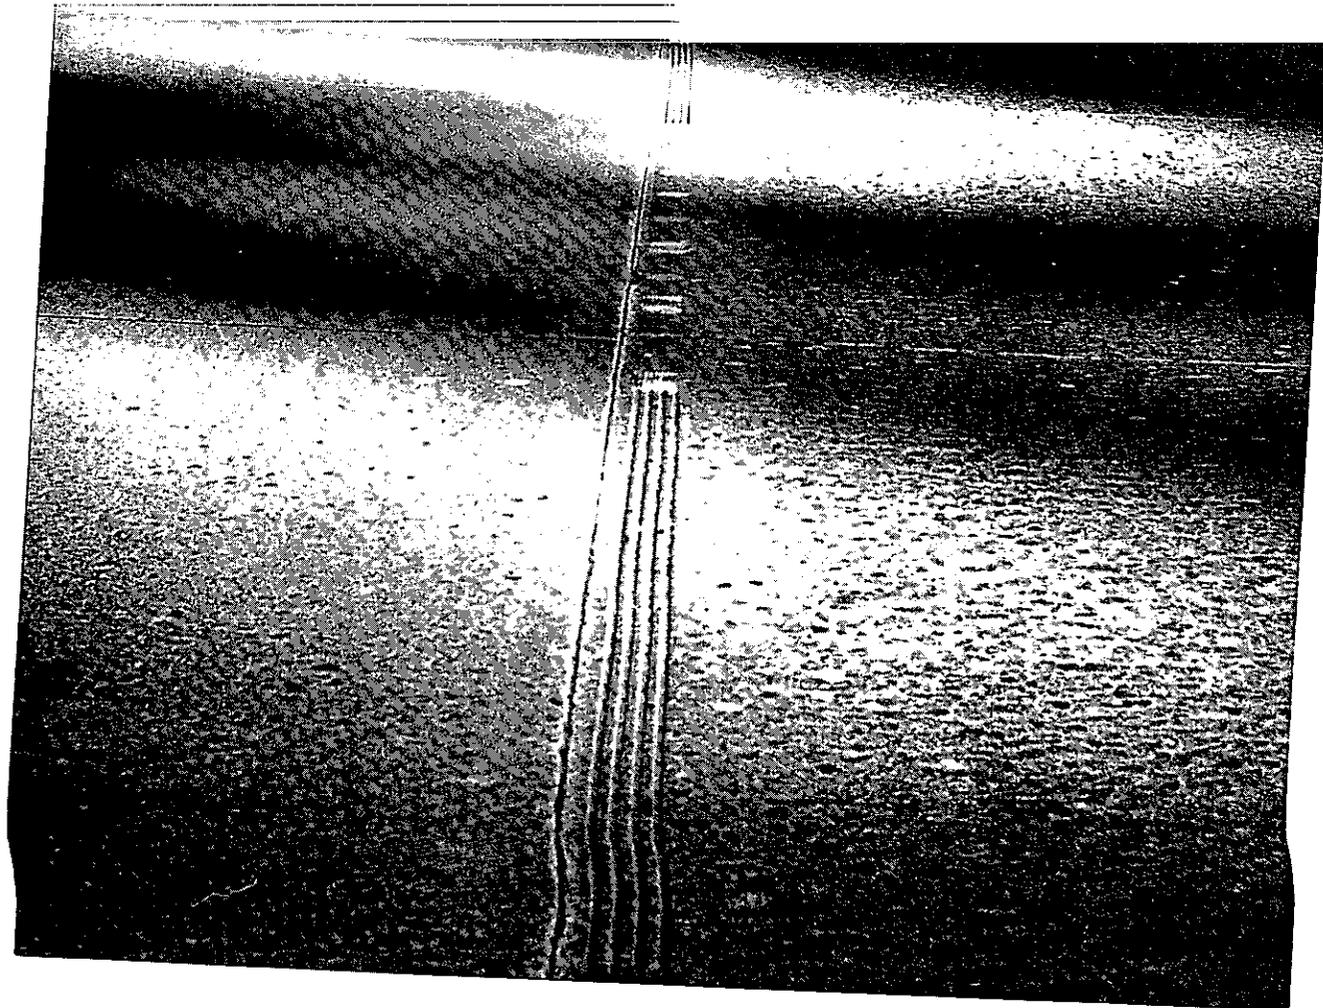
This site was observed again on December 31, 1969. There had been several rain and snow storms since the October inspection. The paint was almost obliterated in both the grooved and control sections. Due to chain and snow plow action, the crests of the grooved line were already beginning to flatten. (Figure 6.)

Figure 6
Kingvale Area after Several Rain and Snow Storms

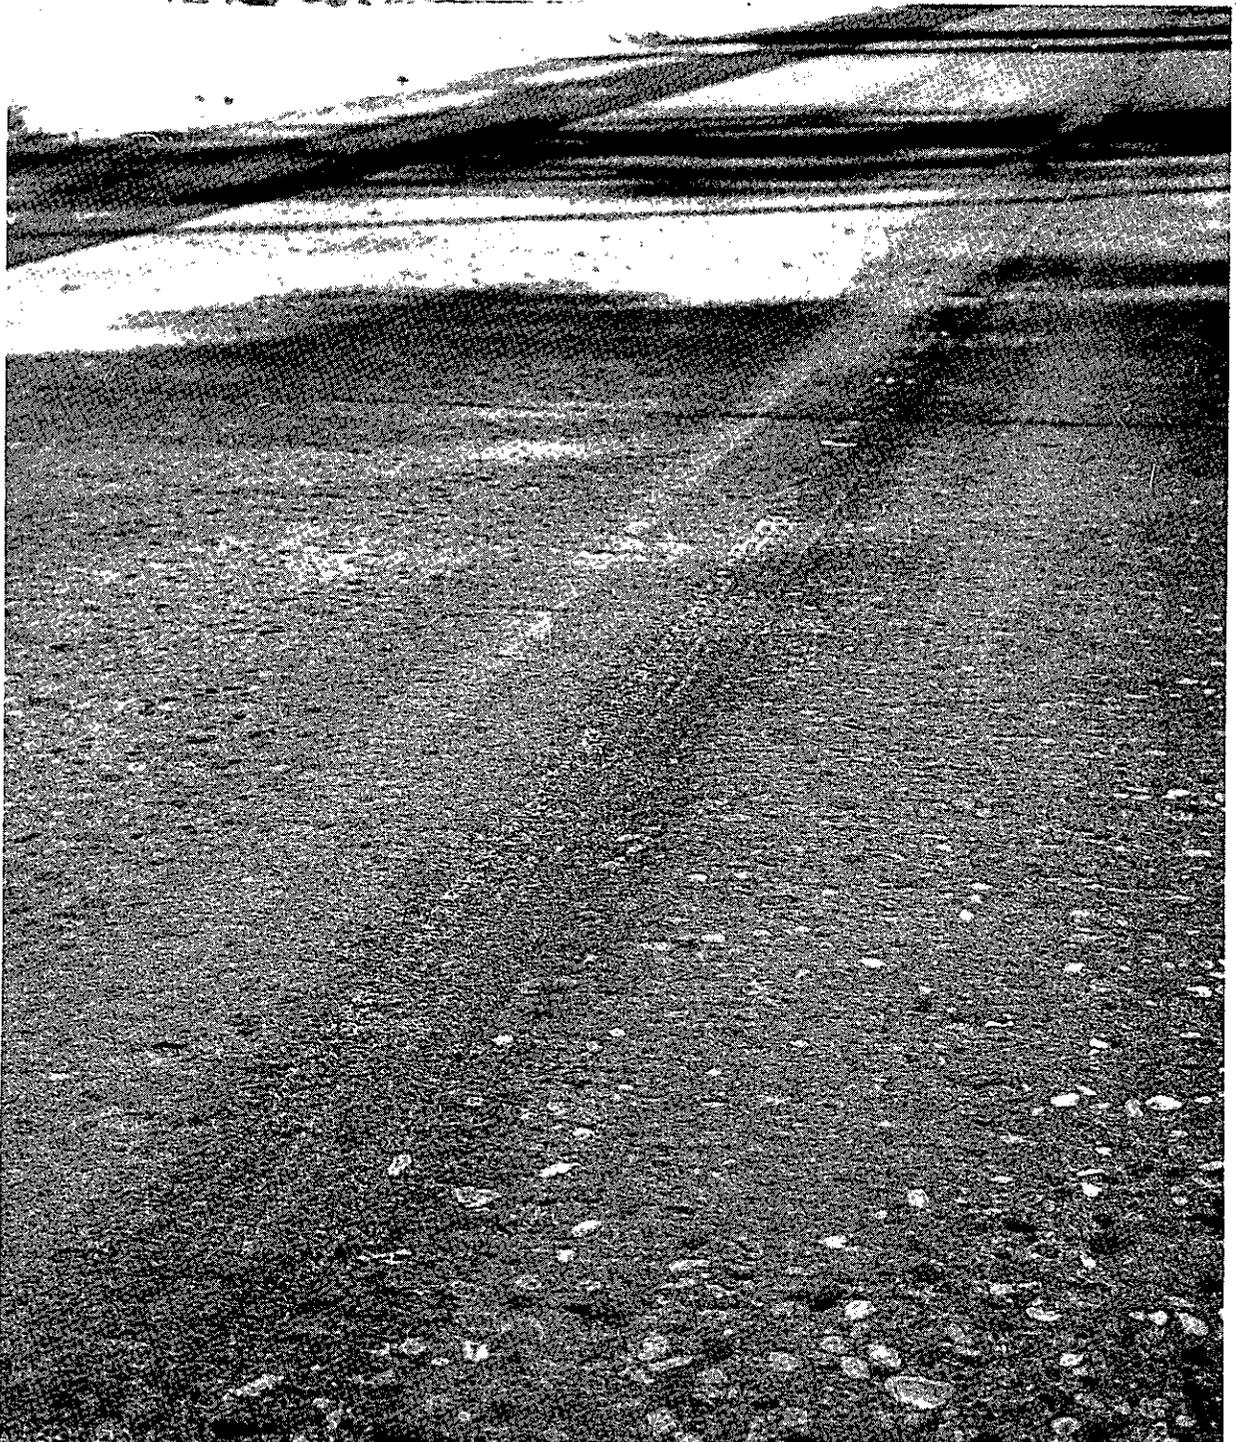
It has been noted that the grooved line at Kingvale often filled with dirt so that there was little or no delineation. This condition was photographed in late November 1971 (Figure 9). At this time the paint was about 80% intact.

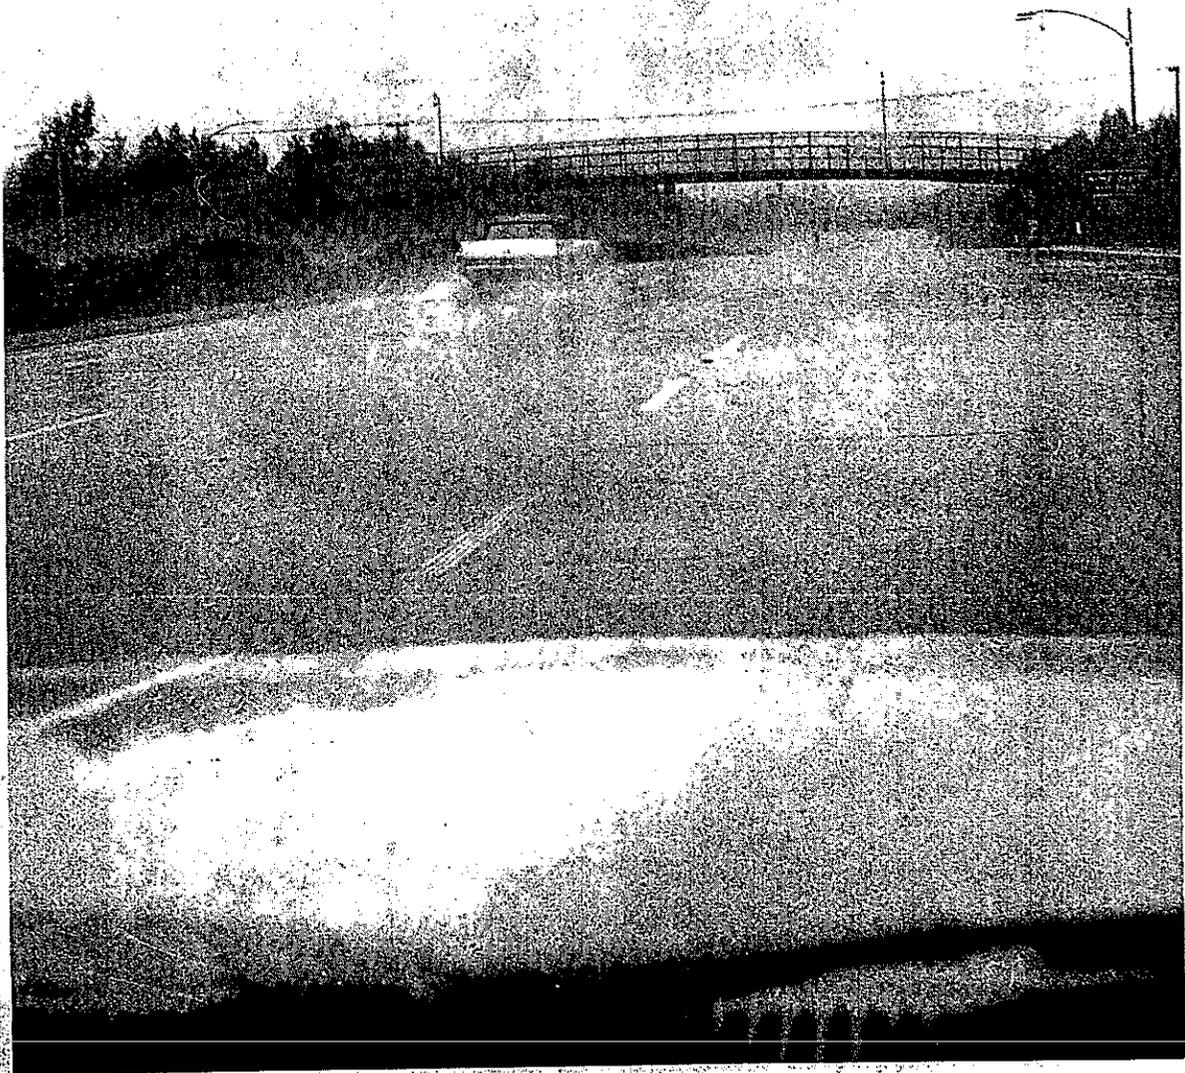
Figure 10.

Figure 10 shows the transition from the grooved to the control section. The first stripe in front of the car is grooved and is actually slightly less visible than the next stripe which is a control stripe. The actual visual observations agreed with the photograph since it was very easy to observe the transition from the grooved to control sections. In contrast, Figures 11, taken during dry weather showing the transition from the grooved to the nongrooved section, shows the lines to be equivalent, and it was very difficult to detect the transition point at freeway speed. (This photograph was taken at the Rocklin section.) All photographs taken at the South

South Sacramento Area During Moderate Rain. Grooved stripe in front of car is slightly less visible than the next control stripe.

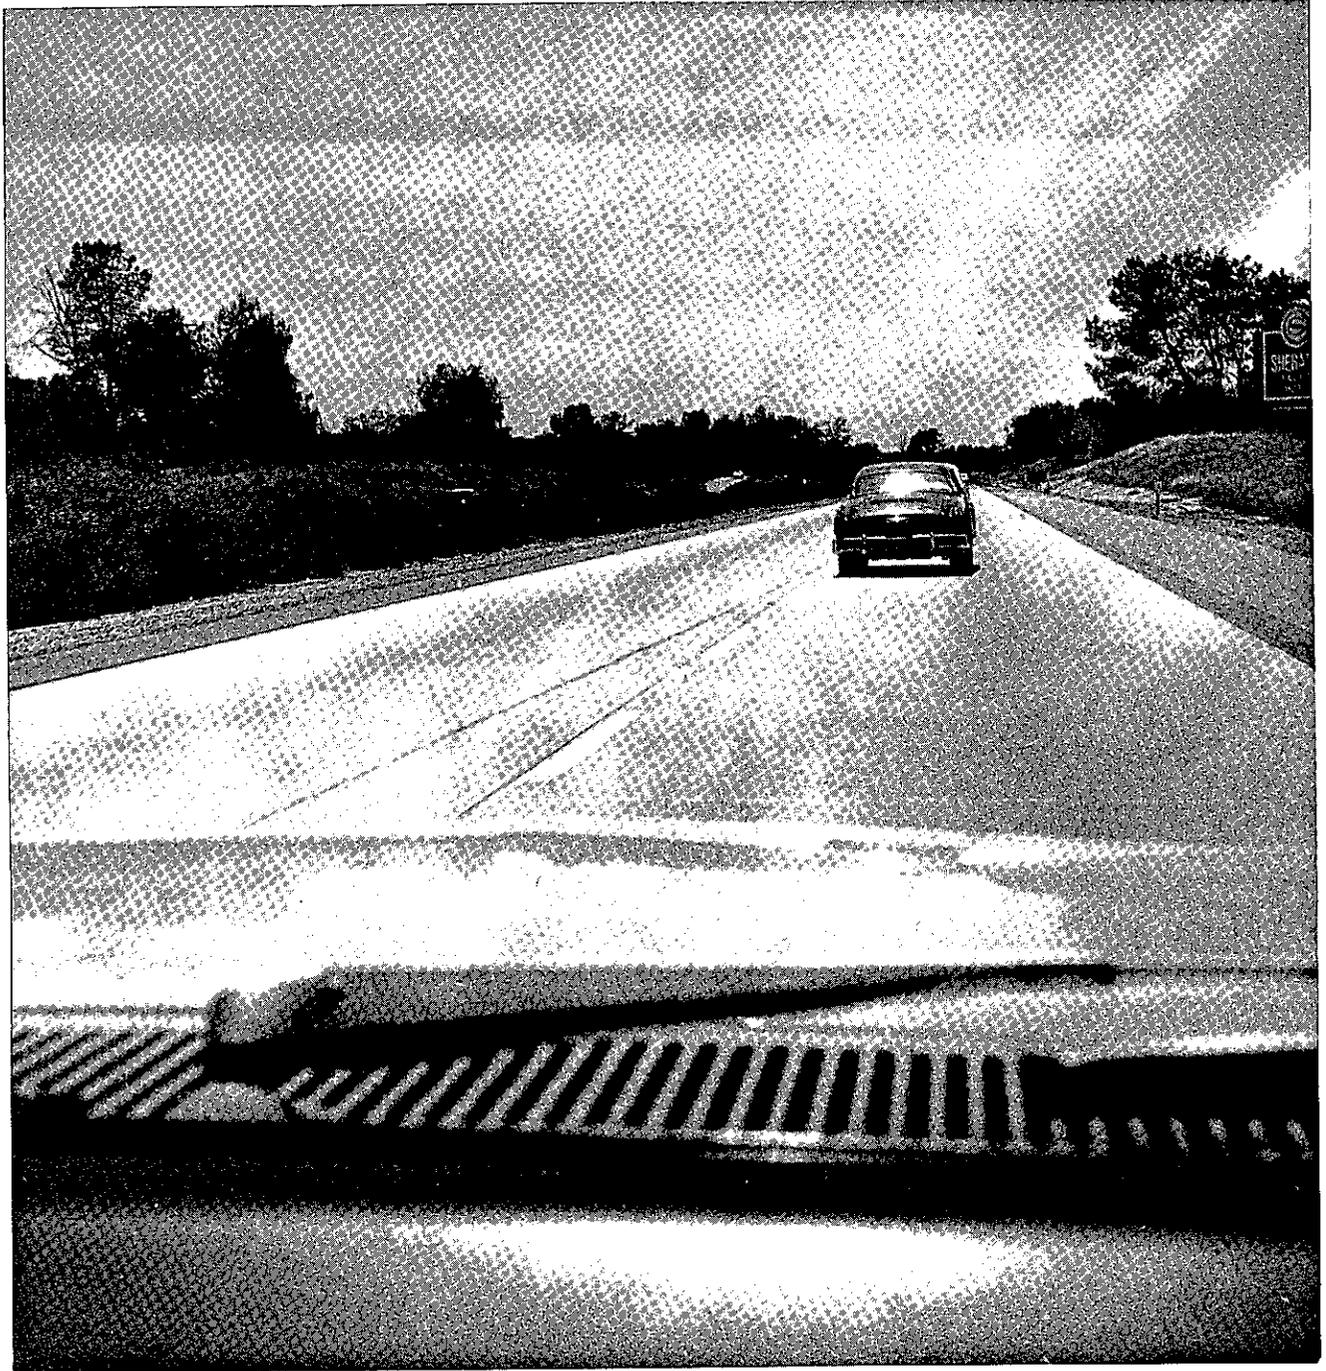
Figure 11

Rocklin Area During Dry Weather. Grooved stripe in front of car is scarcely distinguishable from next control stripe.

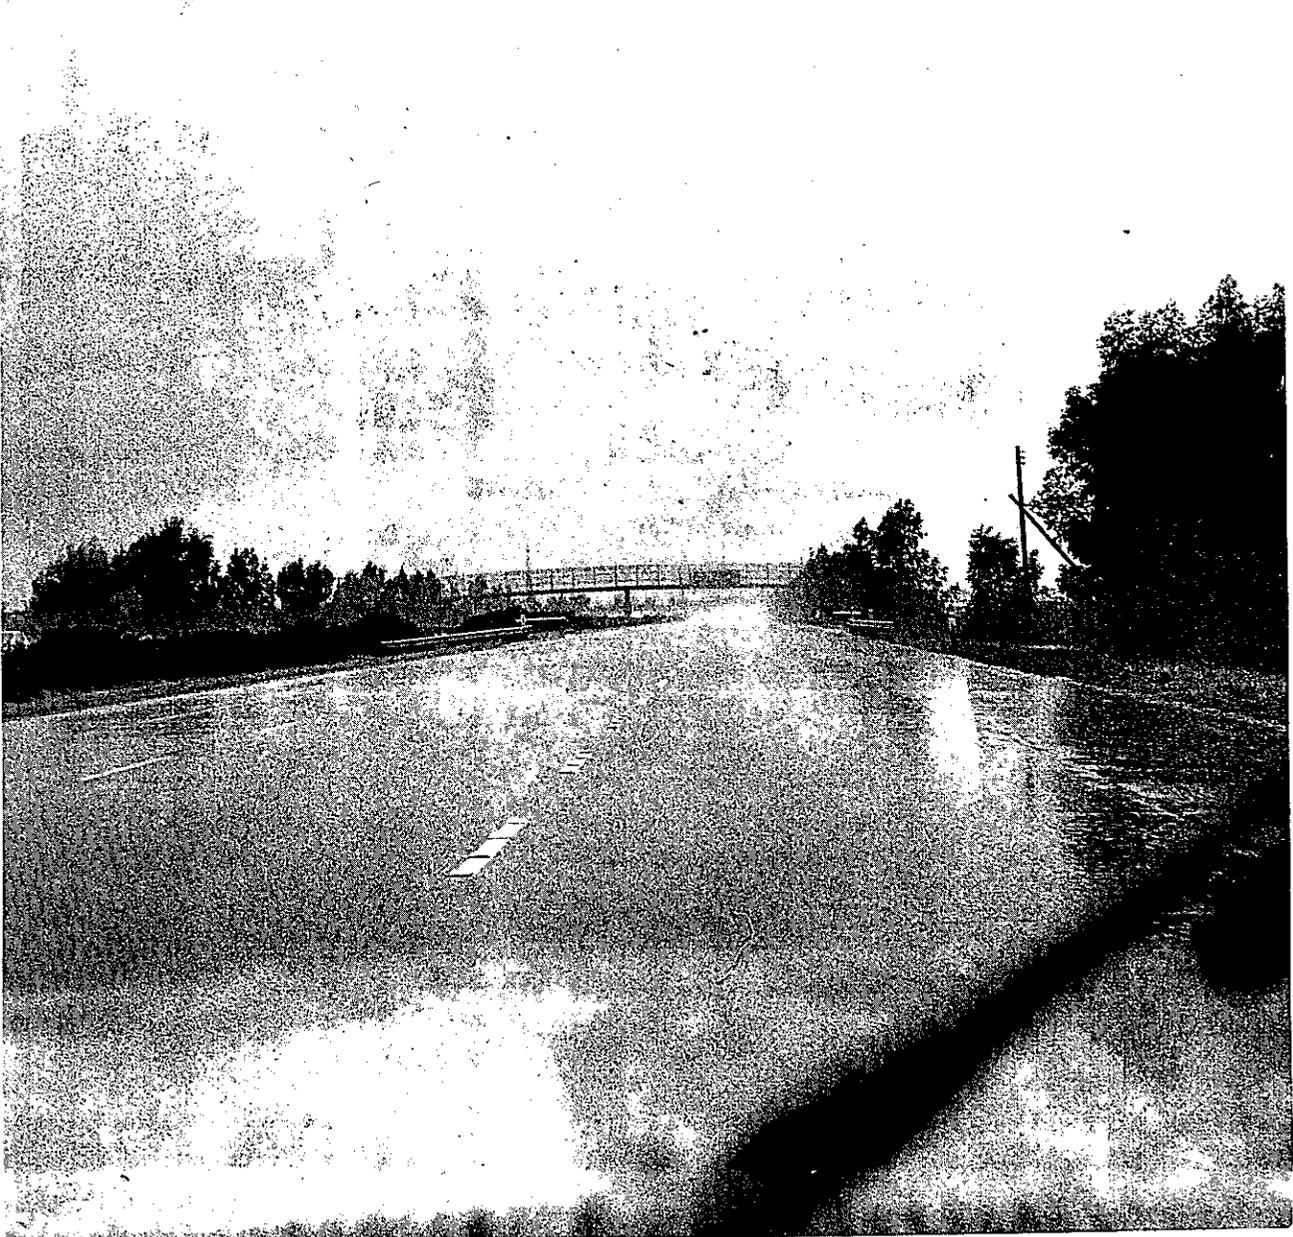
Figure 12

The grooved line is very inferior to ceramic raised markers during wet weather daytime conditions. Photographs taken April 17 on the South Sacramento Freeway in a moderately heavy rain, show a series of raised markers of different types, the whitest of which are ceramic (Figure 12). The grooved section is immediately beyond the last ceramic markers and is completely invisible.

Sacramento Area During Moderate Rain. Series of raised markers followed by the grooved section shows the superiority of raised markers.

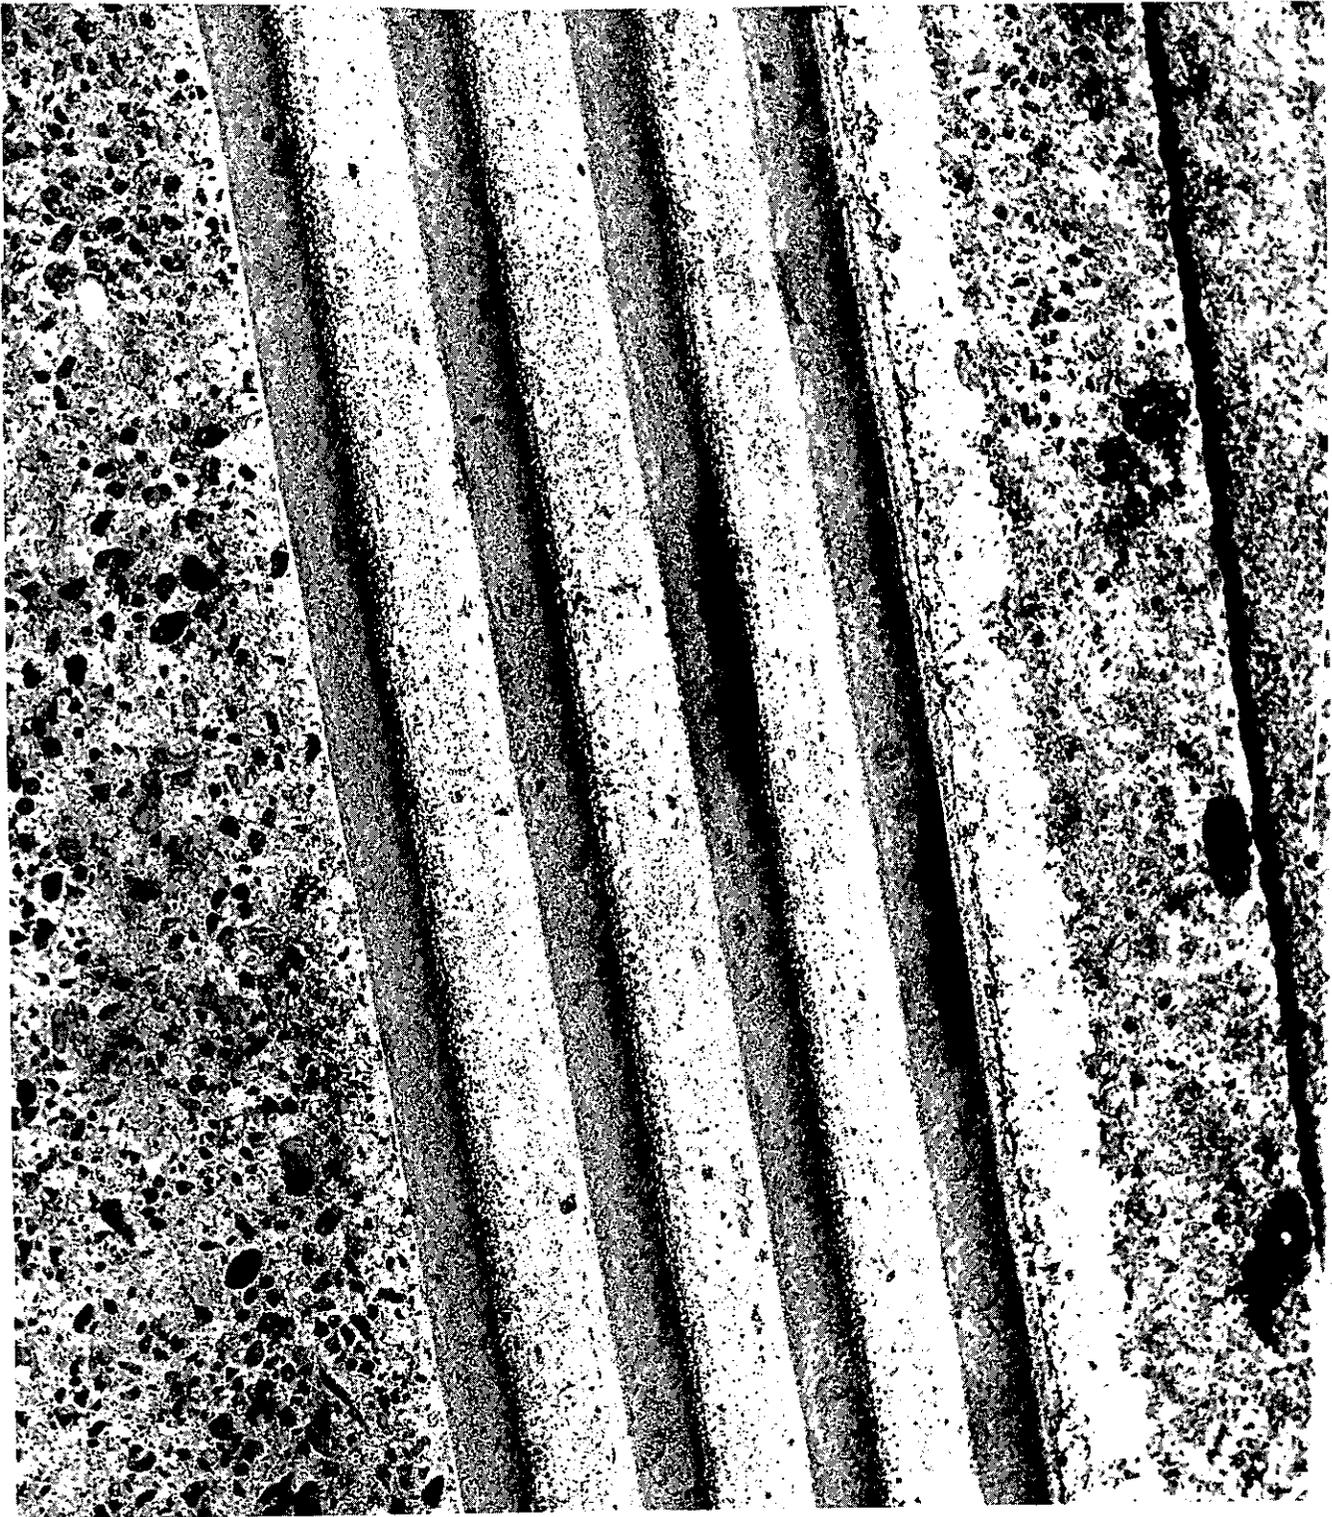
Figure 13

Painted Grooved Traffic Stripe in Sacramento Area. The accumulation of dirt in the trough decreases the visibility somewhat. The wear on the crests is about equal to the adjacent control section (Fig. 14).
