FHWA-CA-TL-78-13

2. GOVERNMENT ACCESSION No.**3. RECIPIENT'S CATALOG No.****4. TITLE AND SUBTITLE**Vehicular Impact Tests of Precast Concrete Median Barriers
With Corrugated Ends And Tensioned Cables**5. REPORT DATE**

R.L. Stoughton, D.M. Parks, J.R. Stoker and E.F. Nordlin

9. PERFORMING ORGANIZATION NAME AND ADDRESSOffice of Transportation Laboratory
California Department of Transportation
Sacramento, California 95819**10. WORK UNIT No.****11. CONTRACT OR GRANT No.**

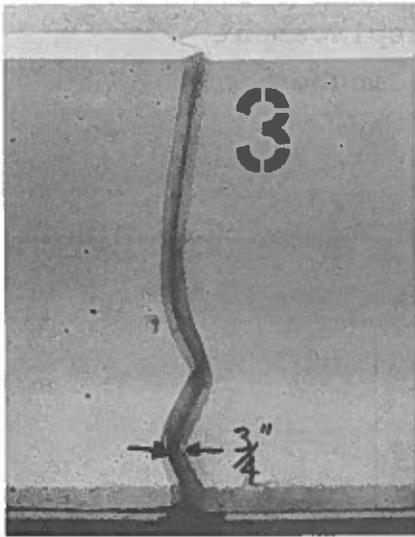
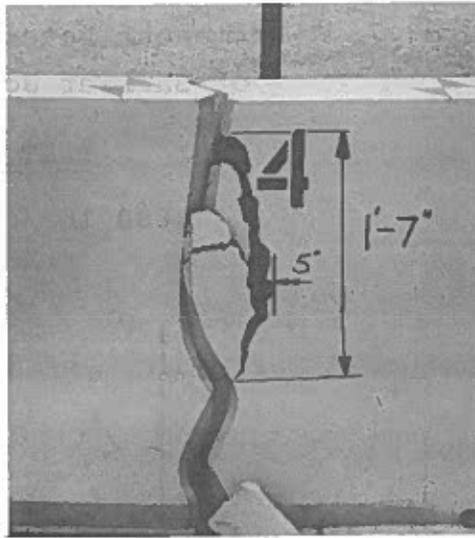
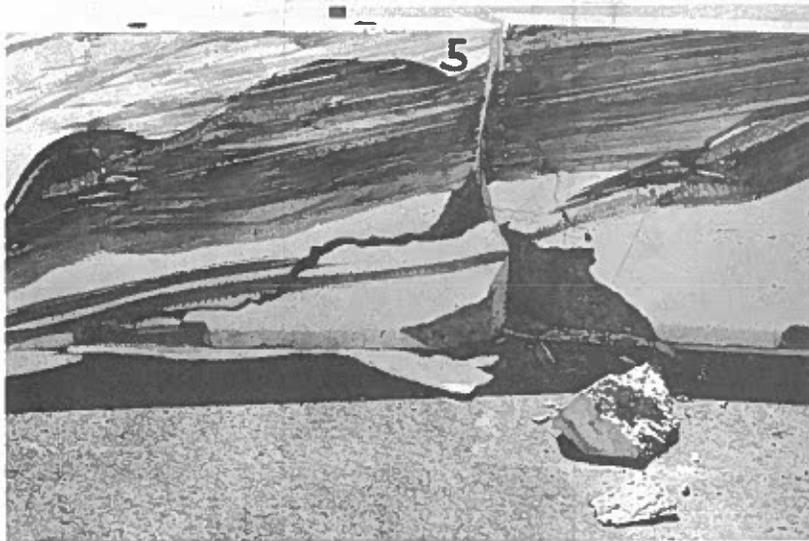
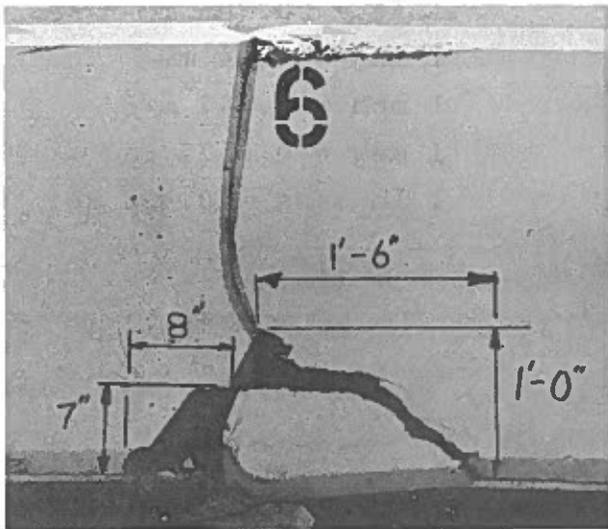
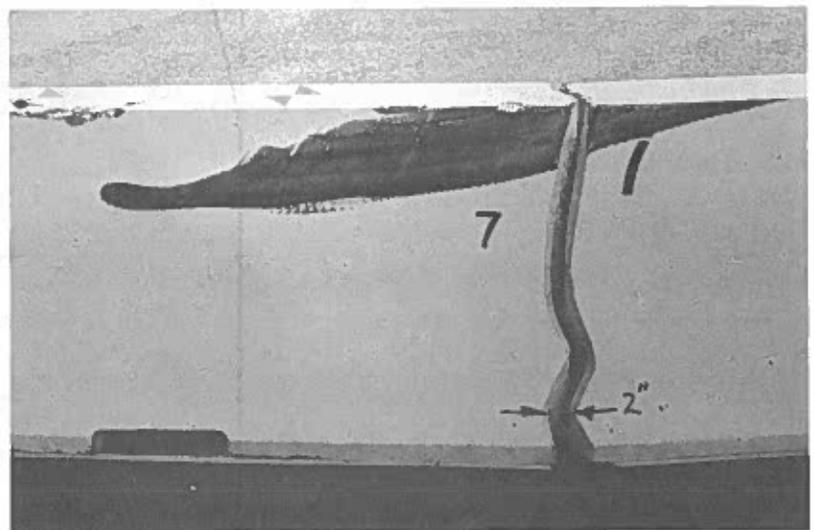
Due to the large deflections and the tight fitting joints there was considerable spalling of the concrete at the corners of the segments, Figures 8 and 9. Figure 10 shows the damage and scuff marks on the barrier where primary vehicle contact occurred.

Figure 8. Barrier Damage and Movement (impact side) at Joints 3, 4, 5, 6 and 7, Test 331.

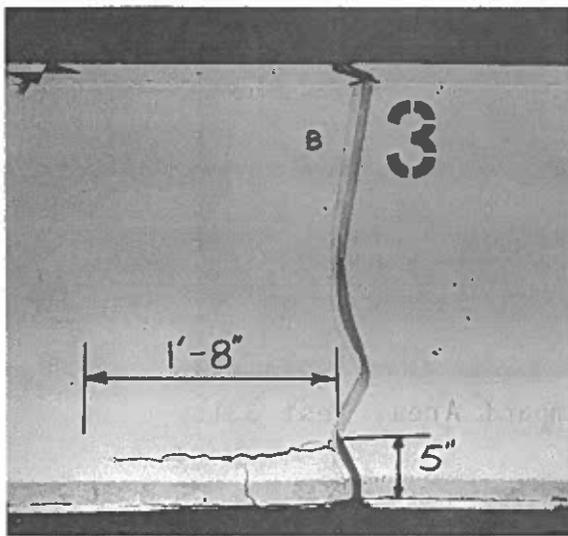
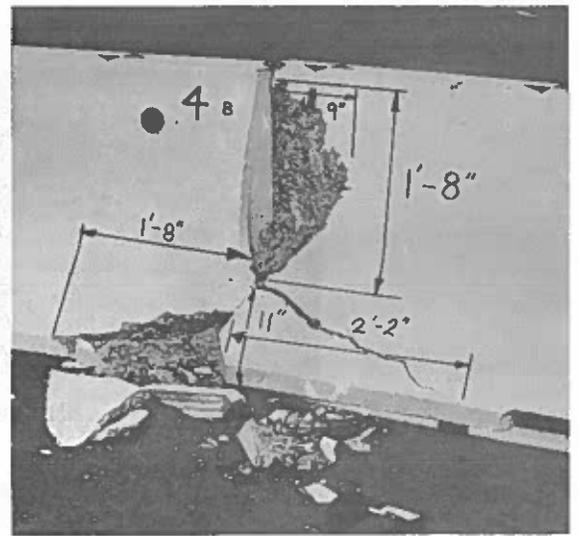
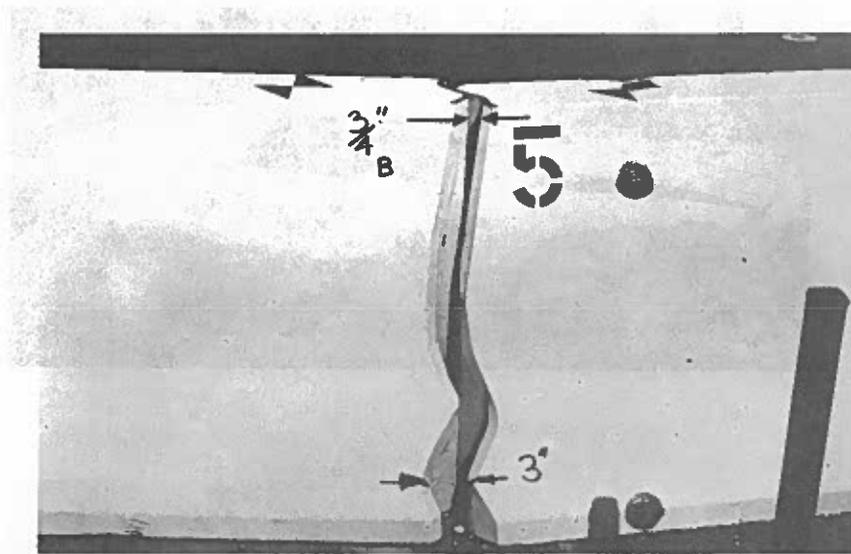
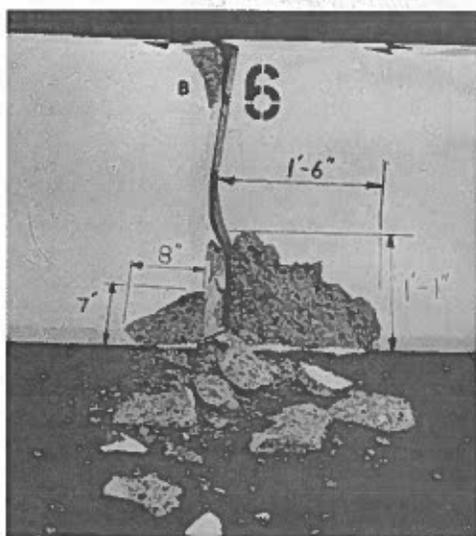
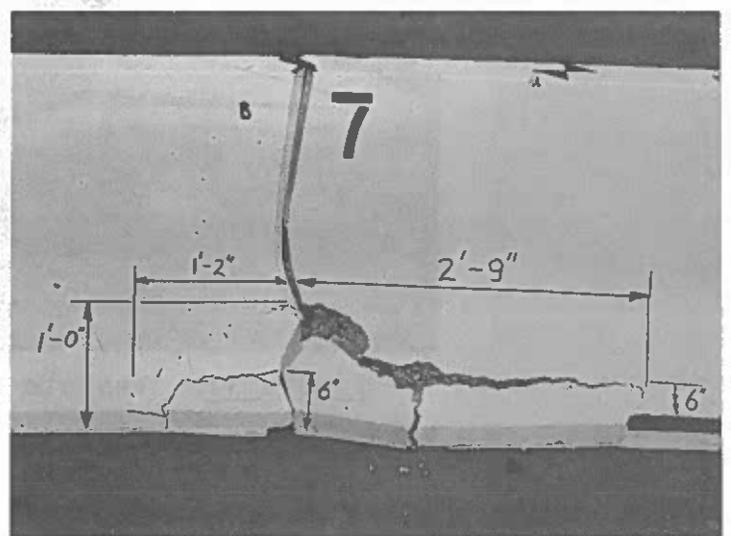
Figure 9. Barrier Damage and Movement (opposite side of impact) at Joints 3, 4, 5, 6 and 7, Test 331.

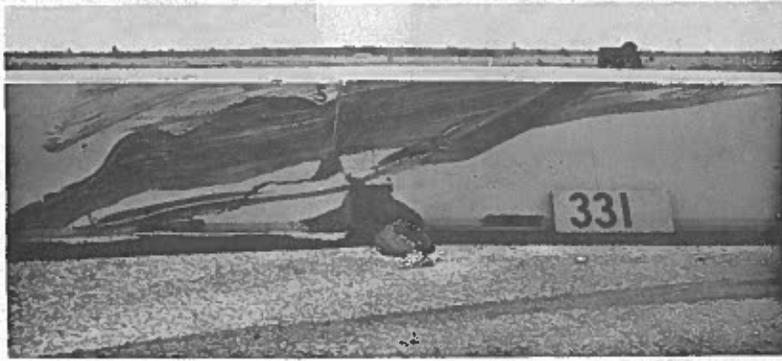
Figure 10. Primary Impact Area, Test 331.

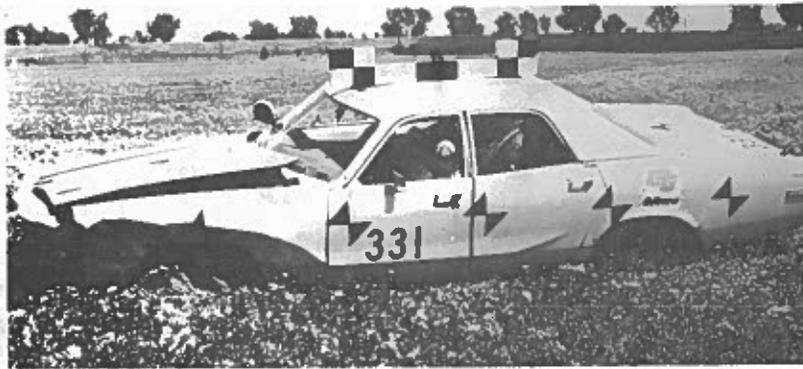
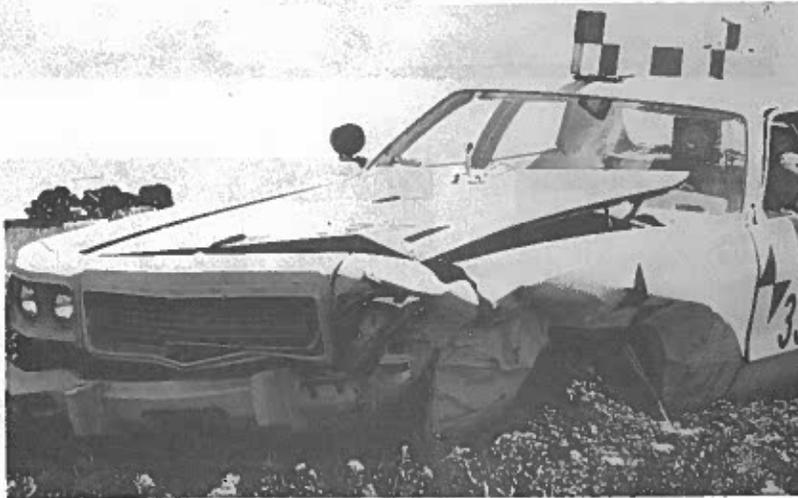
c. Vehicle Damage - Moderately severe crushing was sustained at the left front bumper and quarter panel and extended back to the left front door, Figure 11. There was virtually no other apparent damage around the remaining perimeter of the vehicle. No intrusion of vehicle or barrier parts into the passenger compartment occurred during the test. Damage measurement according to the Traffic Accident Scale (TAD)(9) was LFQ-5 and to the Vehicle Damage Index (VDI)(10) was 10LFEW3.

Figure 11. Vehicle Damage, Test 331.

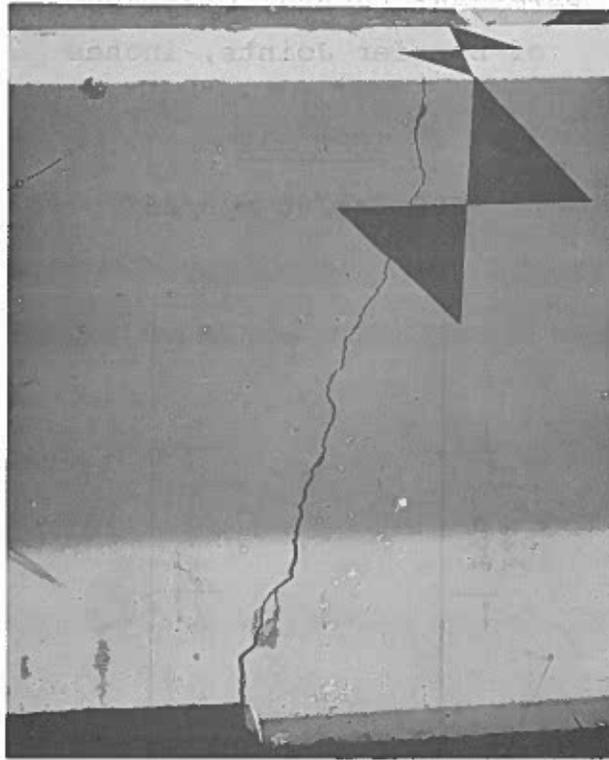
Segment 5, the first segment hit during impact, sustained a flexural failure extending from its downstream scupper opening back towards the middle of the segment, Figure 14.

Figure 14. Flexural Failure in Segment 5, Test 332. View of Side Opposite Impact.

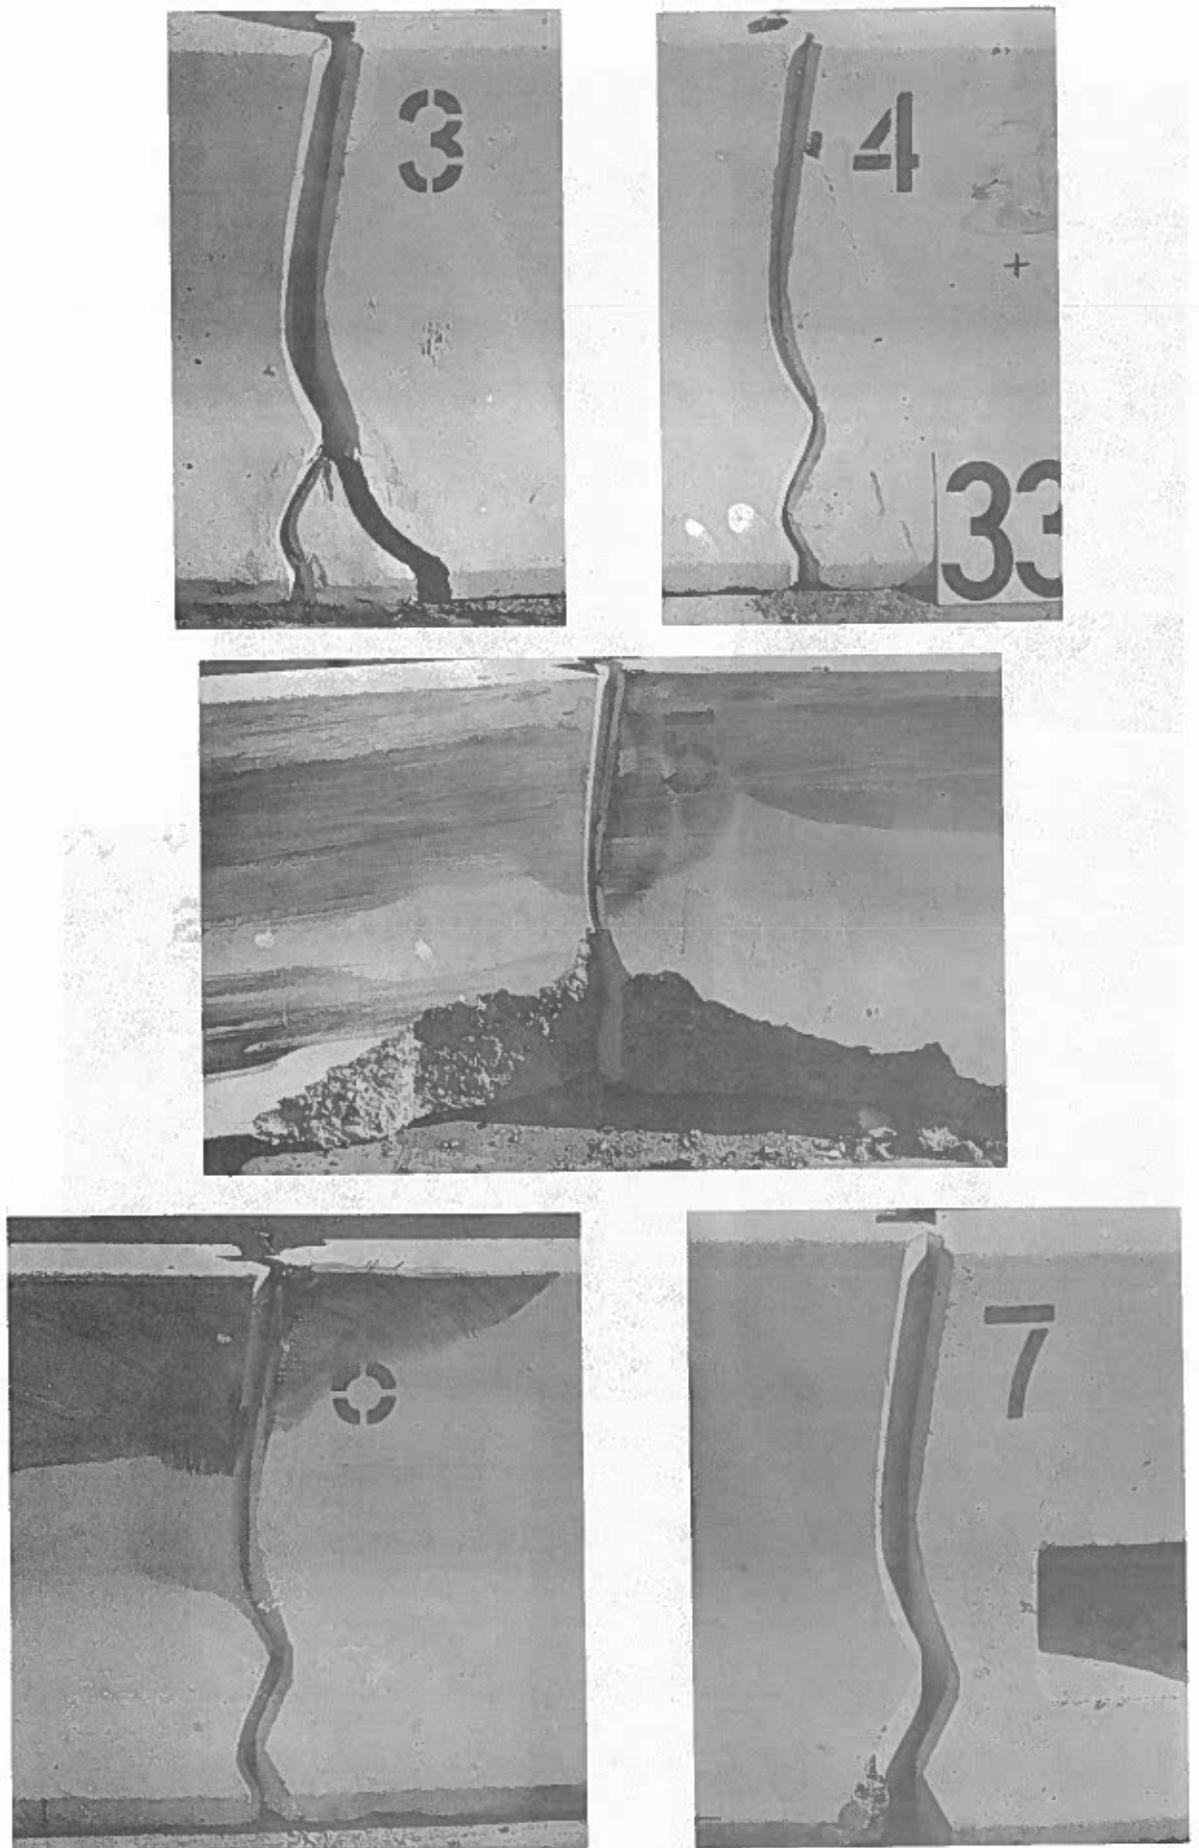
There was also considerable spalling of the concrete at the corners of the segments which moved as shown in Figures 15 and 16. Figure 17 shows the damage and scuff marks on the barrier where vehicle contact occurred.

Figure 15. Barrier Damage and Movement (impact side) at Joints 3, 4, 5, 6 and 7, Test 332.

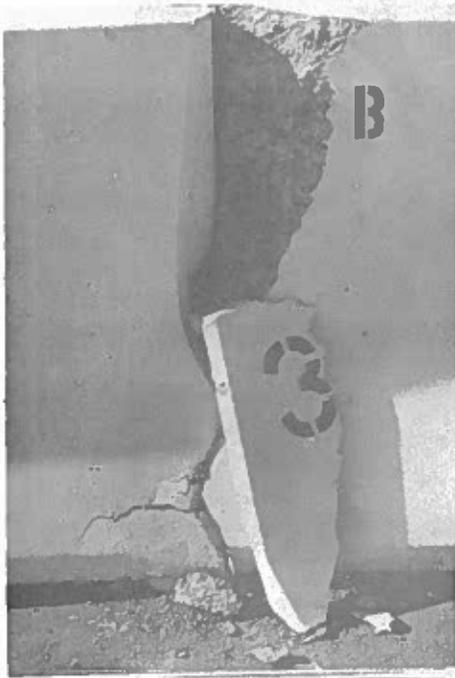
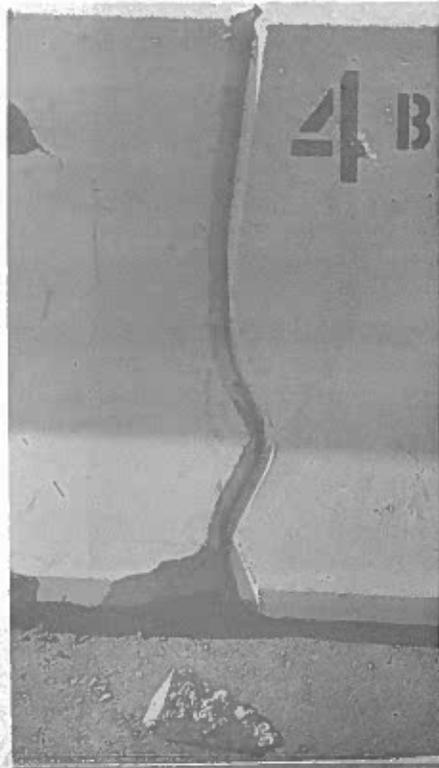
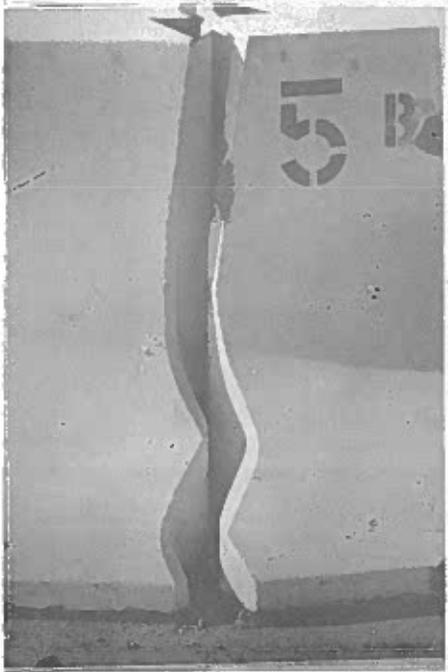
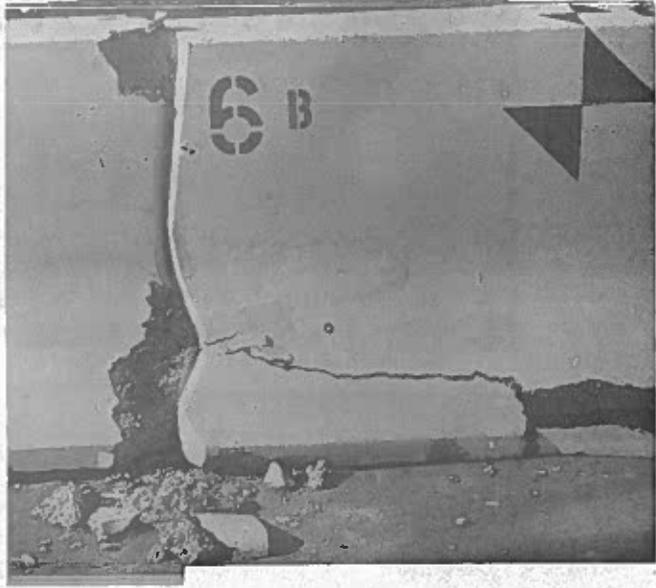
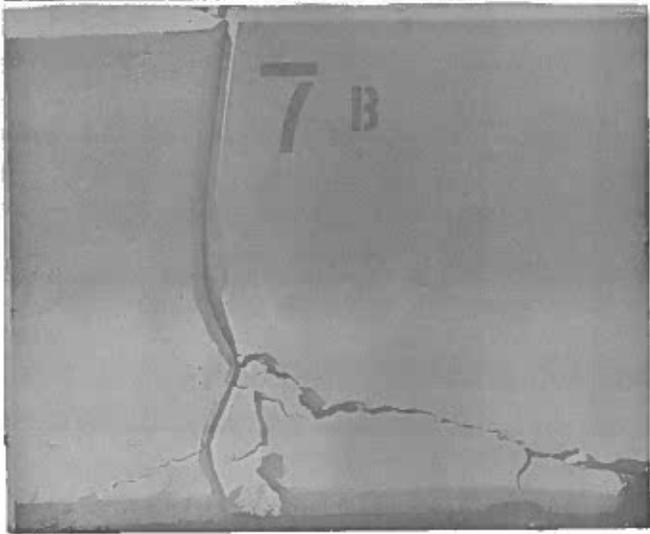
Figure 16. Barrier Damage and Movement (opposite side of impact) at Joints 3, 4, 5, 6 and 7, Test 332.

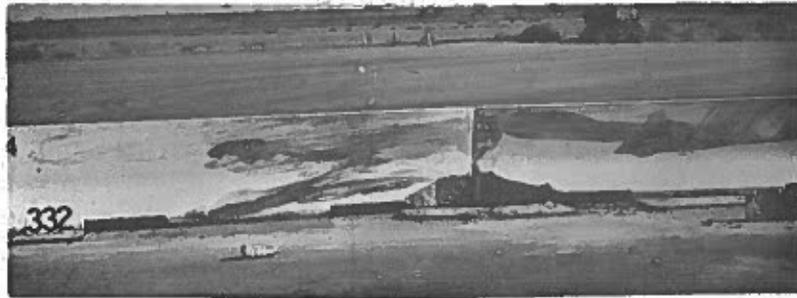
Figure 17. Primary Impact Area, Test 332.

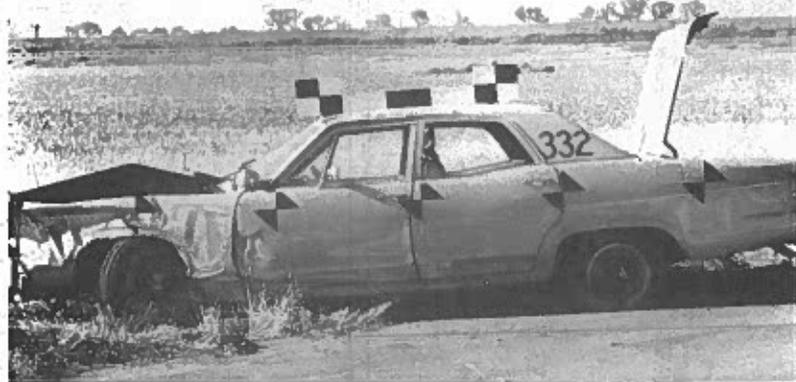
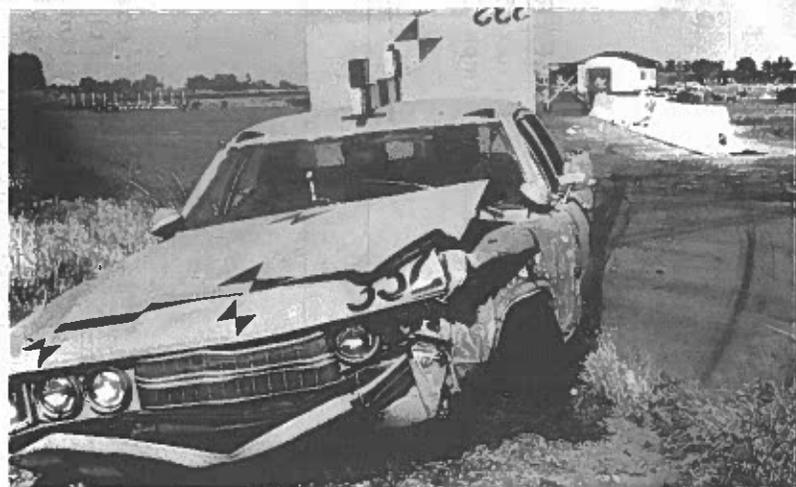
c. Vehicle Damage - Moderately severe crushing was sustained at the left front bumper and quarter panel, Figure 18. The remainder of the left side was scratched and scraped from barrier contact with some light crushing of the left rear sheet metal. No intrusion of vehicle or barrier parts into the passenger compartment occurred during the test. Damage measurement according to the Traffic Accident Scale (TAD)(9) was LFQ-5 and to the Vehicle Damage Index (VDI)(10) was 10LFEW3.

Figure 18. Vehicle Damage, Test 332.

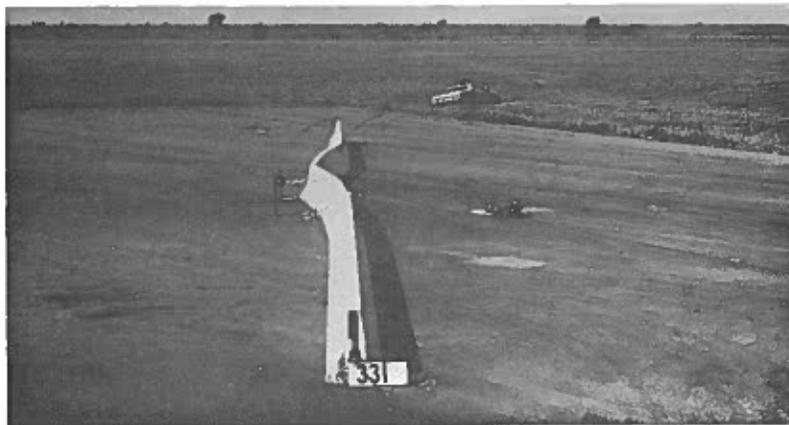
In Test 331 the large barrier deflection caused the vehicle to become airborne on a hazardous trajectory over the top of the barrier. If the barrier had been longer, the vehicle easily might have toppled over the backside of the barrier or rolled over. In Reference 4 more weight was given to tilting of the barrier segments than to lateral deflection as the cause of vehicle vaulting. Due to the low tilt angle of under 6° (0.11 rad) in Test 331 and a lateral deflection more than that in a similar previous Caltrans test, Test 292(4), it now appears that large lateral deflection alone can be a primary cause of vehicle vaulting in severe impact tests. This negates any possible benefits claimed in the form of reduced vehicle decelerations caused by barrier deflection for this type of barrier. It should be noted that differences in vehicle suspensions and crushability also may affect vehicle vaulting tendencies during CMB impacts.

Figure 20, Post Impact Vehicle Trajectory, Test 331

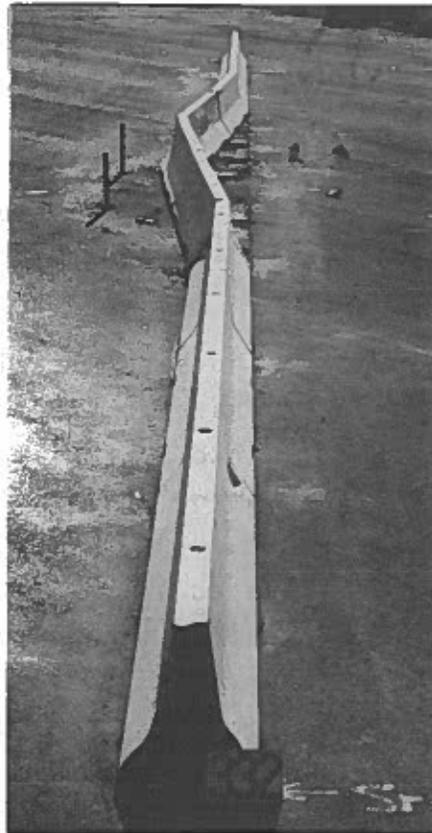
This appraisal factor was covered in the section on Structural Adequacy. In summary, the vehicle trajectory for Test 331 was judged unacceptable. That for Test 332 was relatively good; however, it might have been similar to the one in Test 331 had the vehicle not run over a vehicle guidance system knockoff post. Table 1 and Figures 12 and 19 provide data on the vehicle trajectory. Figures 20 and 21 show the post test trajectories for the two vehicles.

Figure 21. Post Impact Vehicle Trajectory, Test 332.

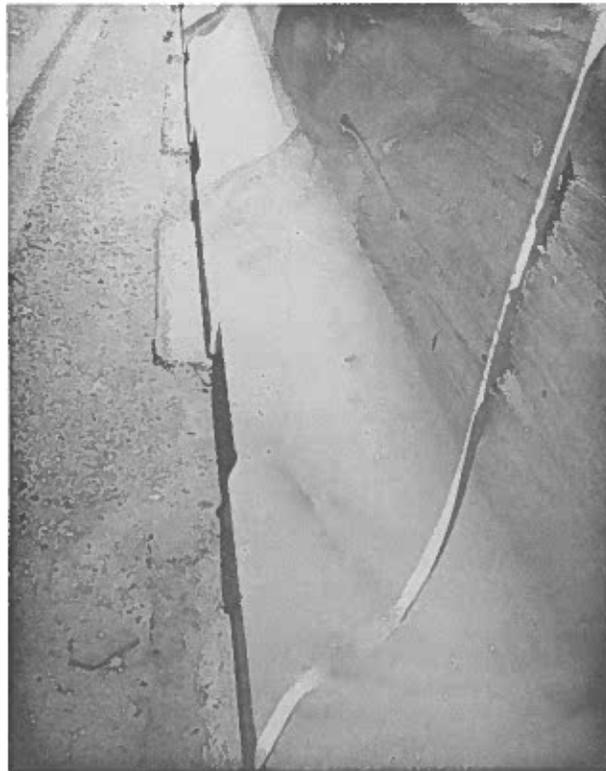
loose from their grout pads. The maximum lateral deflection at one joint was four inches (10 mm), Figure 17A. In at least one accident the vehicle straddled the top of the barrier before returning to the southbound lanes. The barrier segments were fairly tight at the joints, which may have been due in part to a tightening of the "arch" of the horizontal curve as the segments moved laterally to the east. At several of these tight joints there was some cracking and spalling of the concrete. One segment had a crack at mid-length running up the west face and part way down the east face.

Figure 17A. Lateral Barrier Movement, Type 50V Barrier, Santa Cruz County.

Due to the high localized accident frequency, the breaking of the grout bond to the barrier segments, and the movement which had already occurred, it was decided to provide additional lateral restraint for the barrier, or replace it with a continuous cast-in-place or slipformed CMB.
