FHWA/CA/TL-81/14

Vehicular Impact Tests of Breakaway Wood Supports for Dual-Support Roadside Signs

R. L. Stoughton, J. R. Stoker, and E. F. Nordlin

Office of Transportation Laboratory
California Department of Transportation
Sacramento, California 905819

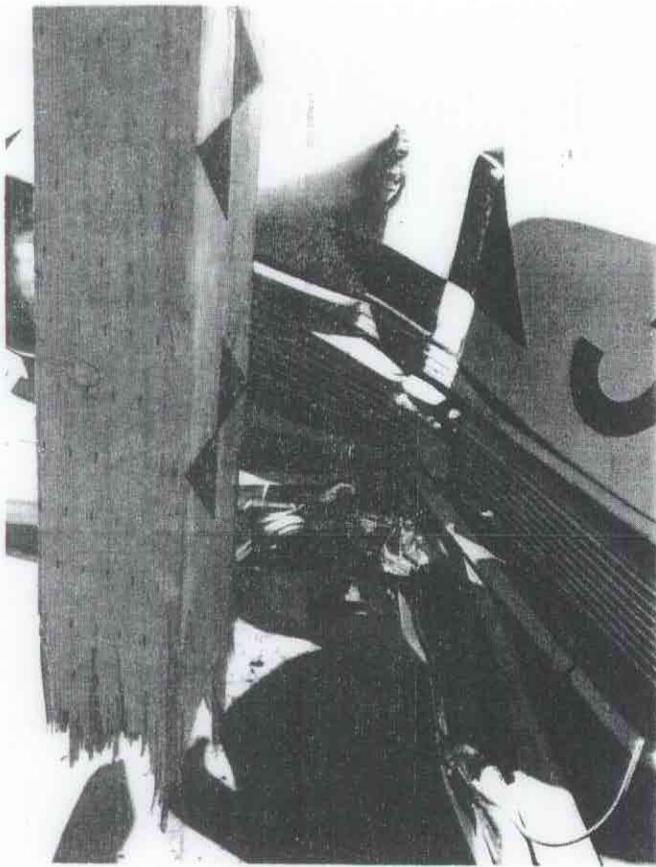
Test 351

Note Post Segment
Under Car

During impact the 30-inch post segment that separated from the main post first split lengthwise into halves with the split passing through the 2 1/2-inch diameter holes. As the upper post section moved forward, the post segment halves below it were loaded independently as cantilevers and failed in bending below ground.

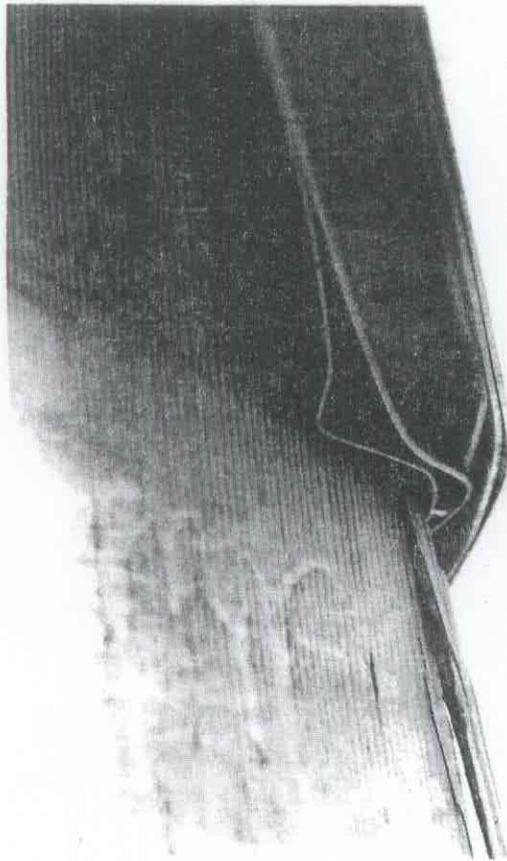
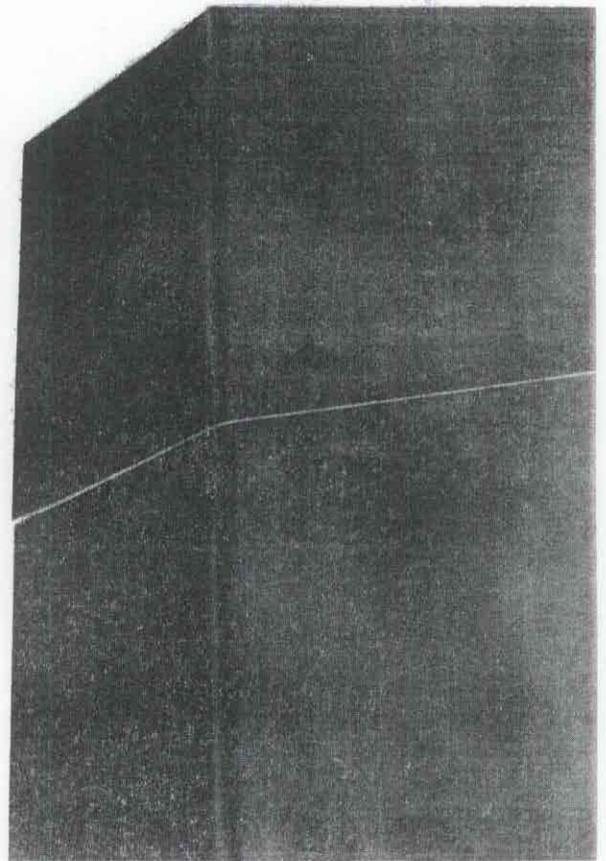
Buckling At Bottom Of Sign Panel

Sign Panel Bent Around
Non-Impacted Post

The sign panel bent around the nonimpacted 6 in. x 8 in. post for the full panel height, and delaminated slightly at the bend. An angle of 77° was measured between the bent sign panel and its original plane. Other than the bend, there was no damage to the sign panel. The bolts which attached the sign panel to the posts did not pull through, and only caused a minor depression in the panel at one bolt location.

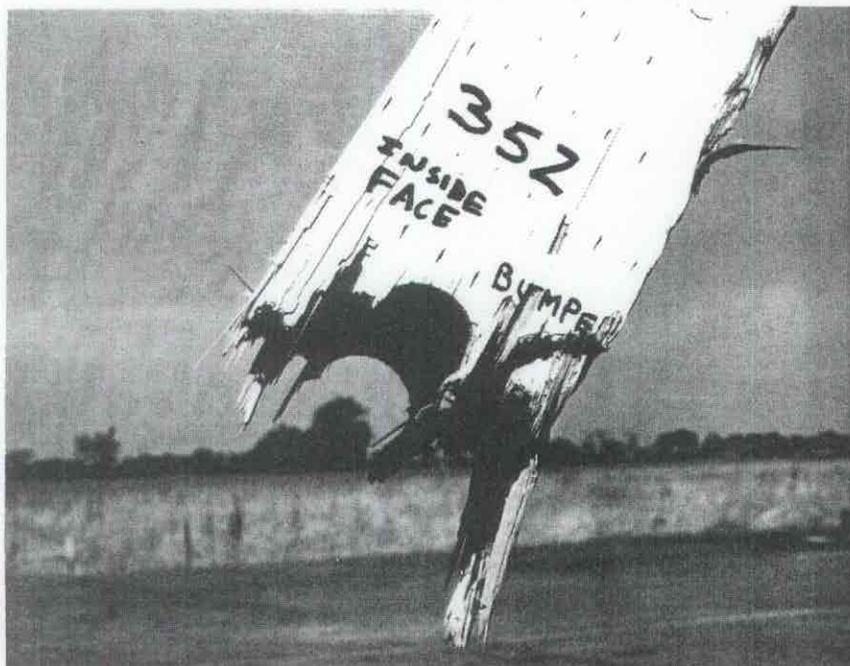
Post Segment

The broken post segment which was lodged underneath the vehicle was 28 inches in length. This segment split lengthwise in halves initially during impact similar to

the post in Test 351. These two halves failed in bending below ground as the car bumper loaded the top of the post segment.

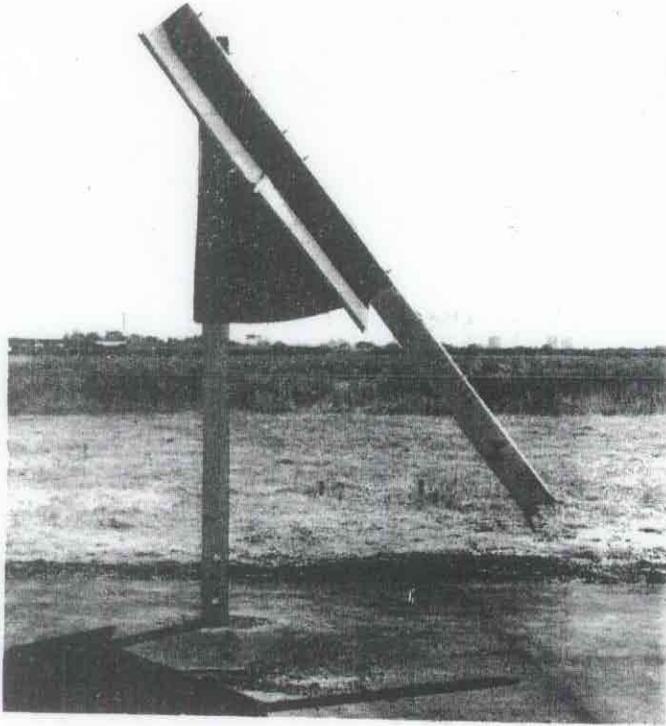
Figure 19

Failure Through Upper
Hole of Post

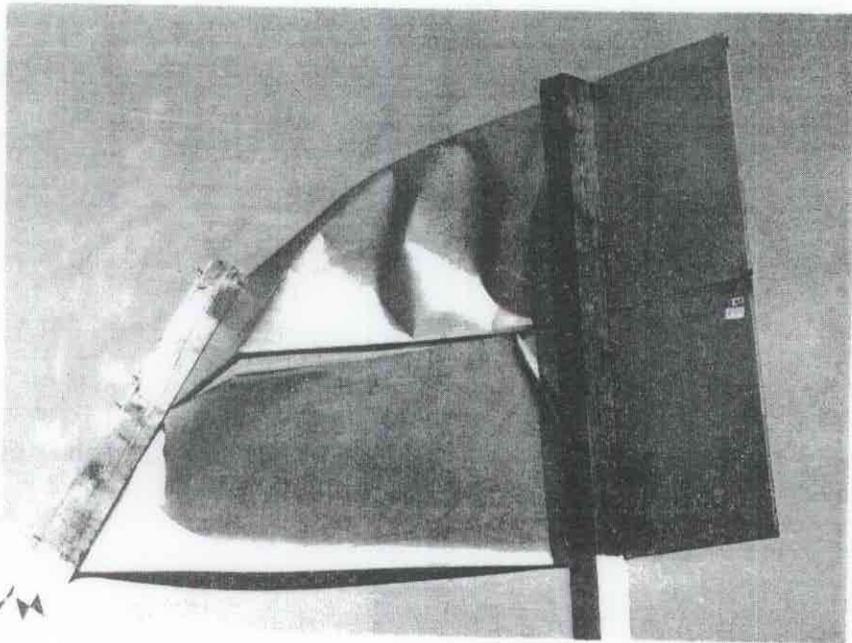
Test 352

Test Sign After Impact

The sign panel buckled near its midpoint between the two supporting posts about an axis parallel to the top of the sign. There was no local buckling around the sign panel bolts. Some separation occurred between the aluminum sheets on the panel and the honeycomb core. The nonimpacted post was not damaged.

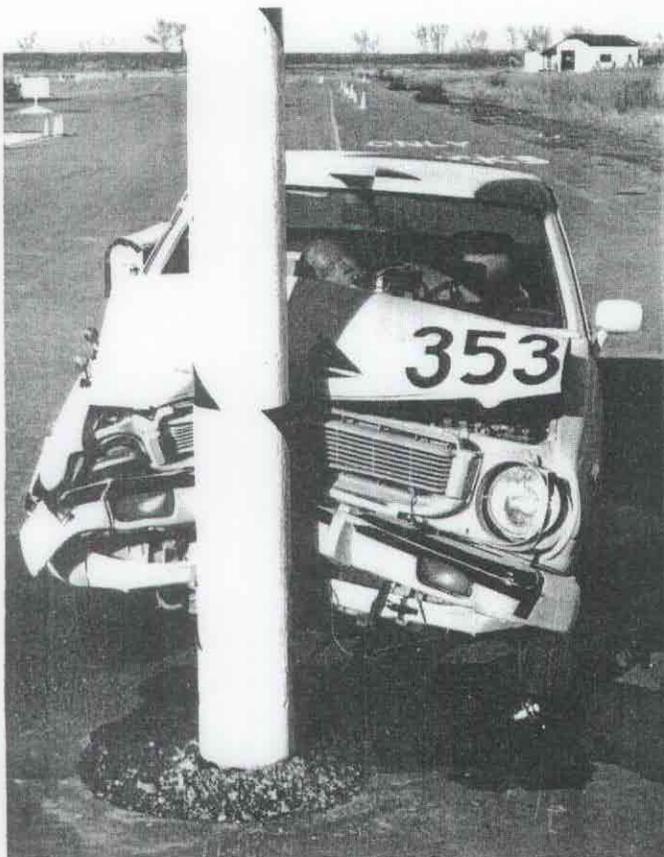
Figure 22

Scuff Marks
Due to Impact

The roadside sign suffered virtually no damage during the impact. The impacted pole was dented and scuffed slightly in the vicinity of the impact zone. There was also a hair-line fracture extending between the breakaway holes in the pole. The high speed movie film showed a crack opening up between the ground and the lower sole in the impacted pole for a few milliseconds after impact and then closing. Both timber poles were pushed forward slightly during the impact. Groundline movements of the impacted pole and the adjacent pole were 3/4 inch and 3/16 inch respectively.

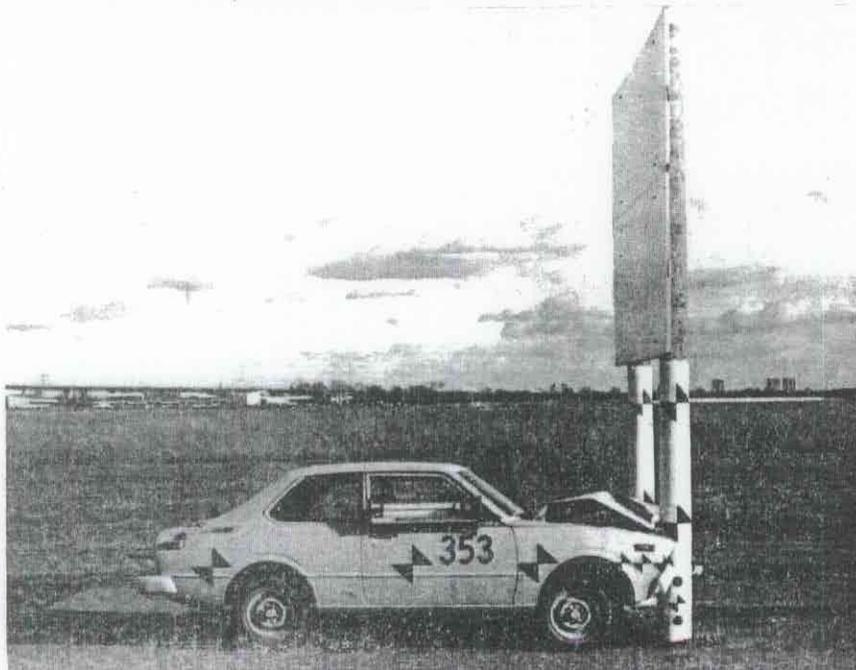
Figure 23

Test Vehicle and
Test Sign After Impact

The test vehicle suffered major front-end damage during the test. Frontal crush of the vehicle was 16 inches, maximum. The right front wheel of the test vehicle was pinned back against the wheel well. The tie rods on this side of the vehicle were also bent. The front bumper, the hood, and the radiator of the test vehicle were all pushed back into the engine block. The radiator was also punctured during the test and fluid started to drain after the impact.

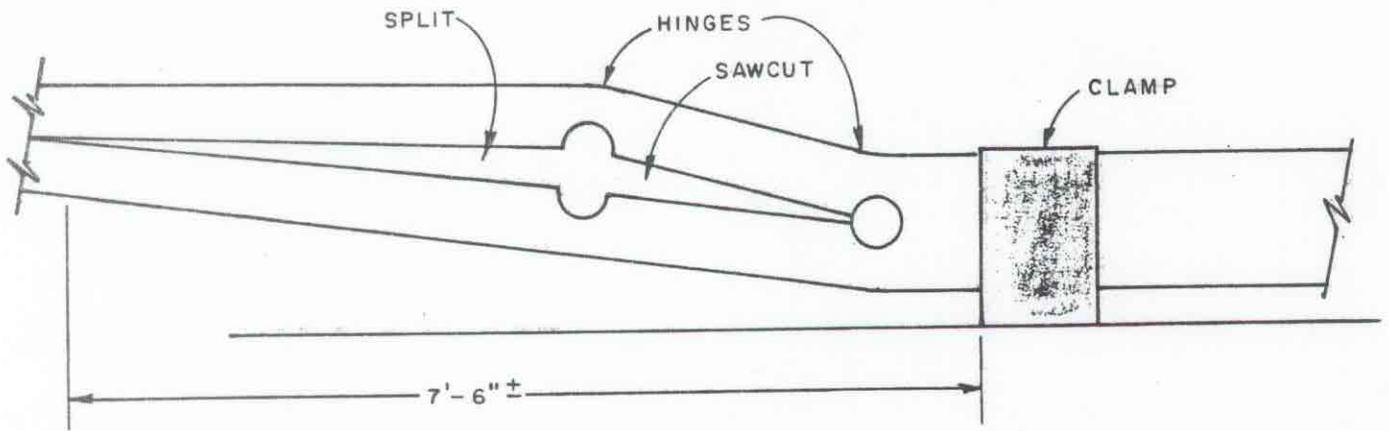
TEST 1

STATIC BEND TESTS-TIMBER POLES FAILURE MODES

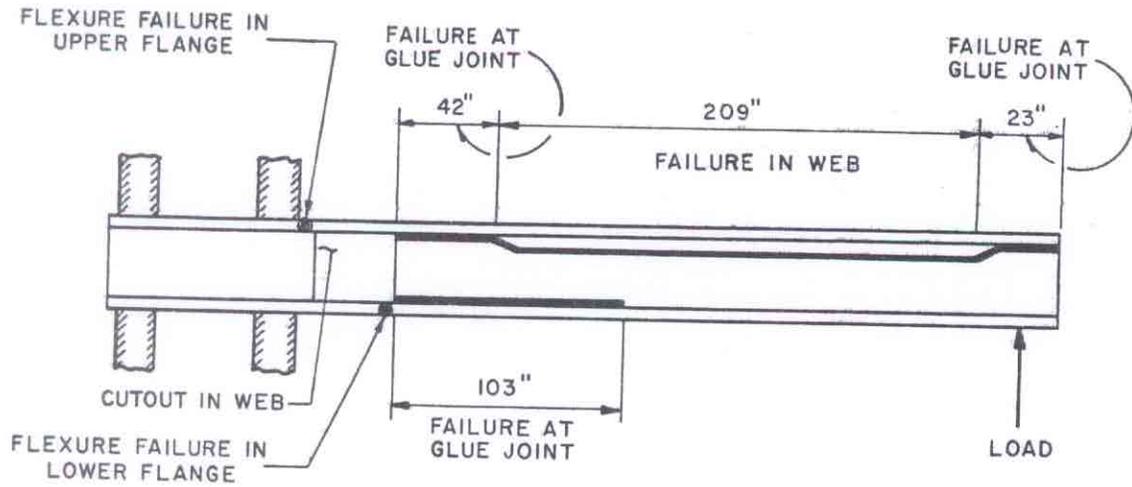
FAILURE MODE - STATIC TEST No. 1

STATIC BEND TESTS ON LAMINATED WOOD VENEER POSTS FAILURE DESCRIPTIONS TESTS No. 1&2

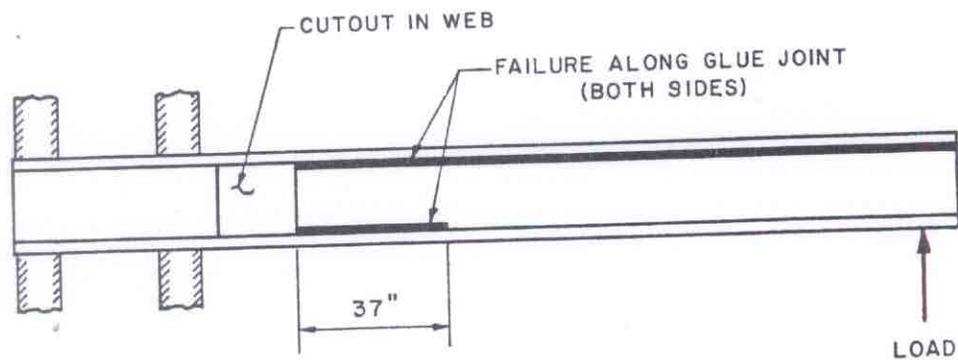
FAILURE MODE - STATIC TEST No. 3

STATIC BEND TESTS ON LAMINATED WOOD VENEER POSTS FAILURE DESCRIPTIONS TESTS No. 3 & 4

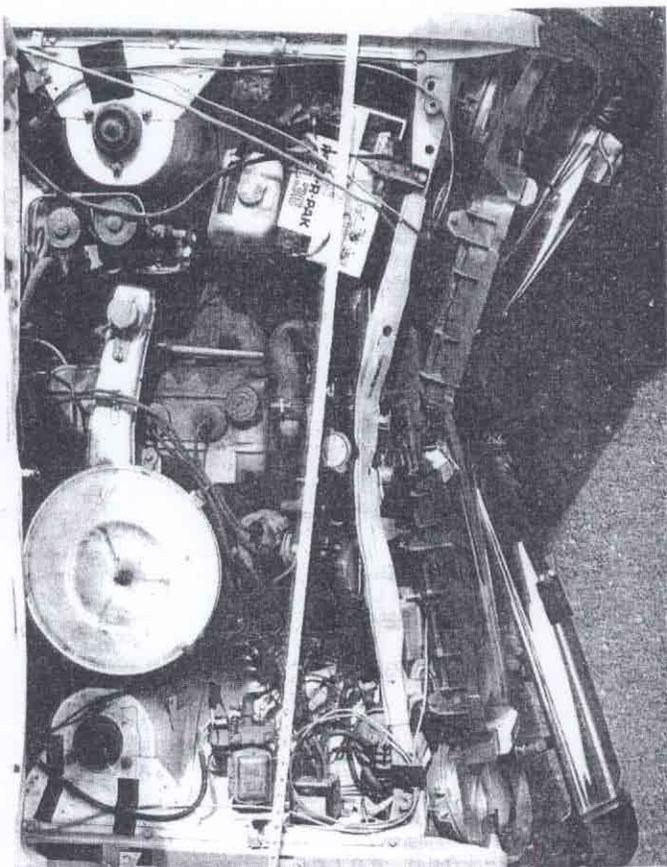
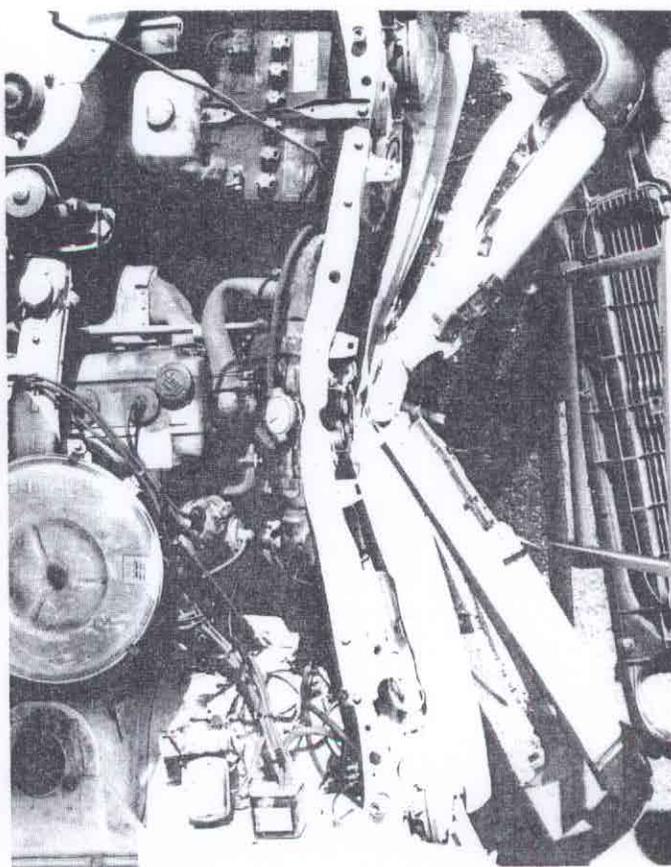
Figure 46 Front of Vehicle Crush

The front of the test vehicle was bent around the 6 in. x 8 in. post during impact. Maximum vehicle crush, measured at the centerline of the vehicle at the top edge of the bumper, was about 9 inches, slightly more than in Test 351. Fluid was leaking from the radiator which was pushed back to the engine block during impact. The cross member supporting the radiator was pushed back about 4 inches by the dislodged post segment. The vehicle could not be driven away after impact. There was no intrusion of vehicle or sign components into the passenger compartment after impact.

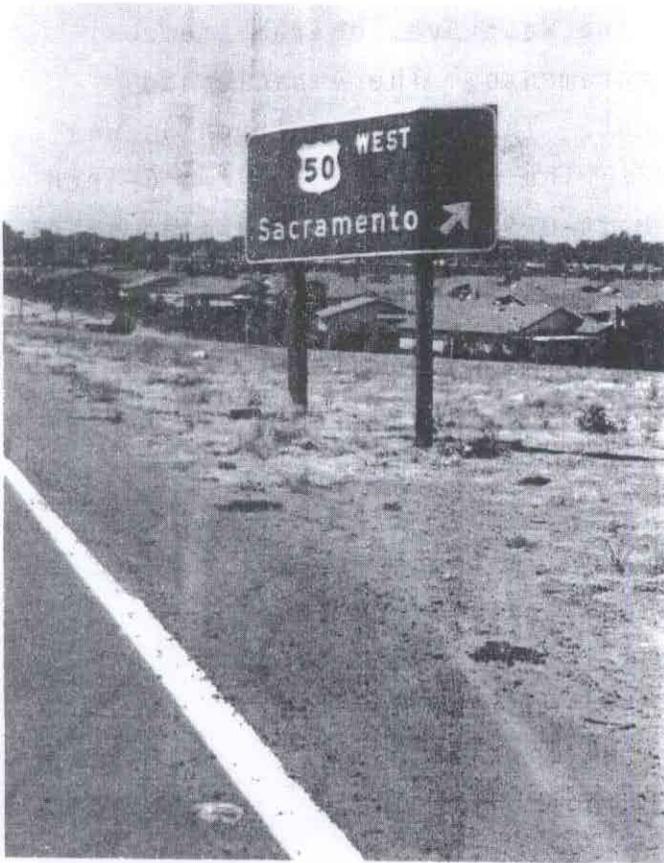
Figure 51

1. A two-post sign was on the Watt Ave. on-ramp to west bound Highway 50 going to Sacramento. The vehicle had left the scene of the accident. The sign construction was similar to that for Test 351. The supports were two 6-inch x 8-inch D.F. posts spaced 8 ft-0 in. apart. The sign panel was 1 1/8 in. x 5 ft-0 in. x 13 ft-0 in. It was connected to the posts with four 3/8-inch diameter bolts and had a ground clearance of 7 ft-0 in. The breakaway holes were 2 1/4-inch in diameter (should have been 2 1/2 inches) and were 6 and 18 inches above ground. Both post holes were not completely backfilled by about 1 ft-0 in. The left side post was impacted about 6 inches to the right of the left front wheel. Wheel tracks were about 48 to 55 inches wide indicating a small car (a Pinto is 55 inches). There were 80 feet of skid marks on the pavement upstream from the gore area, tire tracks on the grassy gore surface, and 30 feet of tire tracks beyond the sign. The impacted post broke off at the upper hole 18 inches above ground and 24 inches below ground. The 42-inch long broken post segment was split through the holes like the ones in Test 351 and 352. The other post was not damaged. The sign panel bent around the undamaged post. The damaged sign is shown in Figure 51.

Accident at Watt Ave.
and Highway 50

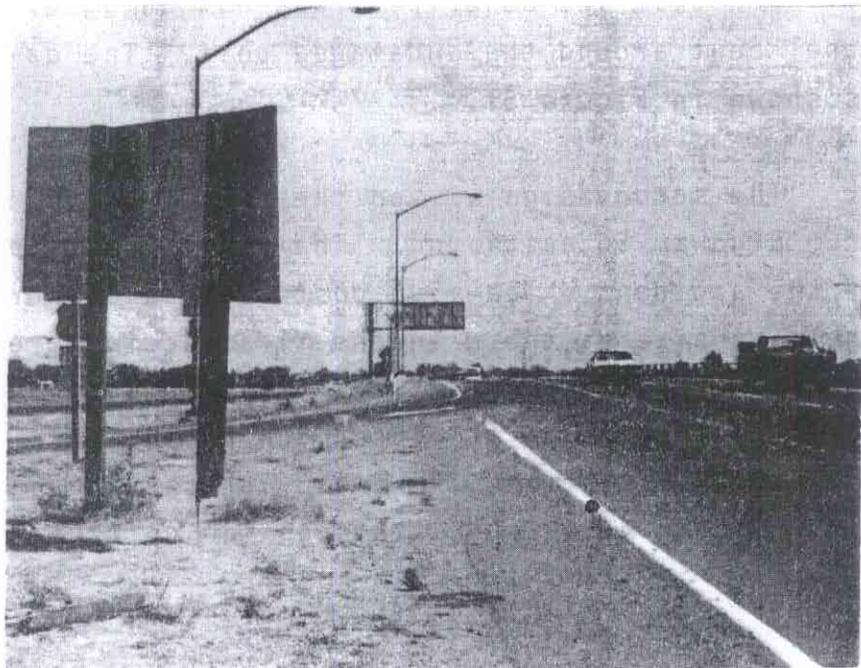
2. The second sign was on the Sunrise Blvd. off-ramp from Highway 50 eastbound. The vehicle had left the scene of the accident. The sign posts and panel were exactly the same size as those in the first accident except that the drilled holes were 2 1/2 inches in diameter. The sign was mounted on a 6-inch high raised gore surface and was 53.5 feet back from the nose of this gore surface. The impacted post failed through the upstream face at the

upper hole diagonally down to the downstream face of the lower hole with considerable splintering. This mode of failure was probably influenced by the asphalt concrete surface that surrounded the base of the post. The adjacent post was not damaged. The impacting vehicle struck the post about 8 inches off-center. The vehicle was skidding before it mounted the 6-inch high gore surface, and left 23- and 47-foot skids on top of the gore surface. These marks stopped 10 feet beyond the sign. Wheel track width was 62.5 inches indicating a large car. The bumper height was estimated at 20.5 inches based on markings on the post. The sign panel bent along the edge of the undamaged post. The damaged sign is shown in Figure 52. No accident reports were ever filed on either of the two above accidents.
